Inspection Photos
Location Name: CAERUS PICEANCE LLC O19E Pad
Location #: 334790

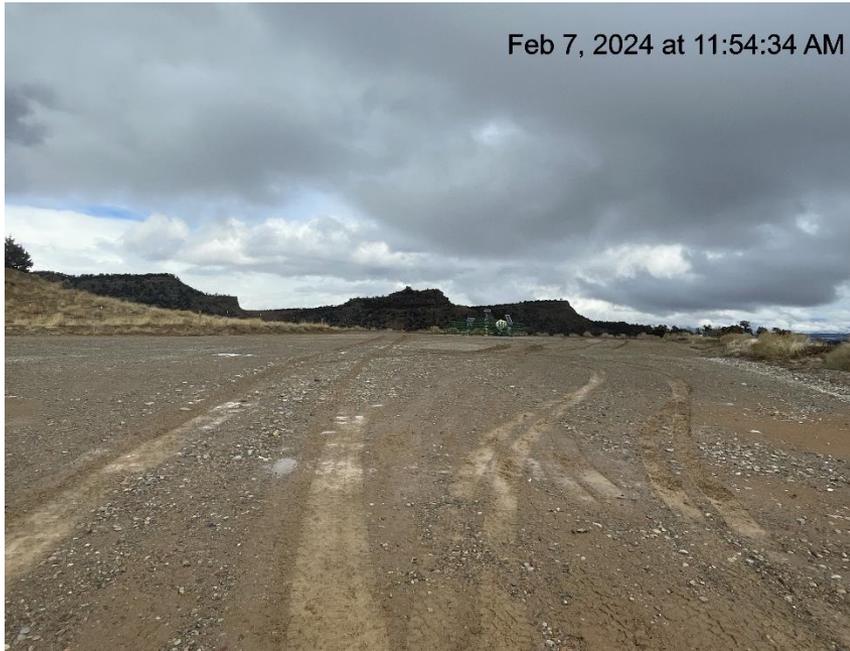
Photo # 5959 From entrance to location

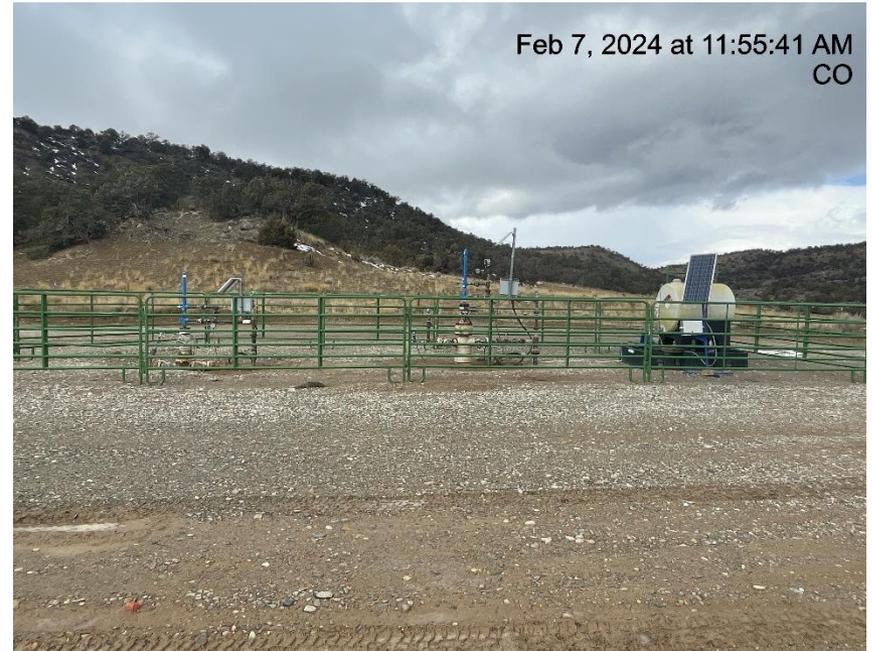
Photo # 5960 Location

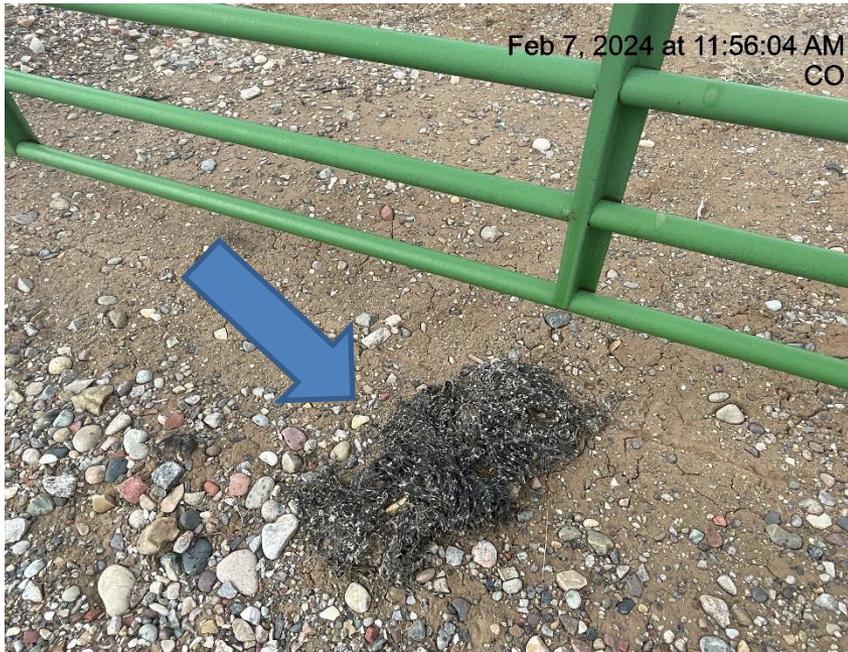
Photo # 5961 Debris

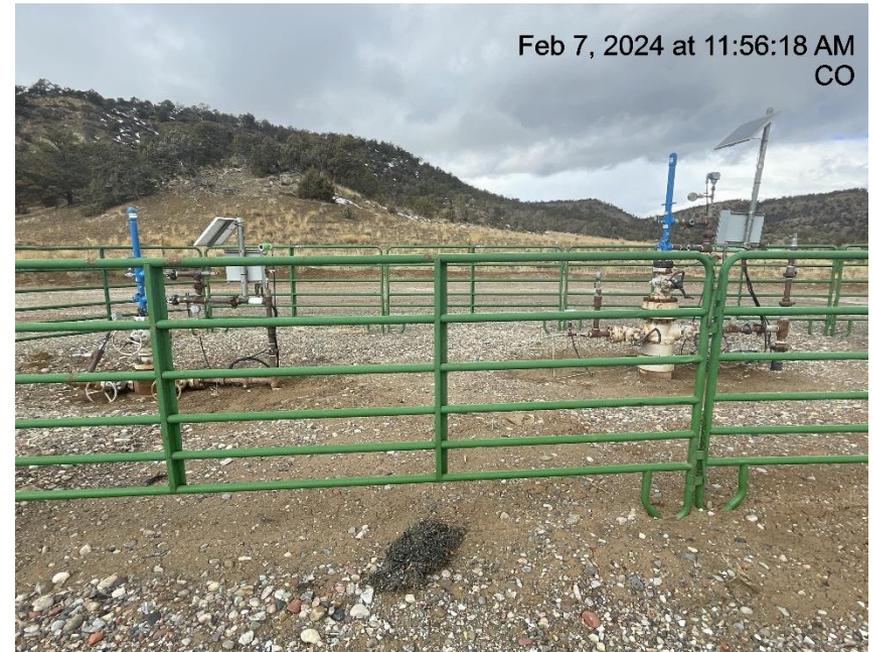
Photo # 5962 Wellheads lack required signage/signs missing required information

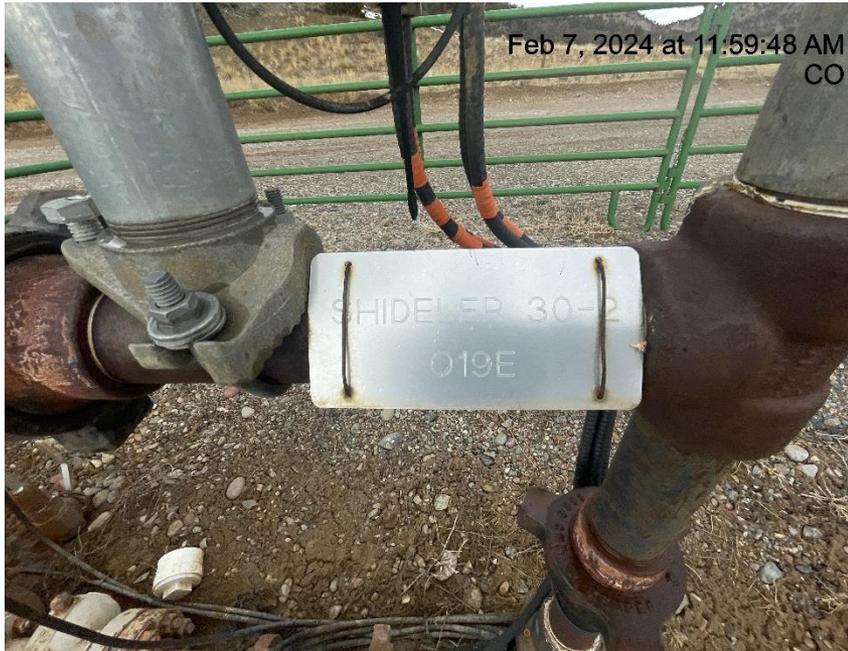
Photo # 5963 Wellheads lack required signage/signs missing required information

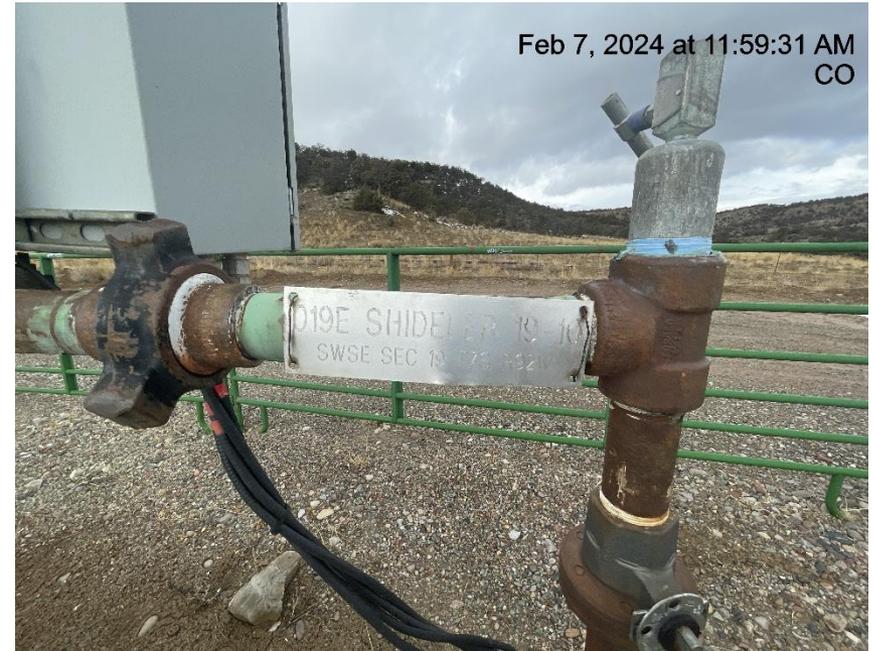
Photo # 5964 Wellheads lack required signage/signs missing required information
