Inspection Photos

Location Name: TEP ROCKY MOUNTAIN LLC, CHEVRON-66S96W/8SESE

Location ID: 335634

Date: 2/8/2024

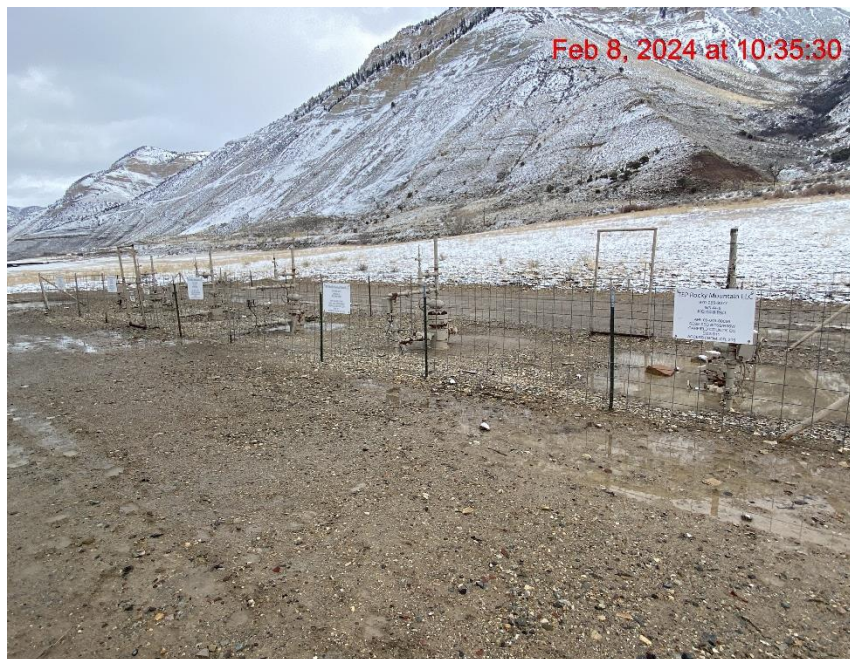
Wellheads – Photo #09185

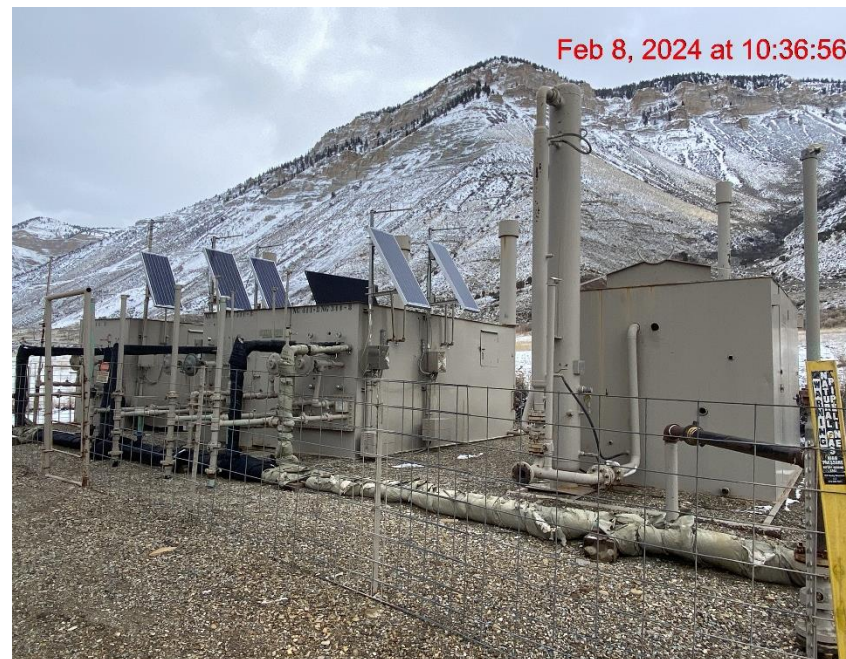
Separators – Photo #09189

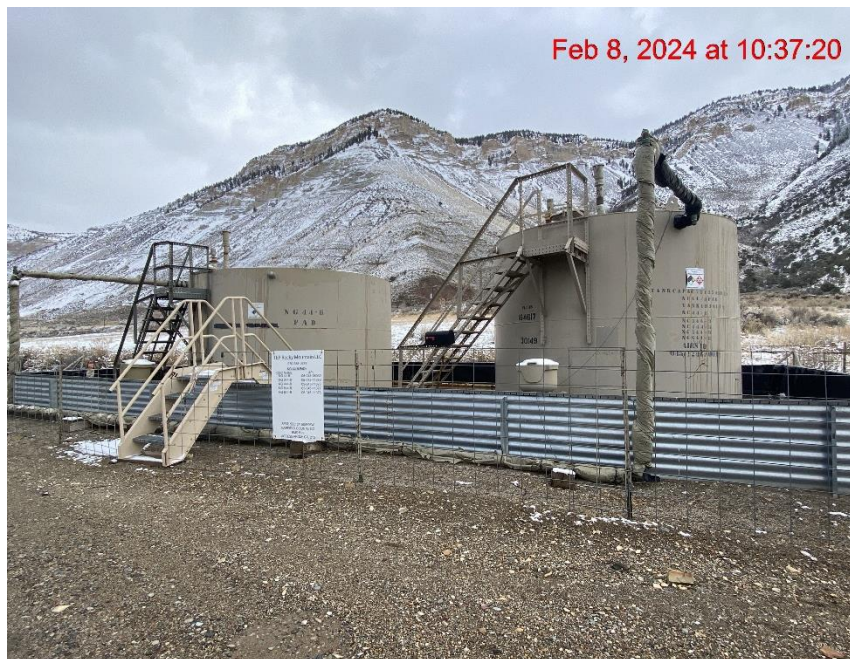
Tank Battery – Photo #09190

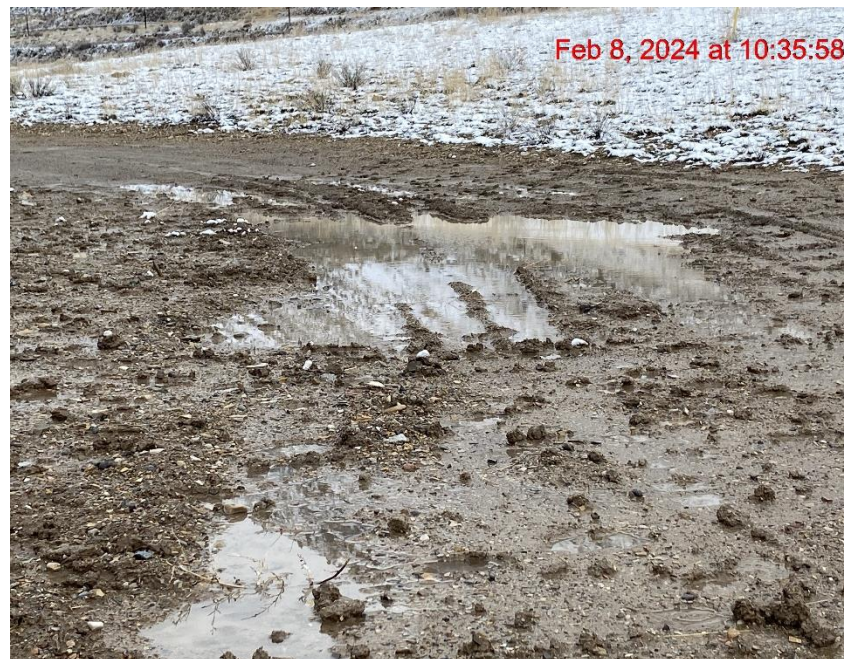
Lack of Stabilization – Photo #09187

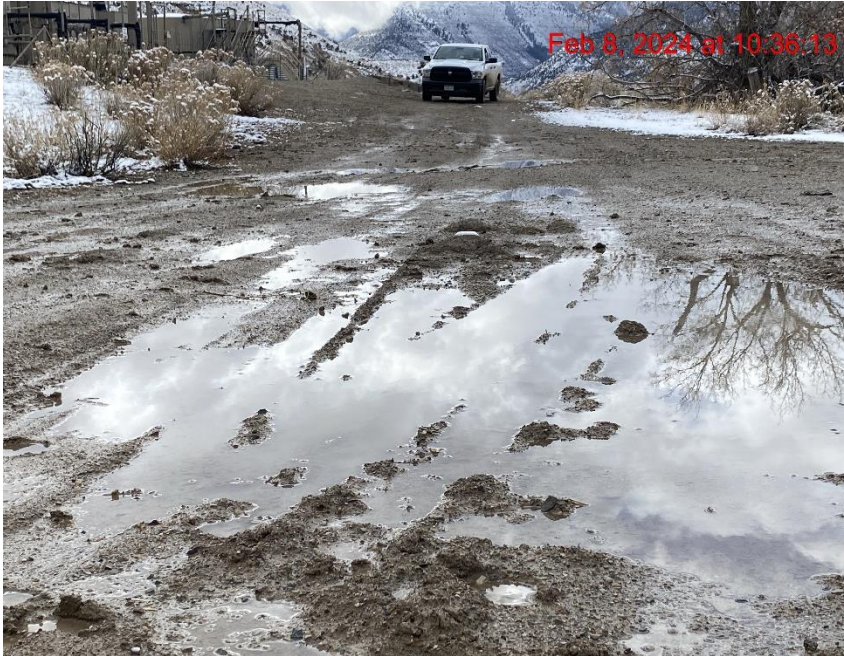
Lack of Stabilization – Photo #09188

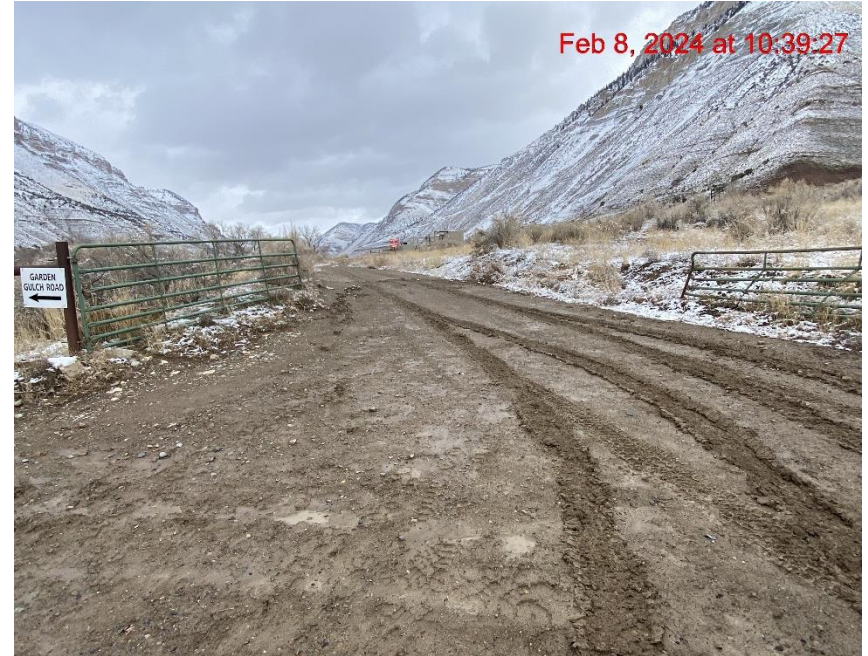
**Insufficient Vehicle Tracking BMPs at Location Entrance/Exit
– Photo #09194**
