KP Kauffman - COGCC Inspection Photos
Location: Johnson #1 Flowline Release
Spill ID #485936 Date 02/09/2024

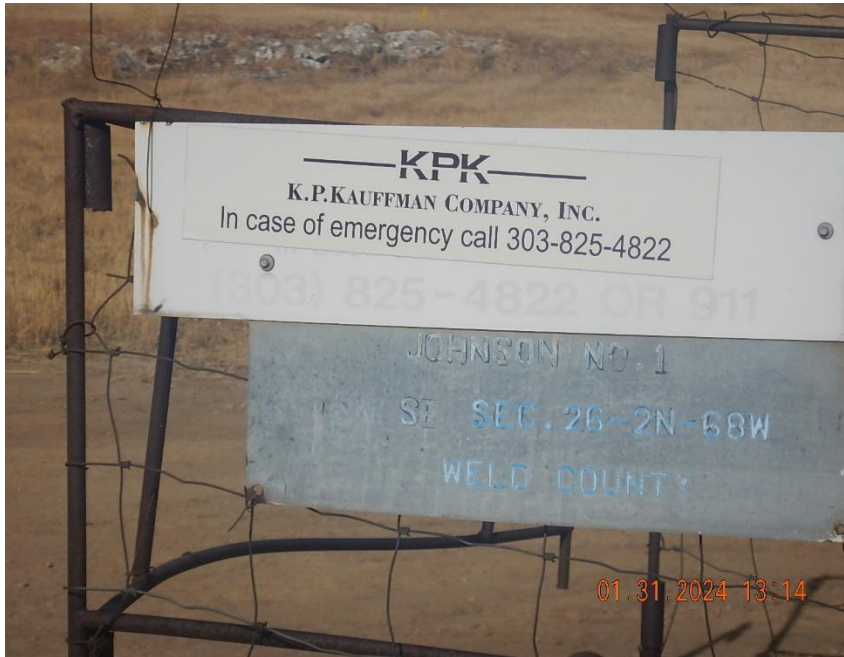
Signage at Johnson #1 Well

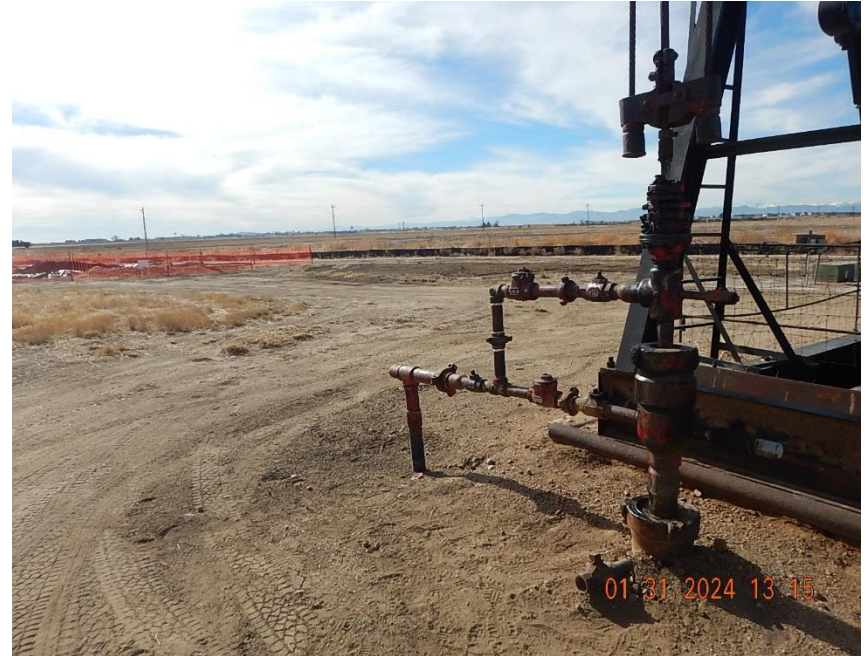
View south from Johnson #1 wellhead to fenced excavation area where release occurred. Well is (SI); No OOSLAT in place at wellhead.

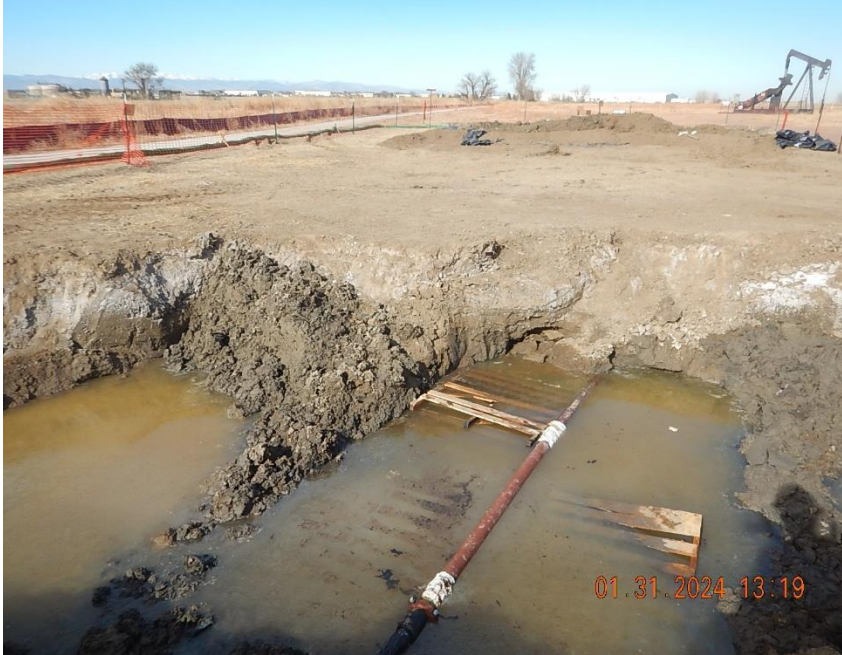
View of on location flowline pipe exposed in excavation; replacement section of 3" OD fiberglass pipe in area of failure.

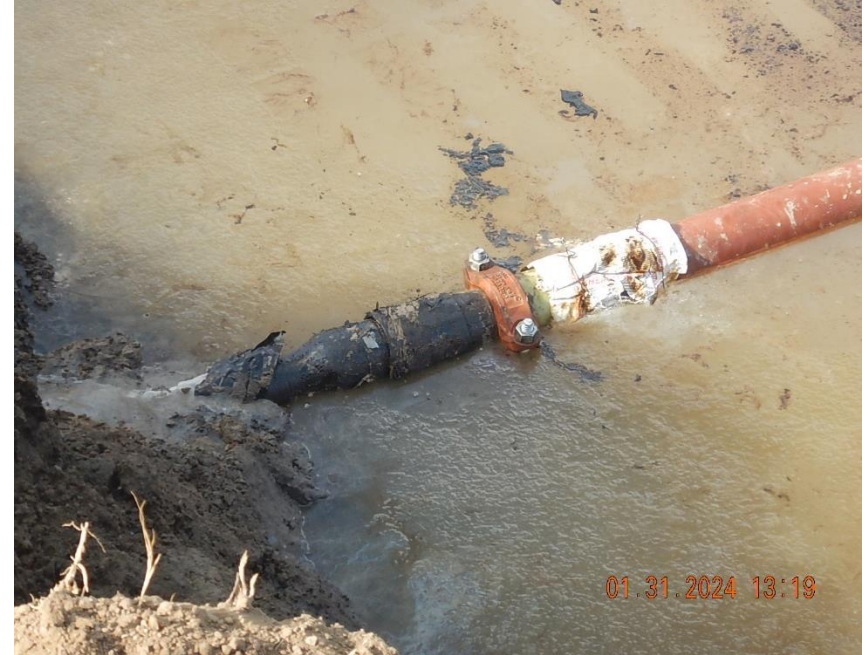
View of transitional fittings used to connect 3" OD fiberglass pipe to existing 2" carbon steel flowline pipe at south wall of excavation. Threaded fitting connections and a bolted clamp are being used; external pipe coating appears to be inadequate to protect from external and/ or thread corrosion.

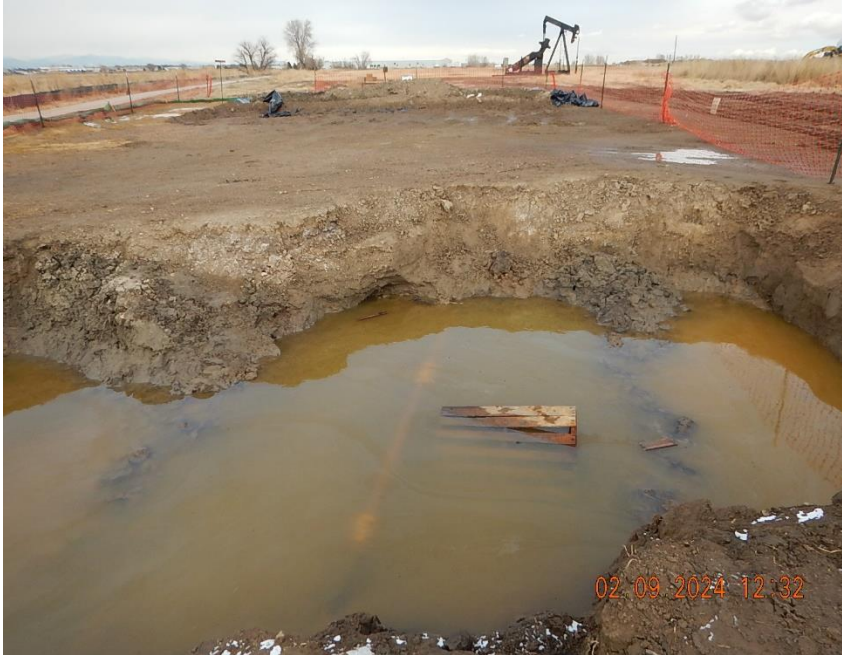
View of flowline pipe exposed in excavation; replacement section of fiberglass pipe is submerged under water/ fluids.

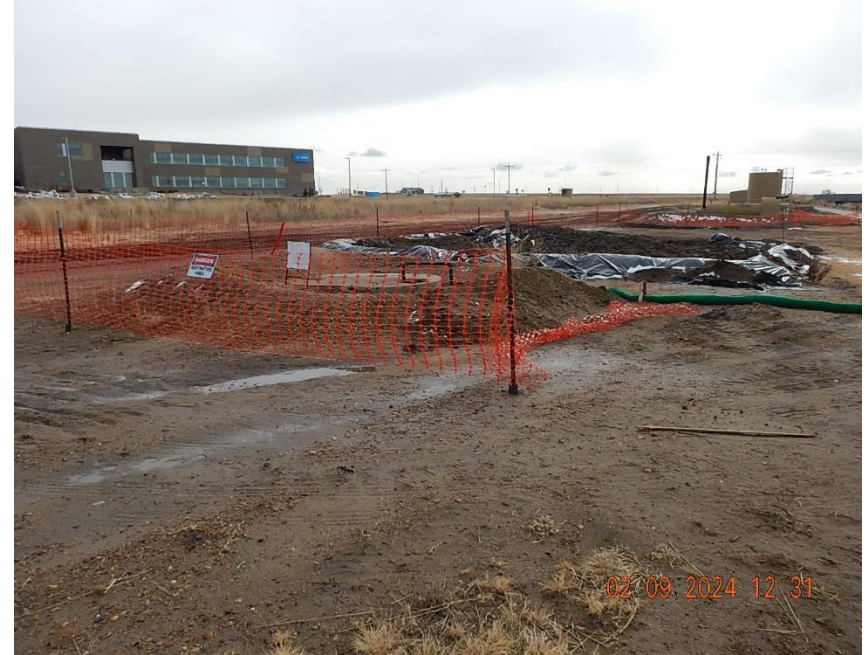
View of soils stockpile and fenced excavation/ work areas on location.
