Inspection Photos
Location Name: Lansons Farm 6
Location ID: 317931

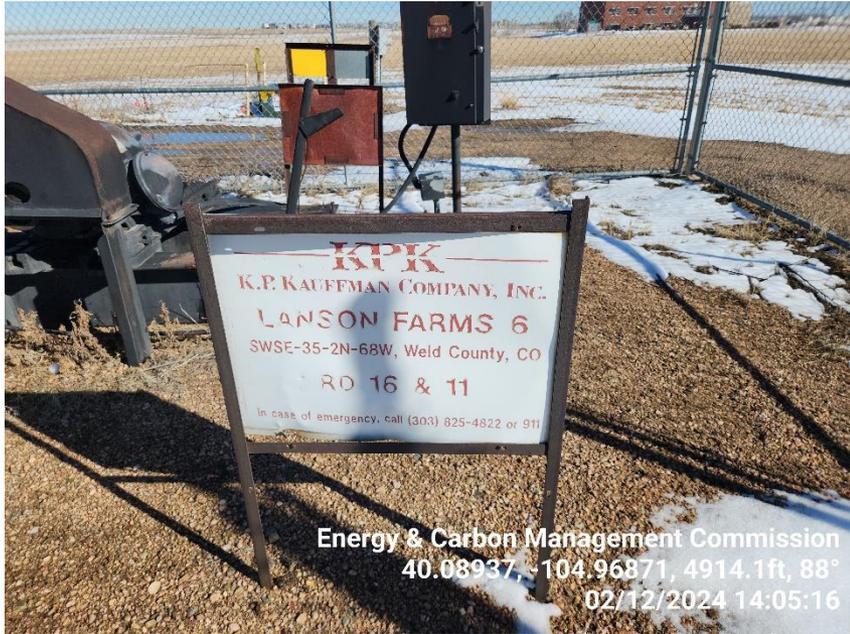
Photo 3 WH sign is faded.

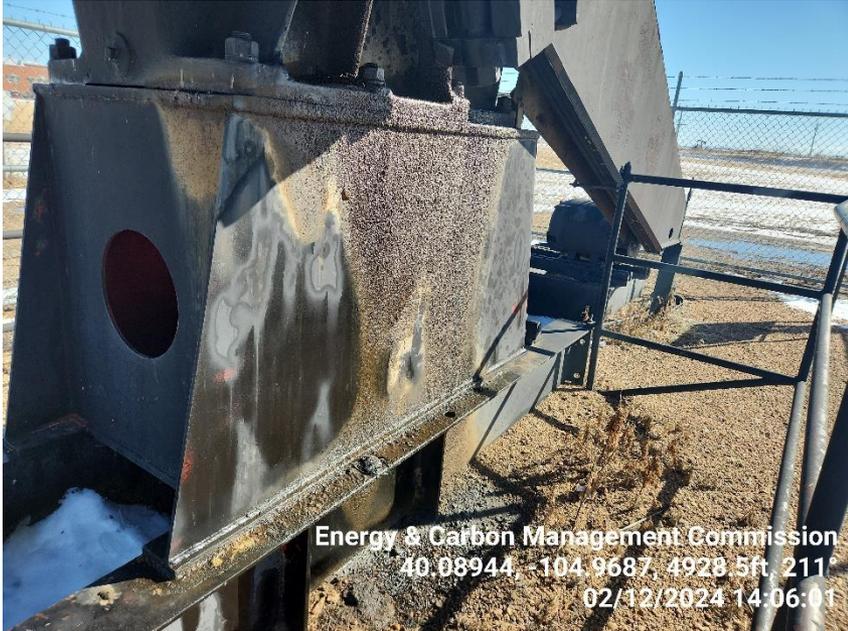
Photo 7 Gear box on the pump jack is leaking oil onto the ground.

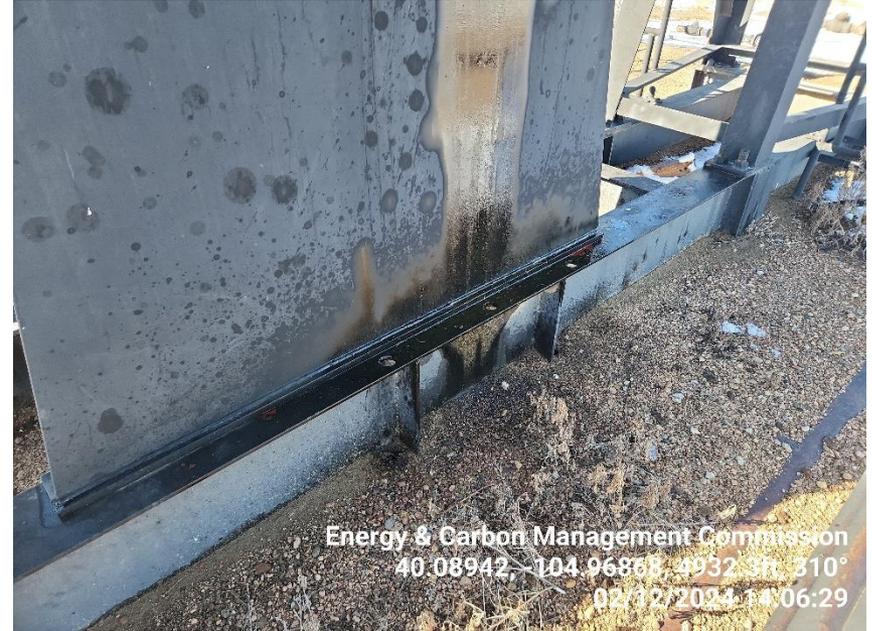
Photo 8 Gear box on the pump jack is leaking oil onto the ground..

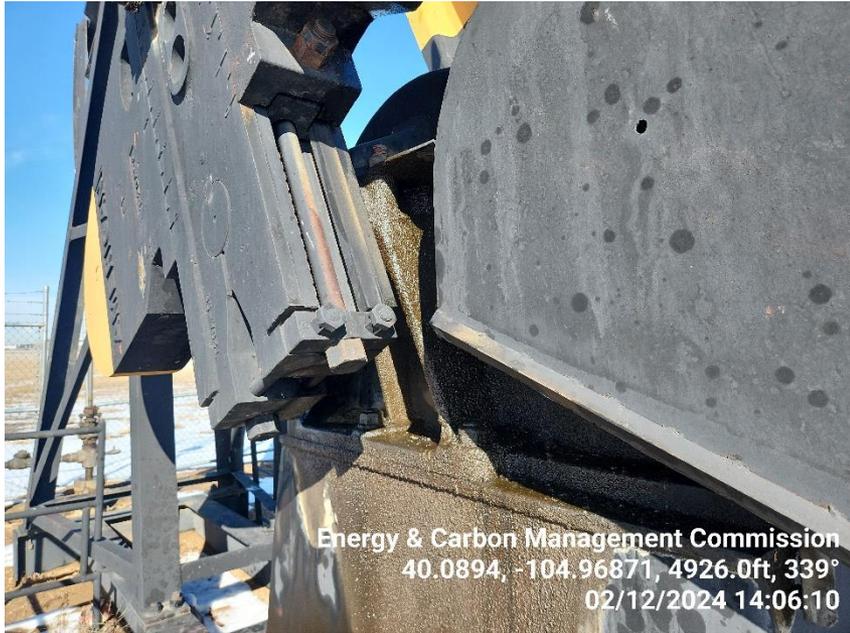
Photo 9 Gear box on the pump jack is leaking oil onto the ground.

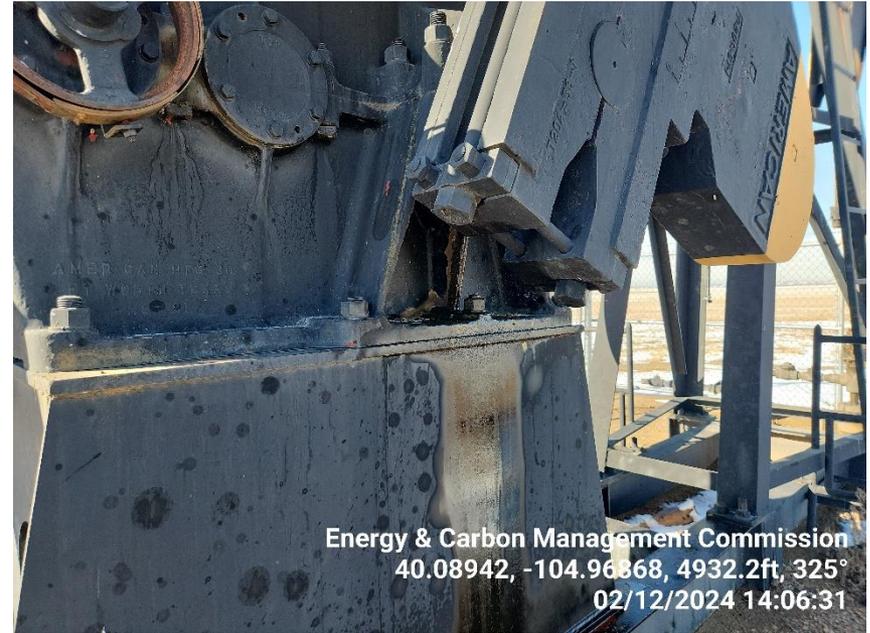
Photo 10 Gear box on the pump jack is leaking oil onto the ground.
