Construction and Stormwater Inspection

Date: 02/07/2024

Operator: CIVITAS NORTH LLC - 10661

Inspection Photos
Location Name: Wade 8-59 17 Pad
Location ID: 484554

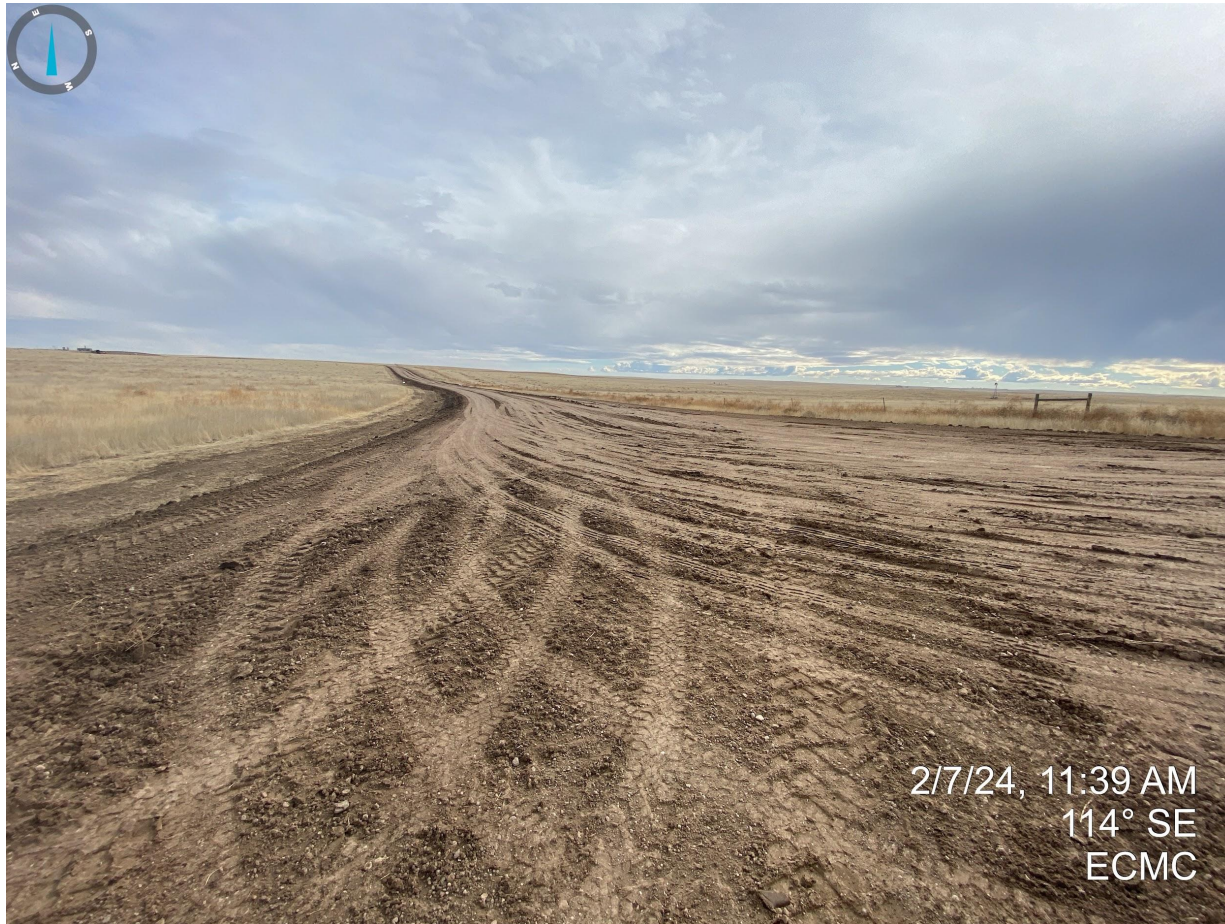
Photo 1. Taken from the start (west end) of the access road. It doesn't appear that any topsoil has been salvaged from the access road since the previous inspection. It also appears that road base has been applied over existing topsoil.

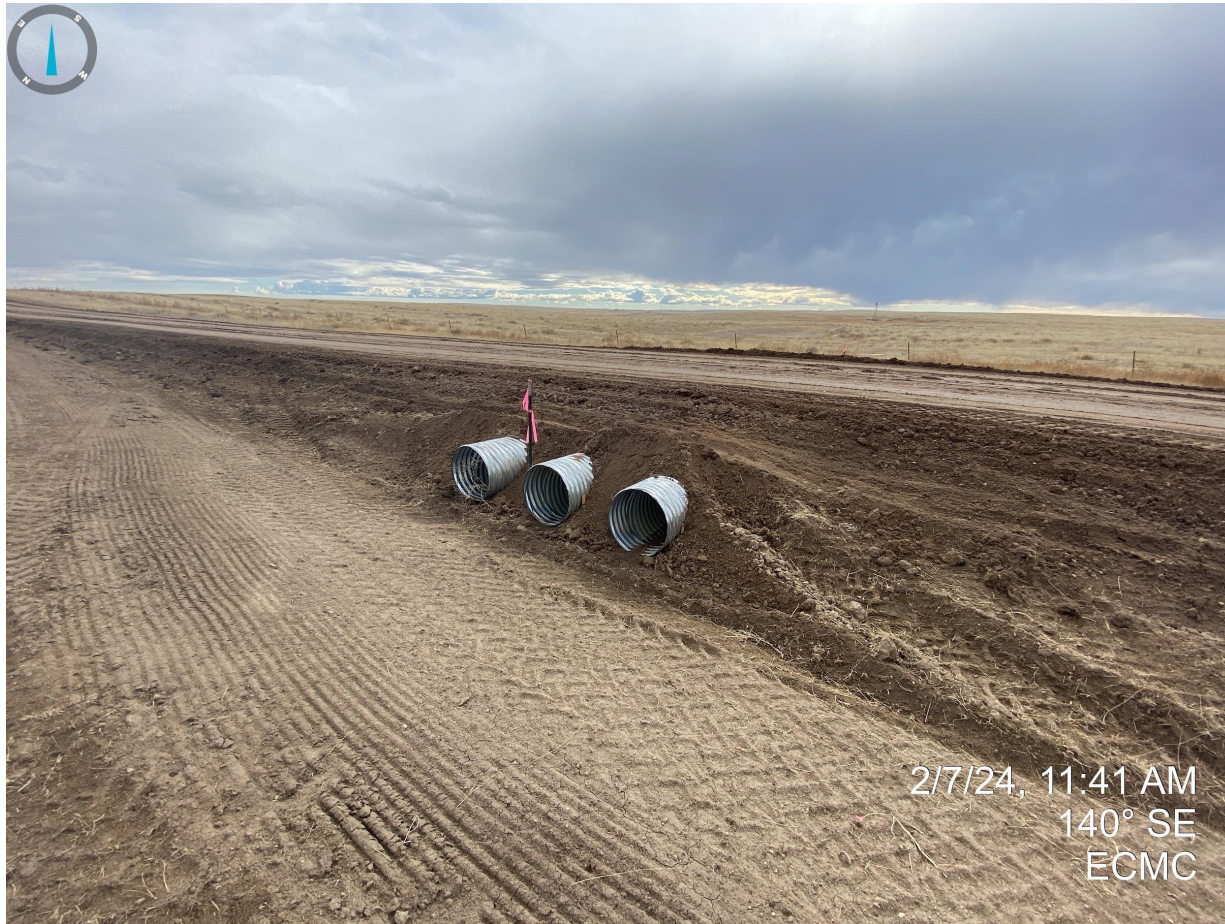
Photo 2. Taken near the west culvert crossing (north side). It doesn't appear any topsoil has been salvaged since the previous inspection and any topsoil used as fill at the culvert crossing has not been removed.

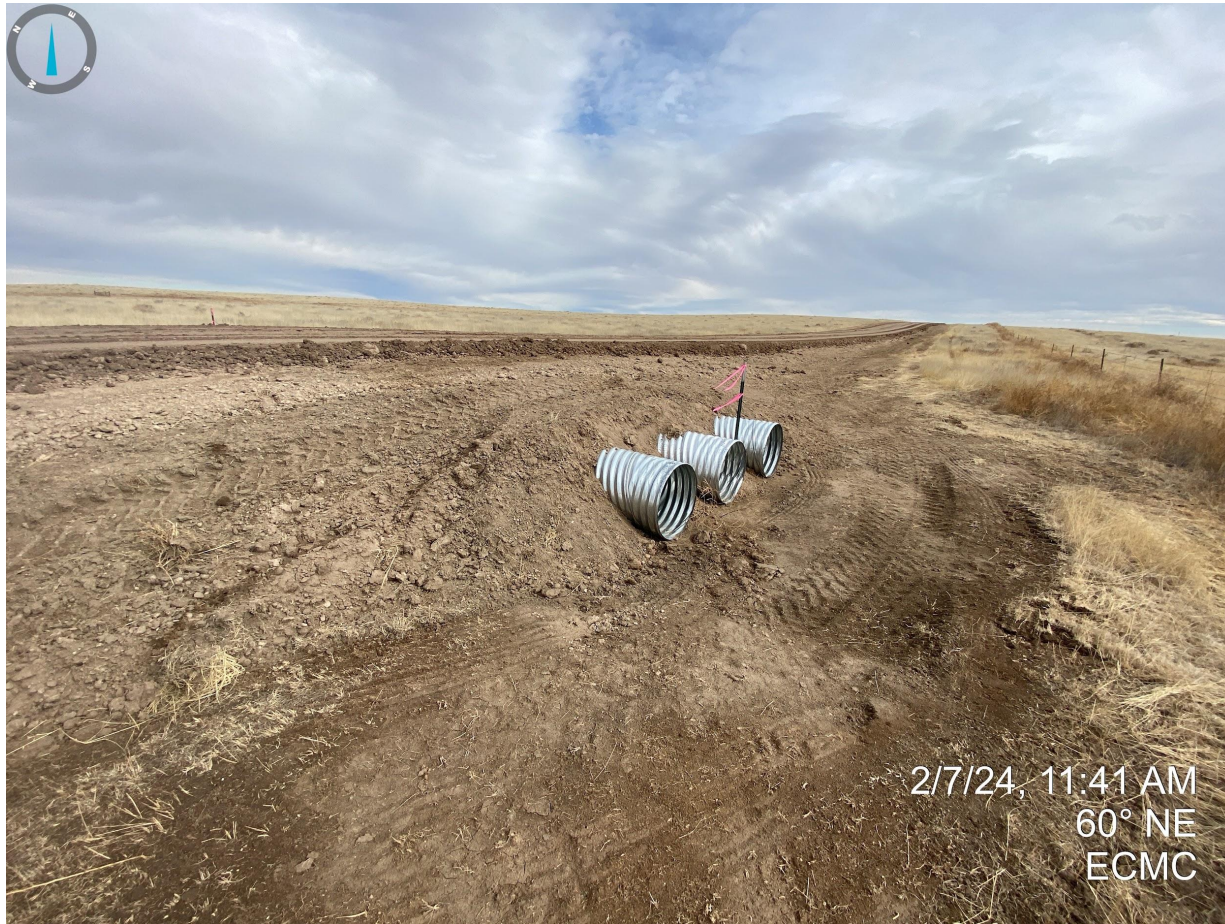
Photo 3. Taken near the west culvert crossing (south side). It doesn't appear any topsoil has been salvaged since the previous inspection and any topsoil used as fill at the culvert crossing has not been removed.

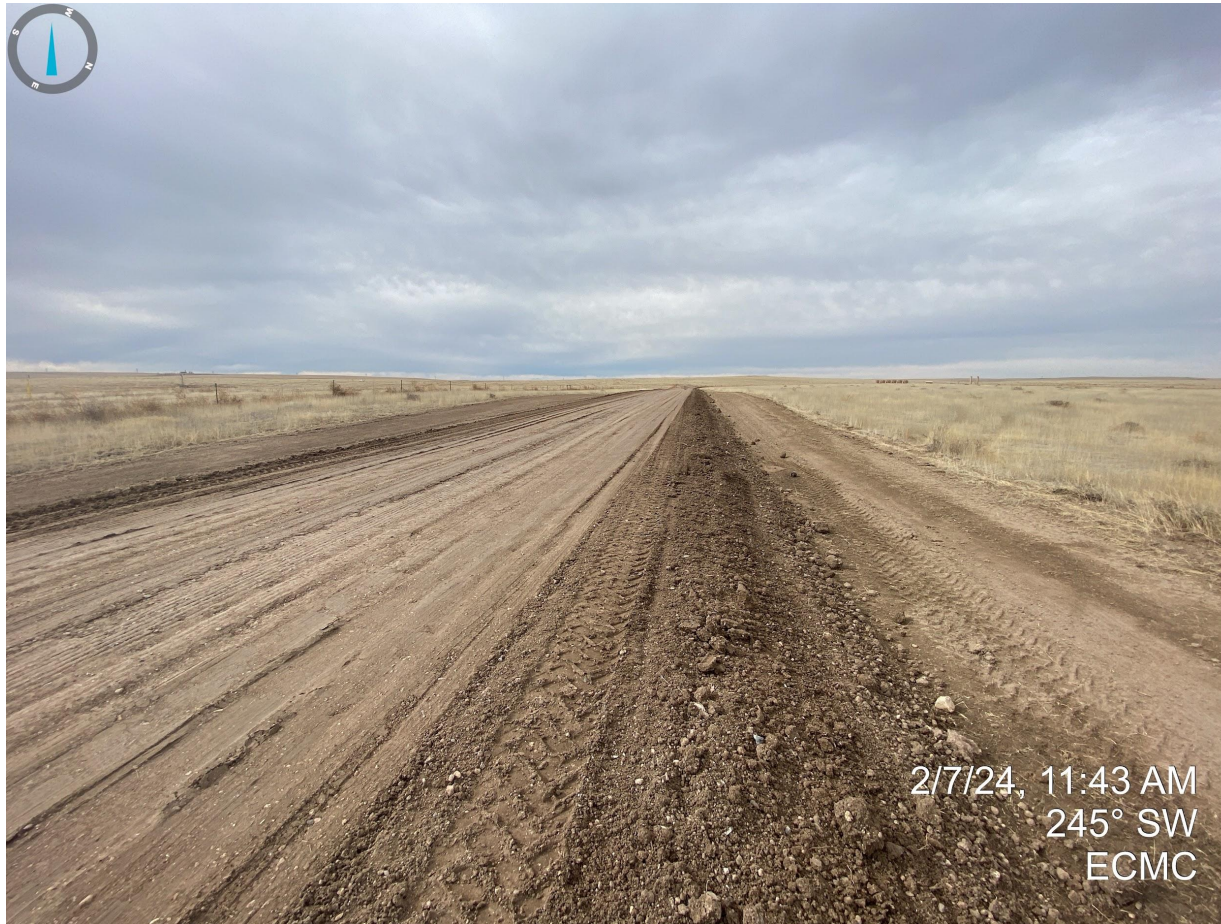
Photo 4. Taken from the middle portion (between the two culverts) of the access road. It doesn't appear that any topsoil has been salvaged from the access road since the previous inspection. It also appears that road base has been applied over existing topsoil.

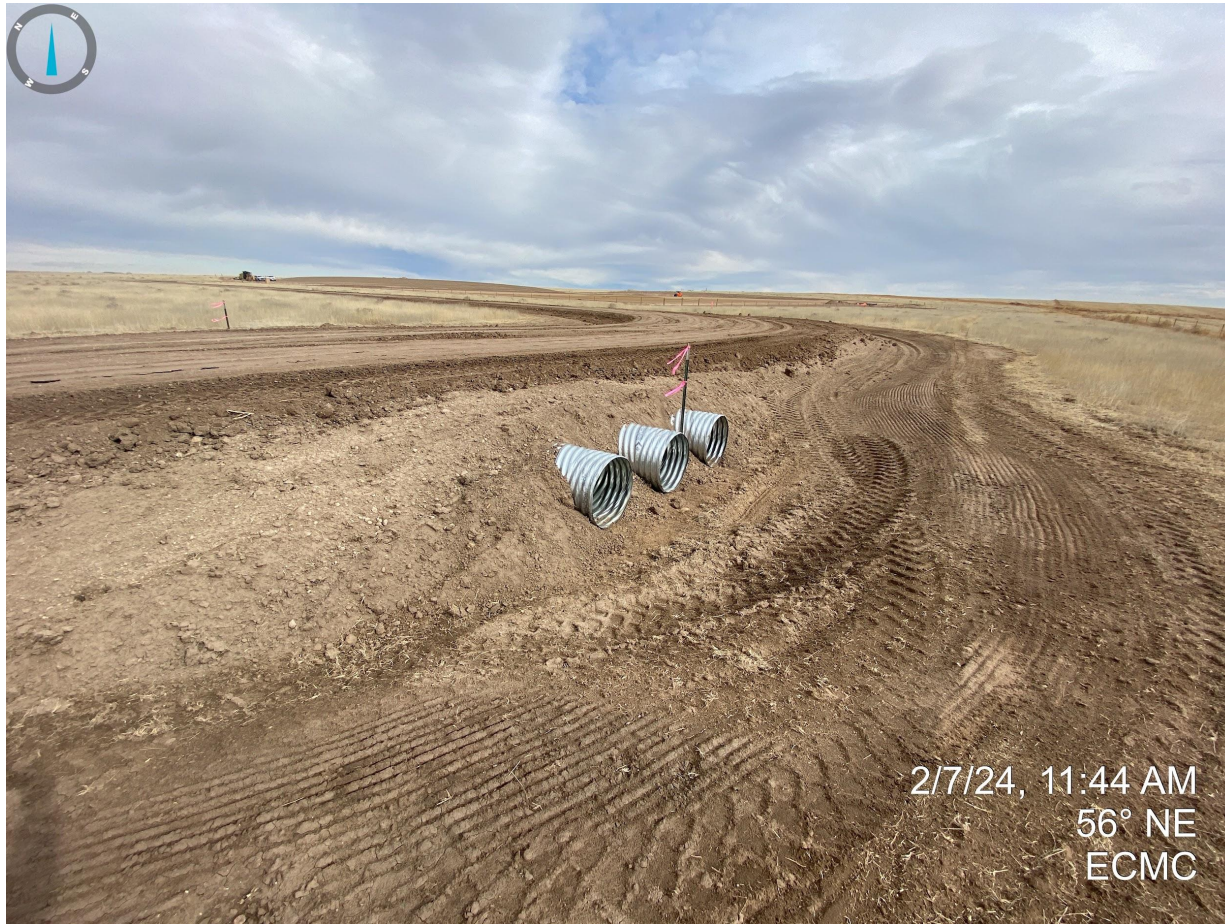
Photo 5. Taken near the east culvert crossing (south side). It doesn't appear any topsoil has been salvaged since the previous inspection and any topsoil used as fill at the culvert crossing has not been removed.

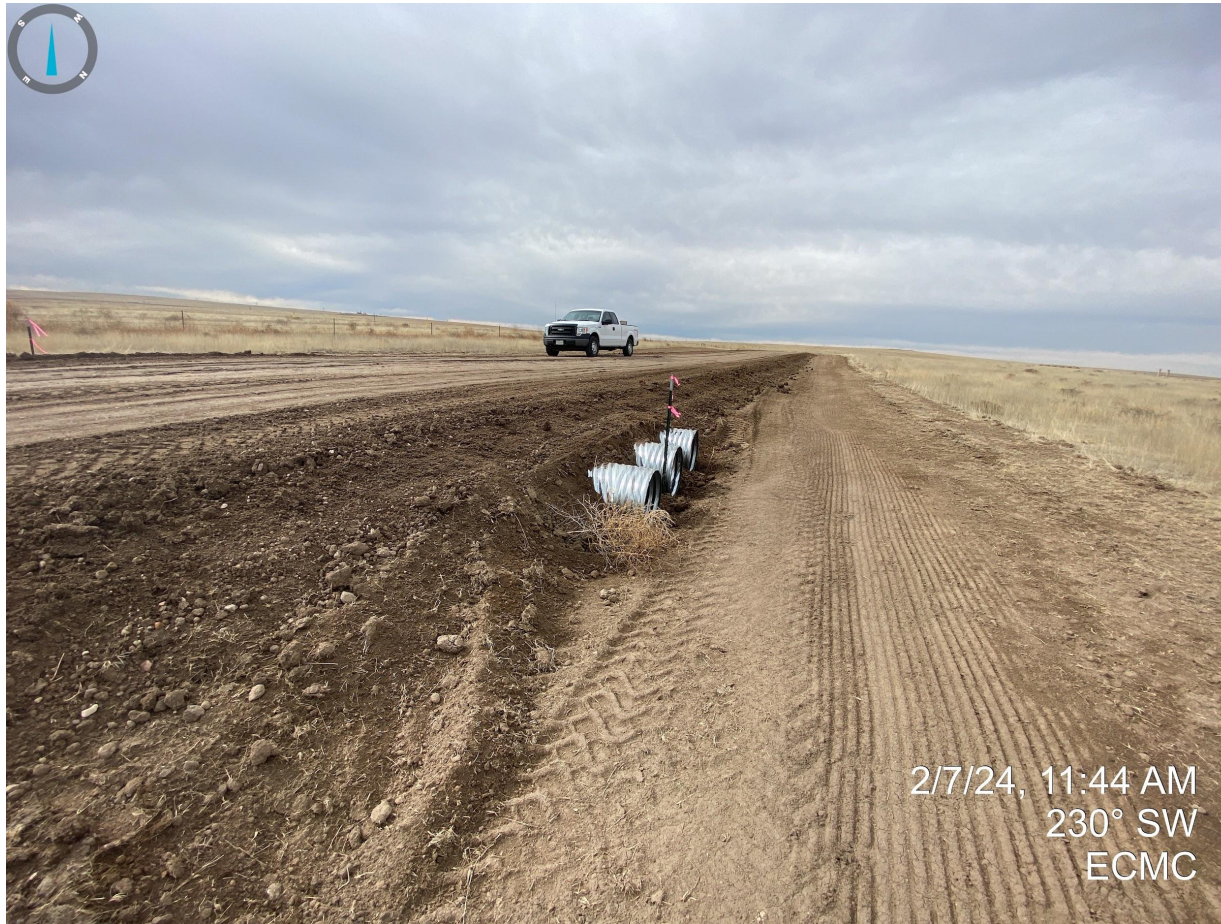
Photo 6. Taken near the west culvert crossing (north side). It doesn't appear any topsoil has been salvaged since the previous inspection and any topsoil used as fill at the culvert crossing has not been removed.

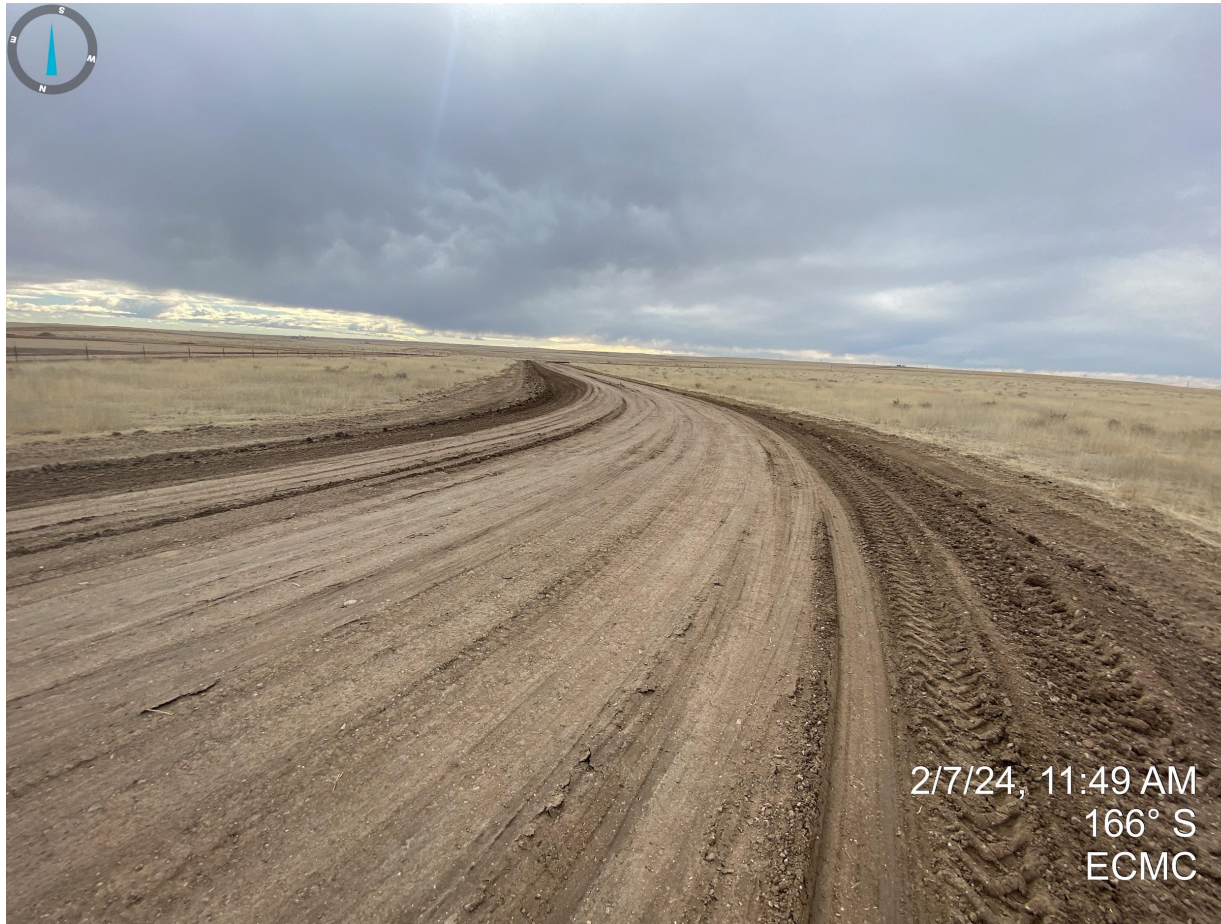
Photo 7. Taken near the entrance to the drilling pad and the access road. It doesn't appear that any topsoil has been salvaged from the access road since the previous inspection. It also appears that road base has been applied over existing topsoil.

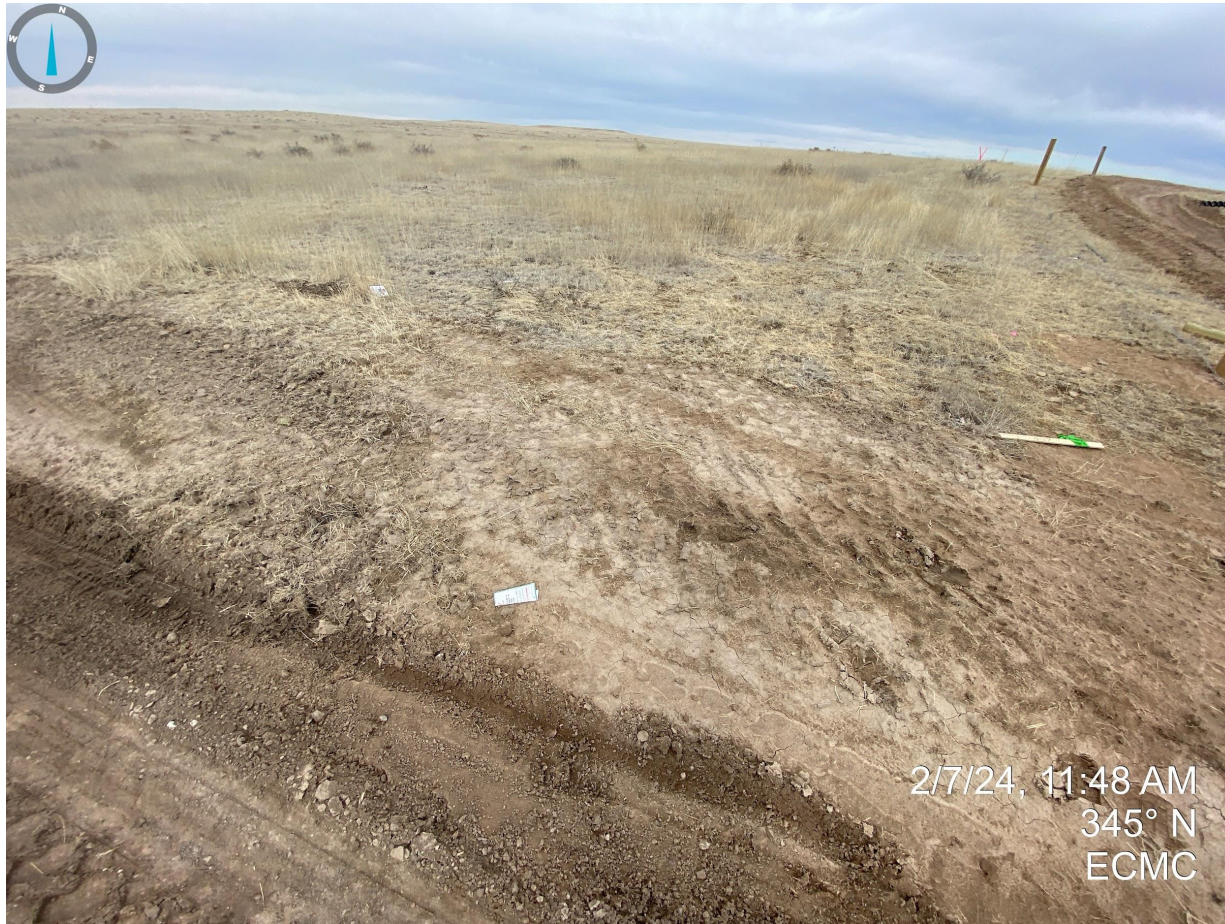
Photo 8. Taken near the location entrance. Trash was observed throughout the location.

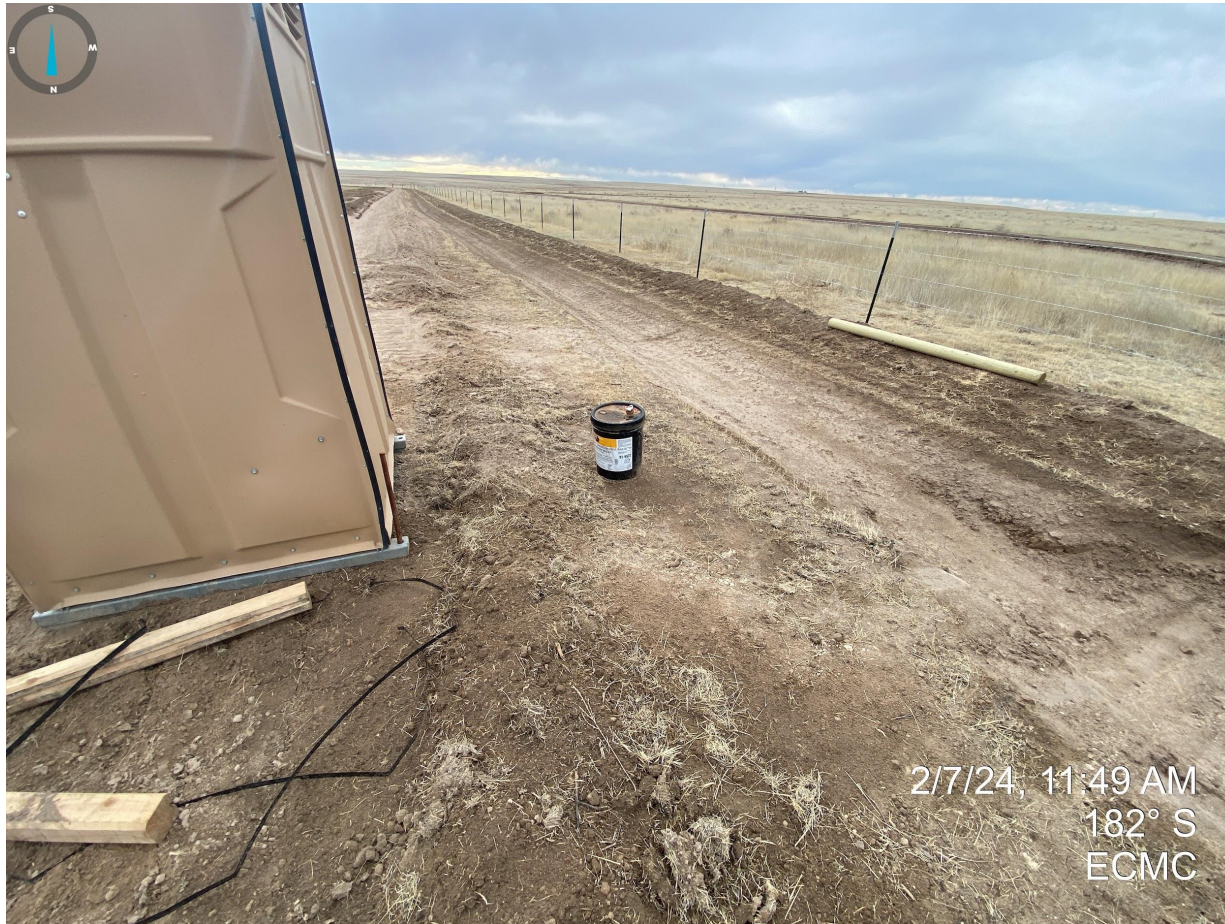
Photo 9. 5 gallon bucket of oil observed without any secondary containment, placed immediately adjacent to perimeter stormwater ditch.

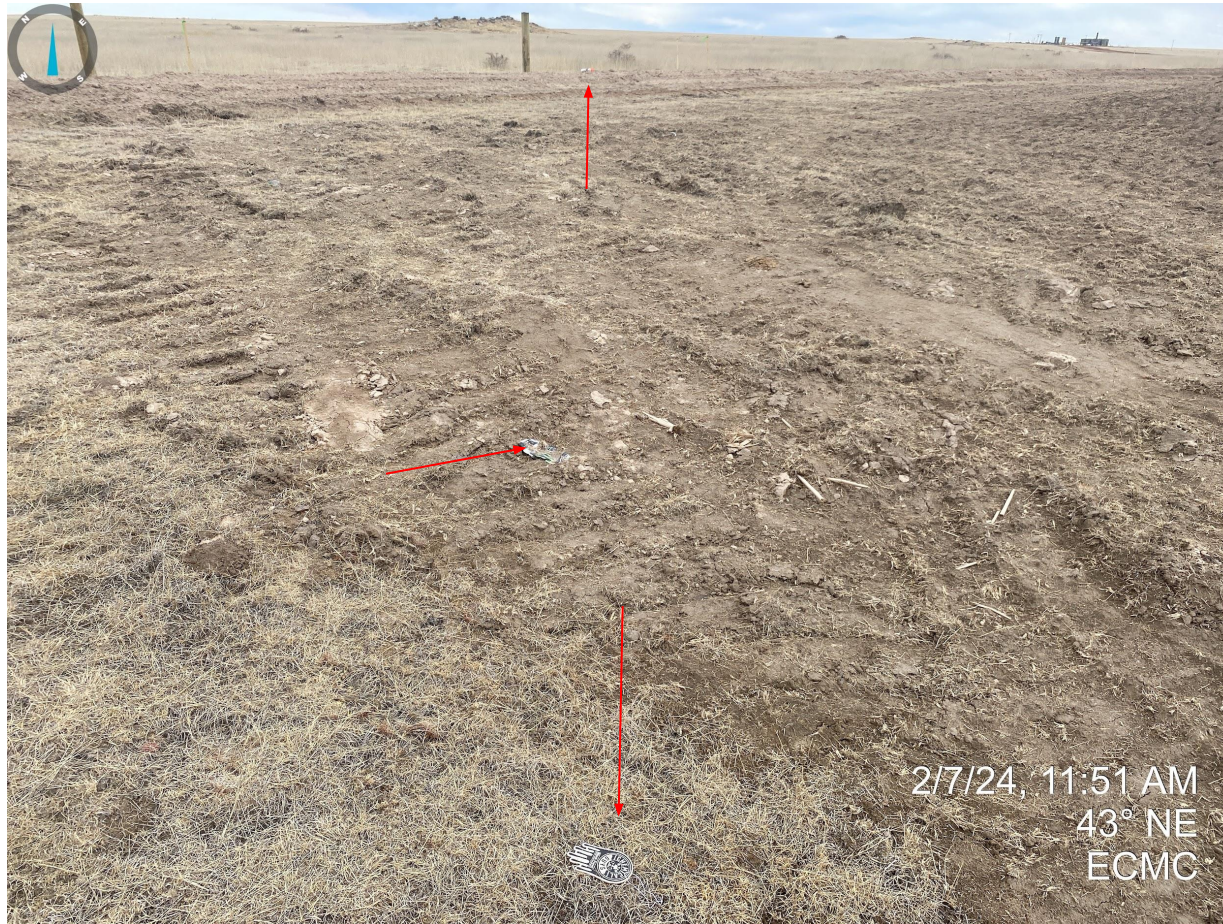
Photo 10. Trash observed near the northwest corner of the location.

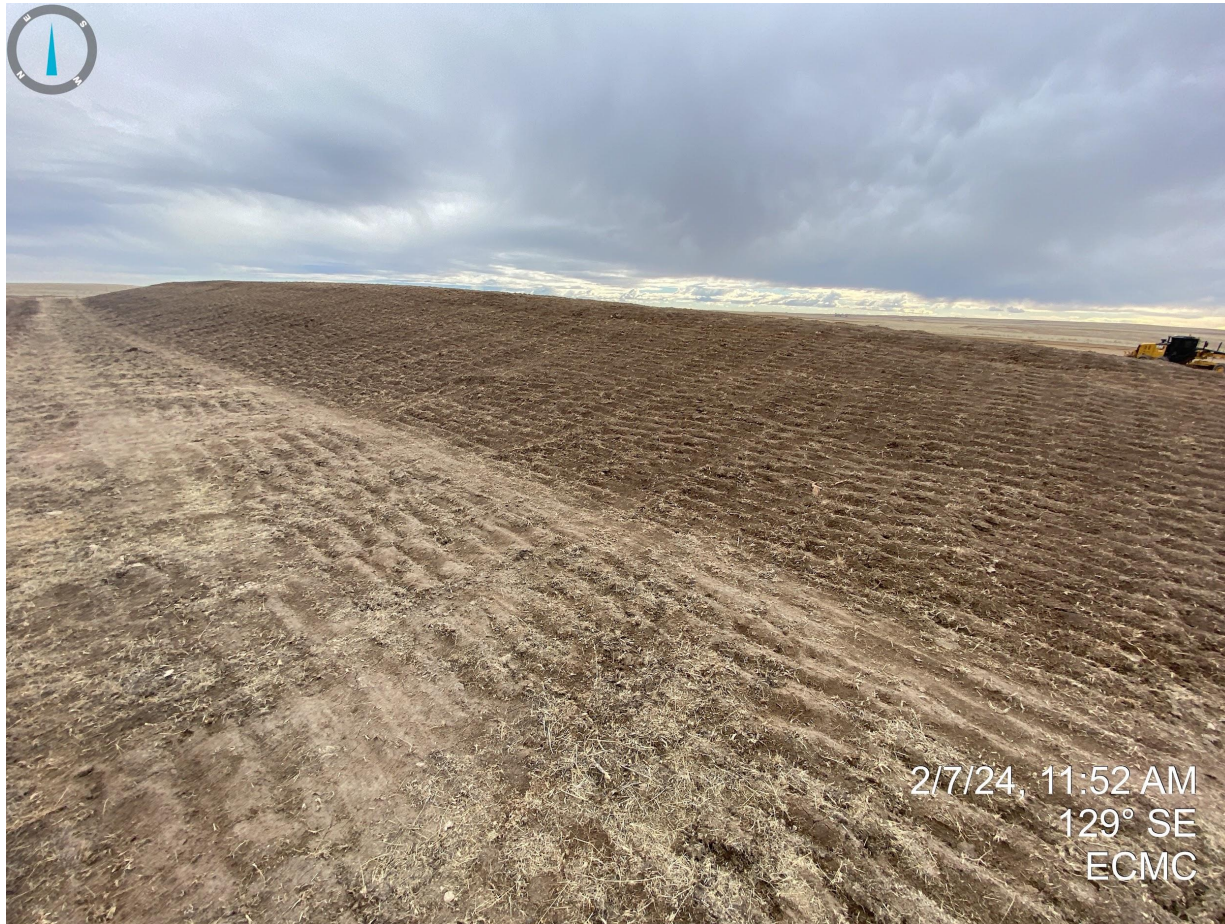
Photo 11. Northwest portion of the drilling pad topsoil stockpile. It appears the stockpile has been temporarily stabilized with evidence of equipment tracking.

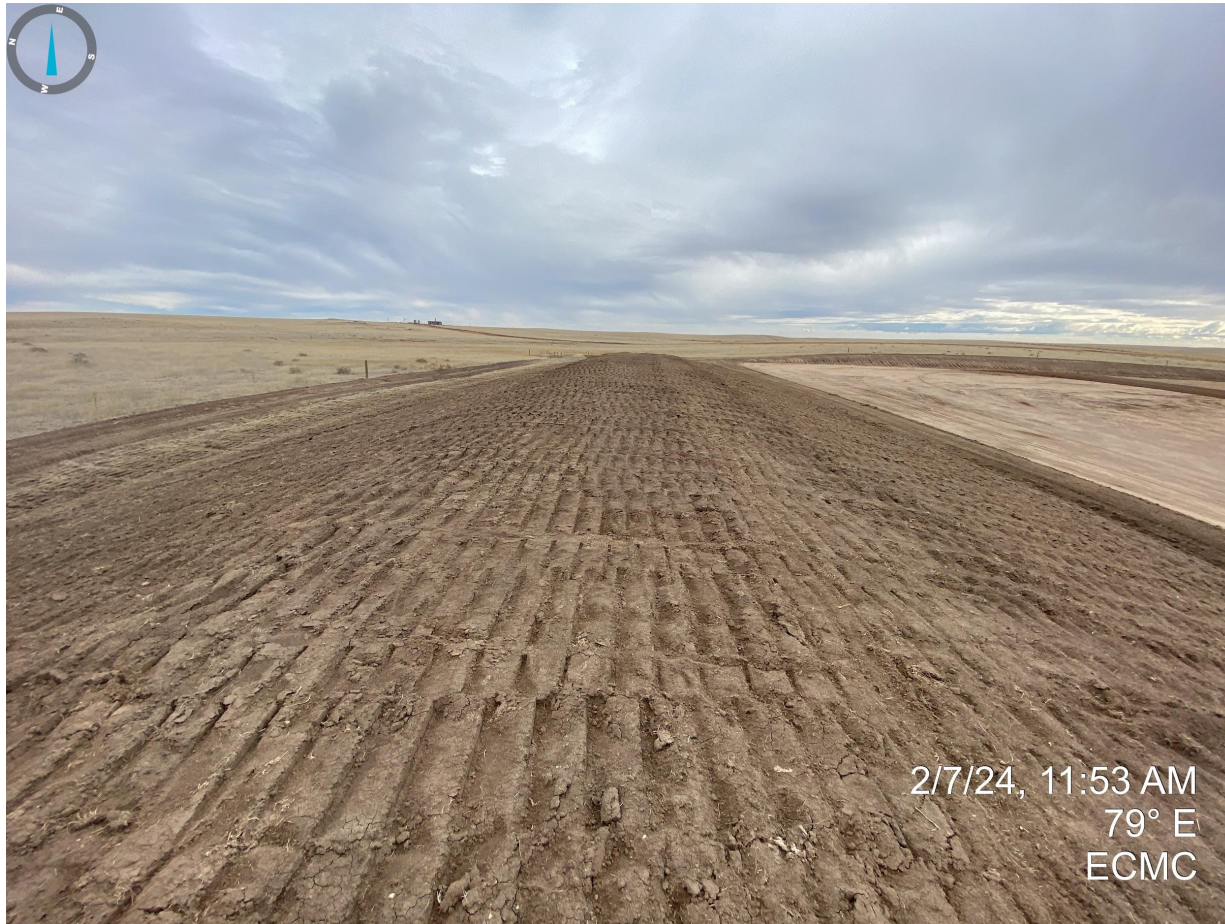
Photo 12. Top, center portion of topsoil stockpile. See comments in Photo 11.

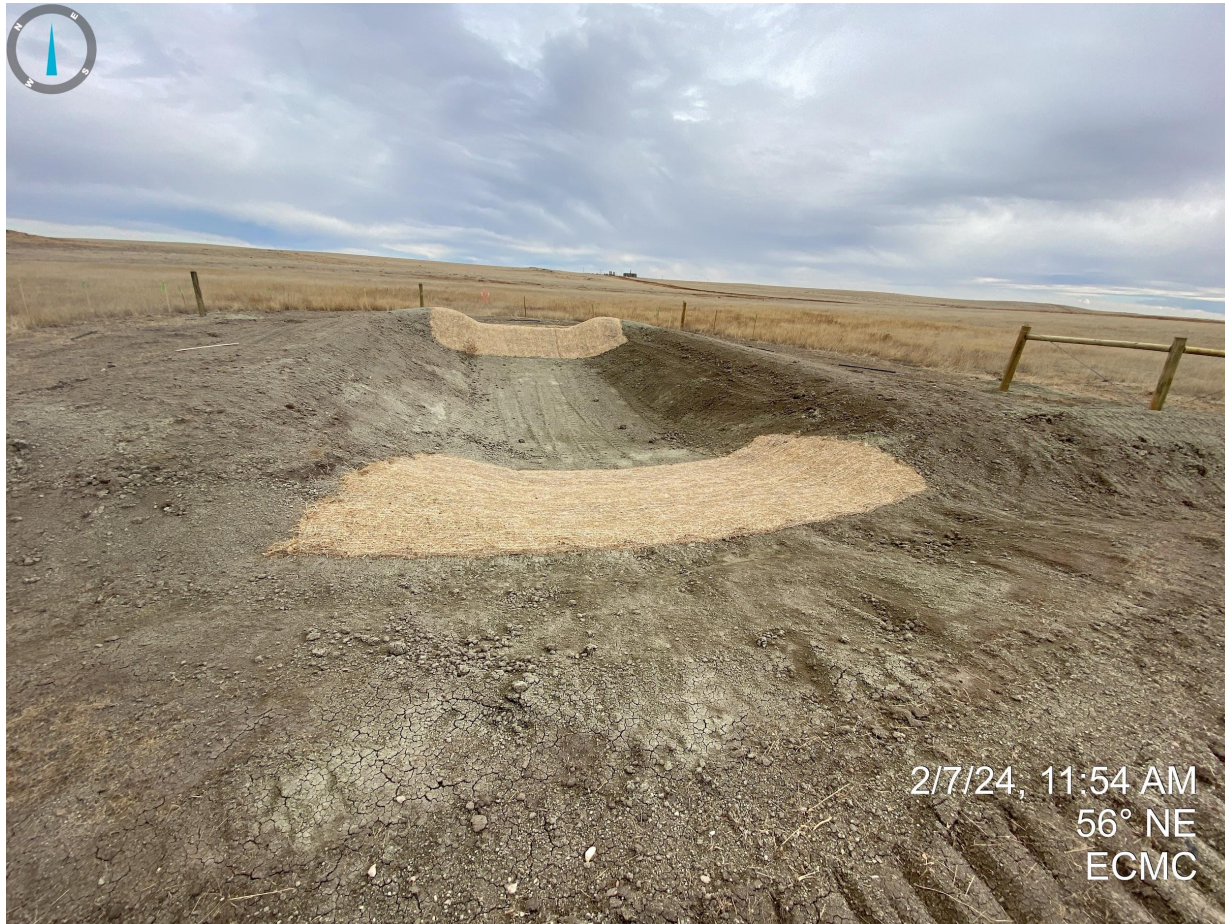
Photo 13. Northeast sediment trap appears to still be under construction.

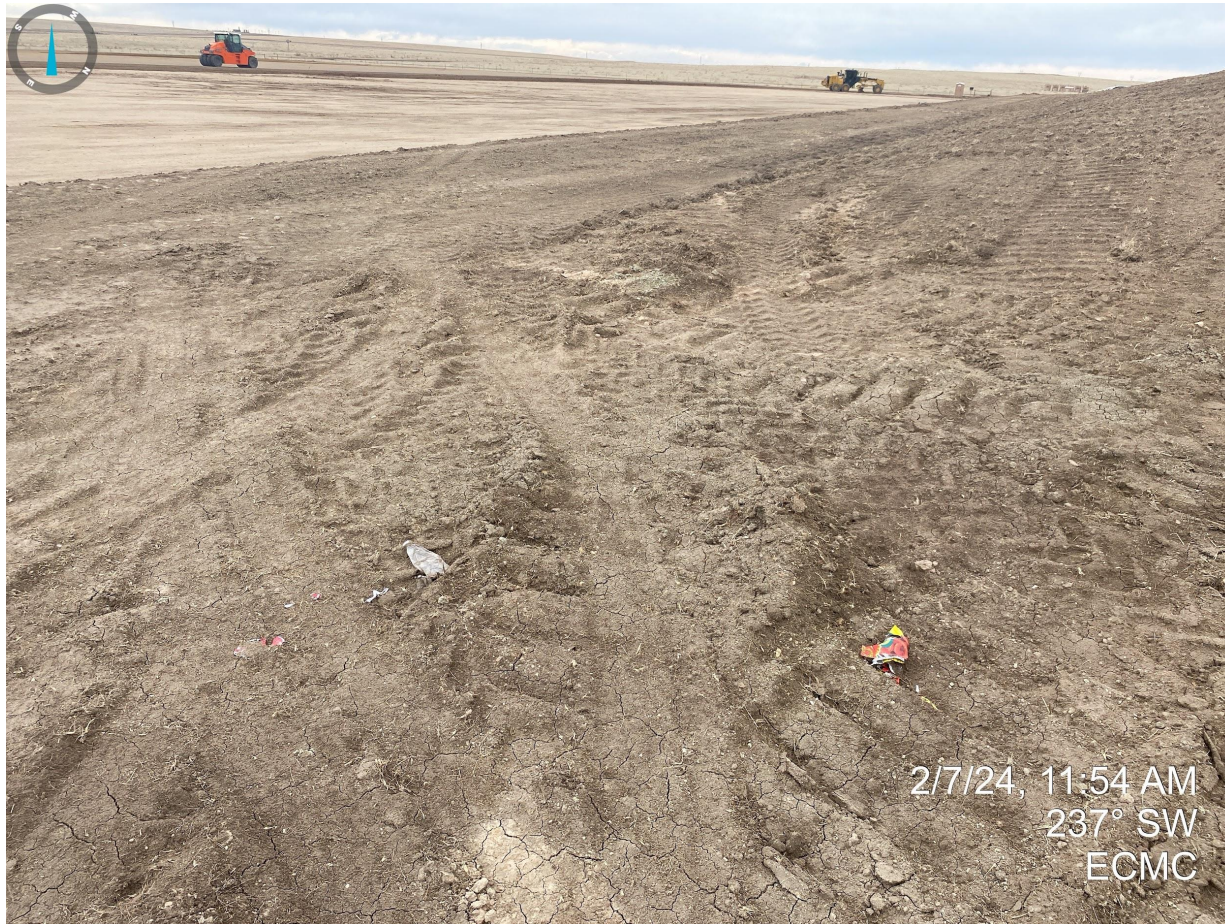
Photo 14. Trash located on the eastern side of the topsoil stockpile.

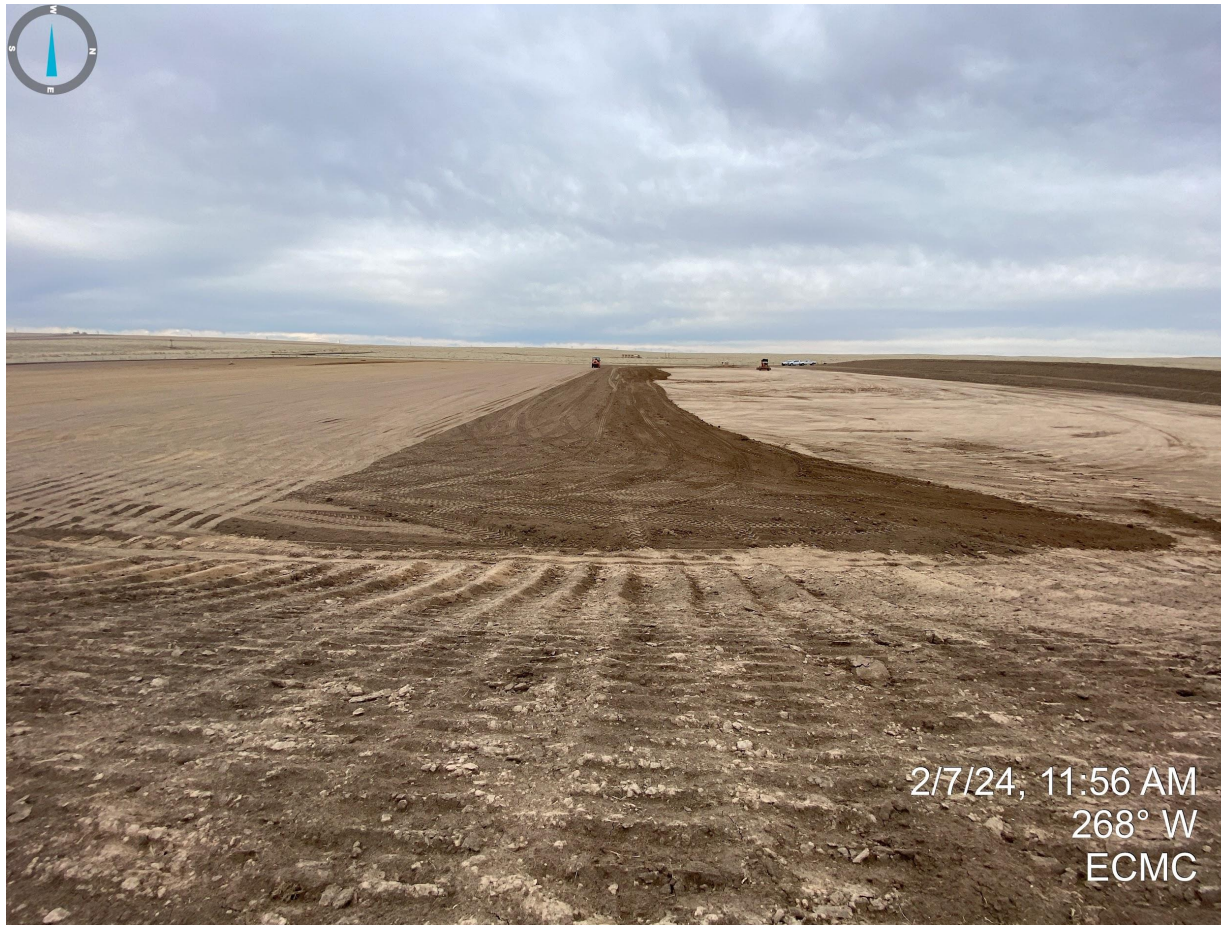
Photo 15. Taken from the eastern side of the location. Onsite crews were actively applying road base/armor to the drilling pad during this inspection.

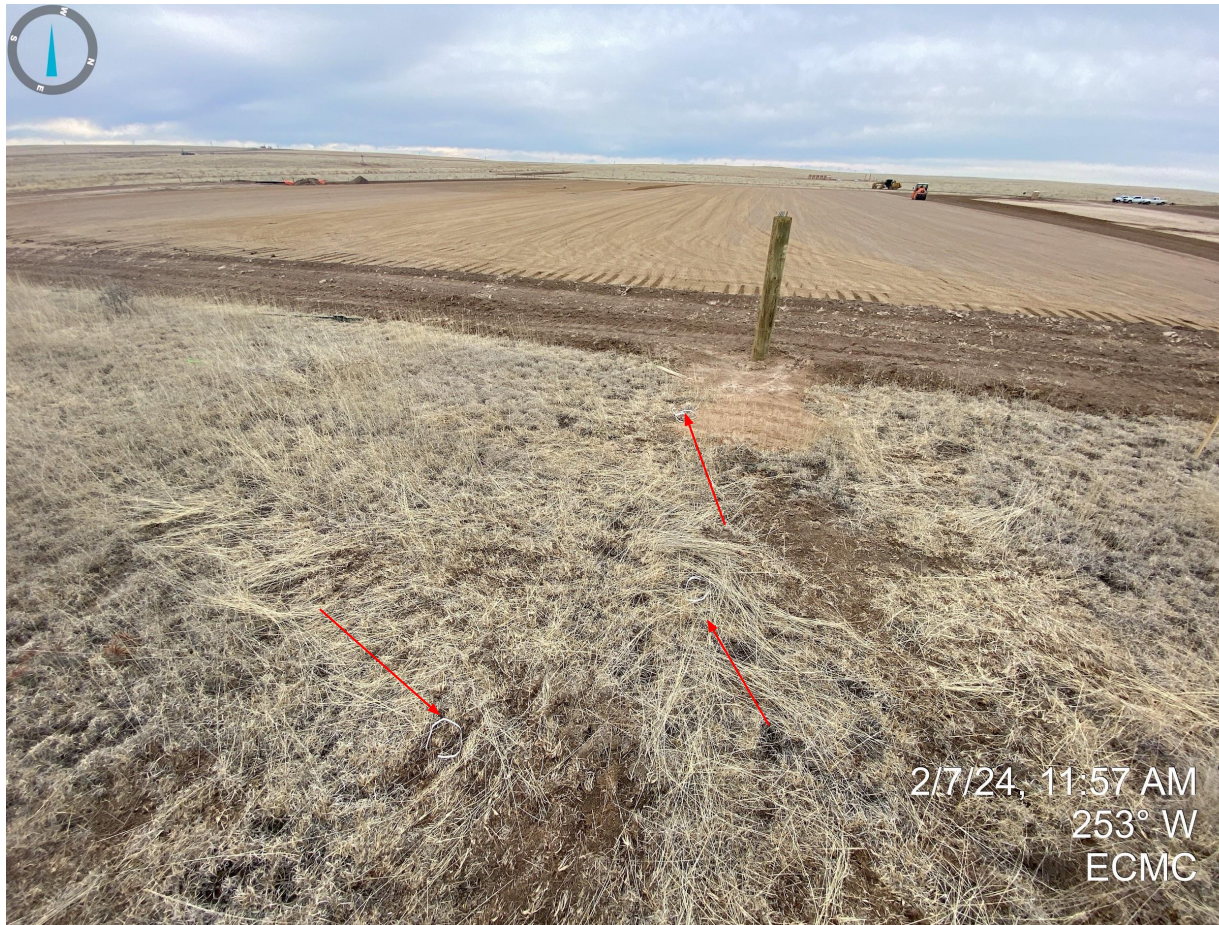
Photo 16. East side of location. Bands/clips from t-post bundles were observed throughout the perimeter of the location. All trash needs to be removed before it migrates off location.

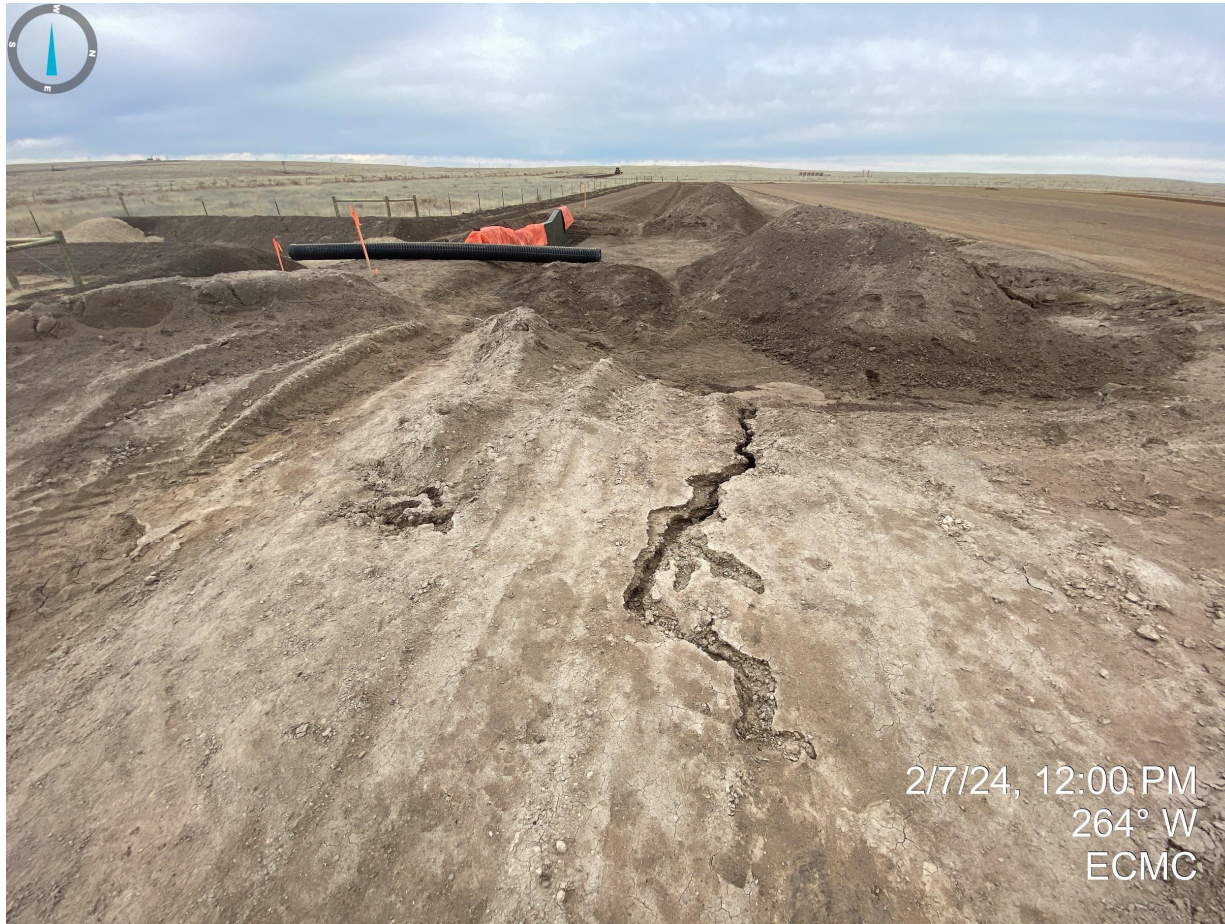
Photo 17. Erosion degradation occurring near the southern sediment trap.

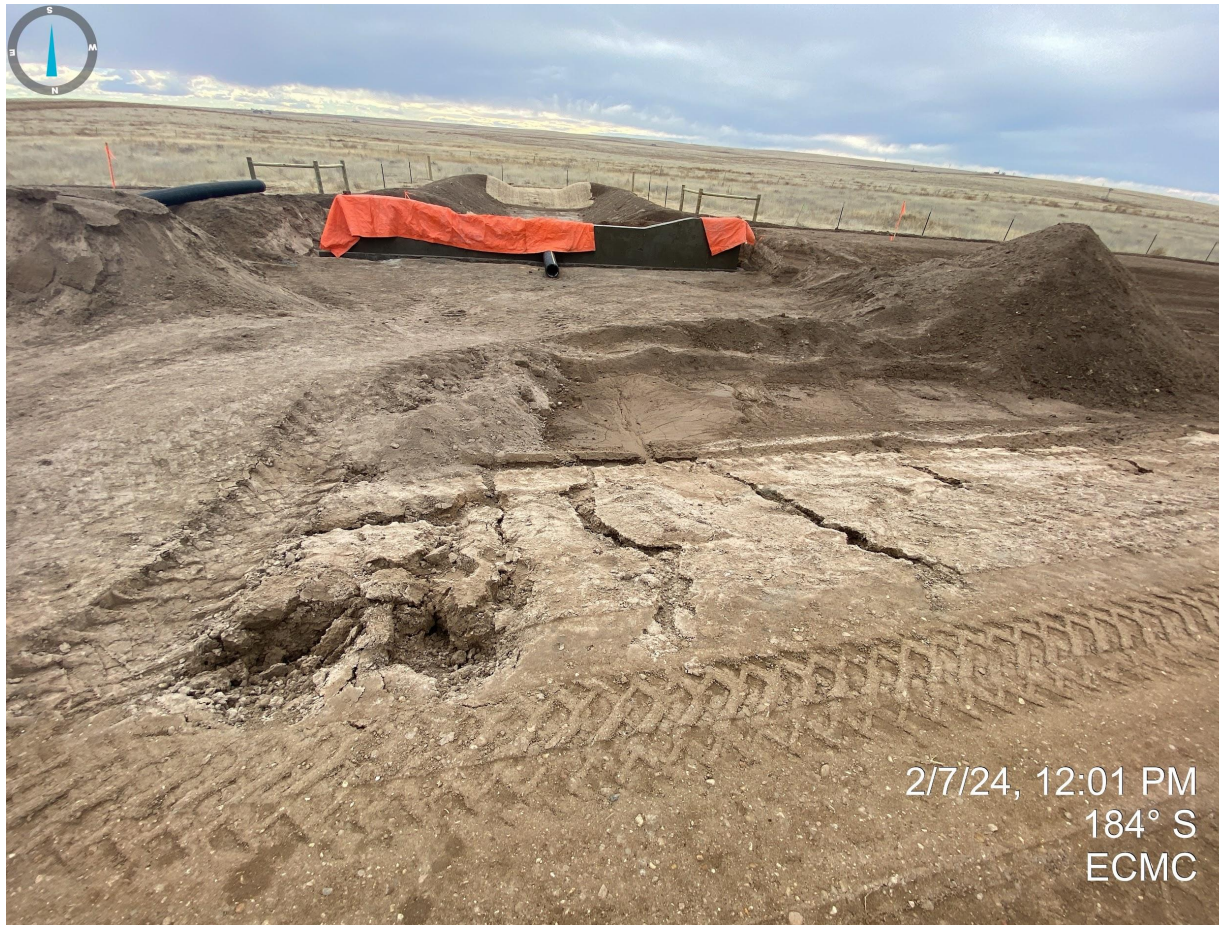
Photo 18. Erosion degradation occurring near the southern sediment trap. The southern sediment trap is still being constructed at the time of this inspection (pictured in background).

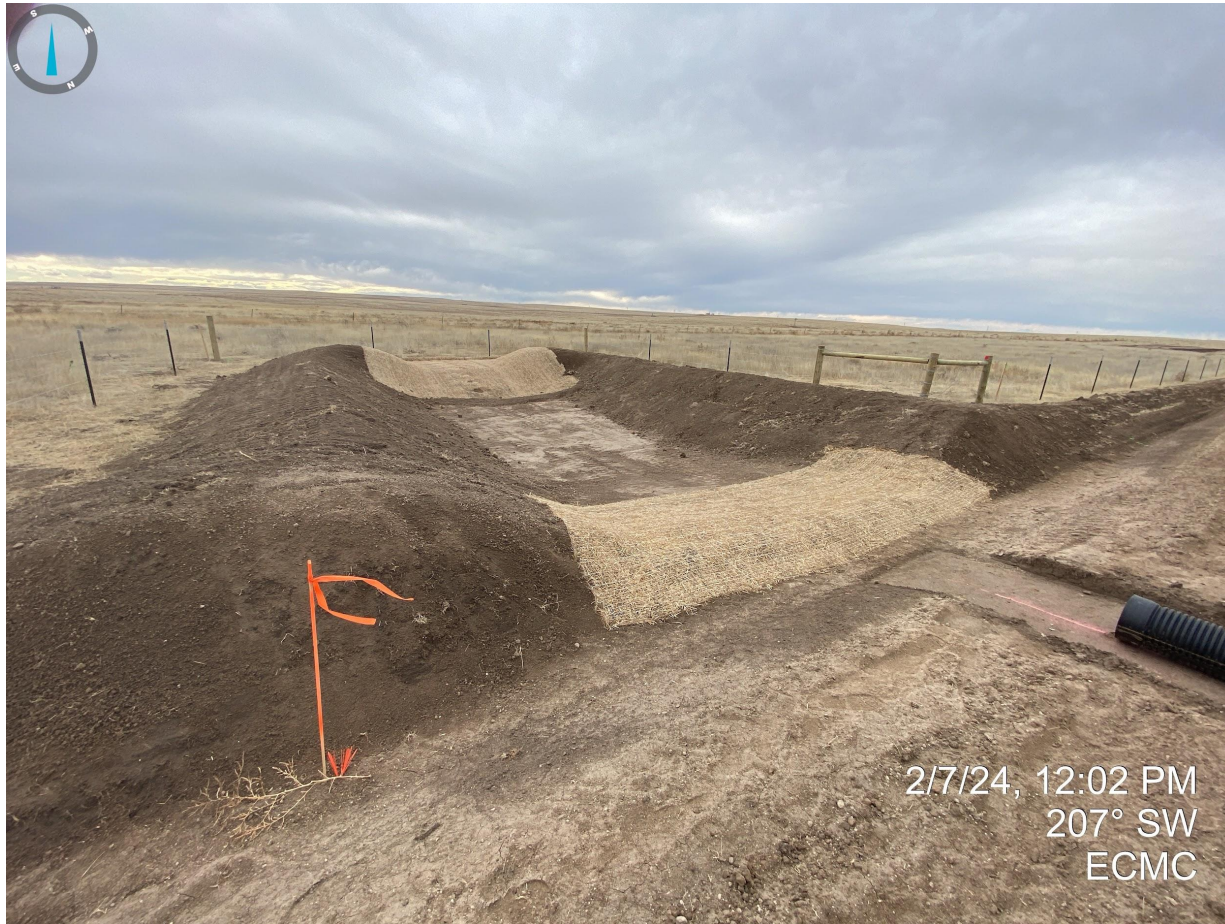
Photo 19. The southern sediment trap is still being constructed at the time of this inspection.
