Construction and Stormwater Inspection

Date: 02/07/2024

Operator: CIVITAS NORTH LLC - 10661

Inspection Photos
Location Name: Wade 8-59 17 Pad
Location ID: 484554

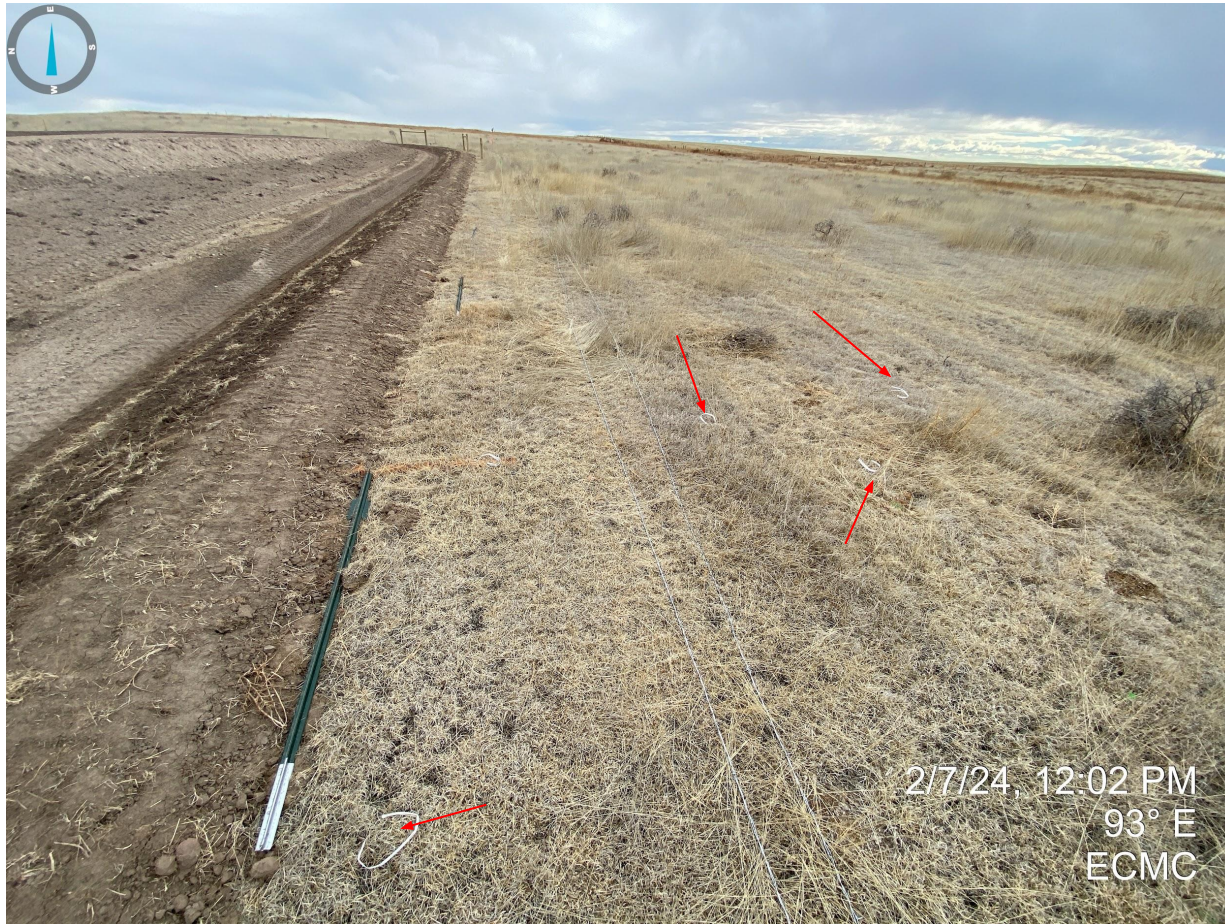
Photo 20. South side of location. Bands/clips from t-post bundles were observed throughout the perimeter of the location. All trash needs to be removed before it migrates off location.

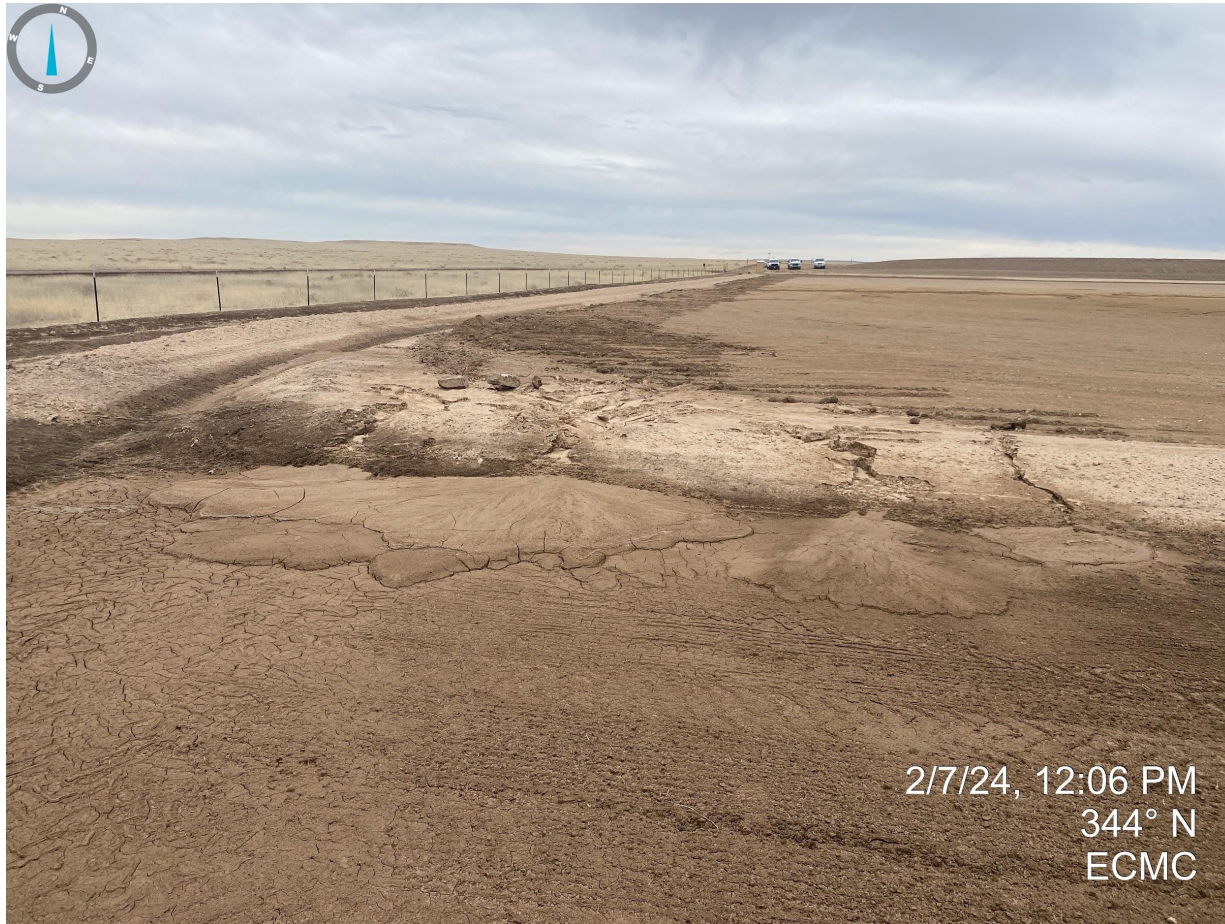
Photo 21. Erosion degradation and sediment transport observed on the southwest corner of the drilling pad.

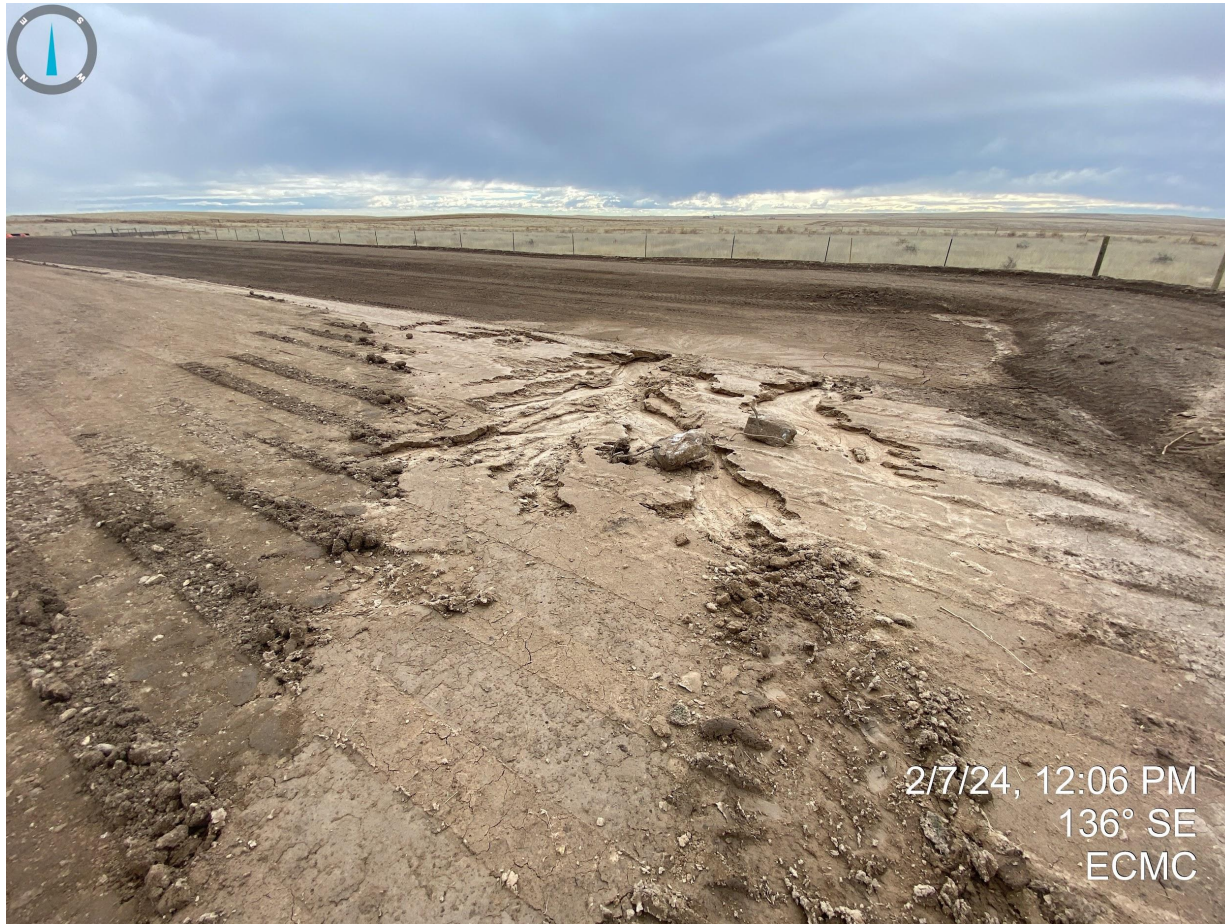
Photo 22. Erosion degradation and sediment transport observed on the southwest corner of the drilling pad.

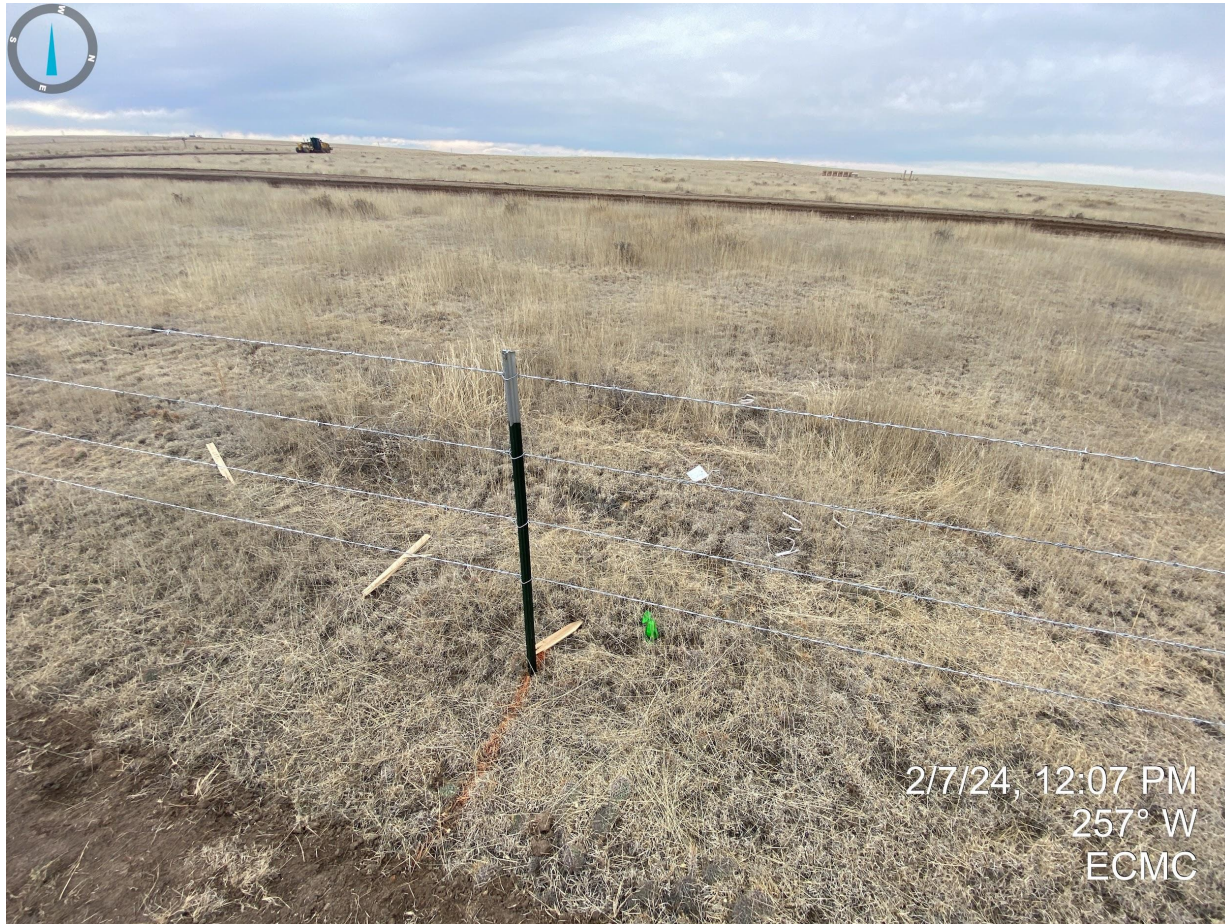
Photo 23. West side of location. Trash from fence construction observed throughout the perimeter of the location. All trash needs to be removed before it migrates off location.
