Inspection Photos
Location Name: S&B 5-11 HZ Pad
Location ID: 474765

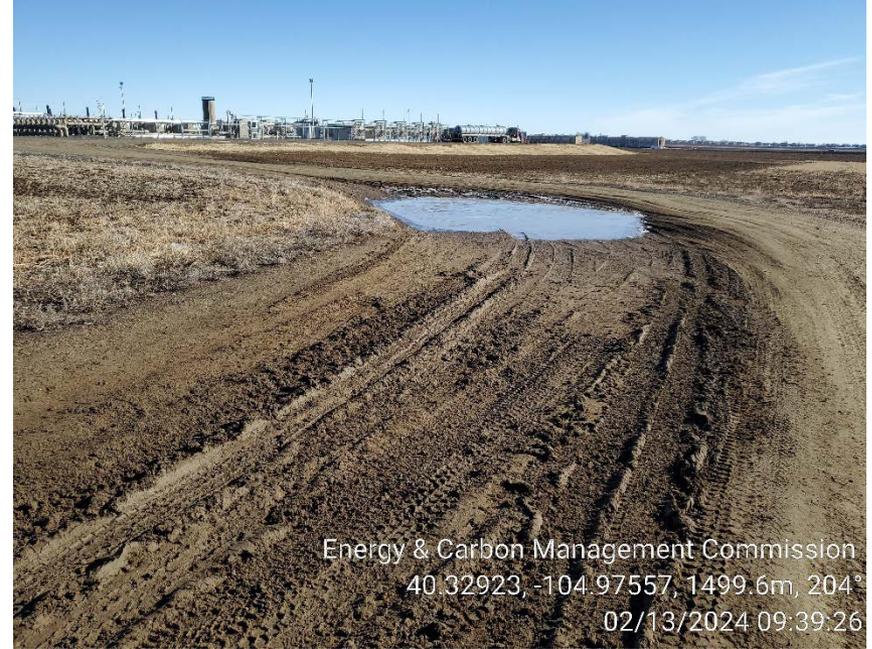
Lease road damage

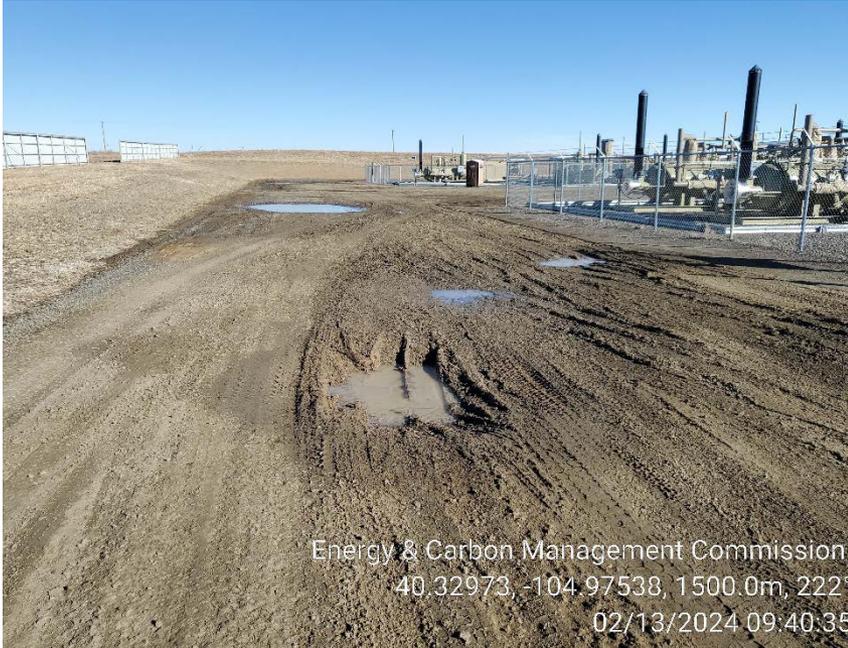
West side of pad damage

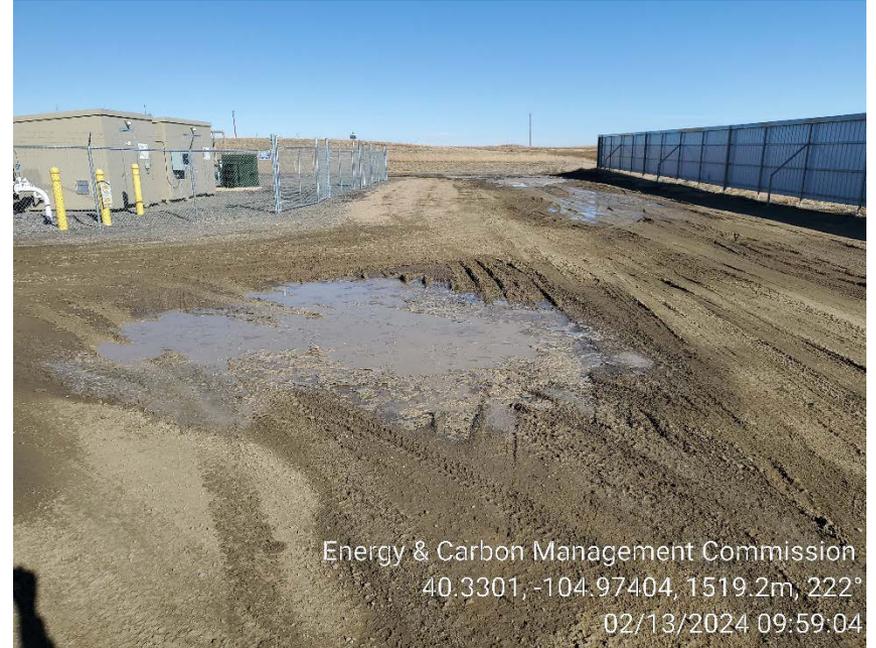
East side of pad damage
