Final Reclamation and Stormwater Inspection

Operator: MAGPIE OPERATING INC - 52530

Location ID: 312143

Inspection Photos
Location Name: Warnecke #1
Location ID: 312143

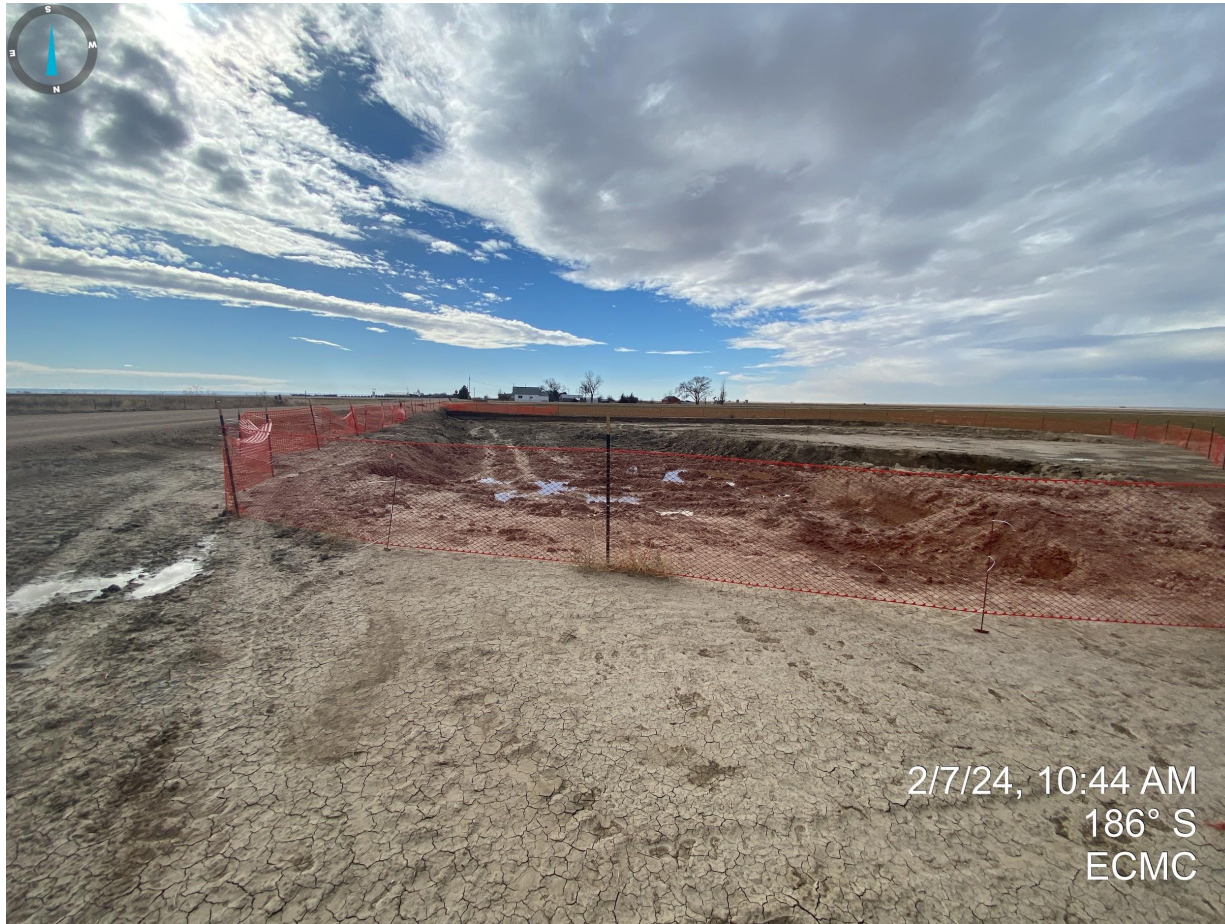
Photo 1. Taken from northeast corner of open excavation. Construction fencing has been installed around the sample holes and excavated area.

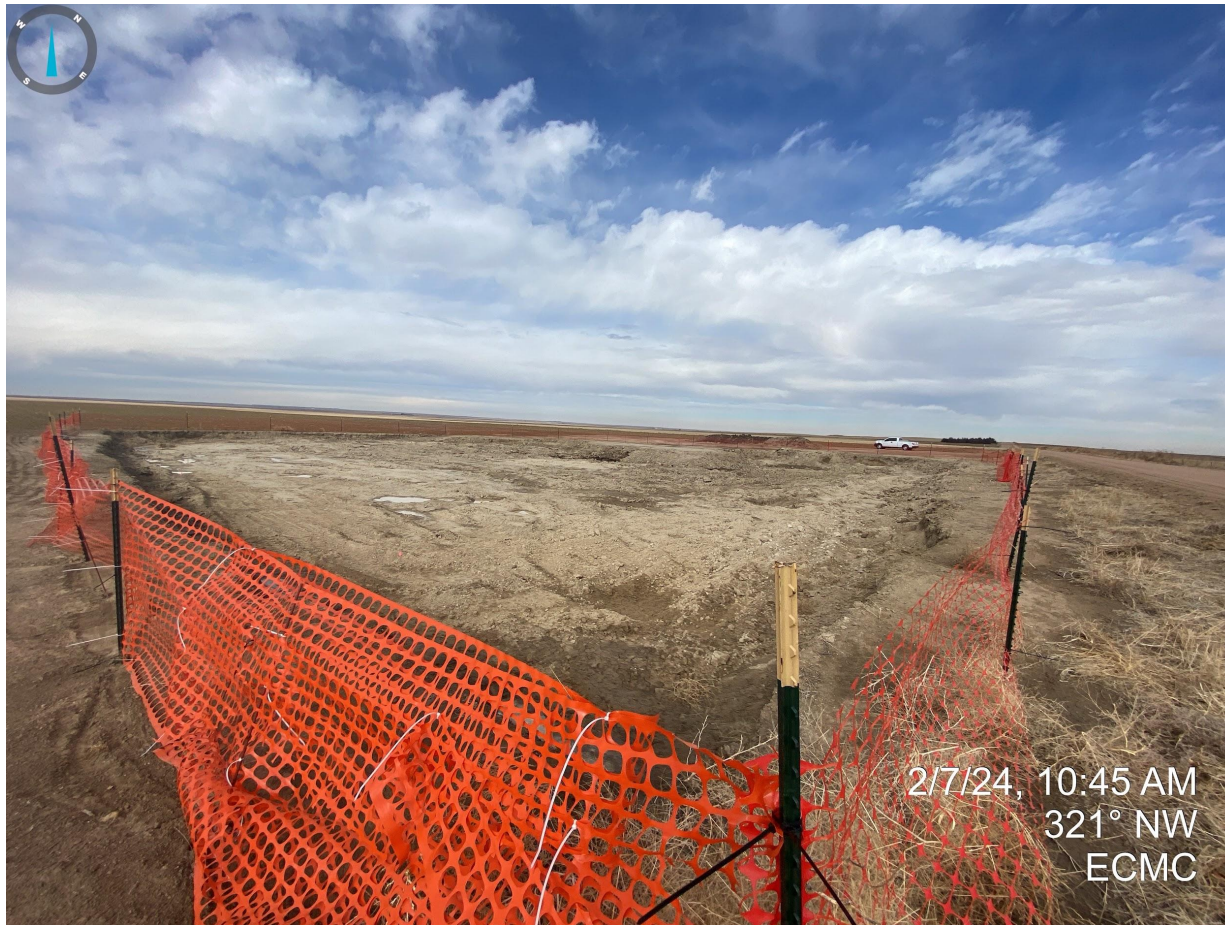
Photo 2. Southeast corner of the open excavation; see comments in Photo 1.

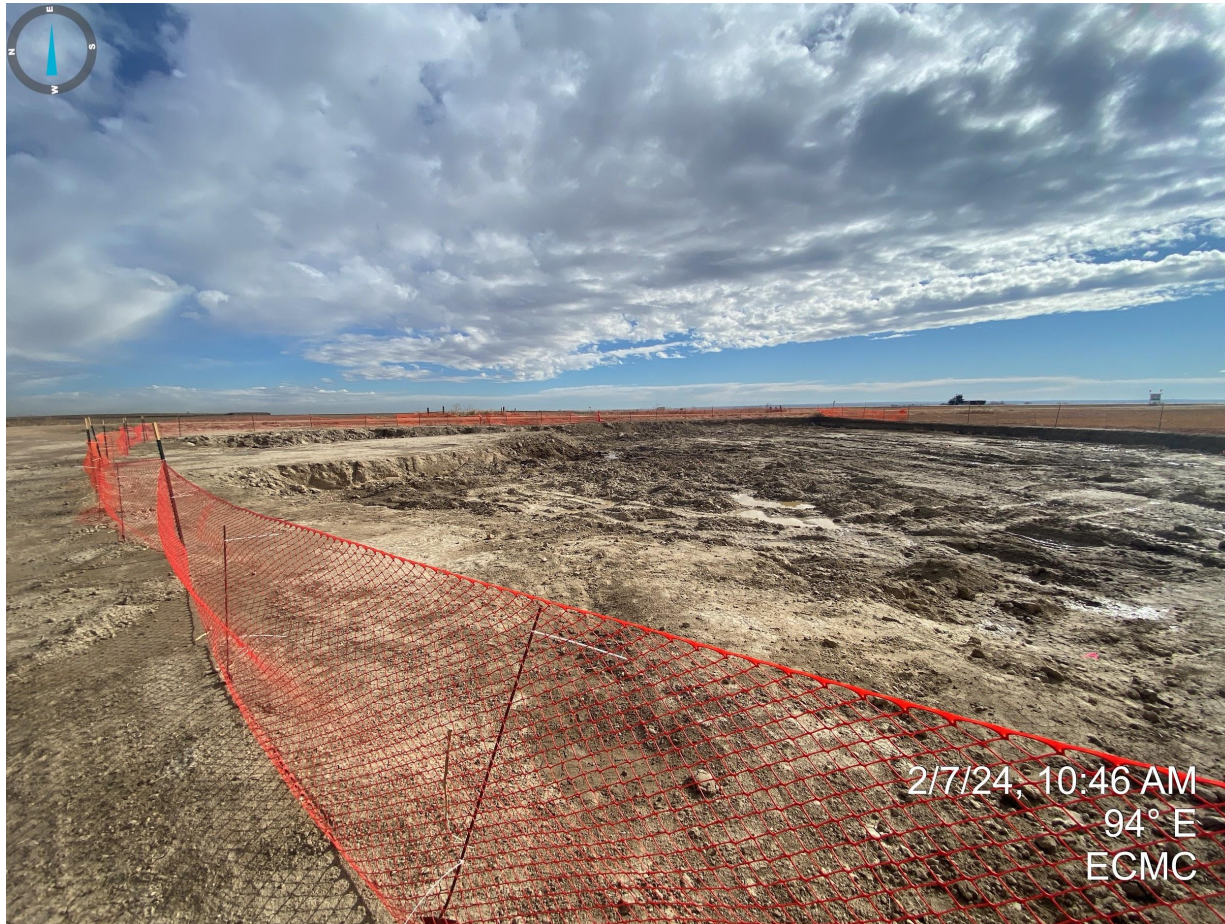
Photo 3. Southwest corner of the open excavation; see comments in Photo 1.

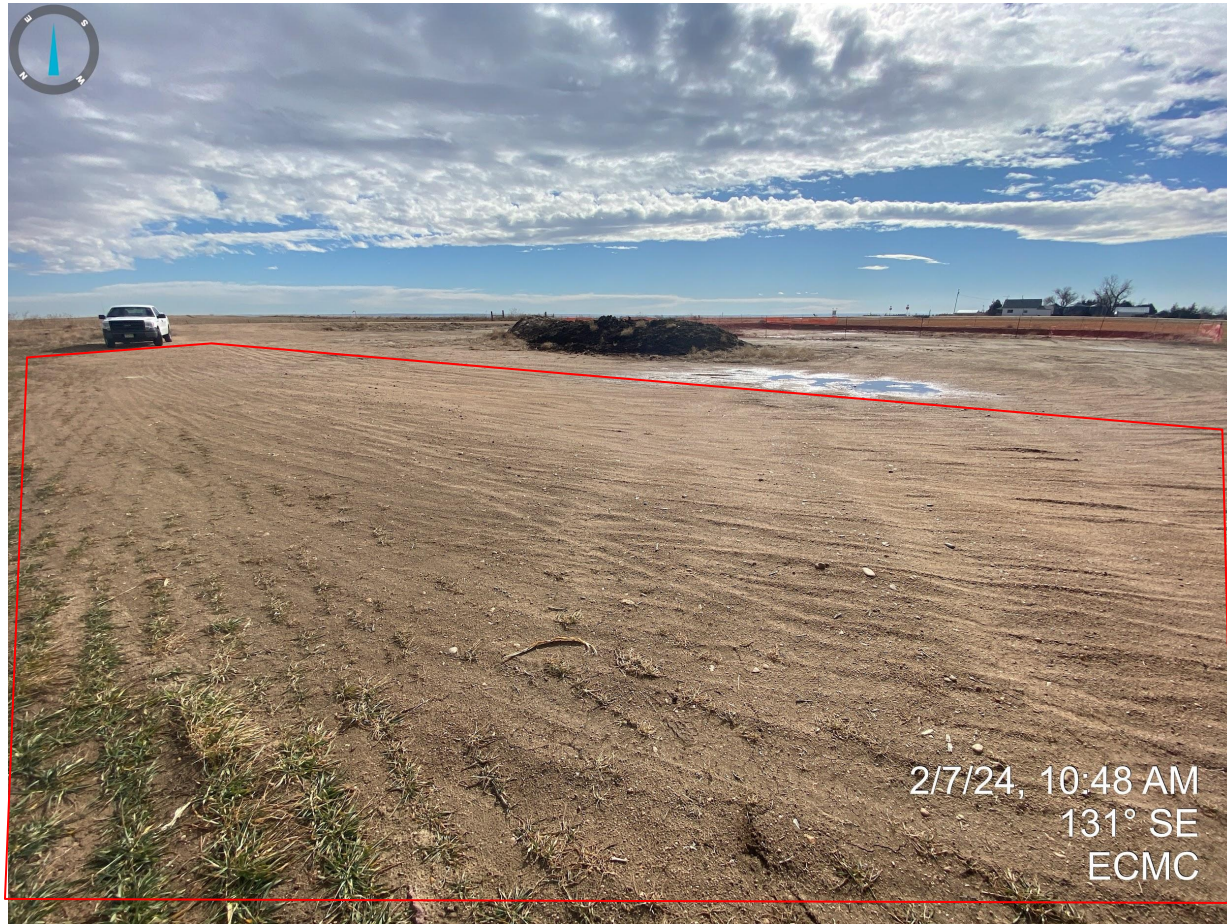
Photo 4. Taken from the northern portion of the former production areas. Photo illustrates the former productions areas that have not been reclaimed, and are not part of active remediation.

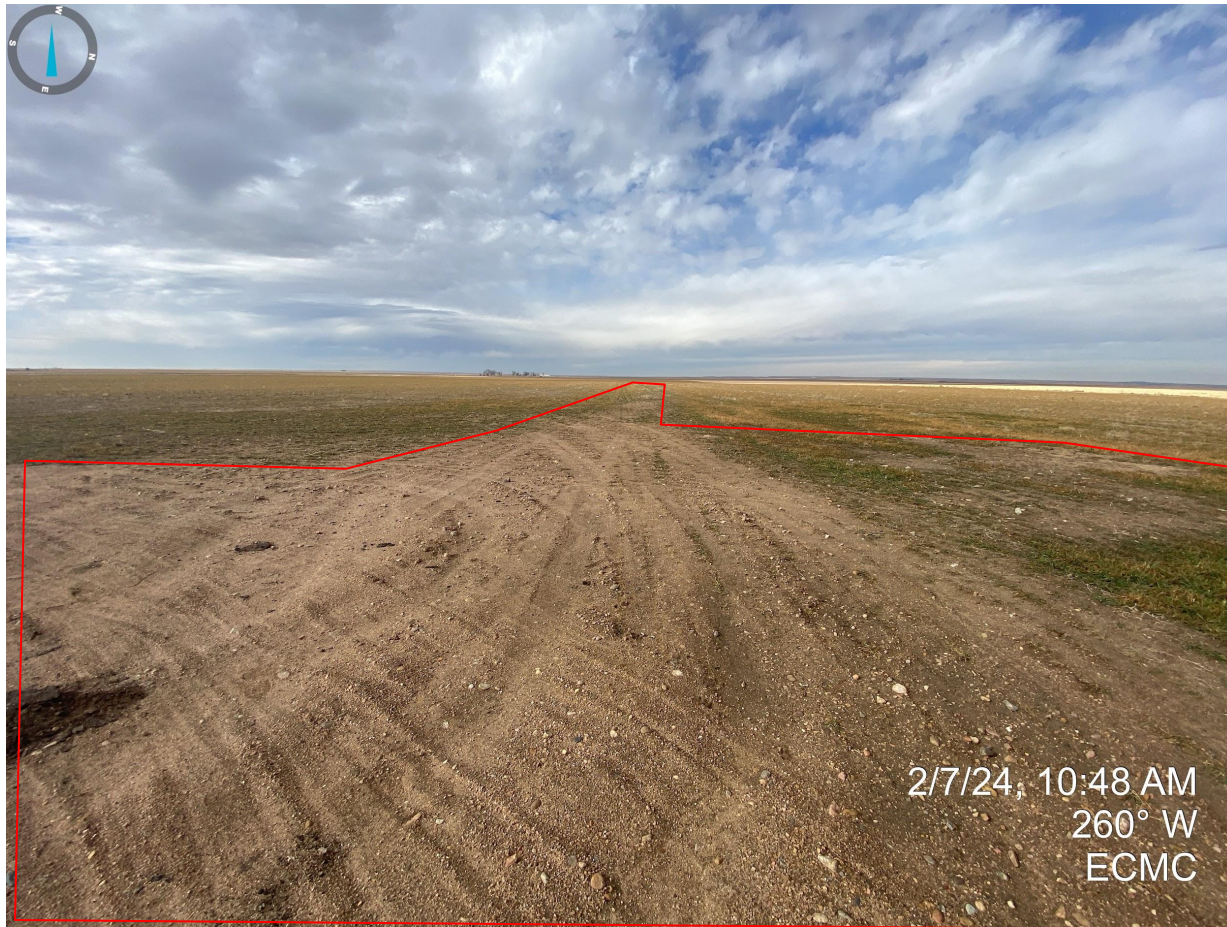
Photo 5. Taken north of the former production areas. Photo illustrates that road base/gravel remains throughout the northern portion of the production areas and along the former access road to the wellhead. Final reclamation activities are required.

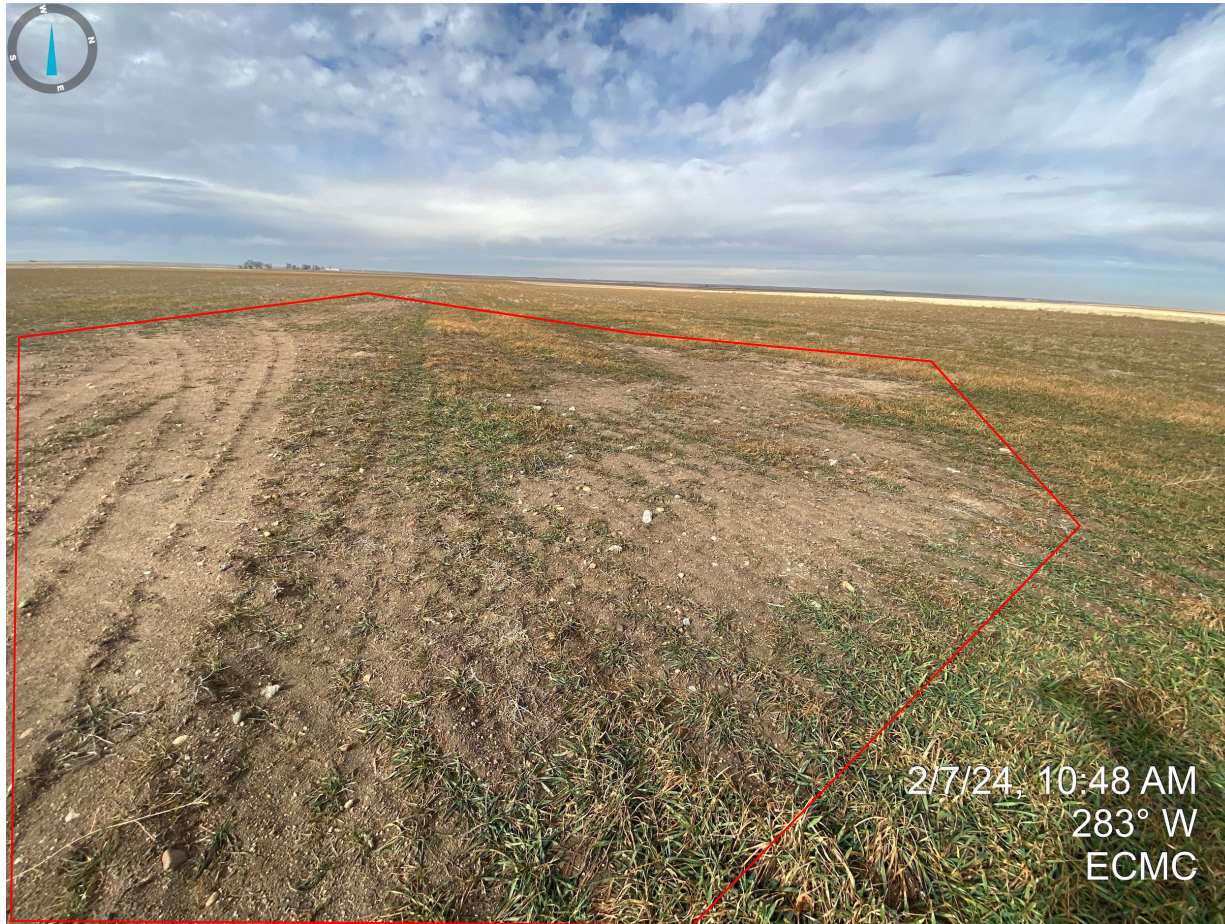
Photo 6. Close up of road base/gravel on the former access road, northwest of the former production areas along the access road.

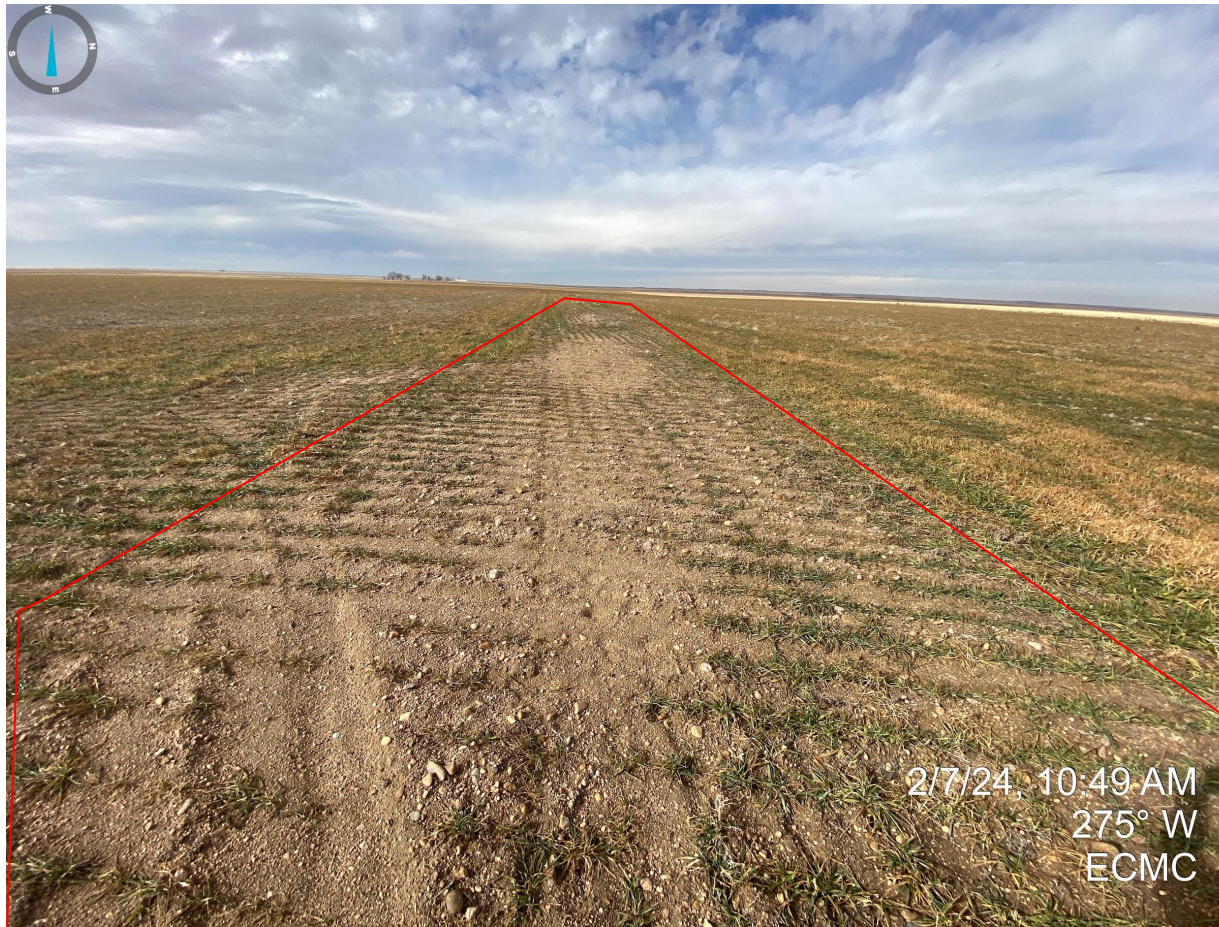
Photo 7. Taken halfway between the former production areas and the wellhead location. See comments in Photo 5.

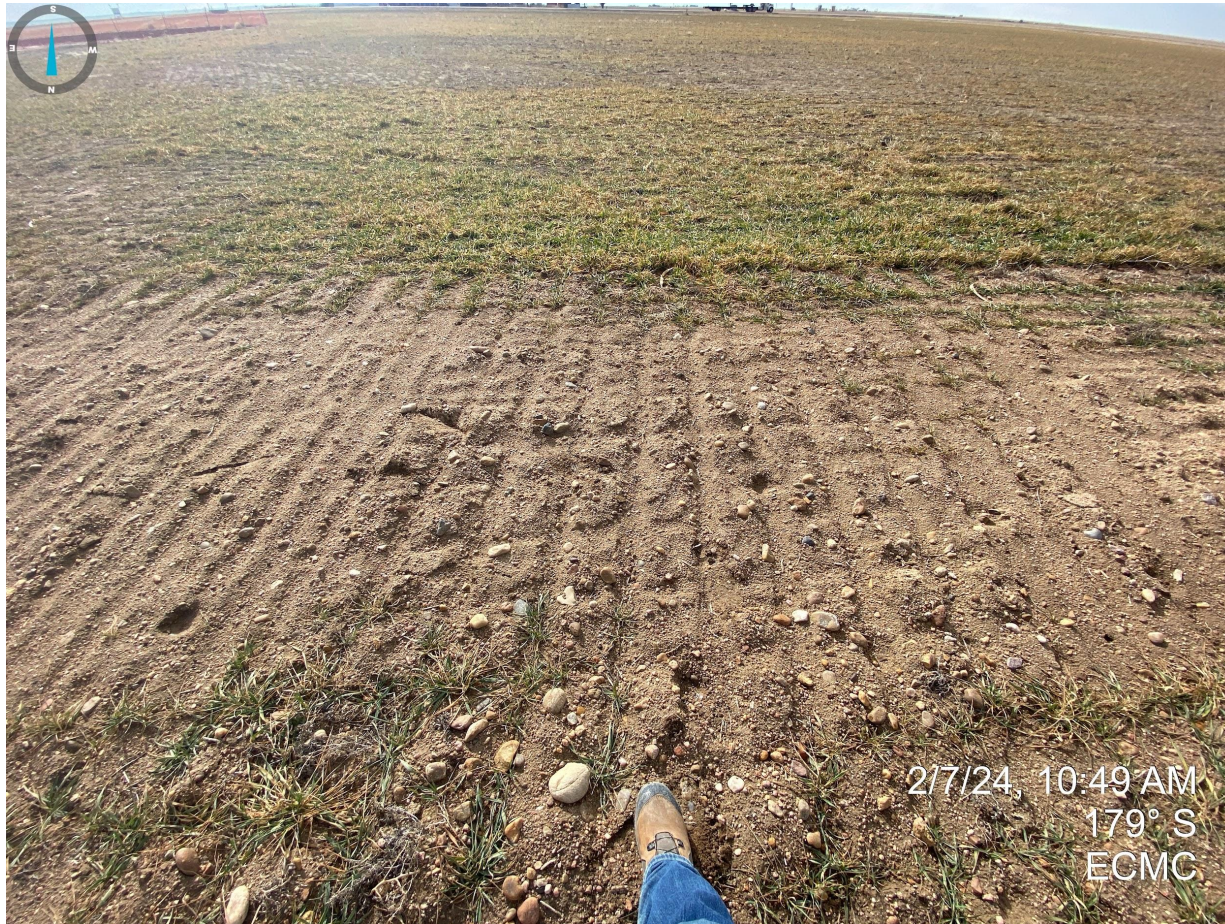
Photo 8. Close up of road base/gravel on the former access road.

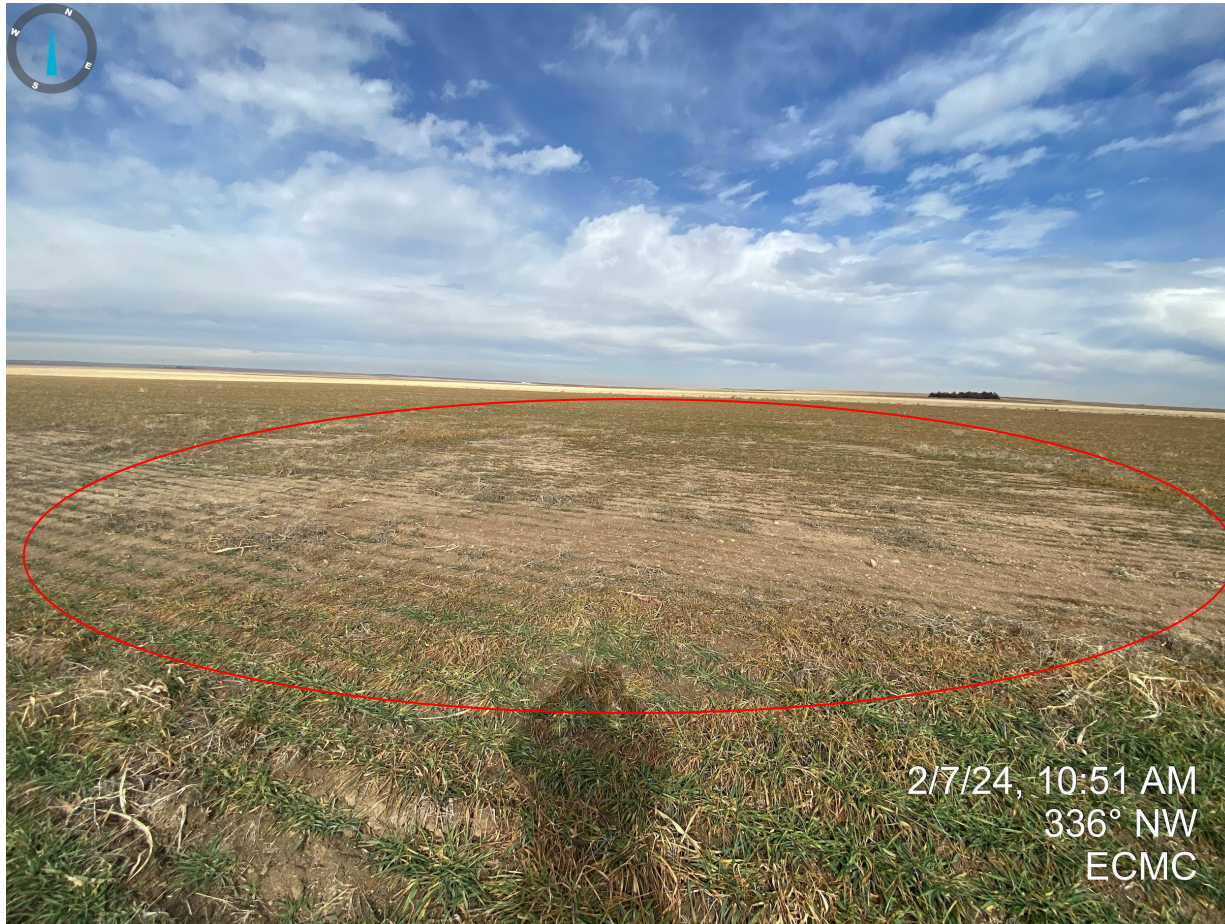
Photo 9. Taken from the southeast corner of the former wellhead location. Road Base and gravel remain throughout and the location will need to be leveled and/or graded to reflect pre-disturbance topography.

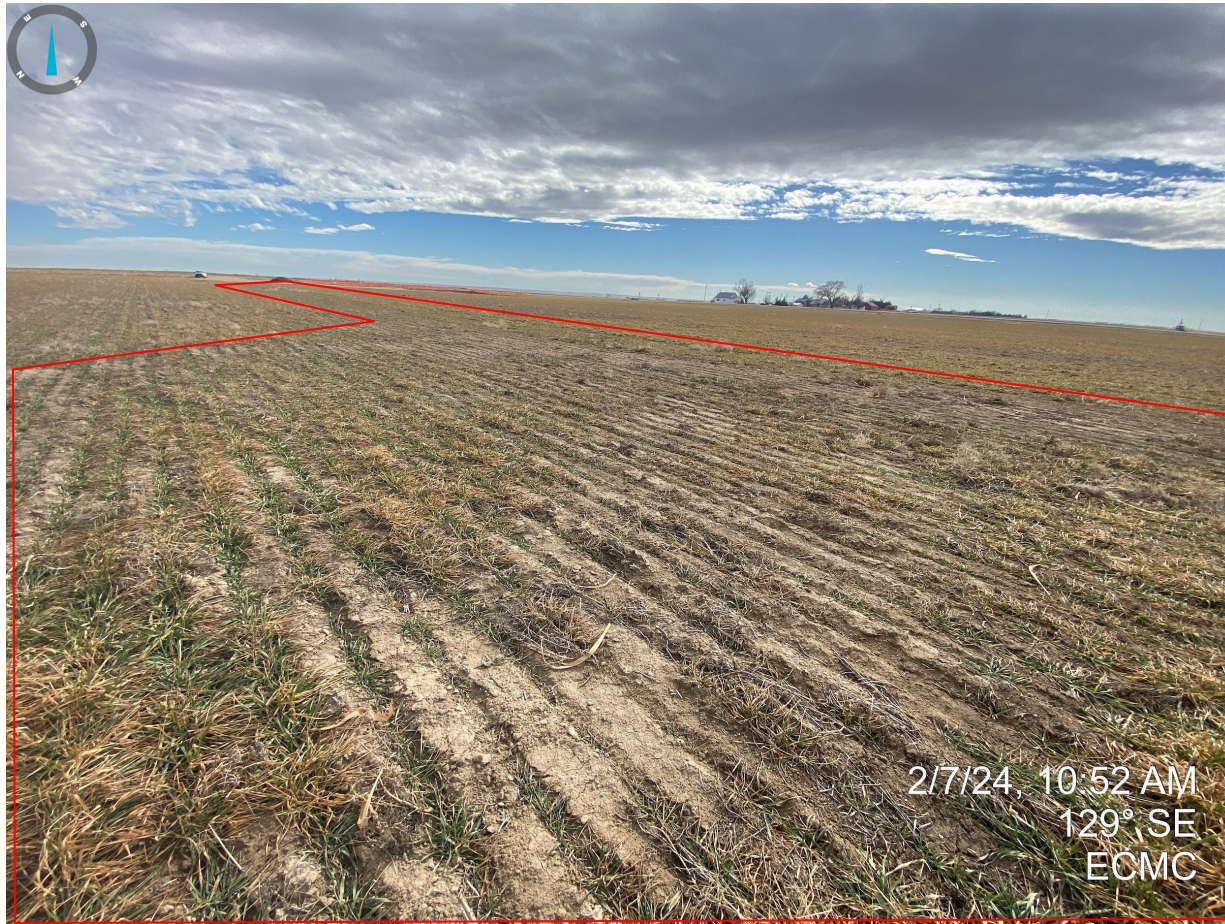
Photo 10. Taken from the approximate center of the former wellhead location, facing southeast. See comments in Photo 9.

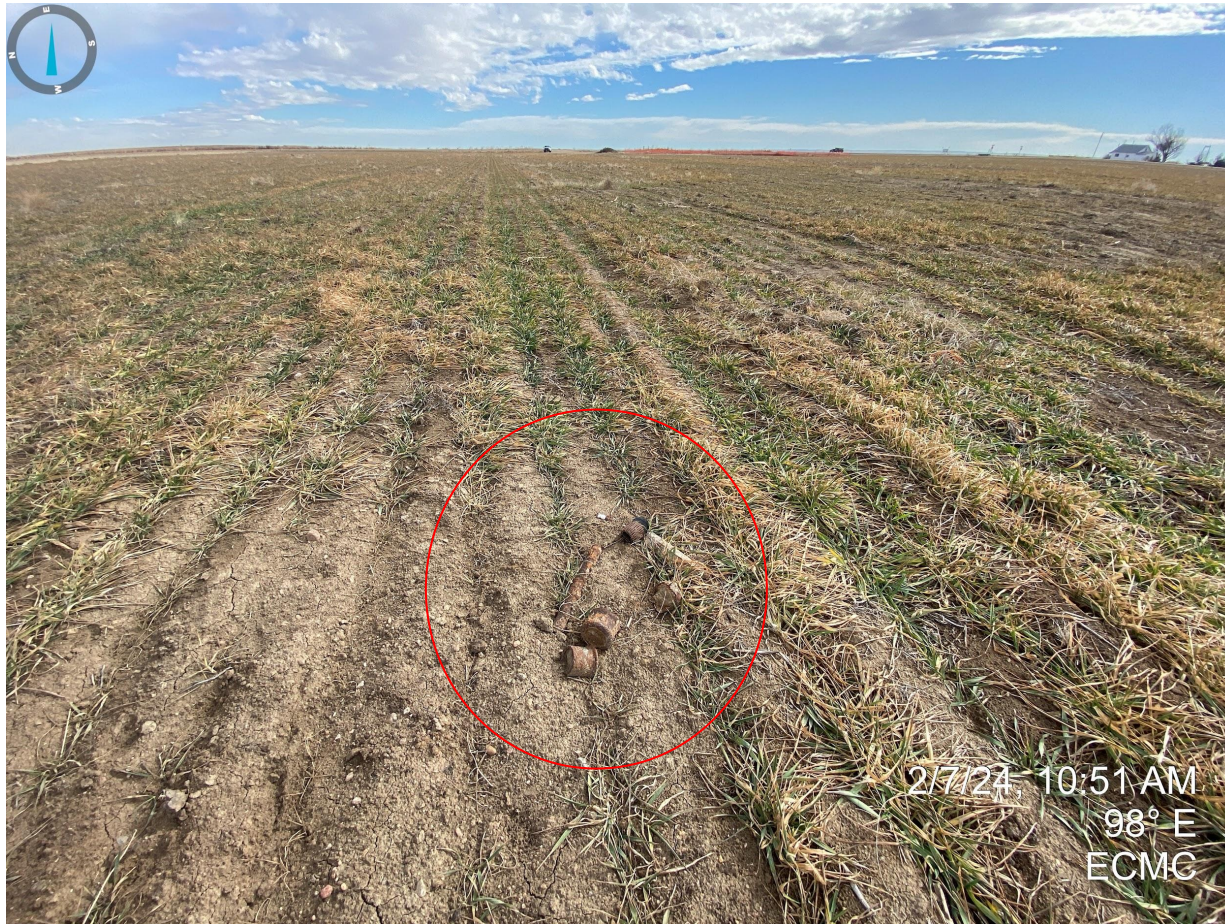
Photo 11. Taken from the northern portion of the former wellhead location. During this inspection, Staff observed debris located throughout the former location. Staff placed debris in a pile for easy identification and removal.

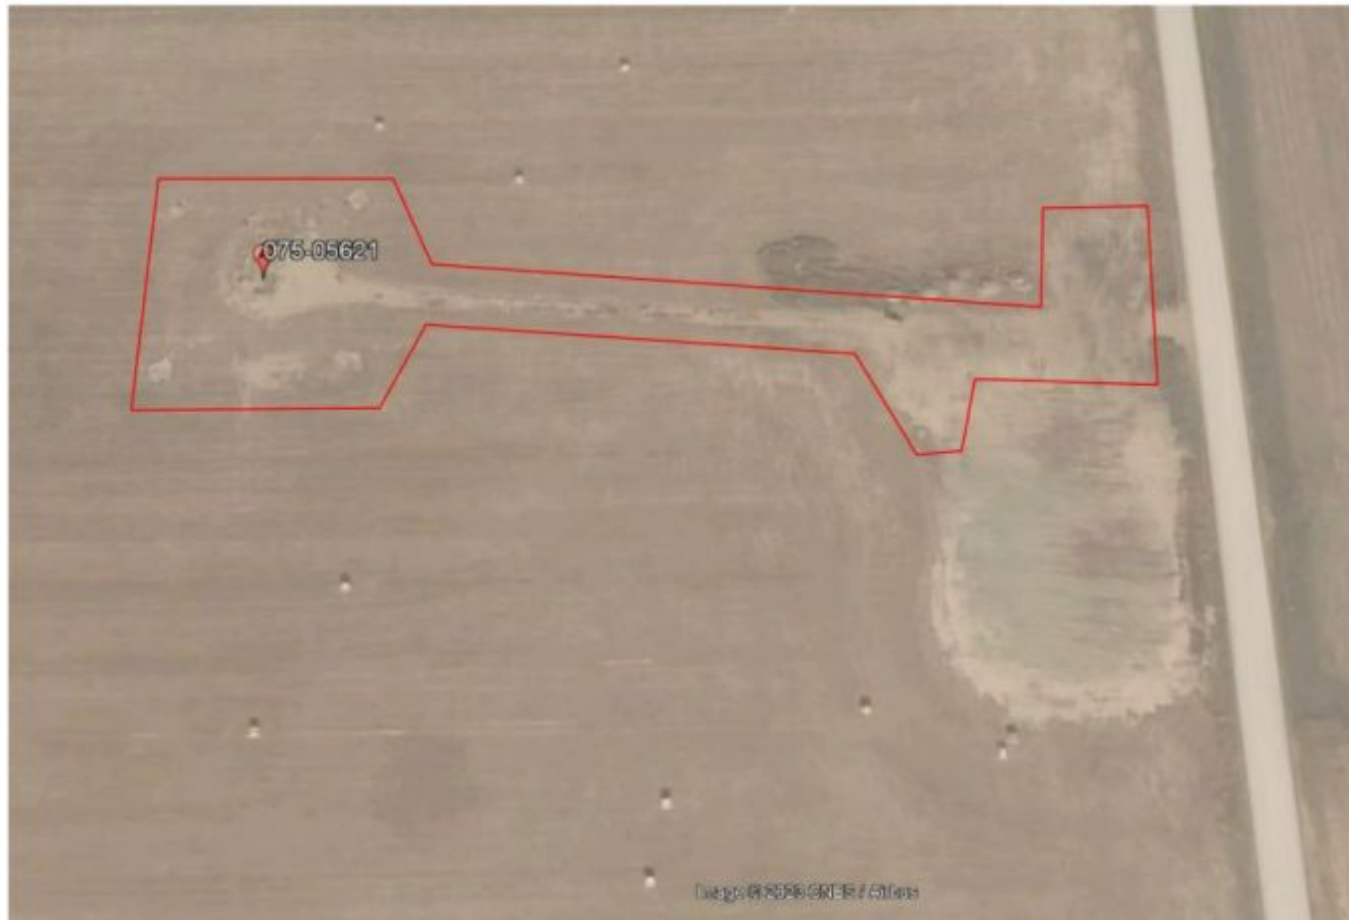
Photo 12. Google Earth aerial imagery (circa 10/2020) illustrating red outline of former access road, well location, and production area disturbances that will require final reclamation activities ASAP. Active remediation should not preclude the commencement of final reclamation activities on the above identified areas. Final reclamation should have been completed by 07/22/2019, per 1004 Rules.
