# Inspection Photos

Loc: 414696

Operator: KTM OPERATING LLC

Inspection Date: 2/13/2024

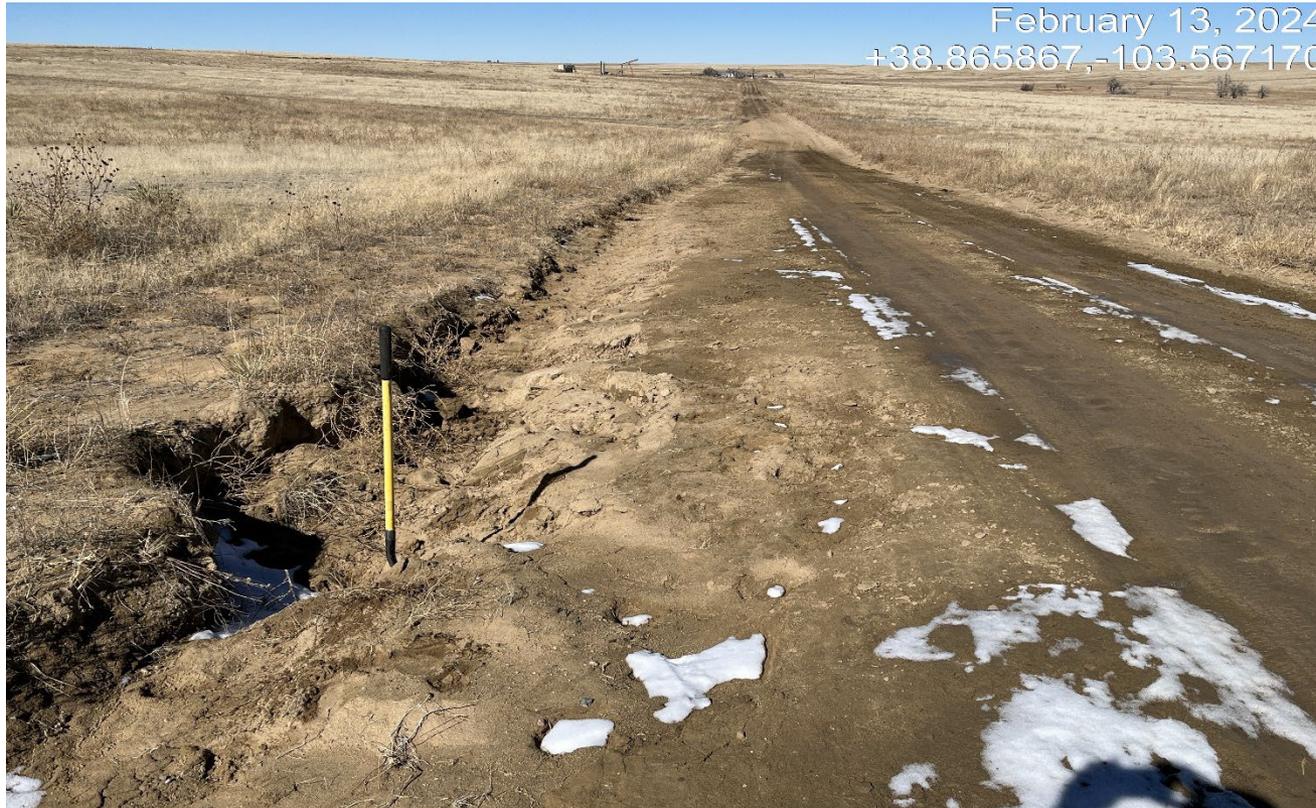
**Photo 1.** Facing north along the main road. There is erosion along the road sides and there are no BMP's installed to prevent further rerosion.

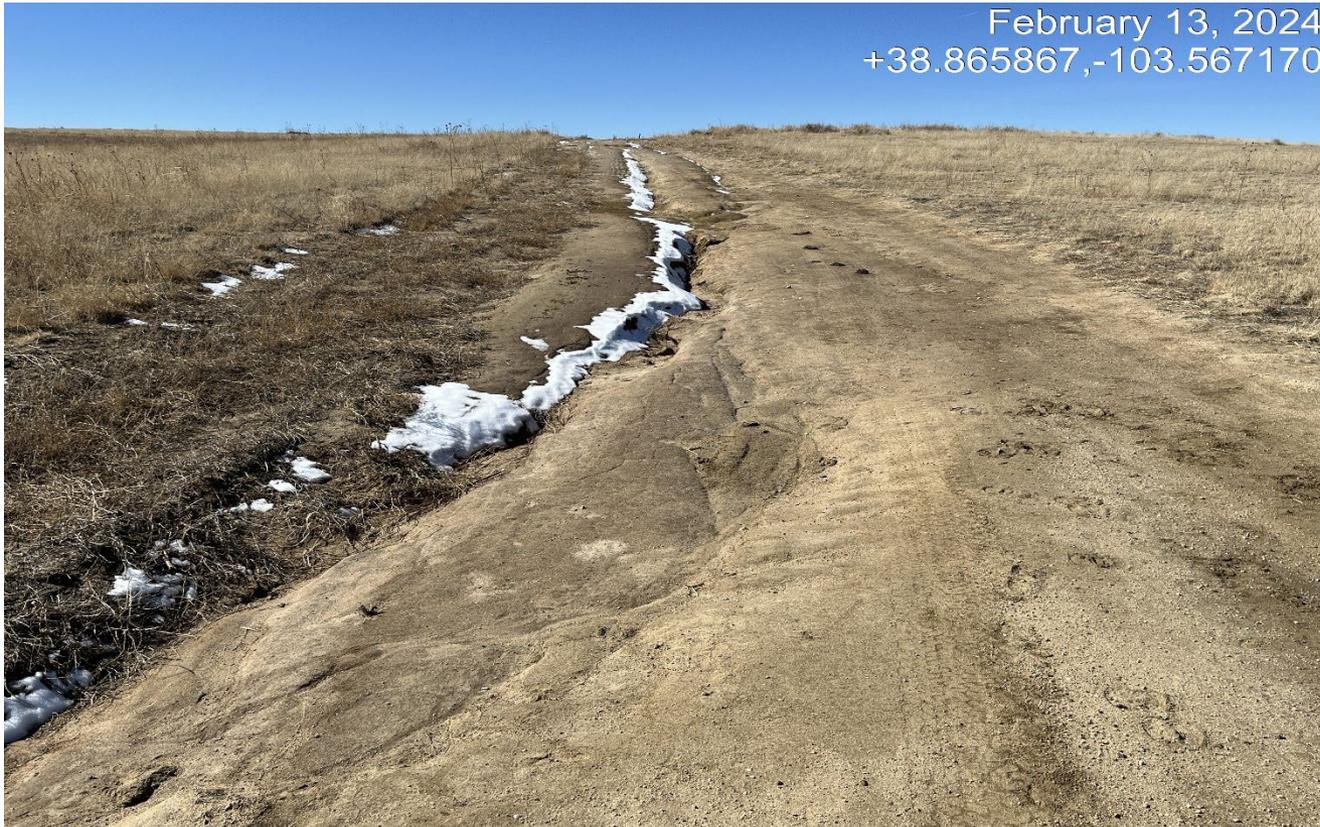
**Photo 2.** Facing west along the access road. There is erosion along the road from stormwater directed down the slope of the road.

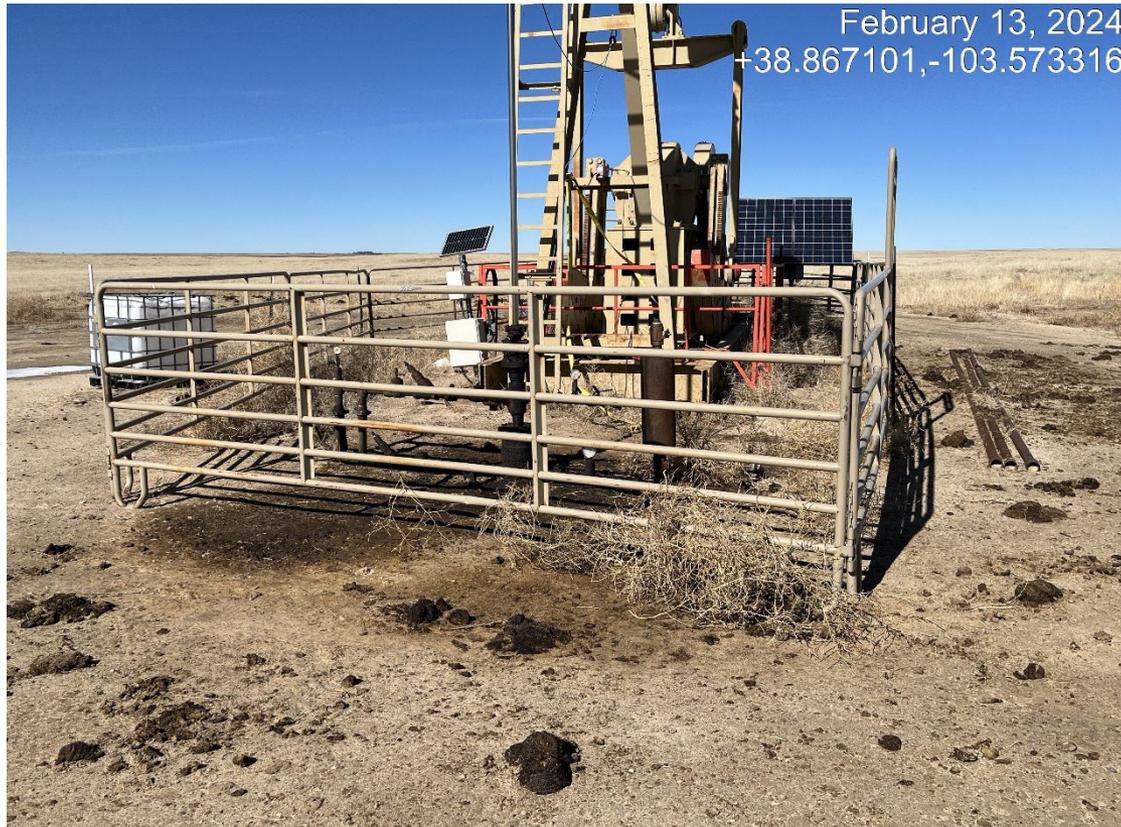
**Photo 4.** Facing toward the wellhed. There is oil stained soils at the wellhead that need to be cleaned up. There is inadequate signage at the well.

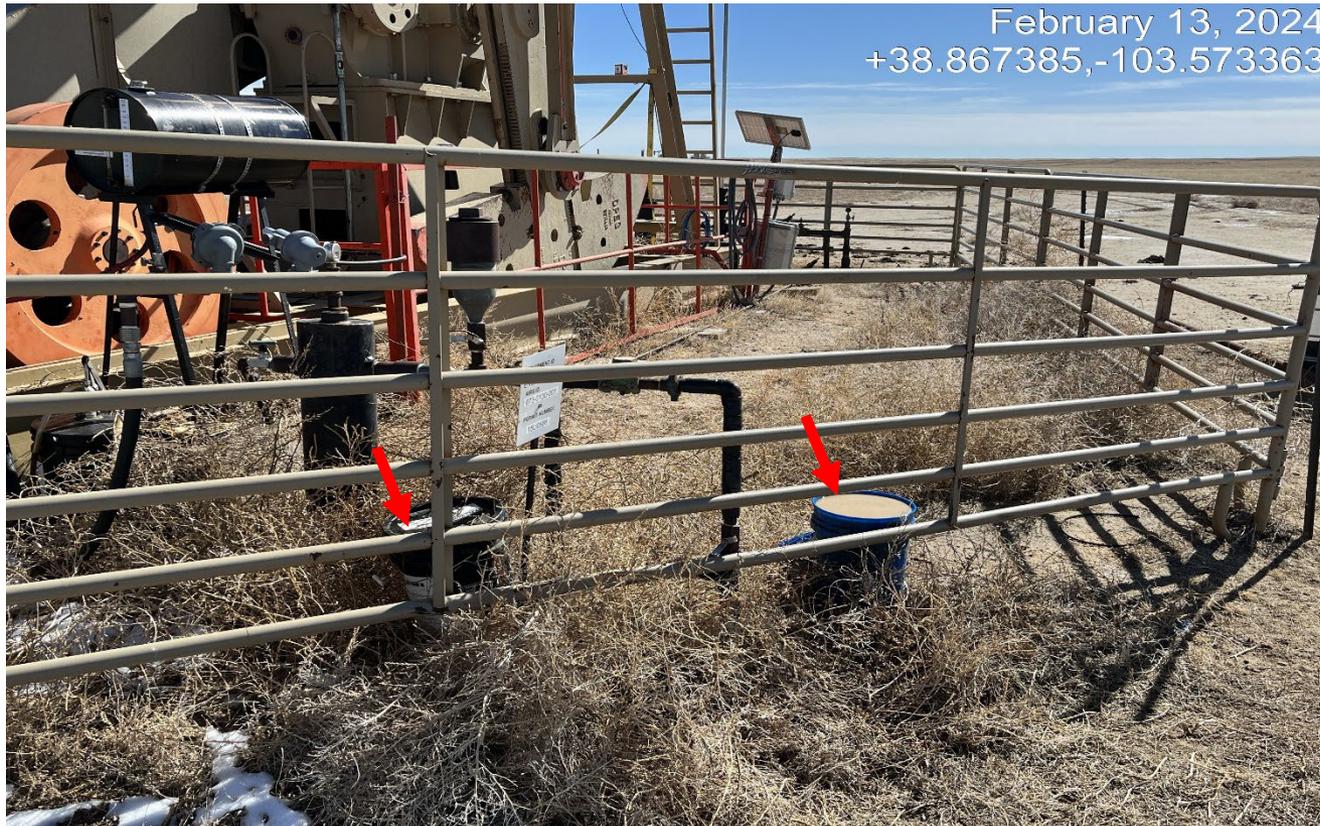
**Photo 5.** There are two 5 gallon containers one of which is full of oily liquid that has spilled onto the ground. There are undesirable weed debris around the equipment which is a fire hazard.

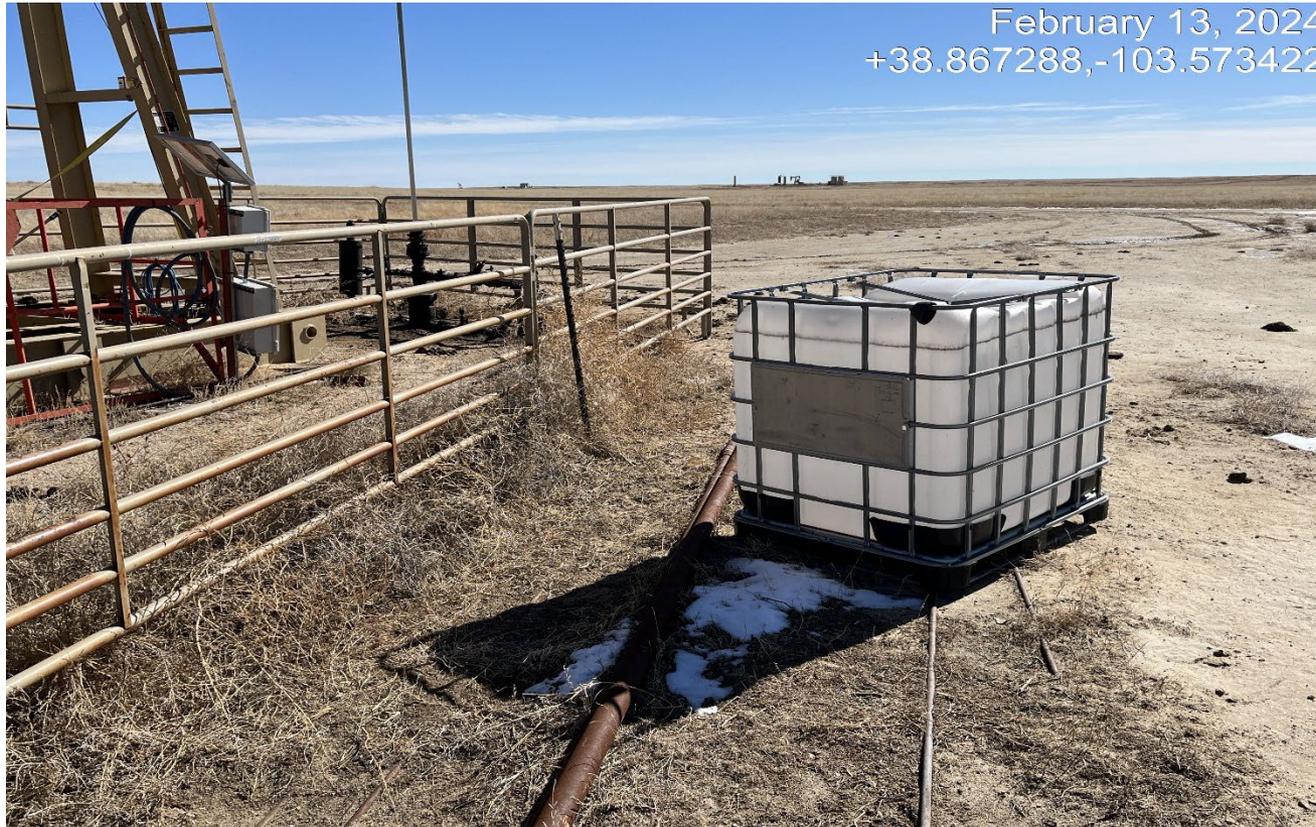
**Photo 6.** There is some pipe and an empty chemical container that needs to be removed..
