Final Reclamation Inspection

Operator: Simcoe LLC - 10749

Location ID: 333468

Inspection Photos
Location Name: Mayfield 14U-01 2, 4
Location ID: 333468

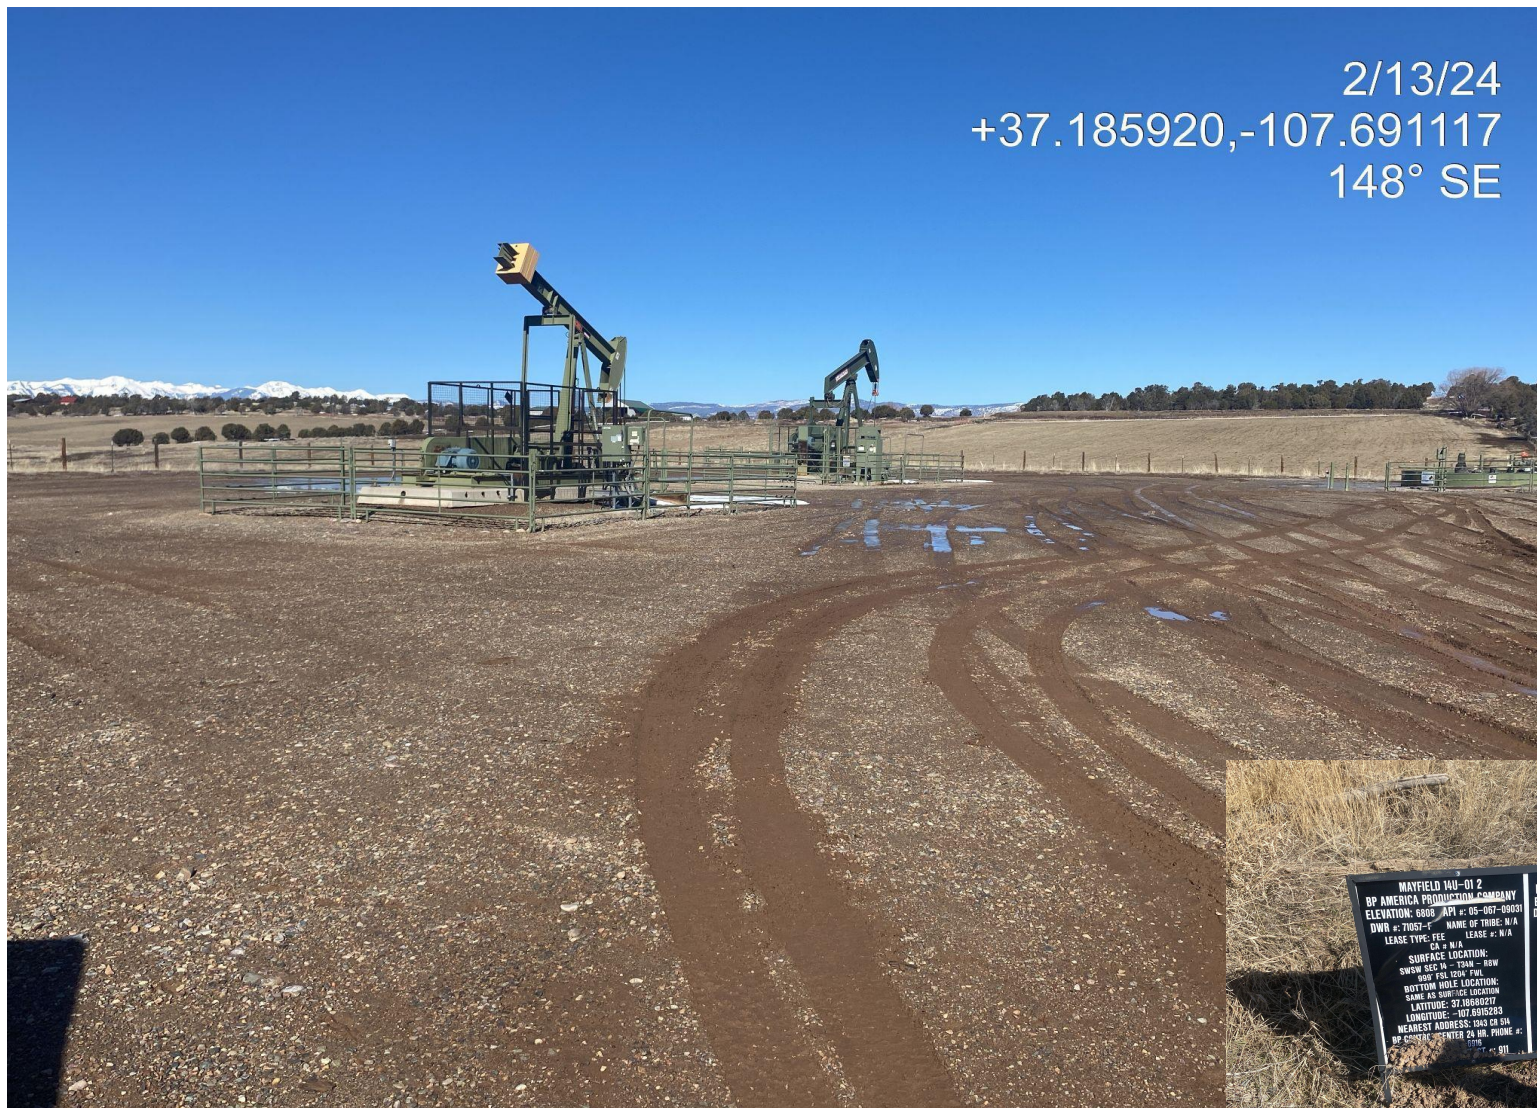
Photo 1. View of the disturbance from the entrance facing center.

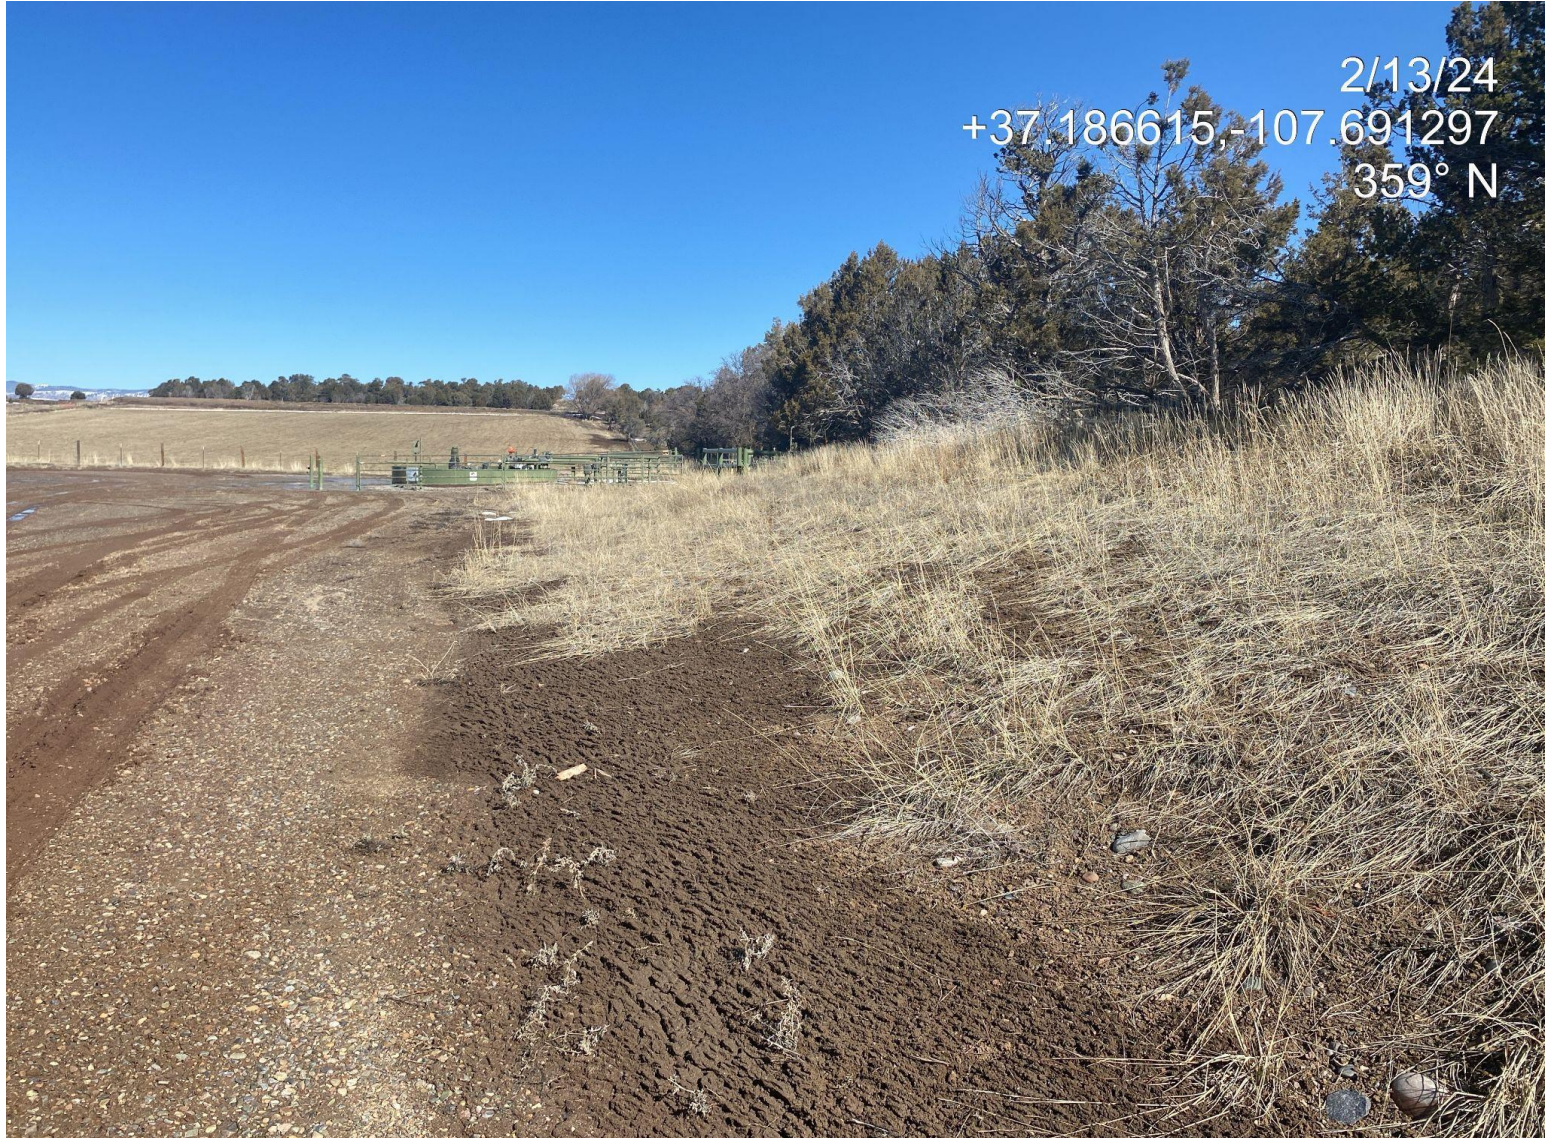
Photo 2. View of the eastern interim reclamation area facing north. Comprised of smooth brome and crested wheatgrass.

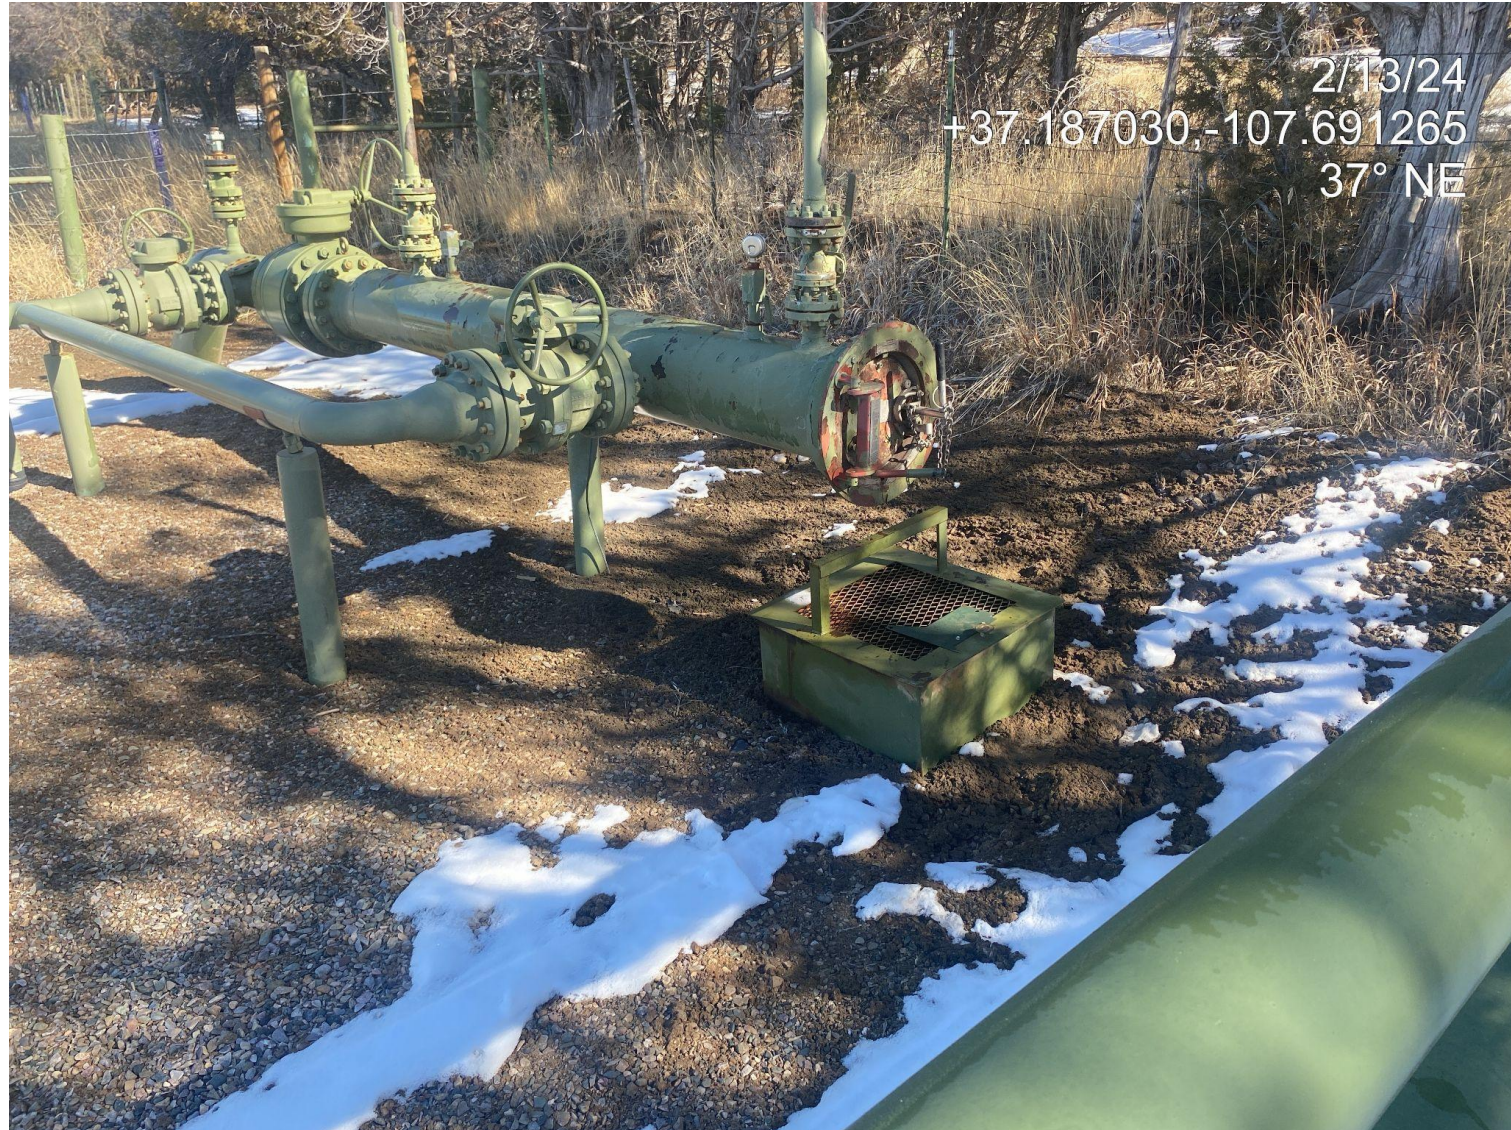
Photo 3. Oily bucket CA identified in the previous inspection doc #712700605 has been addressed/resolved.

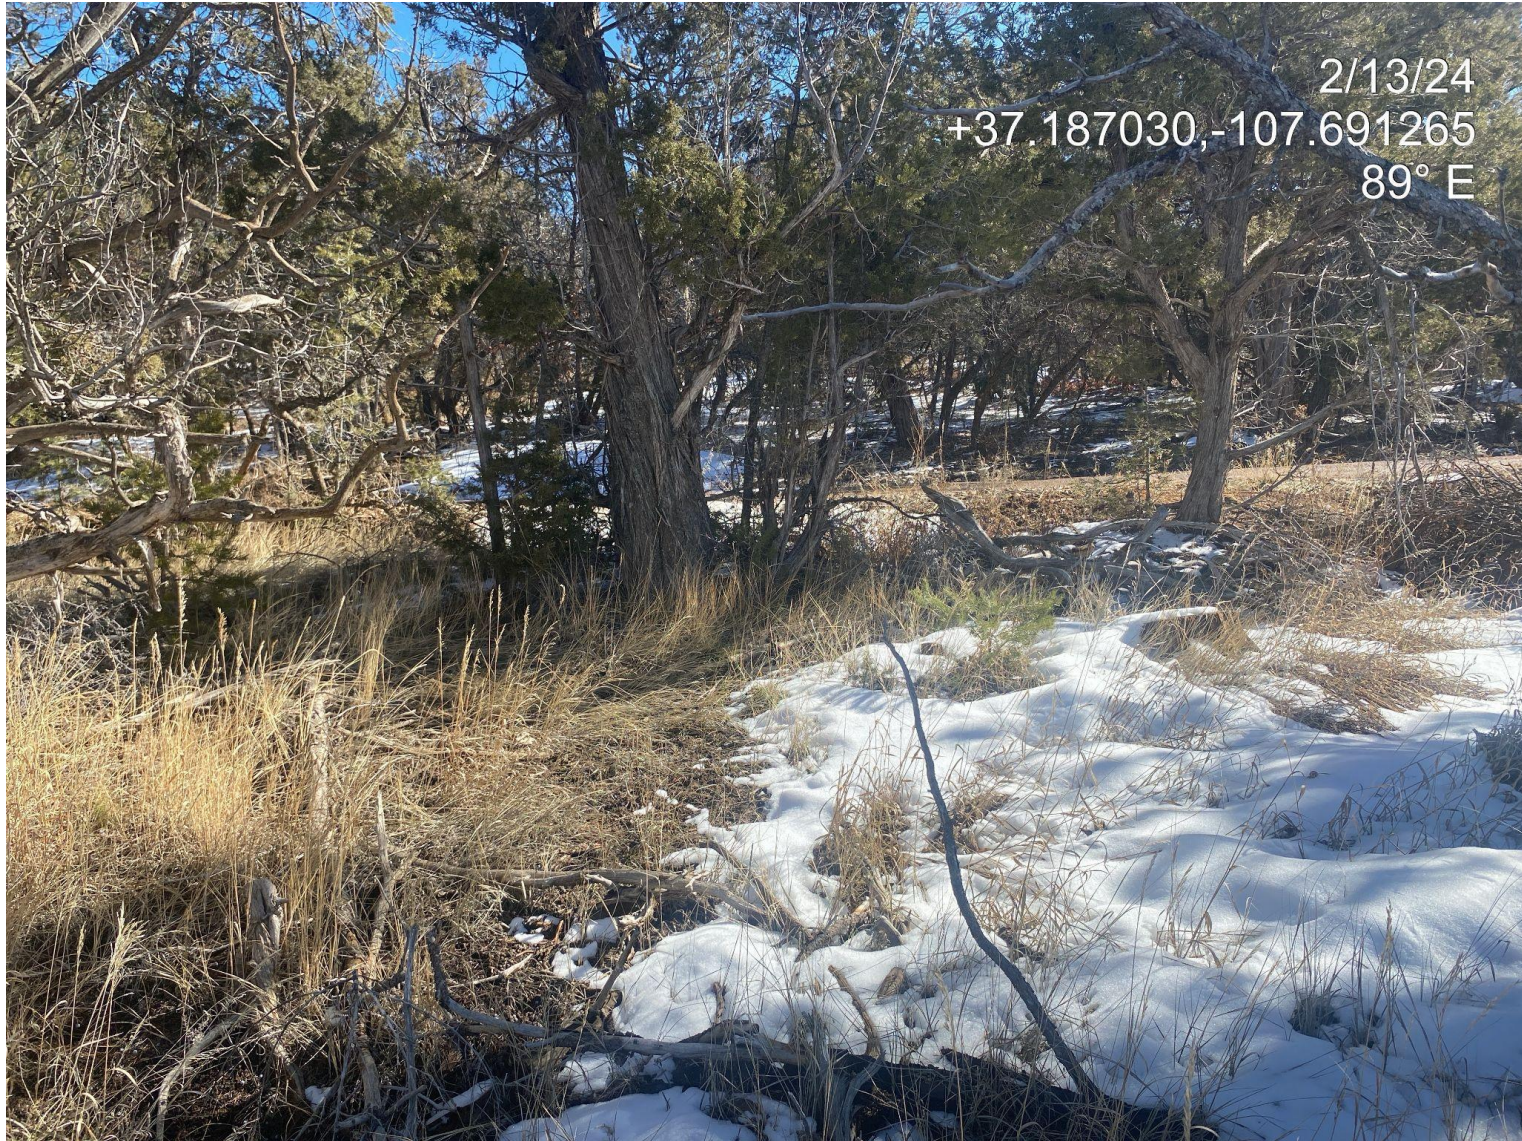
Photo 4. Reference area comprised of smooth brome and juniper.
