# Final Reclamation Inspection

Operator: Simcoe LLC - 10749

Location ID: 312017

Inspection Photos  
 Location Name: Fairfield Farms 2, 4  
 Location ID: 312017

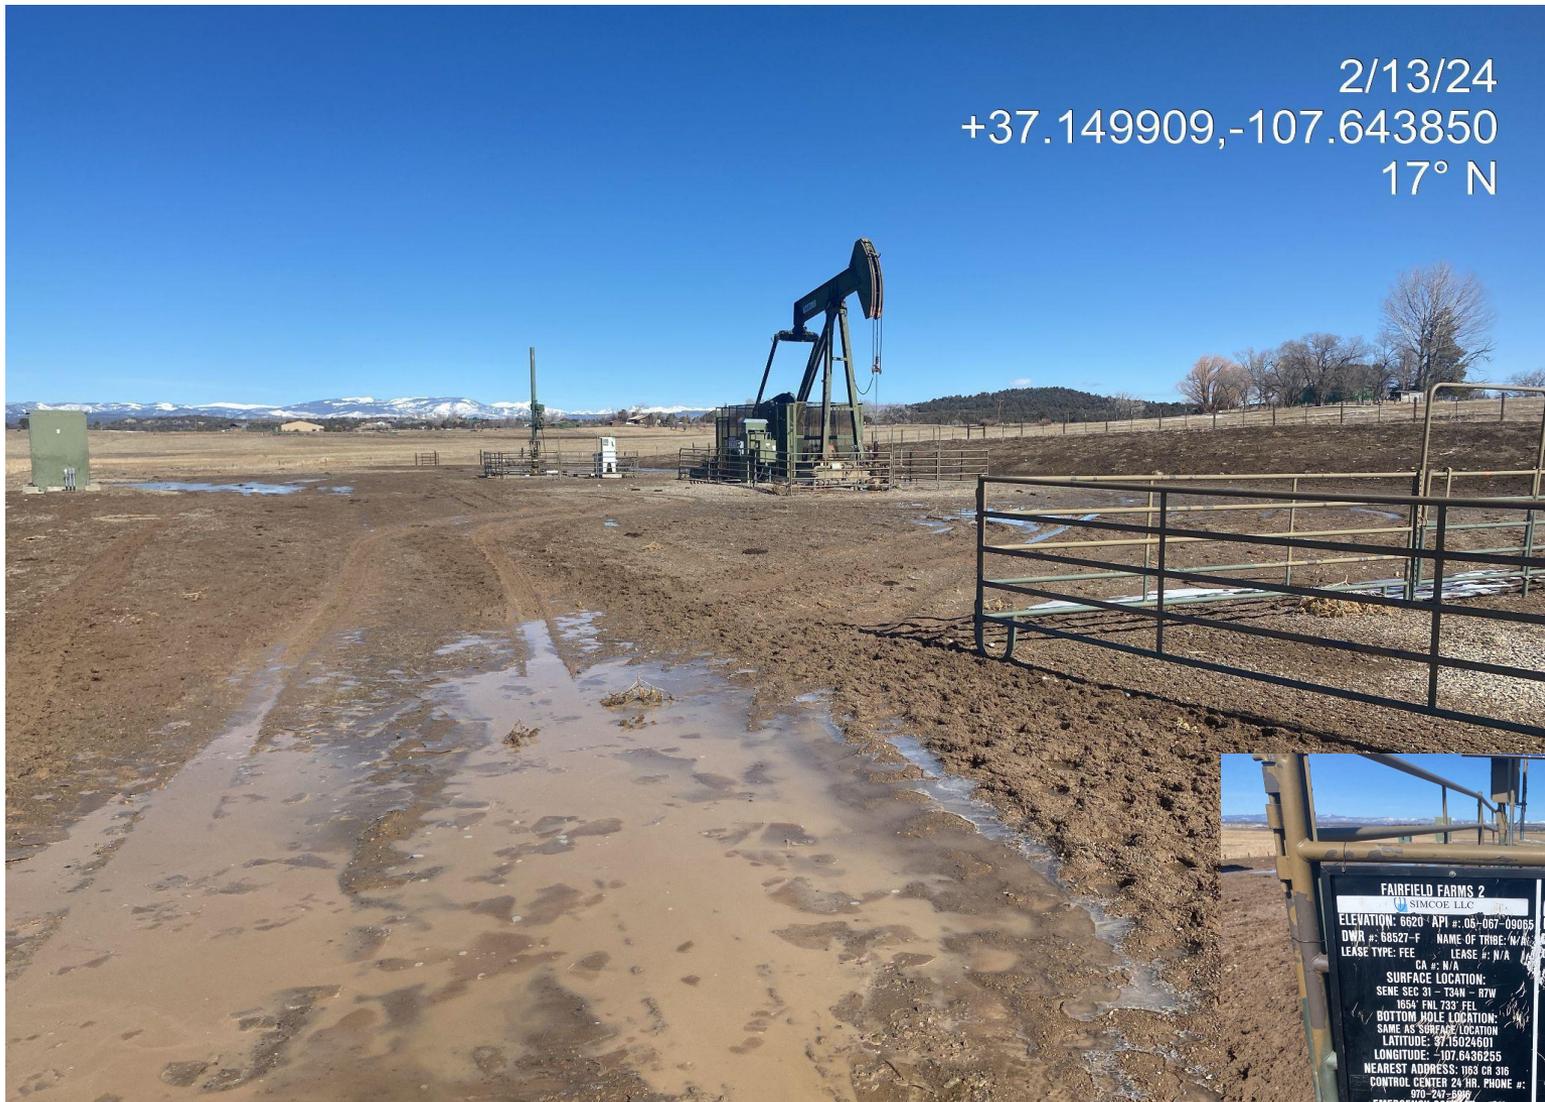
Photo 1. View of the disturbance from the entrance facing center.

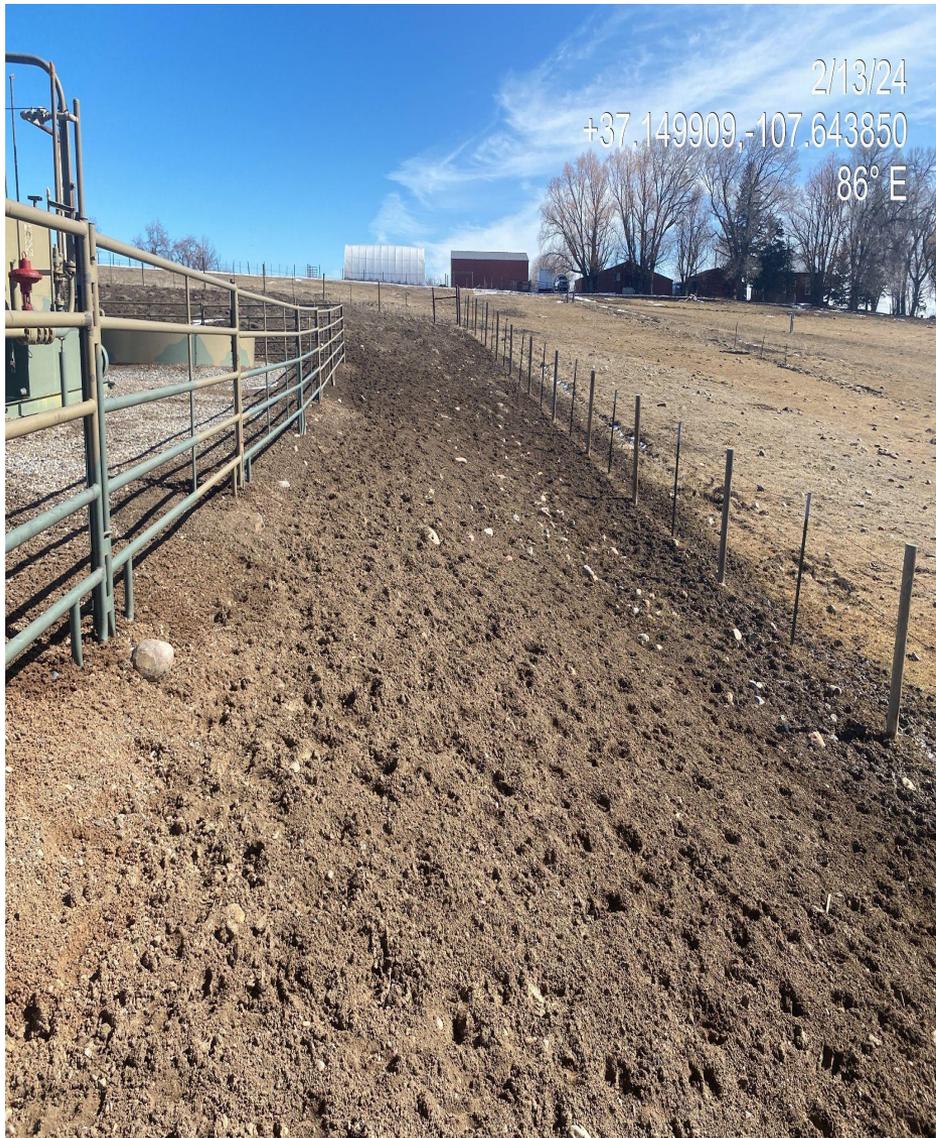
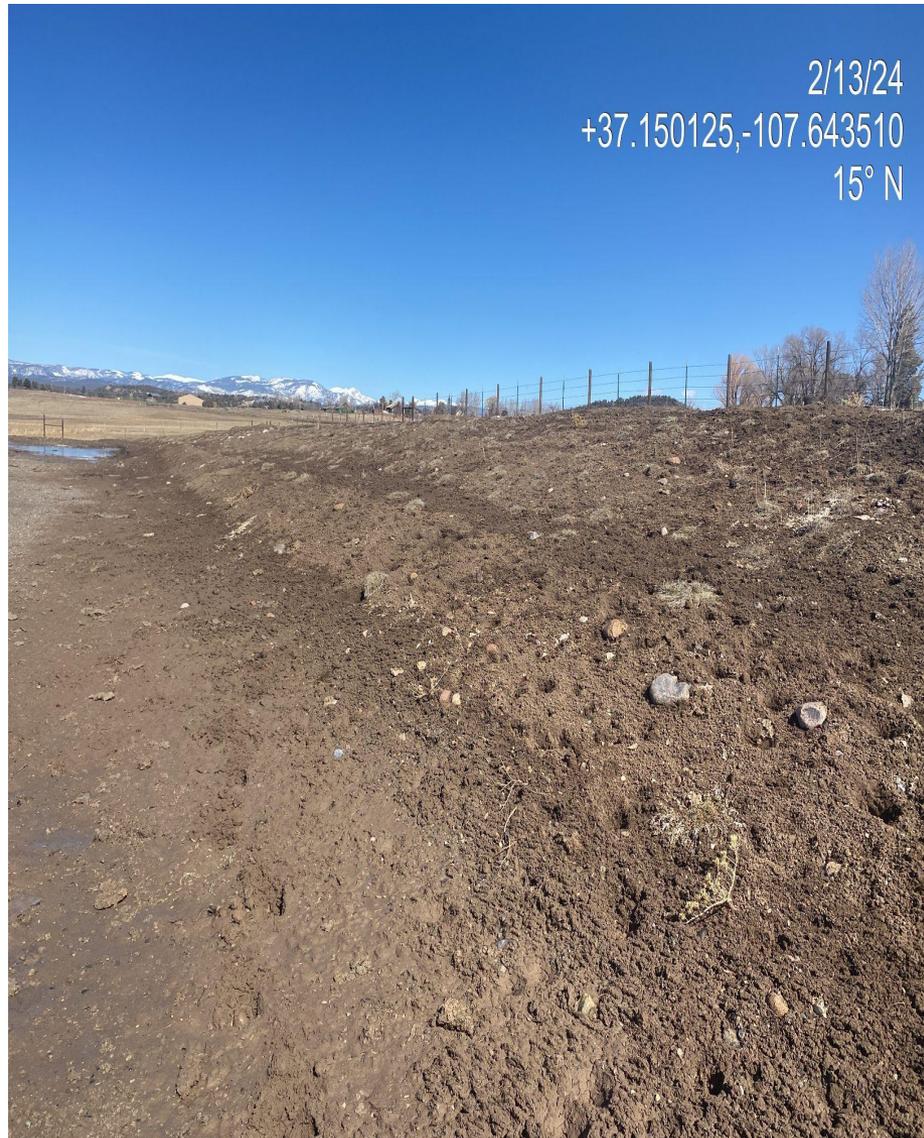
**Photo 2.** Cut and fill slopes lacking vegetation with exposed soil. Disturbance has been degraded by exposure to cattle in the area, no vegetation establishment in the interim reclamation areas.

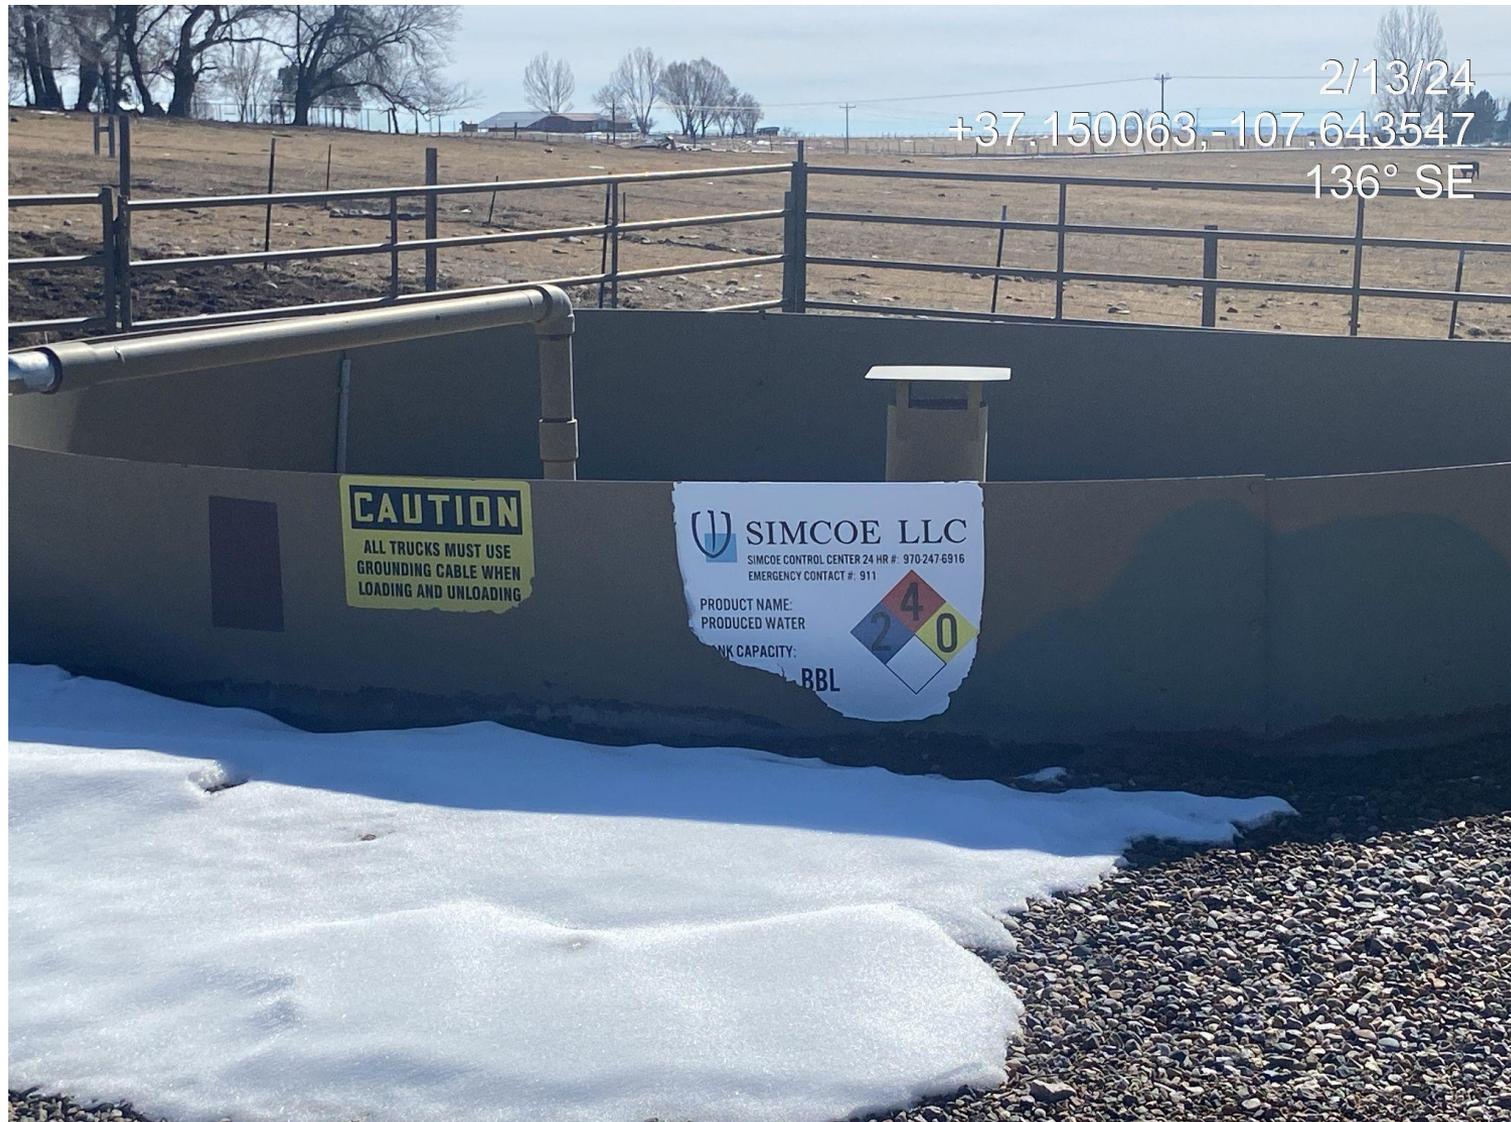
**Photo 3.** View of deteriorating produced water sign that is no longer displaying max capacity.

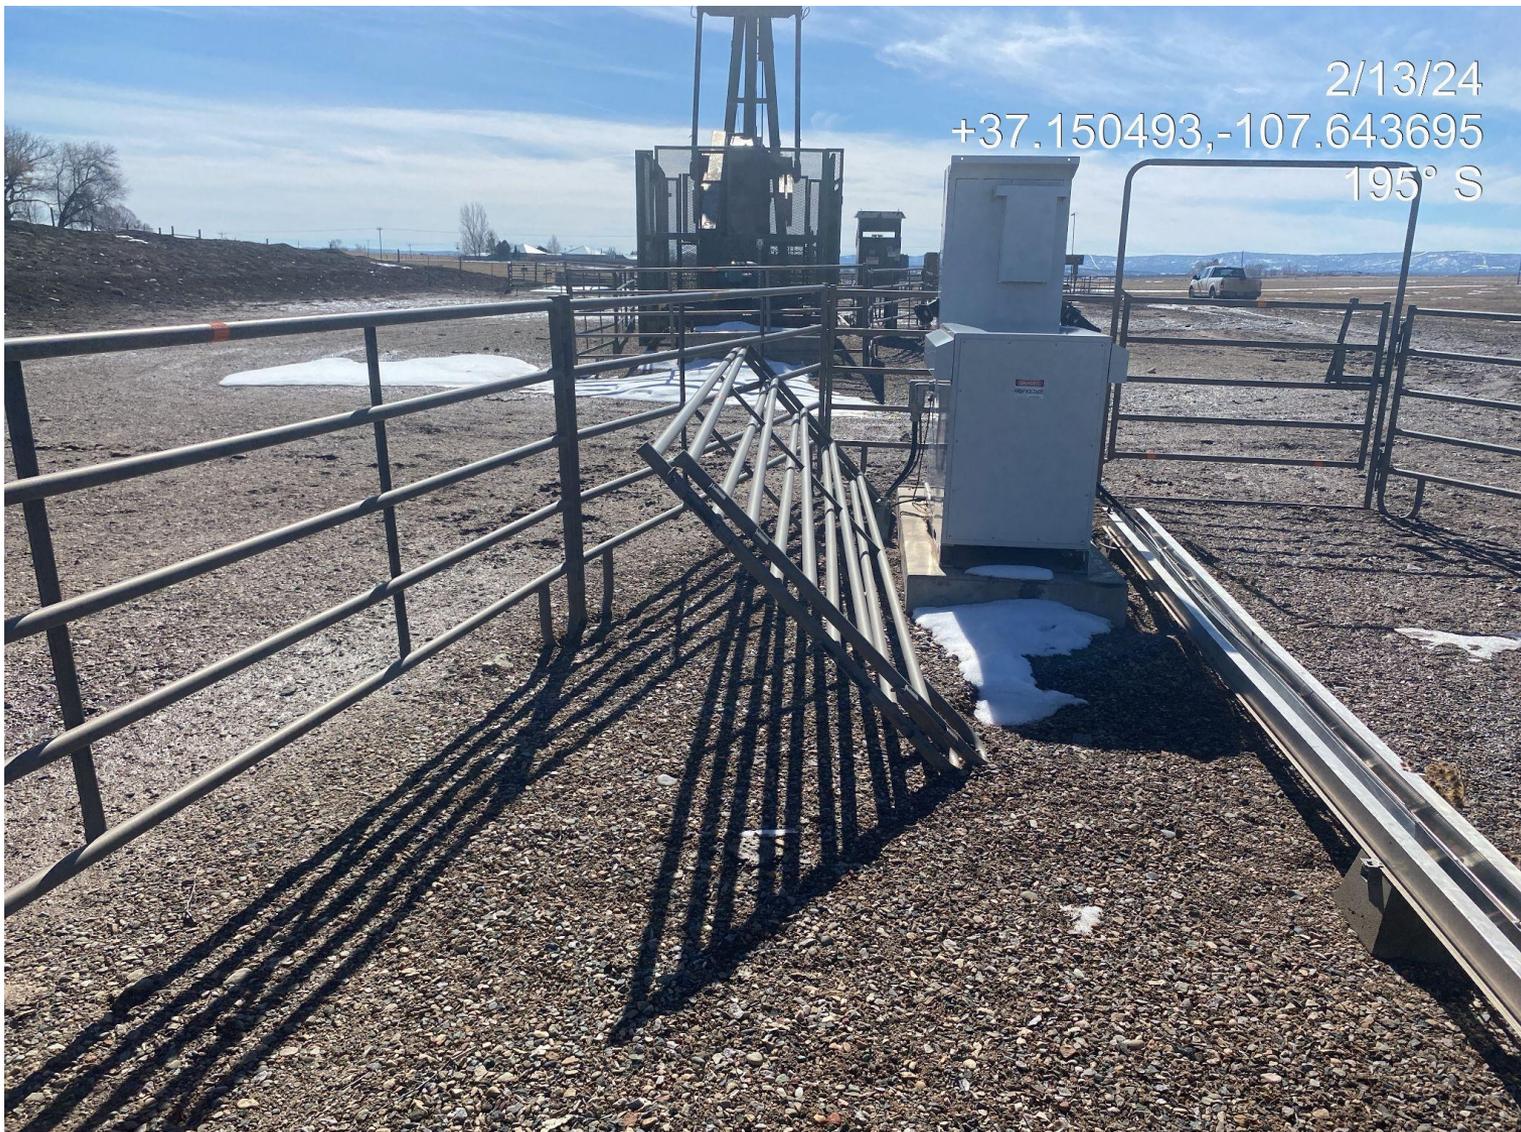
**Photo 4.** View of unused oil and gas fence equipment stored on location.

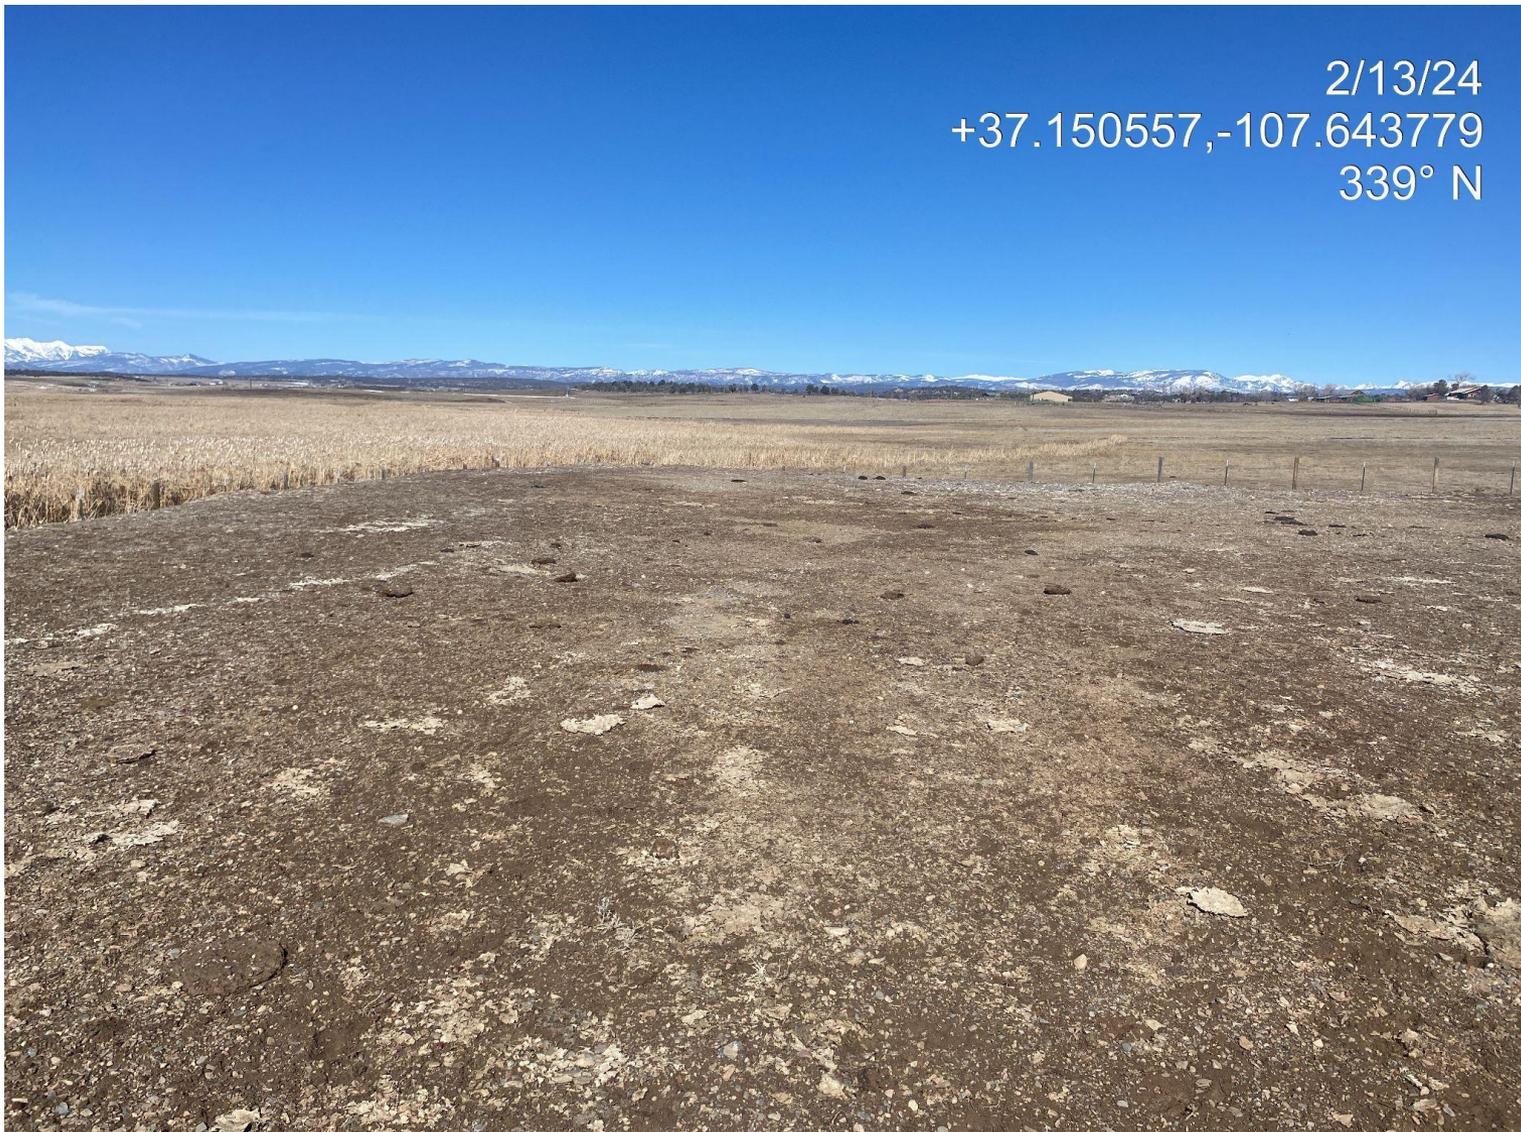
**Photo 6.** Northwest corner of the disturbance does not appear needed for production operations and remain un-reclaimed.

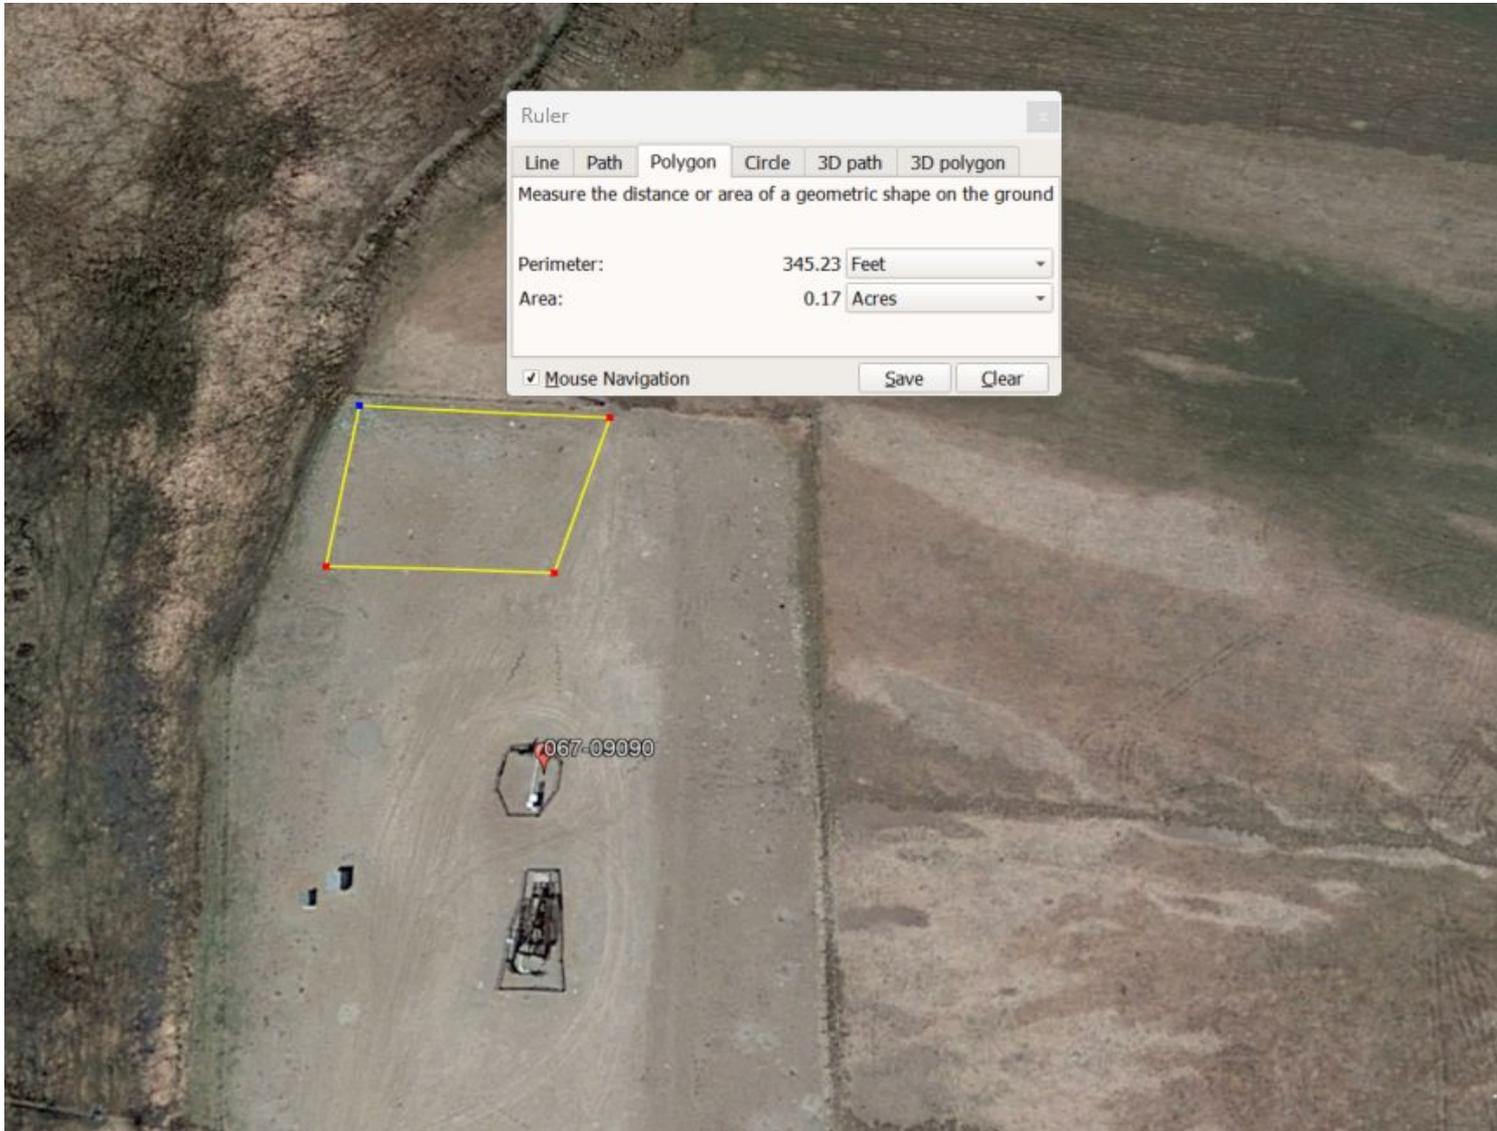
**Photo 7.** Polygon represents approximate areas of the location not reasonably needed for production
