Inspection Photos

Location Name: CAERUS PICEANCE LLC GMR 34-12 (N34) Pad

Location #: 334661

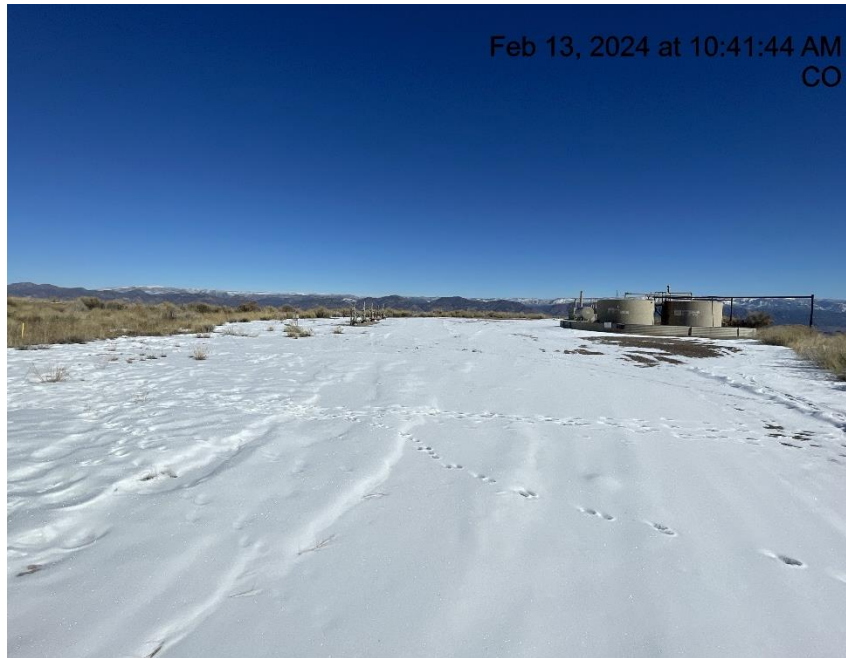
Photo # 6469 From entrance to location

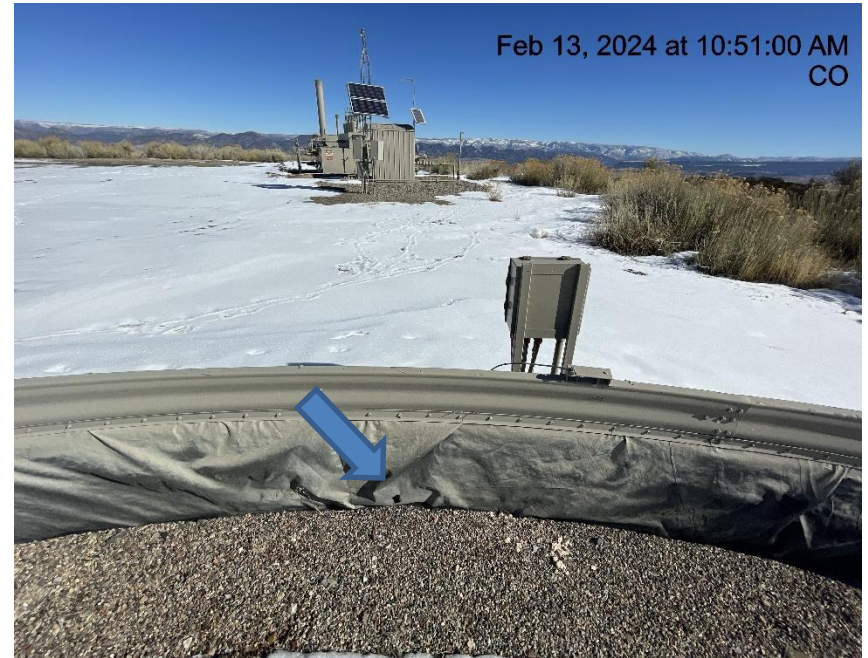
Photo # 6474 Hole in liner/liner needs maintenance

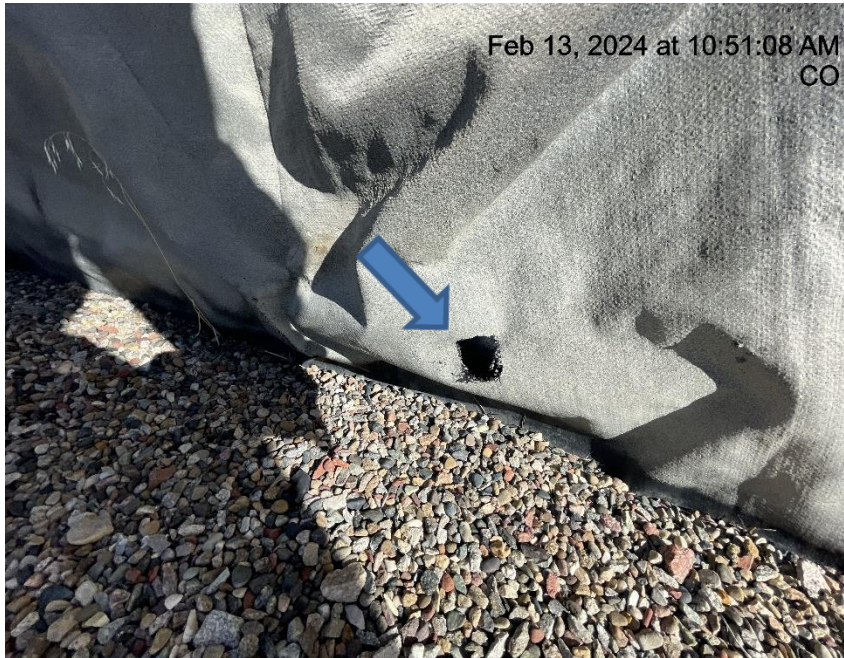
Photo # 6475 Hole in liner/liner needs maintenance

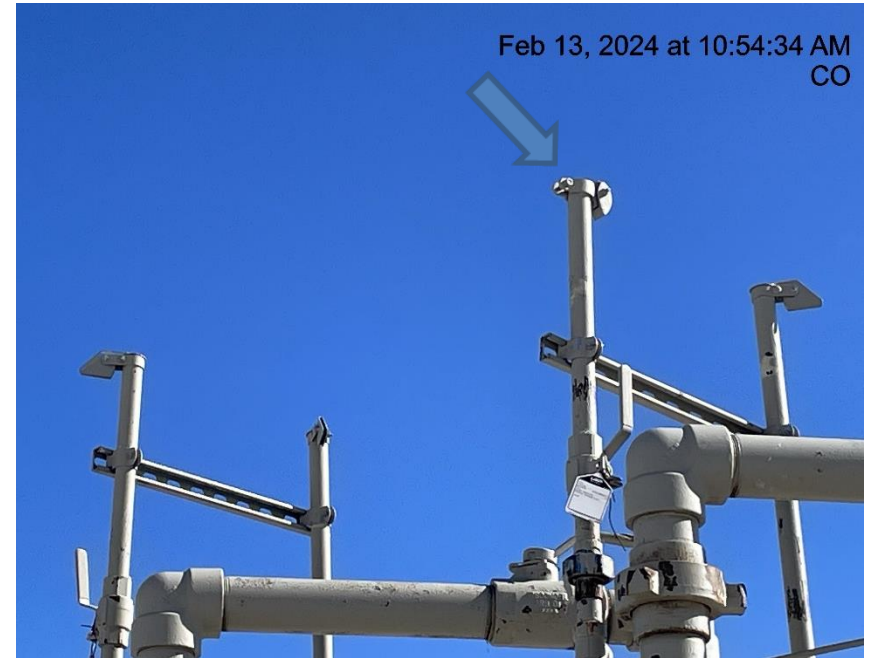
Photo # 6476 Rupture disc vent line lacks cap

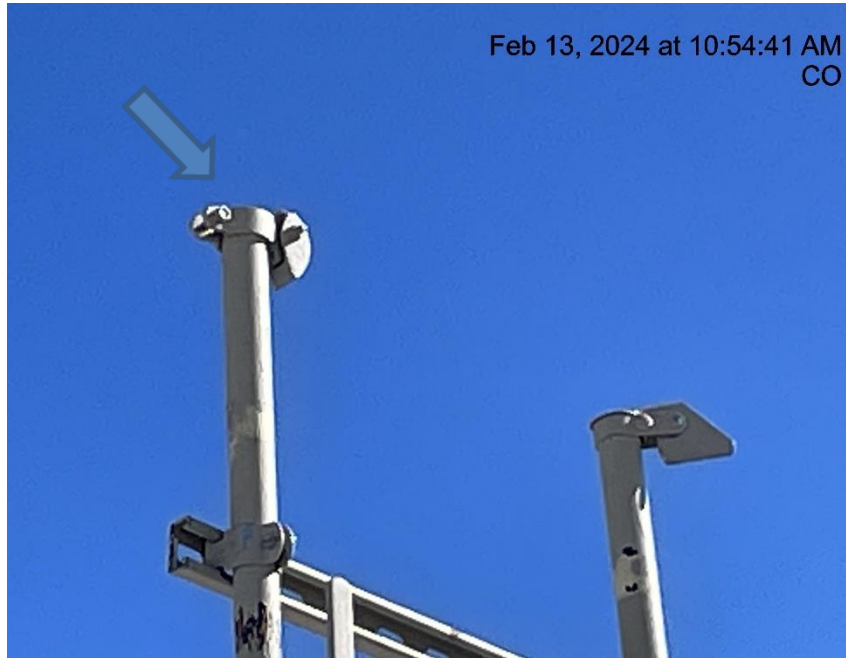
Photo # 6477 Rupture disc vent line lacks cap
