# Final Reclamation Inspection

Operator: Simcoe LLC - 10749

Location ID: 306883

Inspection Photos  
Location Name: Dickens 44-14 2  
Location ID: 306883

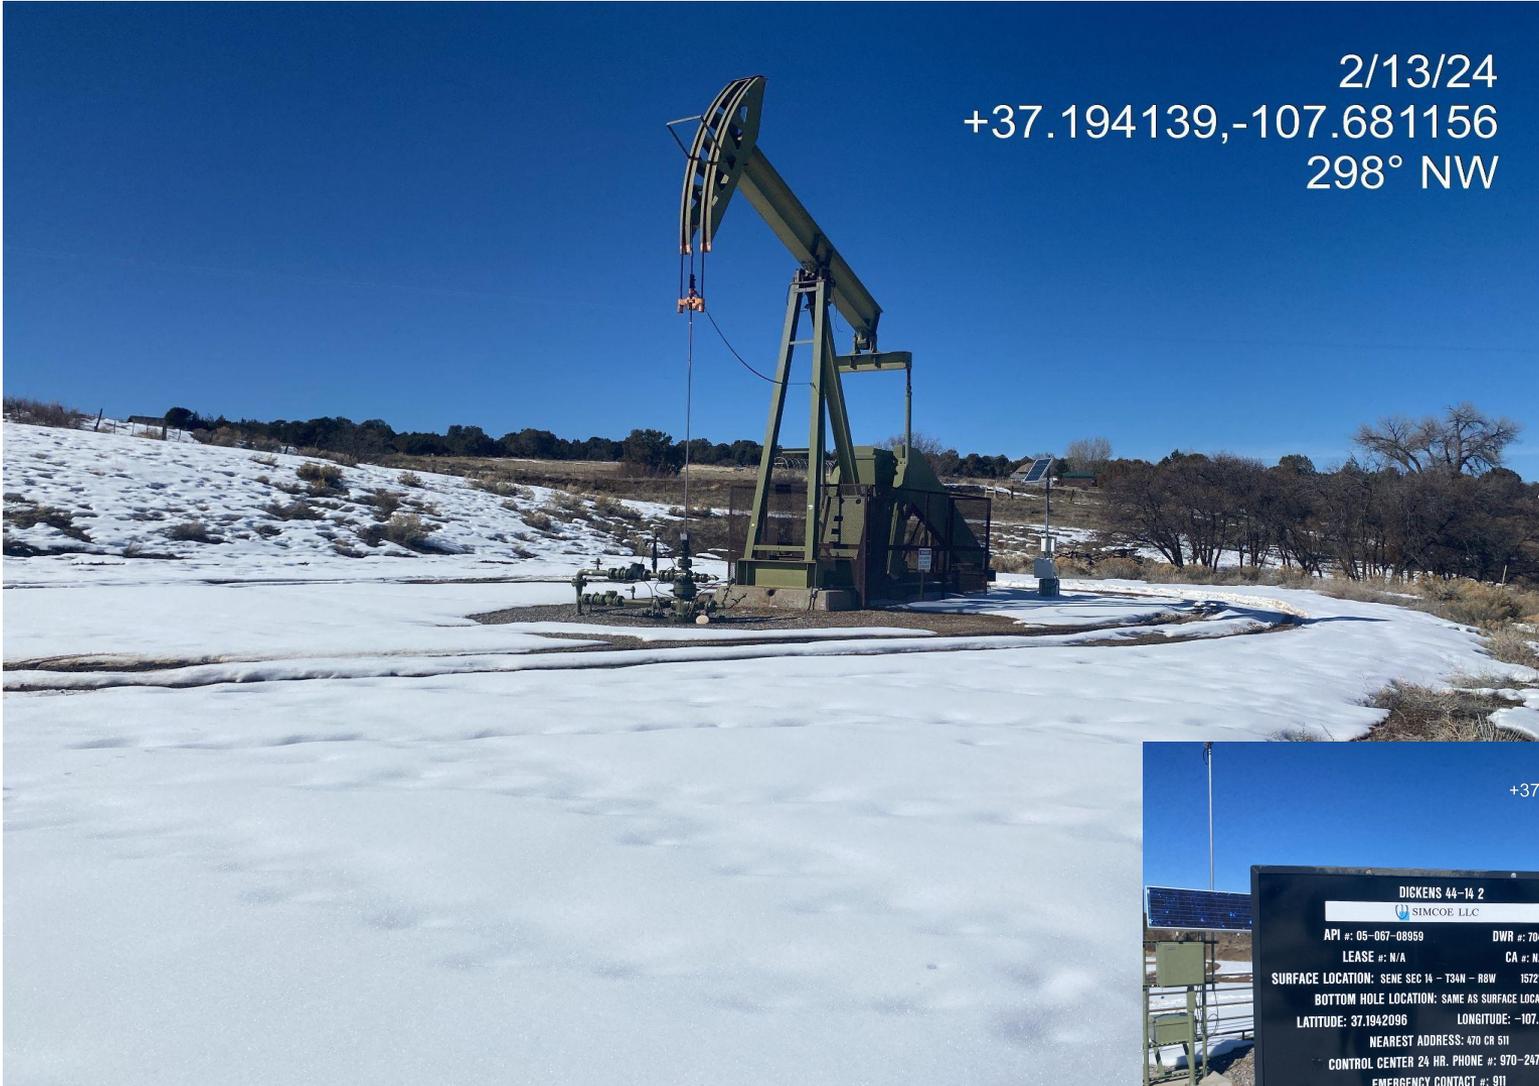
Photo 1. View of the disturbance from the entrance facing center.

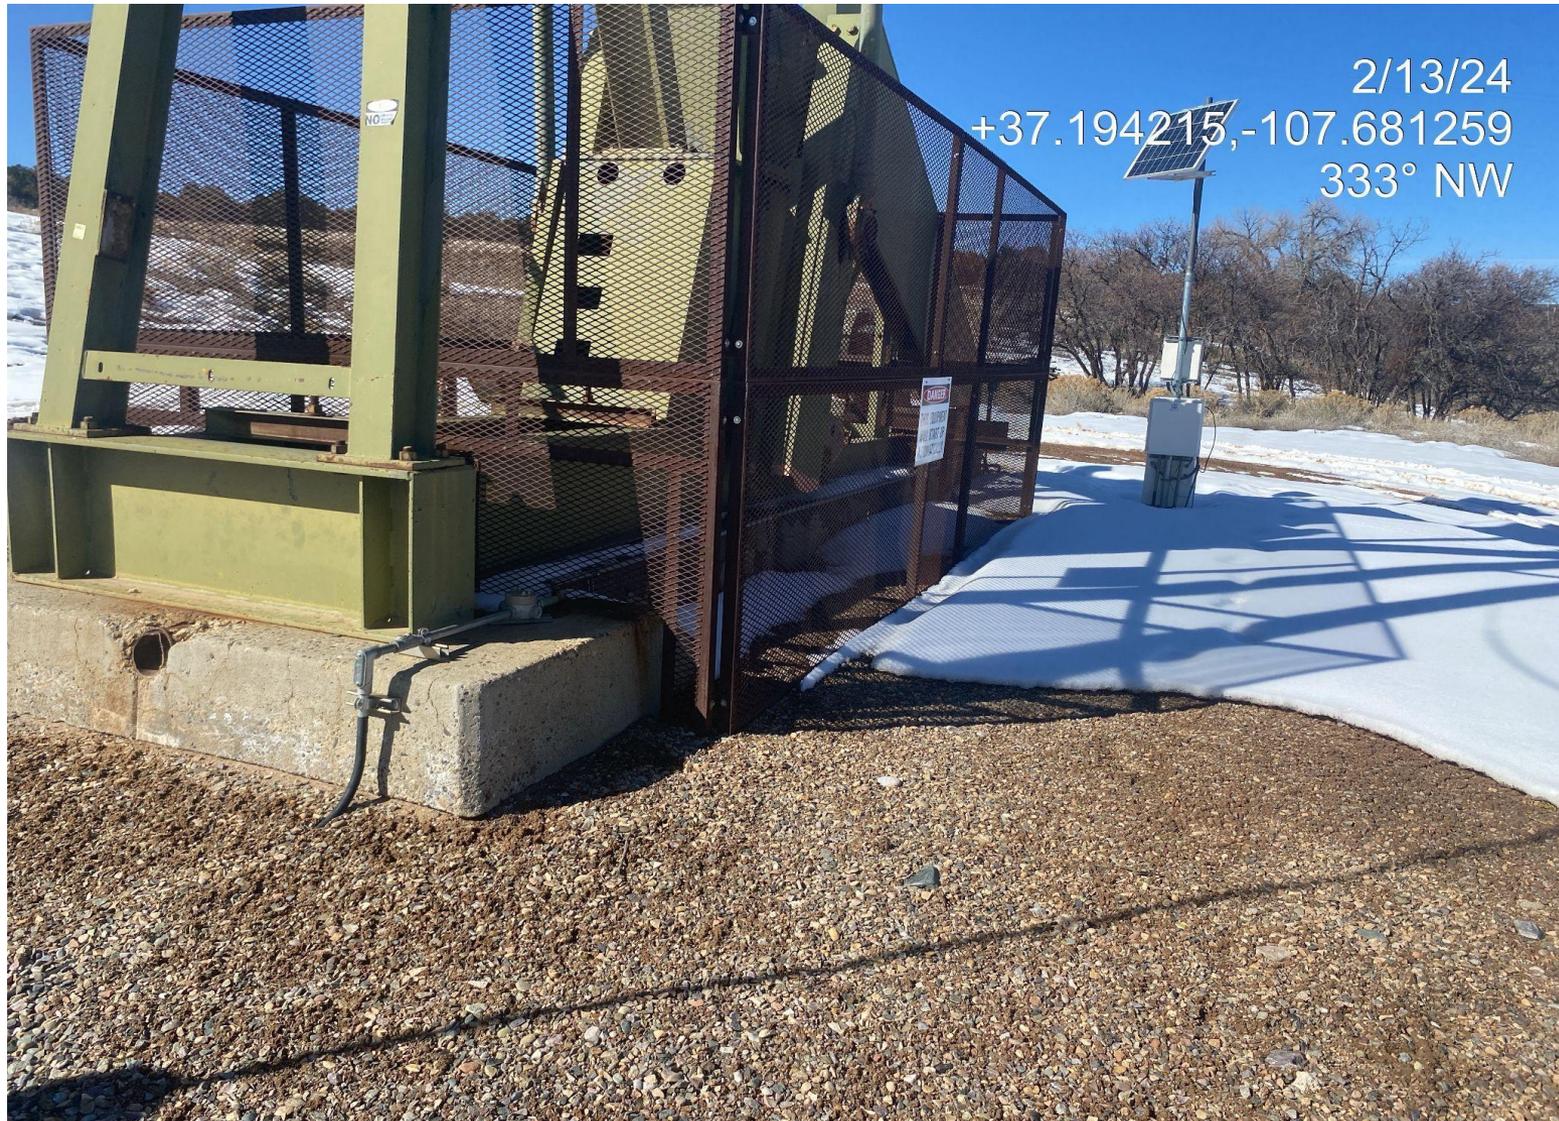
**Photo 2.** Unused tubing CA identified in previous inspection doc #702500200 has been addressed/resolved.

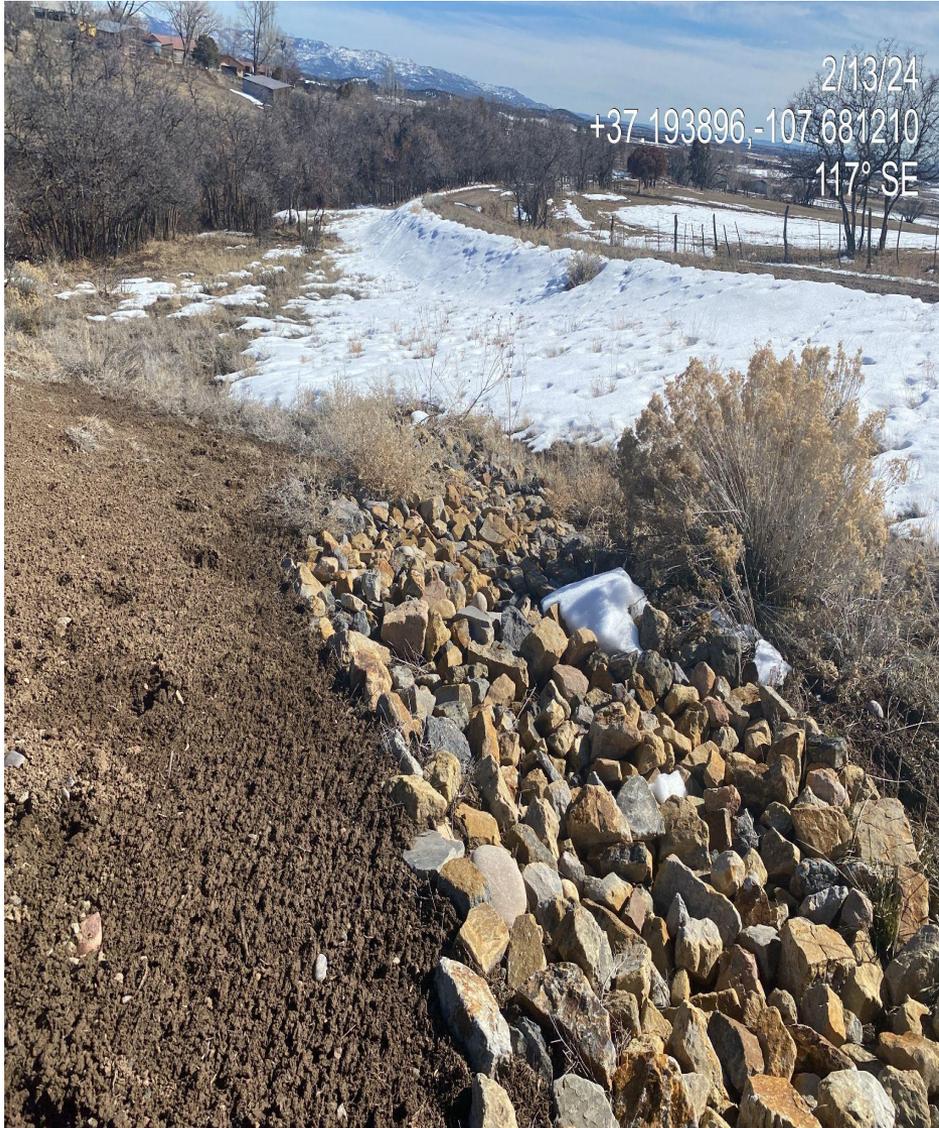
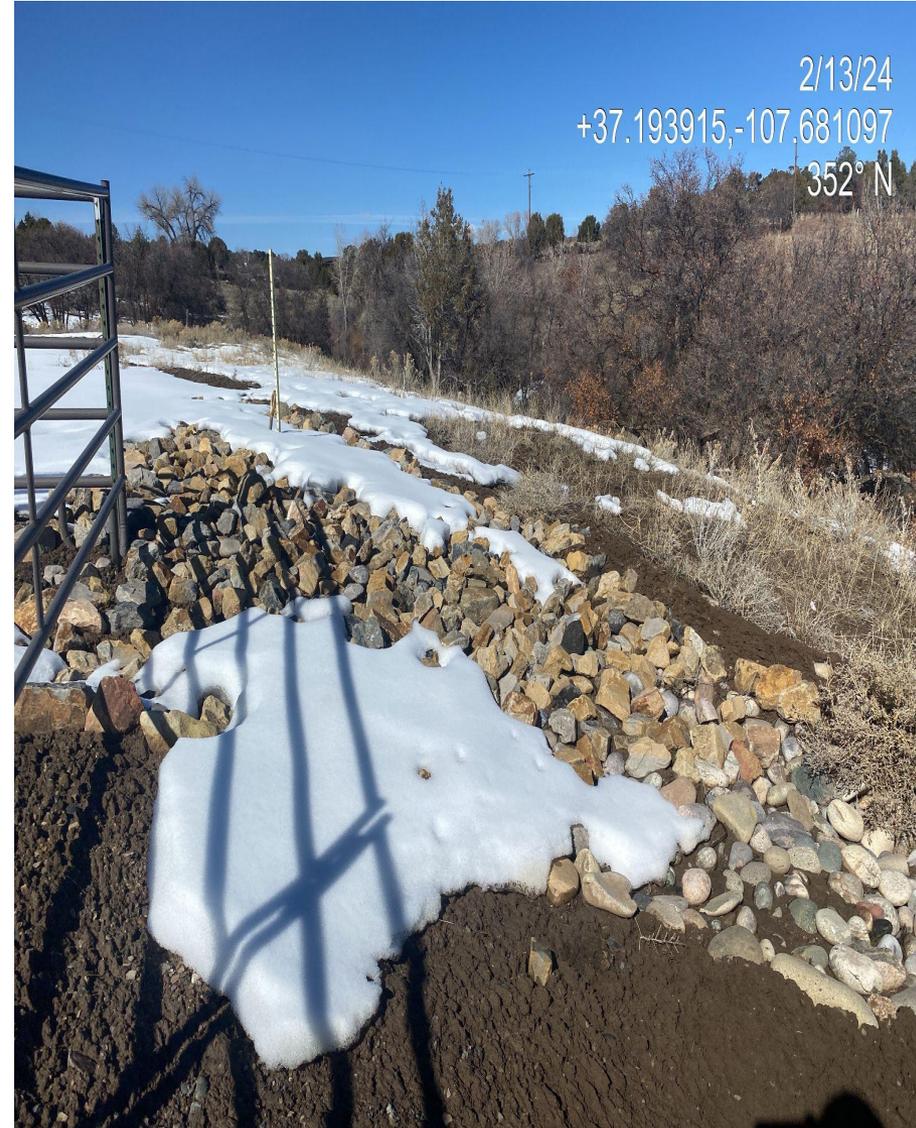
**Photo 3.** Stormwater CA identified in previous inspection doc #702500200 has been addressed/resolved.

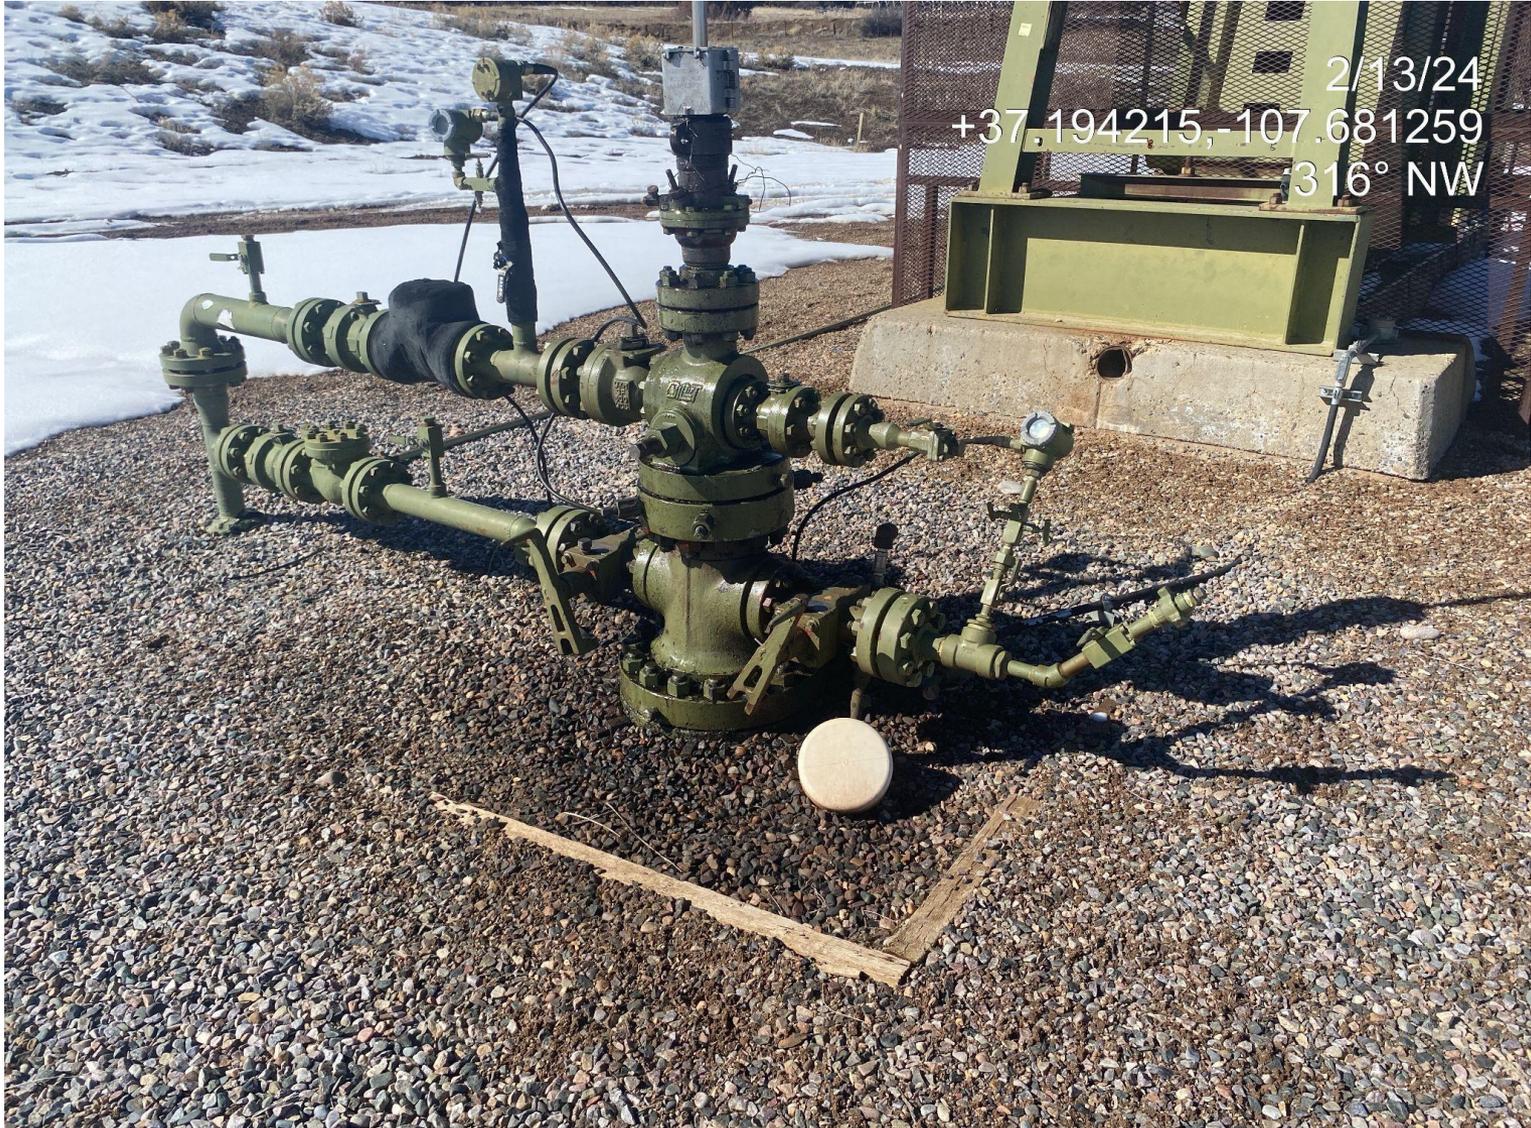
**Photo 4.** Impacted surface material remains at well head.

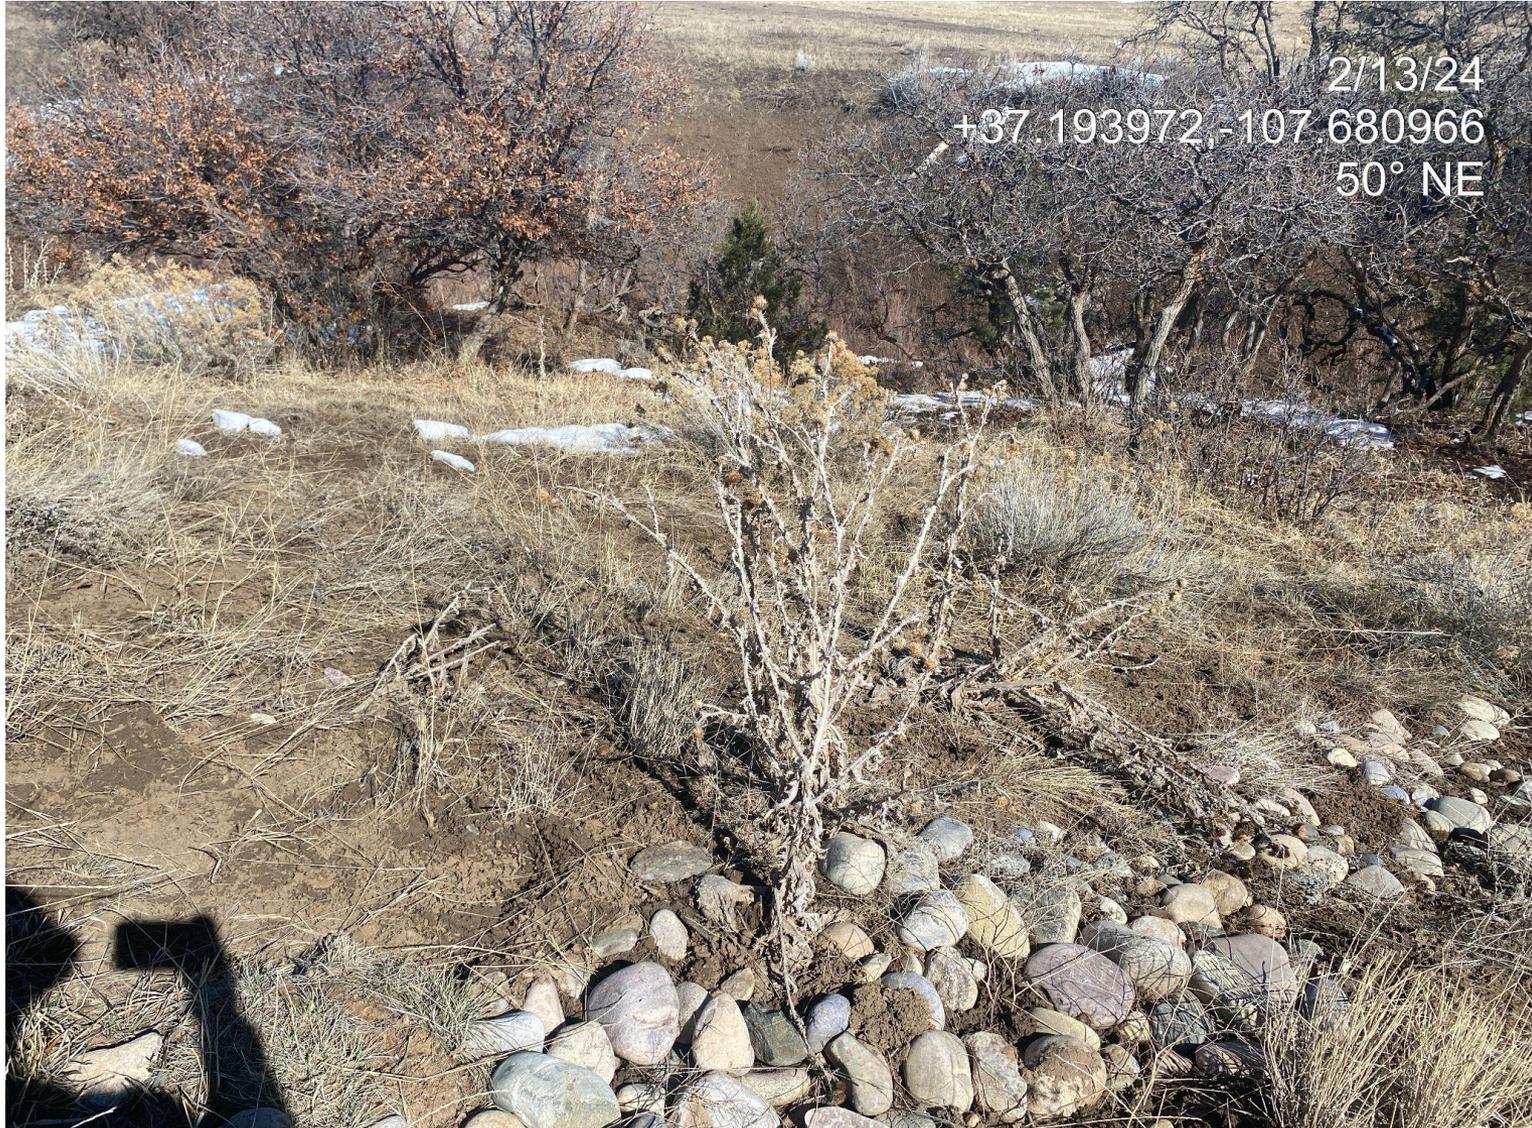
**Photo 5.** Musk thistle observed in the eastern interim reclamation area.

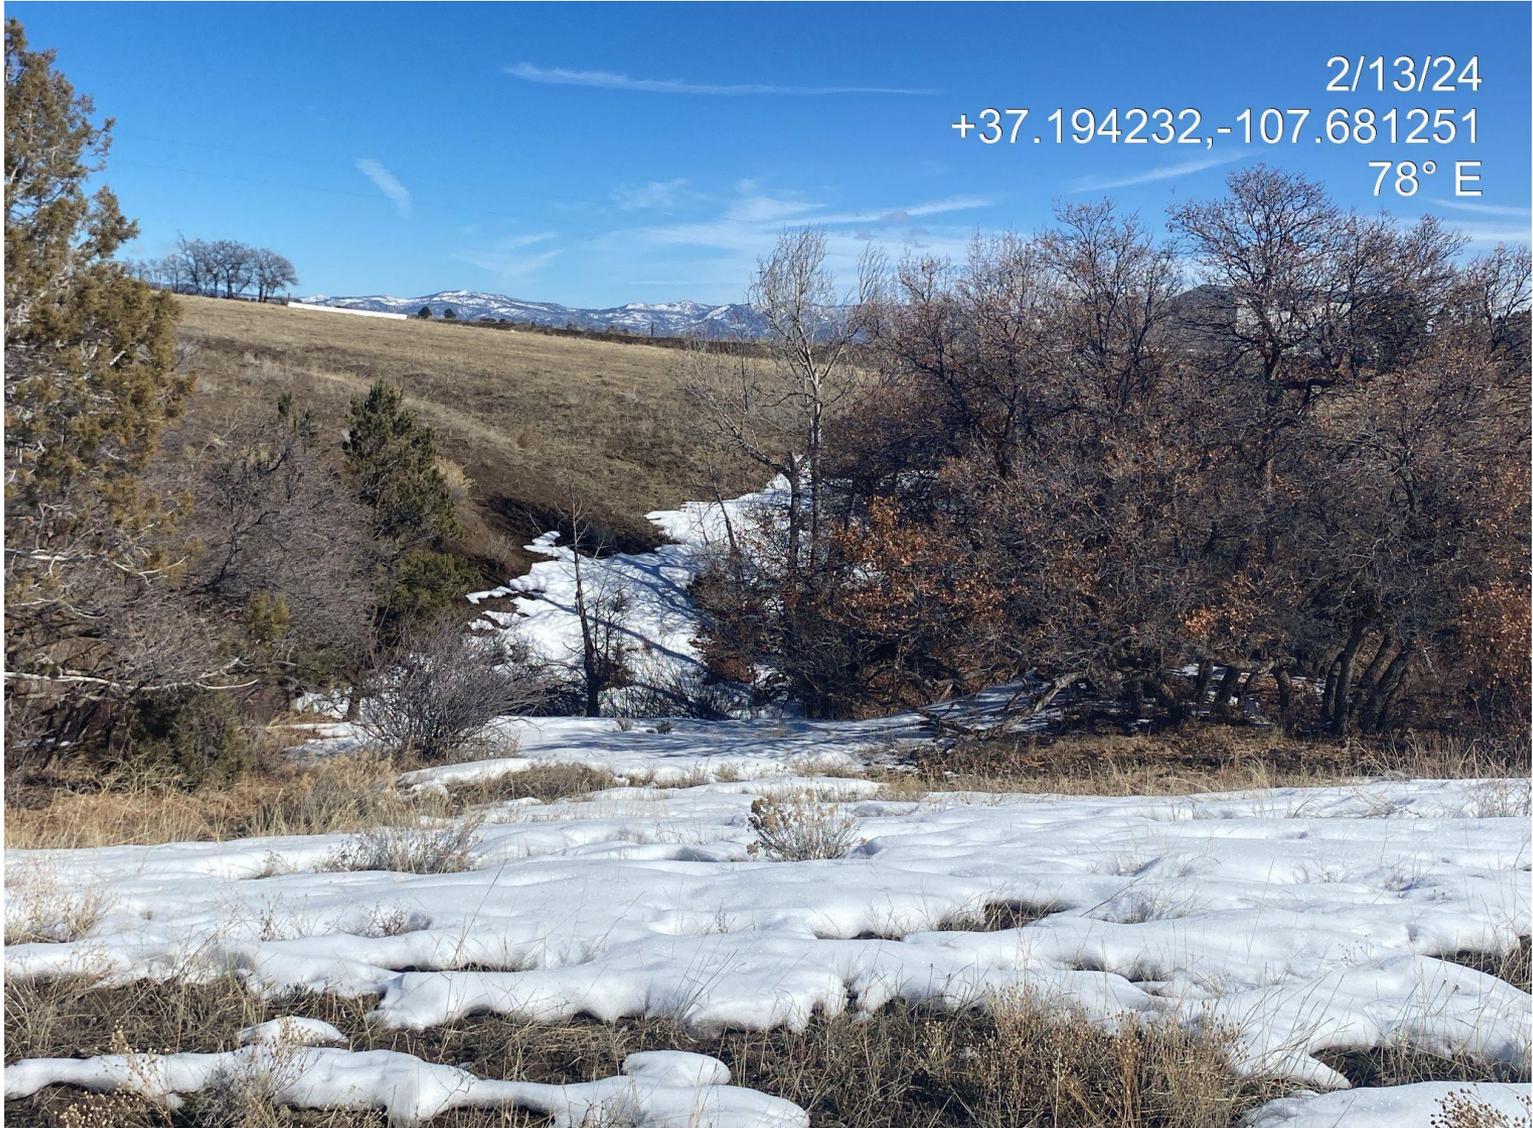
**Photo 6.** Reference area comprised of juniper and smooth brome.
