Interim Reclamation and Stormwater Inspection

Date: 2/9/24

Operator: Smith Energy LLC - 10536

Location ID: 317216

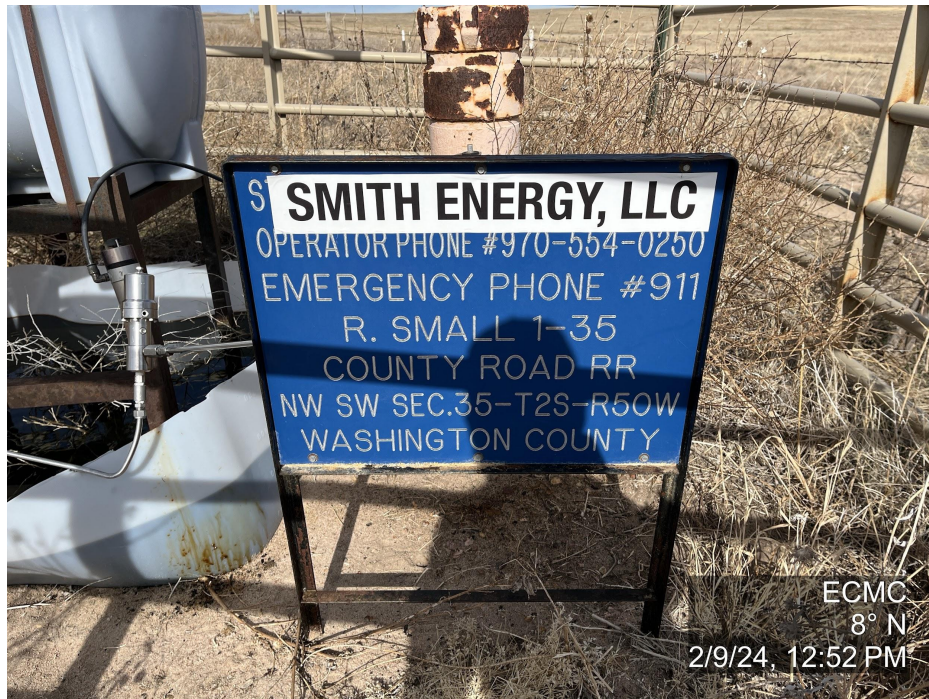
Photo 1. The photo was taken from the well location facing North. The photo illustrates the operator sign with covered emergency contact information.

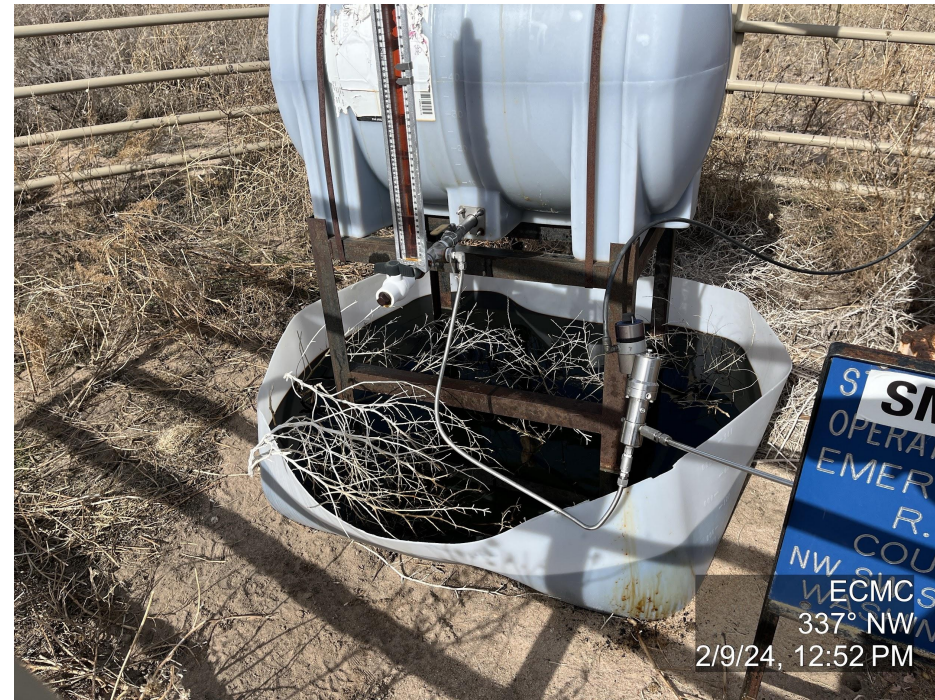
Photo 2. The photo was taken from the well location facing Northwest. The photo illustrates the tank placard is faded and illegible and the secondary containment is full and unprotected without wildlife netting.

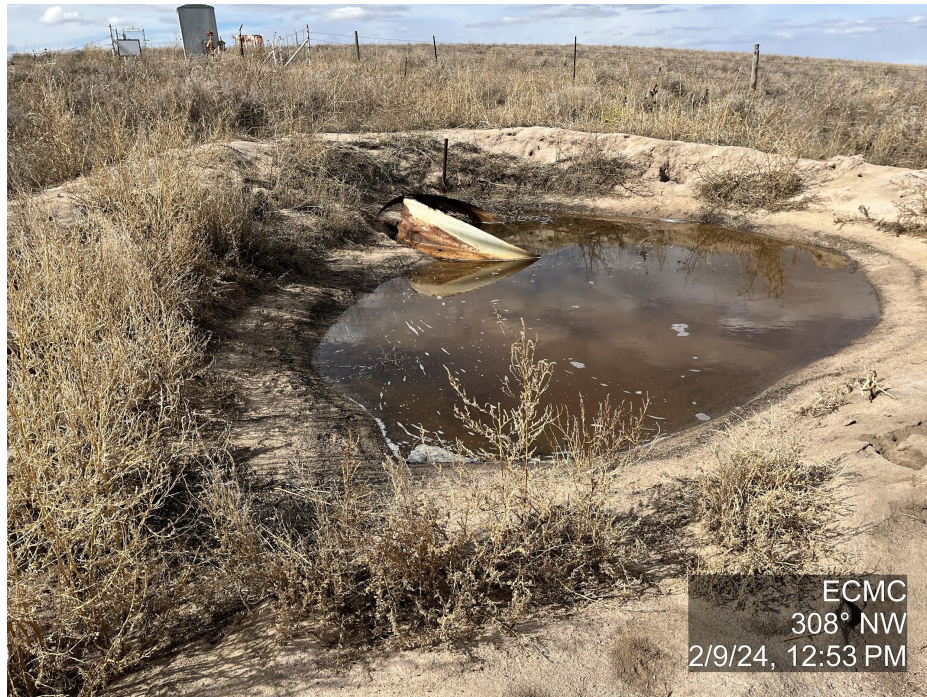
Photo 3. The photo was taken from the well location facing Northwest. The photo illustrates the active skim pit on location with the damaged tinhorn.

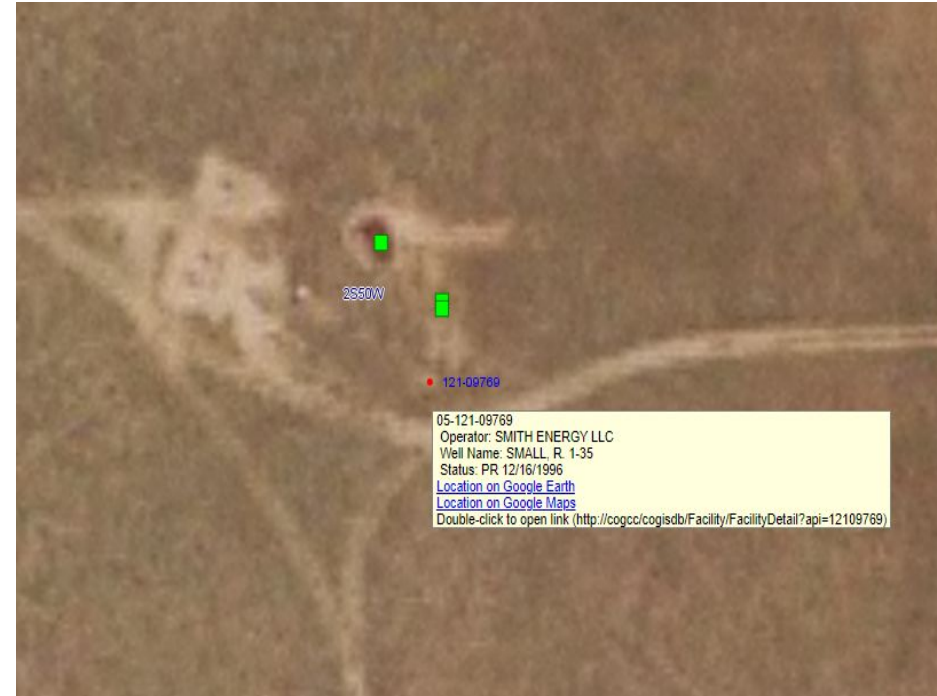
Photo 4. The photo is imagery from the ECMC database and illustrates the three unregistered active pits at the well location.

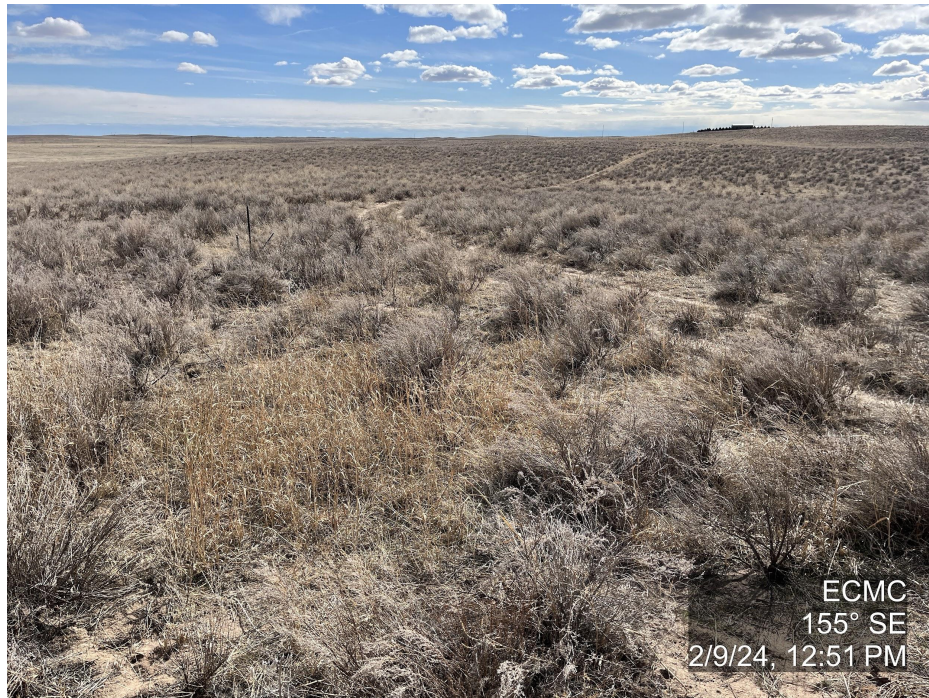
Photo 5. The photo was taken from the well location facing Southeast. The photo illustrates the access road.

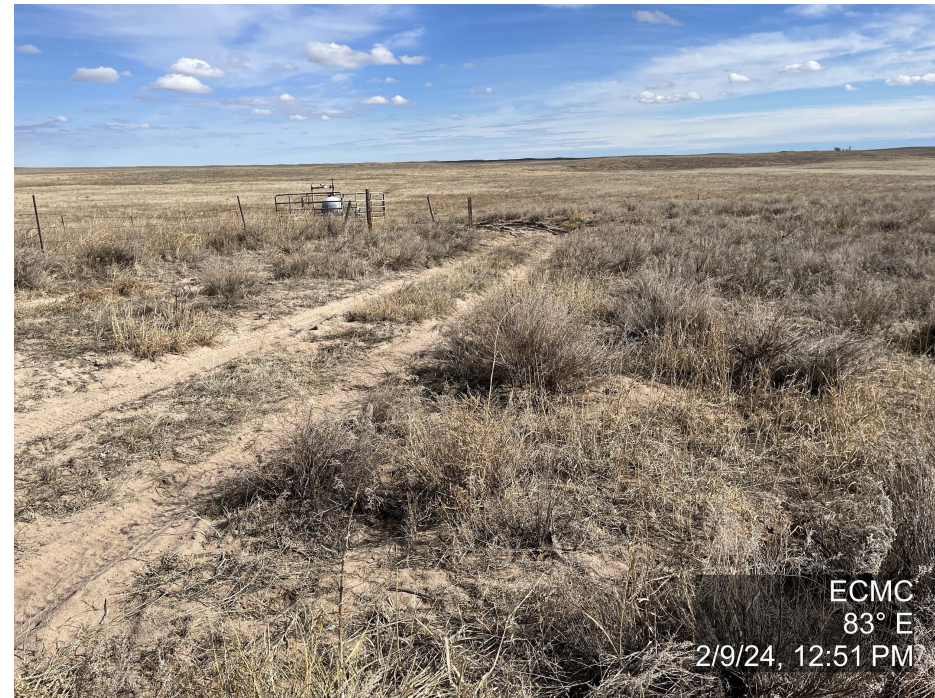
Photo 6. The photo was taken from the well location facing East. Refer to the comment for photo 5.

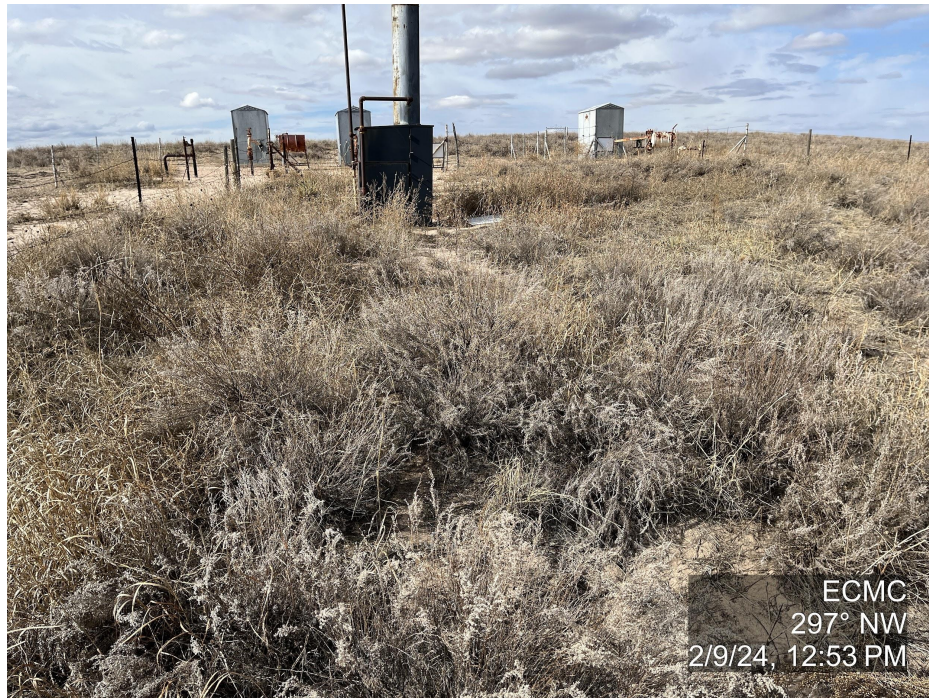
Photo 7. The photo was taken from the well location facing Northwest. The photo illustrates oil and gas equipment; meter sheds and what appears to be midstream equipment.

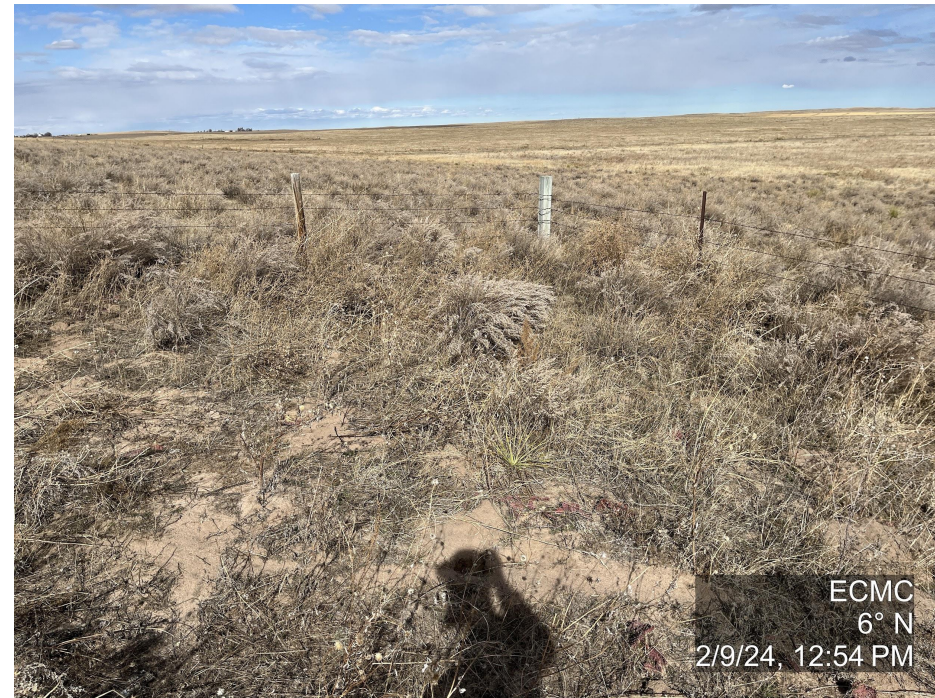
Photo 8. The photo was taken from the well location facing North. The photo illustrates the interim areas are adequately vegetated.

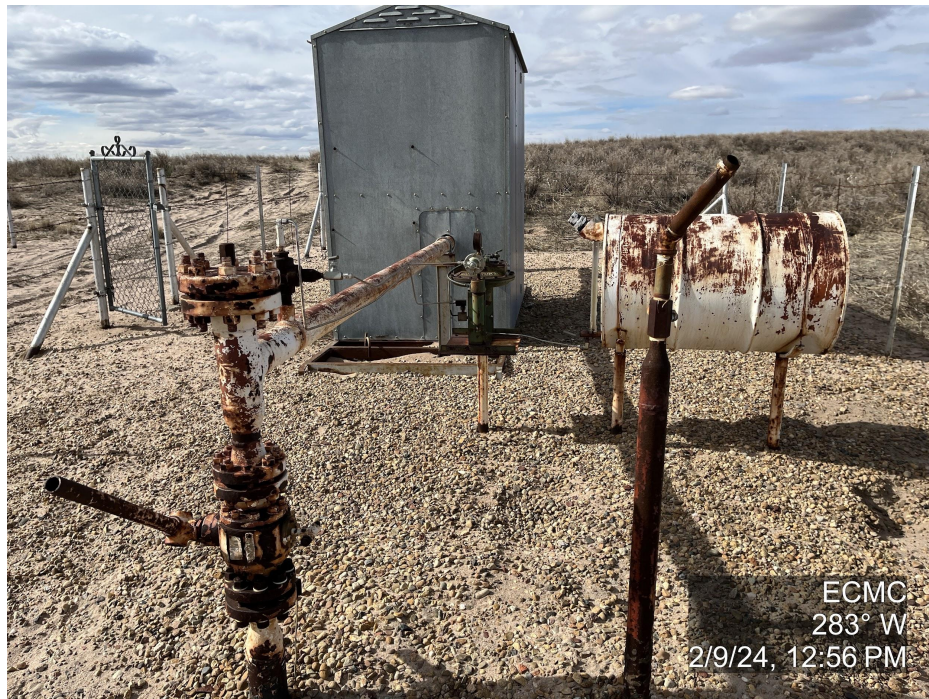
Photo 9. The photo was taken from the well location facing West. The photo illustrates midstream equipment on the well location.

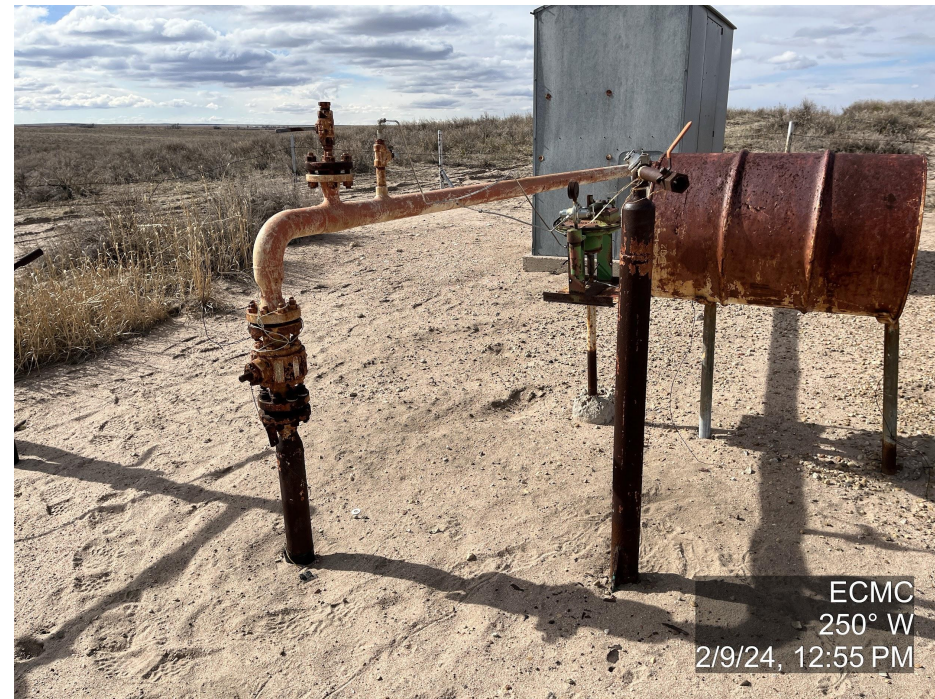
Photo 10. The photo was taken from the well location facing West. Refer to the comment for photo 9.

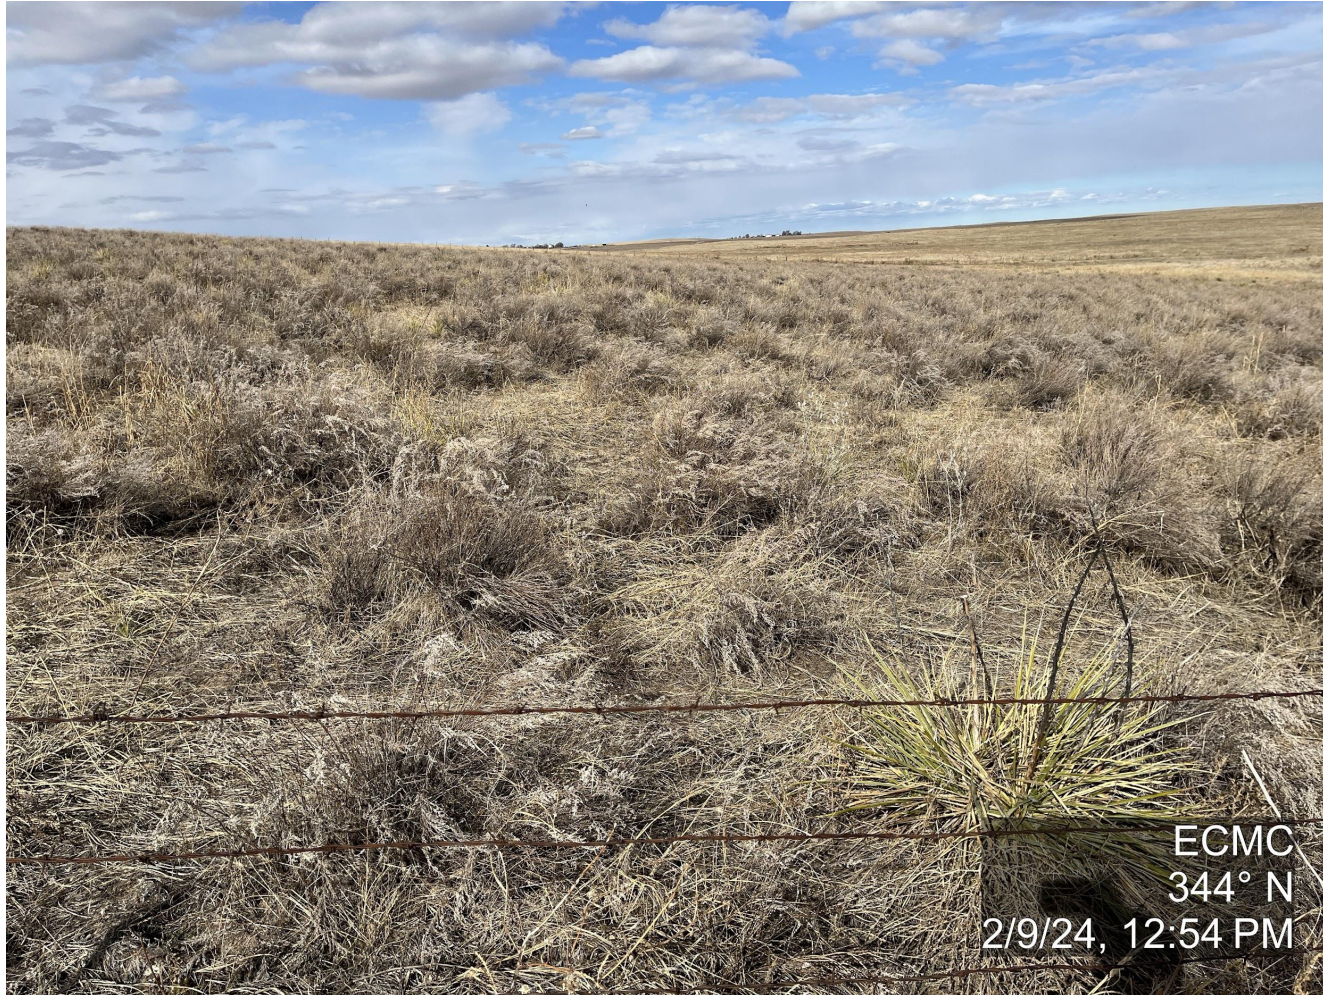
Photo 11. The reference photo was taken from the North side of the well location facing North. The photo illustrates reference areas contain Sandhill sagebrush, Yucca, Sand dropseed, among other vegetation.
