Inspection Photos

Location Name: CAERUS PICEANCE LLC GMR 21-10B (I21) Pad

Location #: 324196

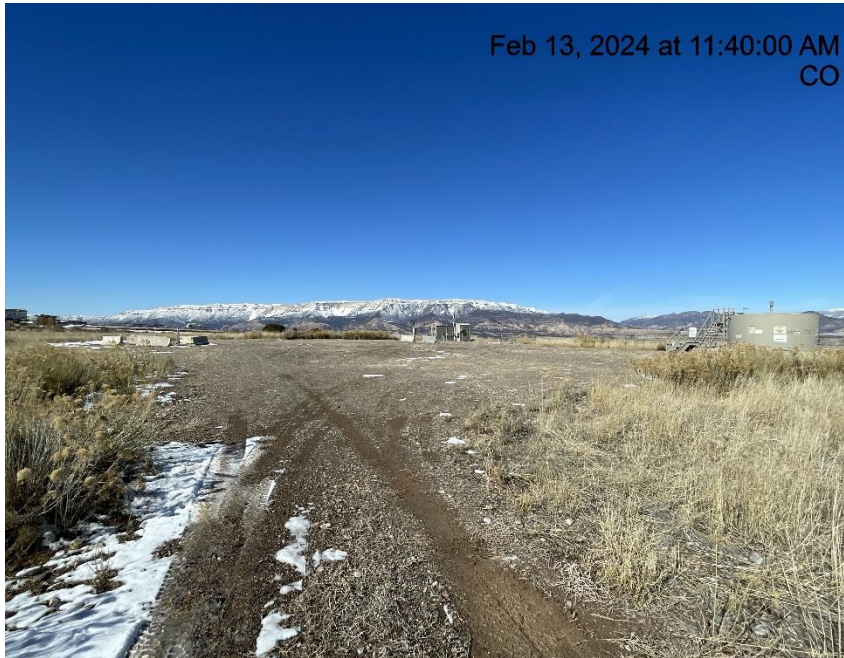
Photo # 6523 From entrance to location

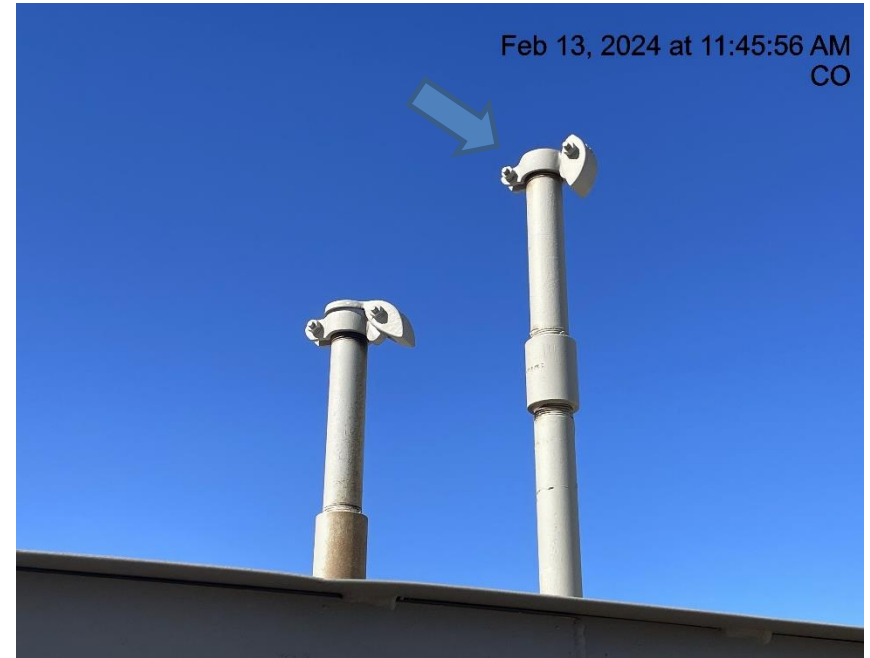
Photo # 6528 PRV vent line lacks cap

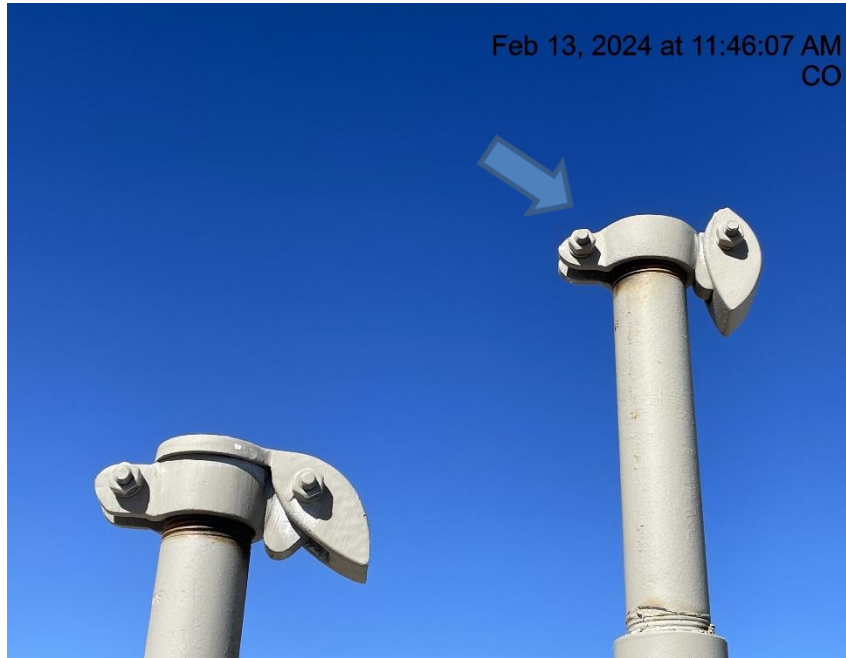
Photo # 6529 PRV vent line lacks cap
