**Location ID: 335228**

Caerus  
B36  
Location ID: 335228

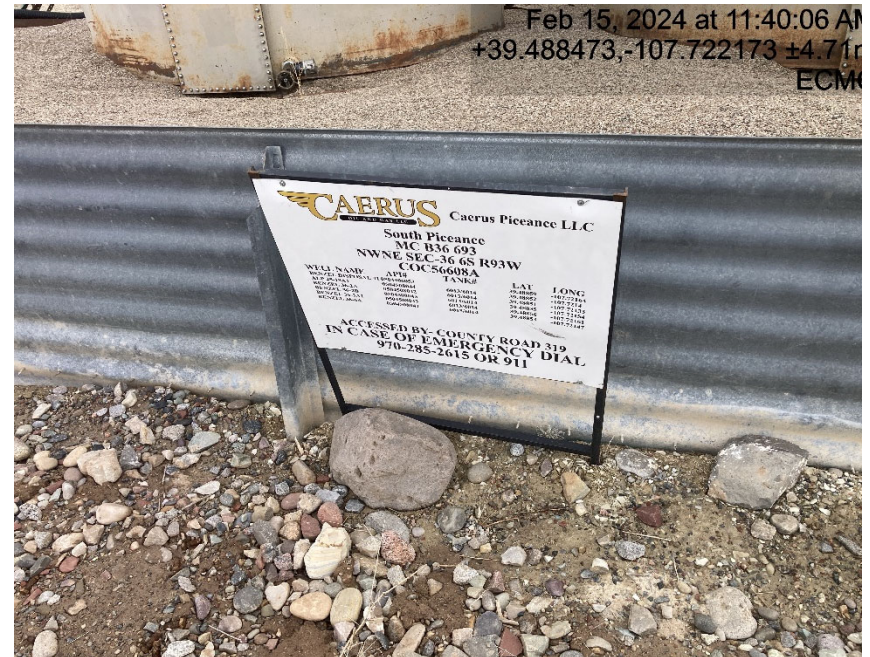
### Location

## Battery signage

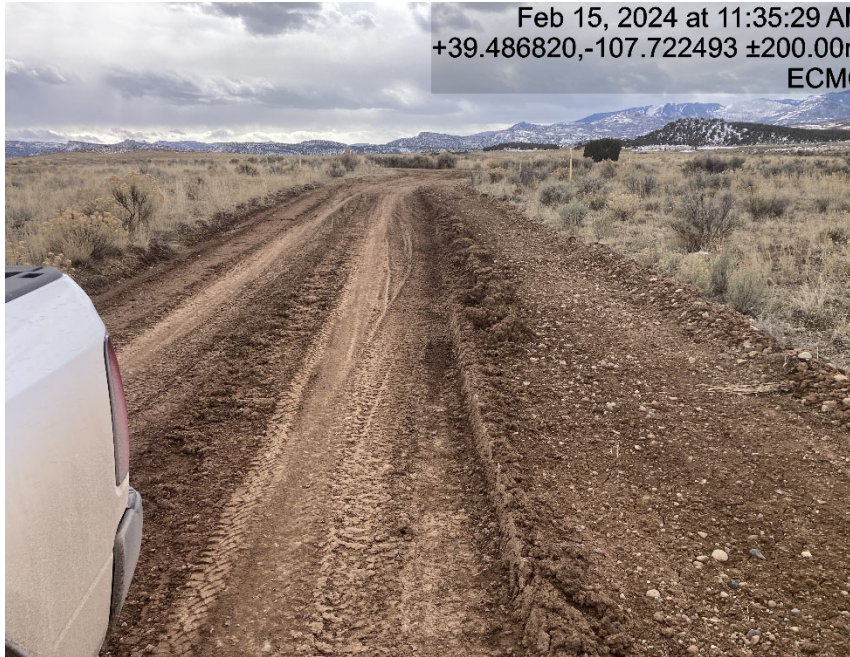
Lack of stabilization/compaction and tracking BMP's

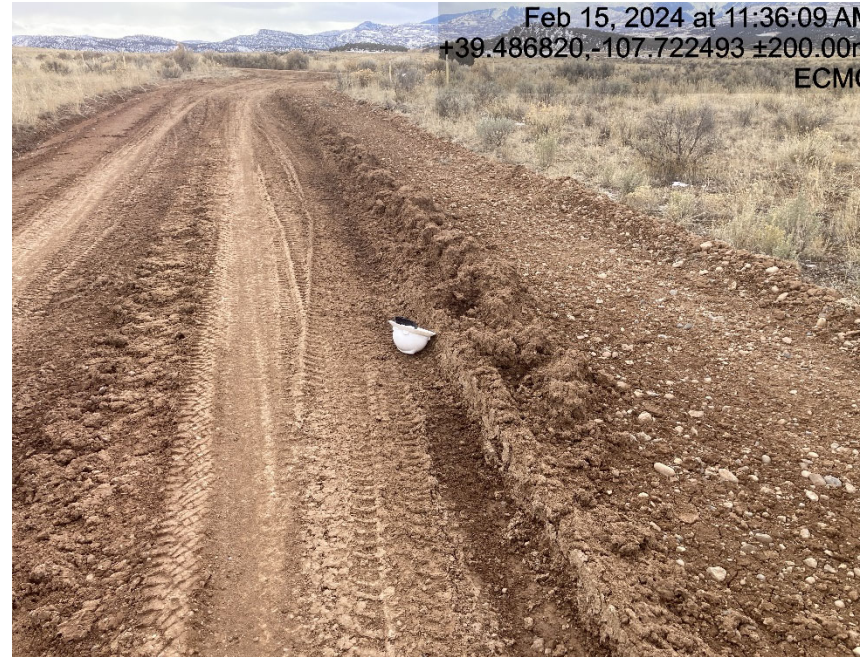
Lack of stabilization/compaction and tracking BMP's

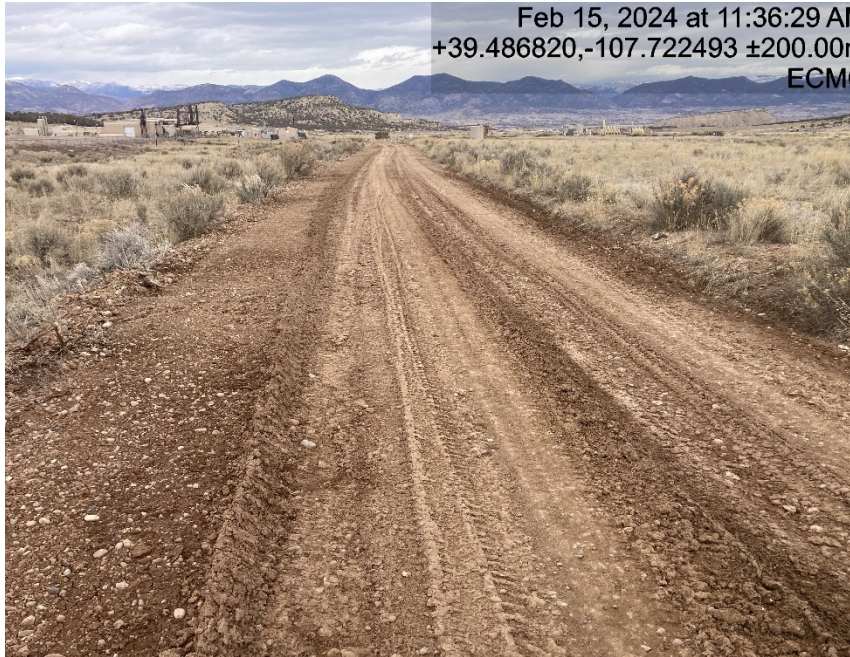
**Lack of stabilization/compaction and tracking BMP's**

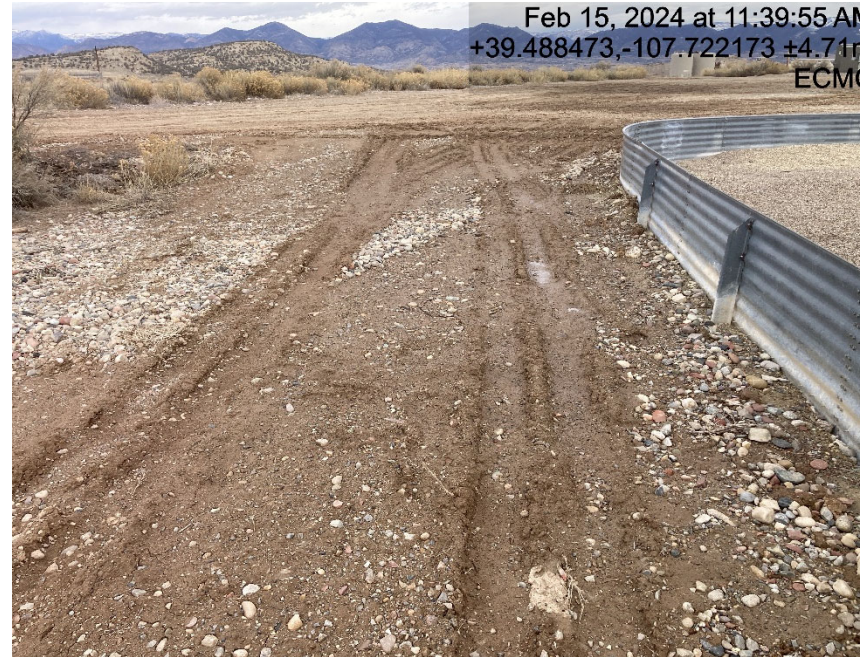
**Lack of stabilization/compaction and tracking BMP's**

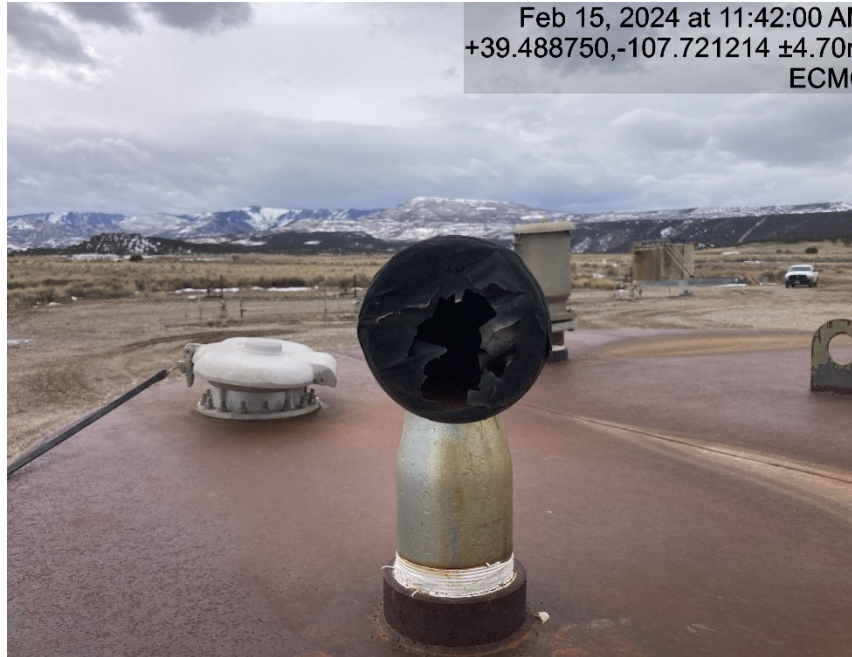
Open pipe on glycol tank

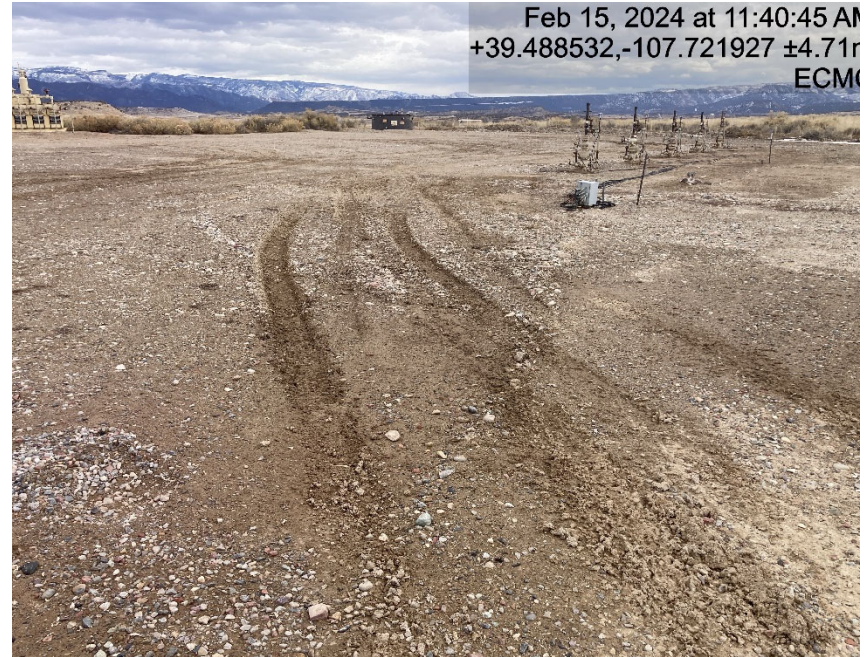
Lack of stabilization/compaction and tracking BMP's

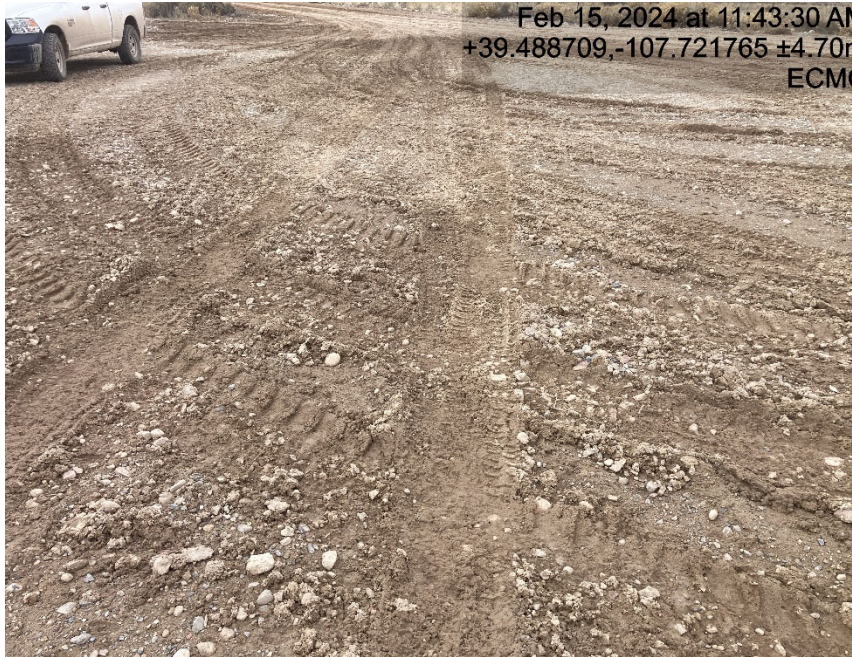
Lack of stabilization/compaction and tracking BMP's

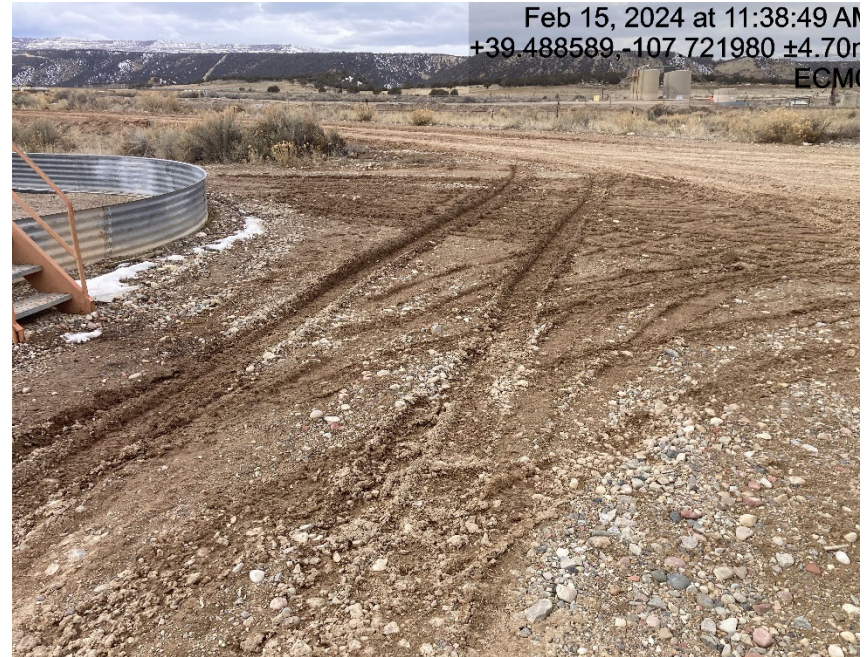
Lack of stabilization/compaction and tracking BMP's

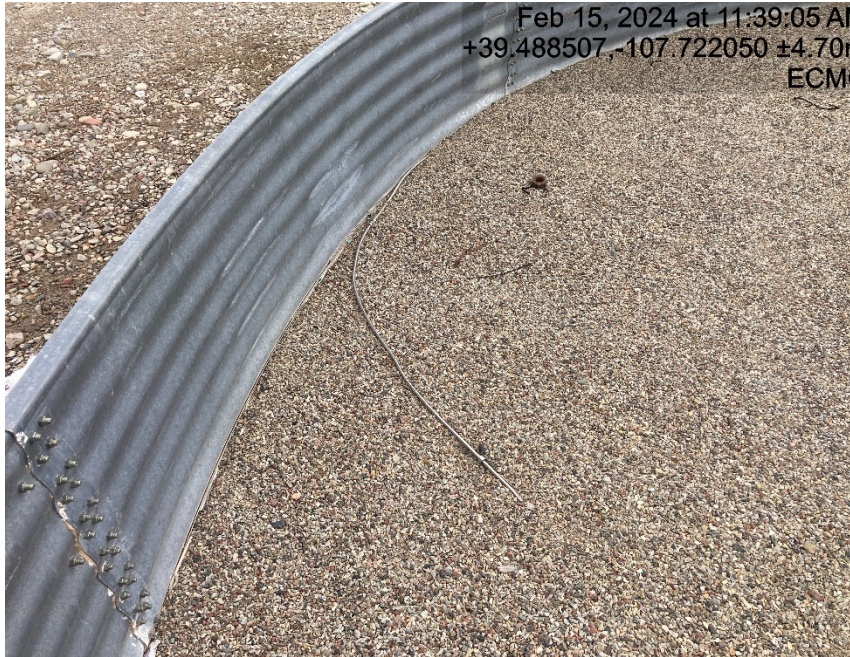
Debris

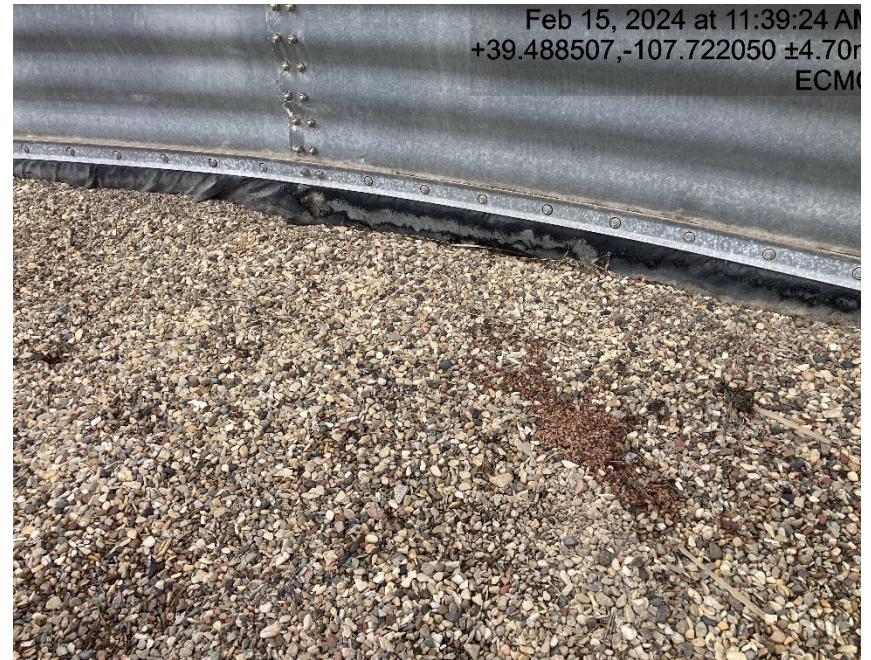
Lining in secondary containment has open holes
