Inspection Photos

Location Name: TEP ROCKY MOUNTAIN LLC, PUCKETT-66S96W/29NENE

Location ID: 335075

Date: 2/13/2024

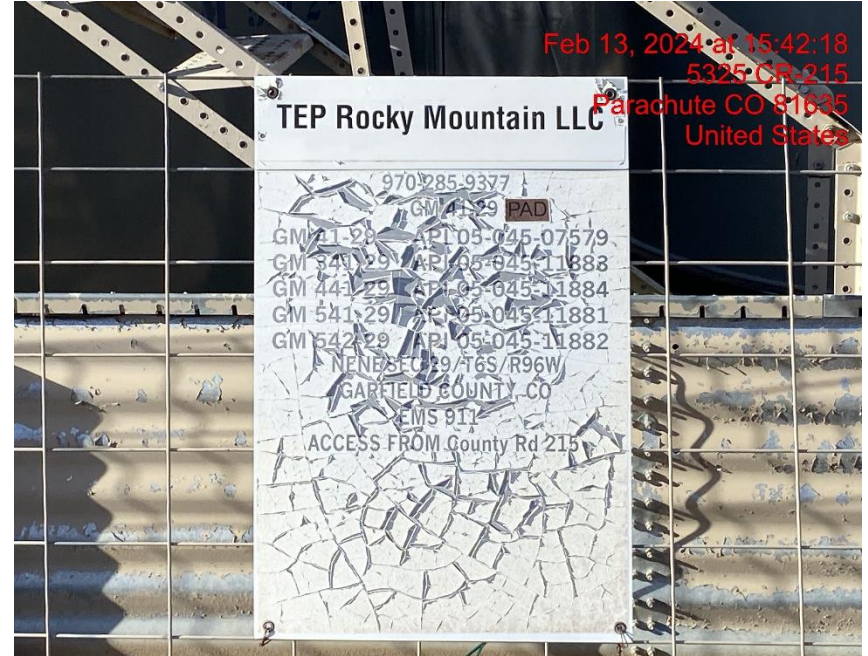
Weathered Battery Sign – Photo #09265

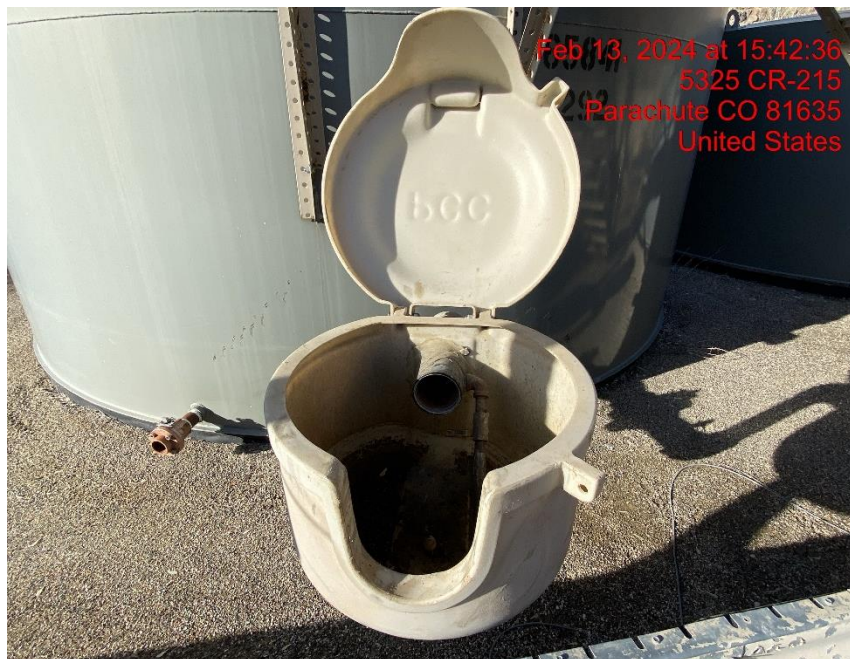
Open-Ended Load Line – Photo #09266

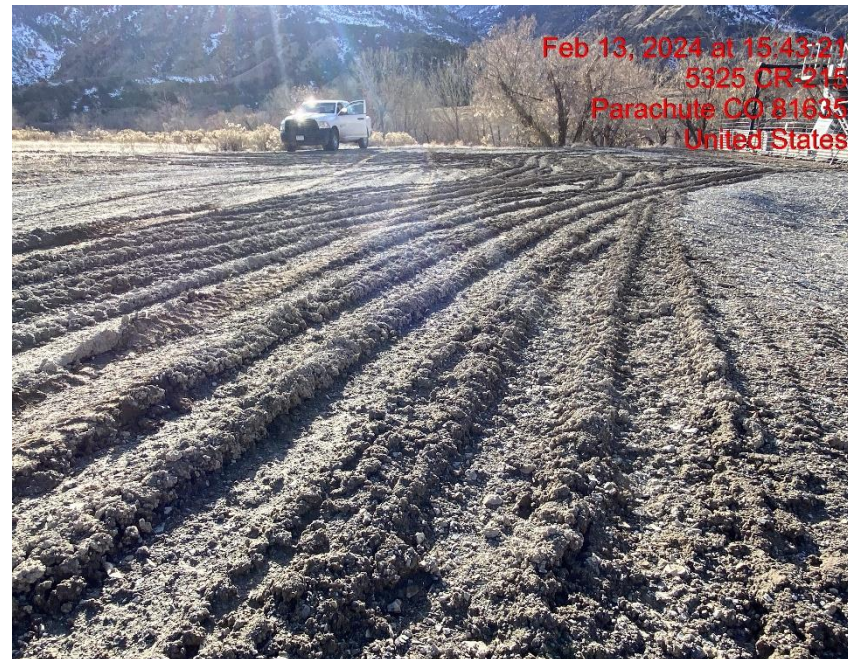
Lack of Stabilization – Photo #09268

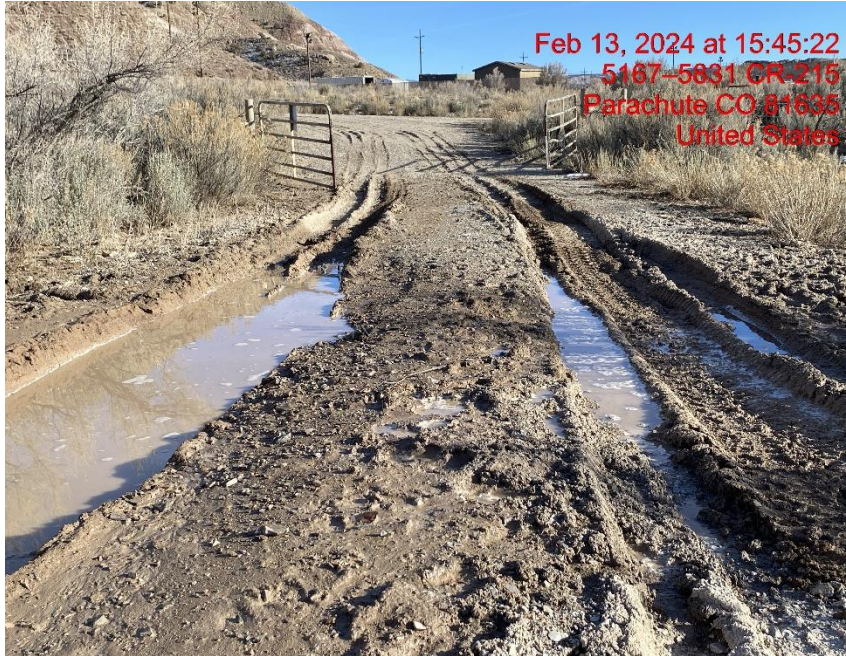
Lack of Stabilization on Lease Road – Photo #09269

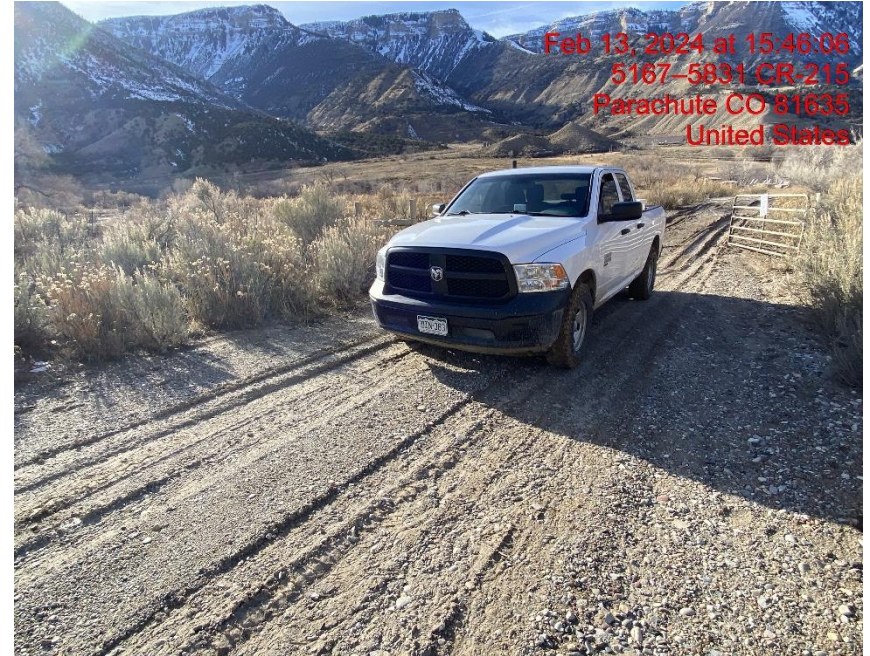
Insufficient Vehicle Tracking BMPs at Location Entrance/Exit
– Photo #09270
