Inspection Photos

Location Name: TEP ROCKY MOUNTAIN LLC, CHEVRON-66S96W/17SENE

Location ID: 324184

Date: 2/13/2024

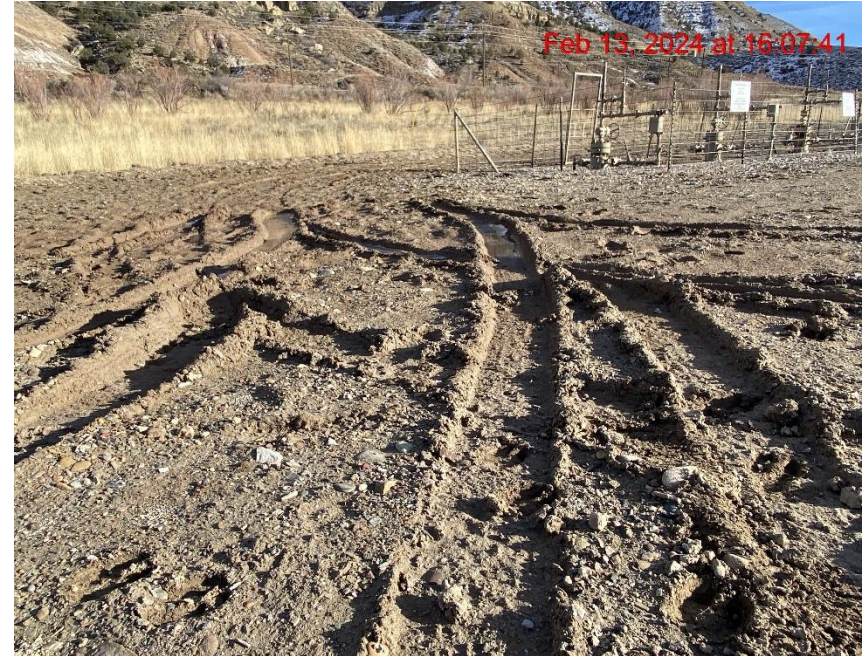
Lack of Stabilization – Photo #09293

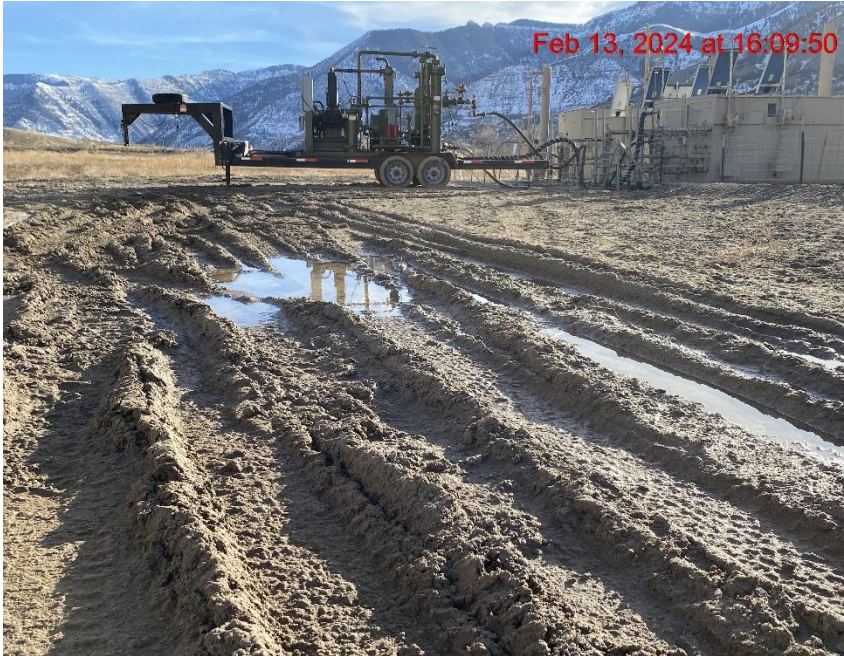
Lack of Stabilization – Photo #09296

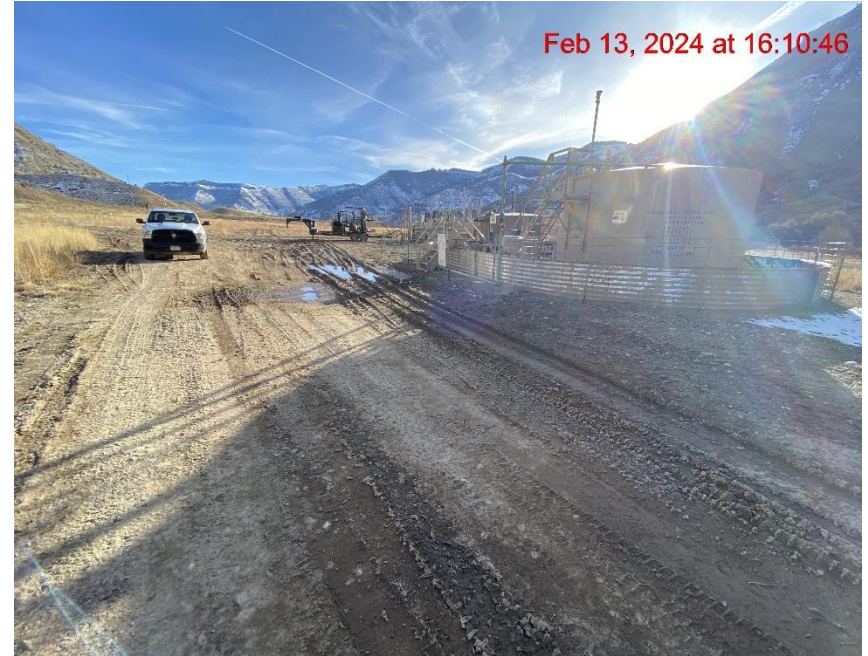
**Insufficient Vehicle Tracking BMPs at Location Entrance/Exit
– Photo #09298**

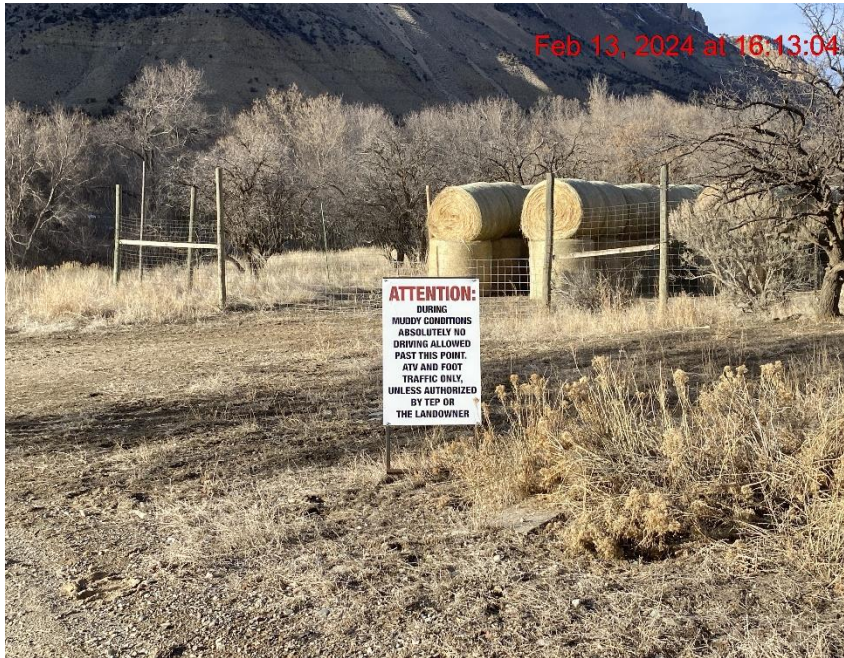
Insufficient Administrative Control – Photo #09300
