KP Kauffman - ECMC Inspection Photos
Location: Facility #4 at UPRR 43 Pan Am AE Flowline Release
Spill ID #485940 Date 02/15/2024

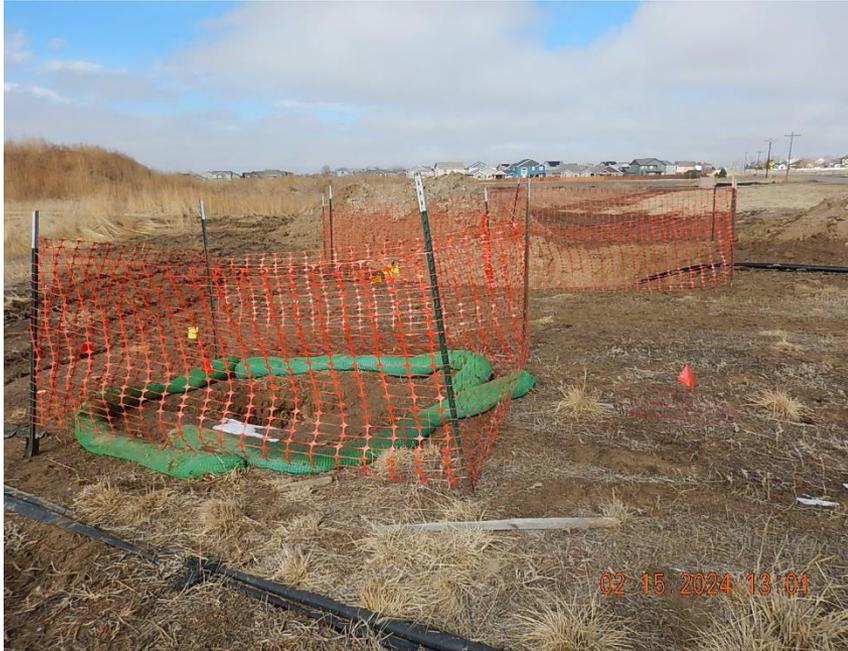
Fenced hydro excavation at spill id #485940
Note: Compromised section of Facility 4 pipe is not exposed

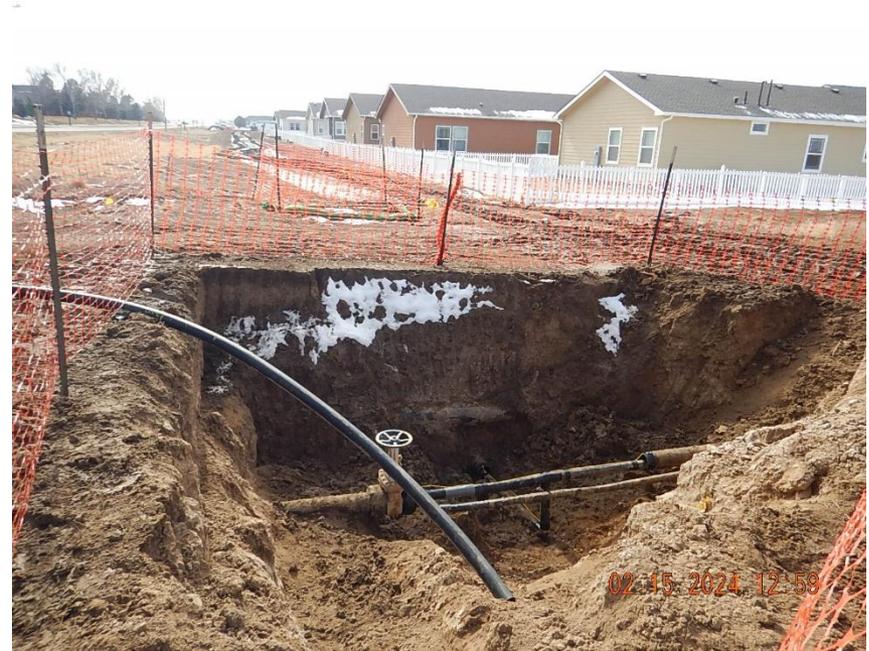
Fenced excavation north of flowline release. Flowline repair pipe (HDPE) and existing consolidation lines are exposed.
View looking south on west side of Ridgeway Bd.

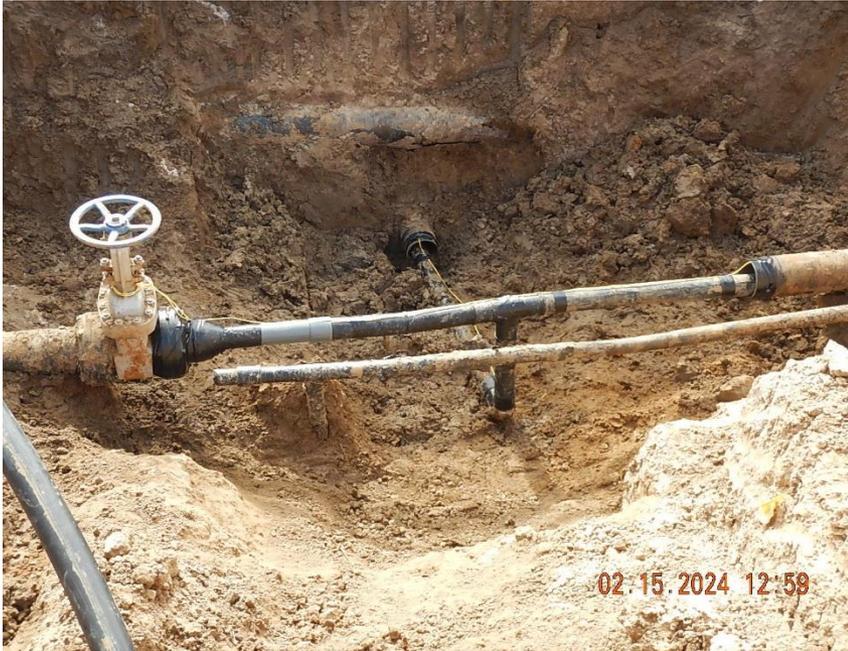
Closer view of flowline repair completed. The existing 6" CS facility #4 flowline transitions to 3" HDPE pipe in both a south and west direction via T fitting/ sliplining. An isolation valve is also present in the excavation.

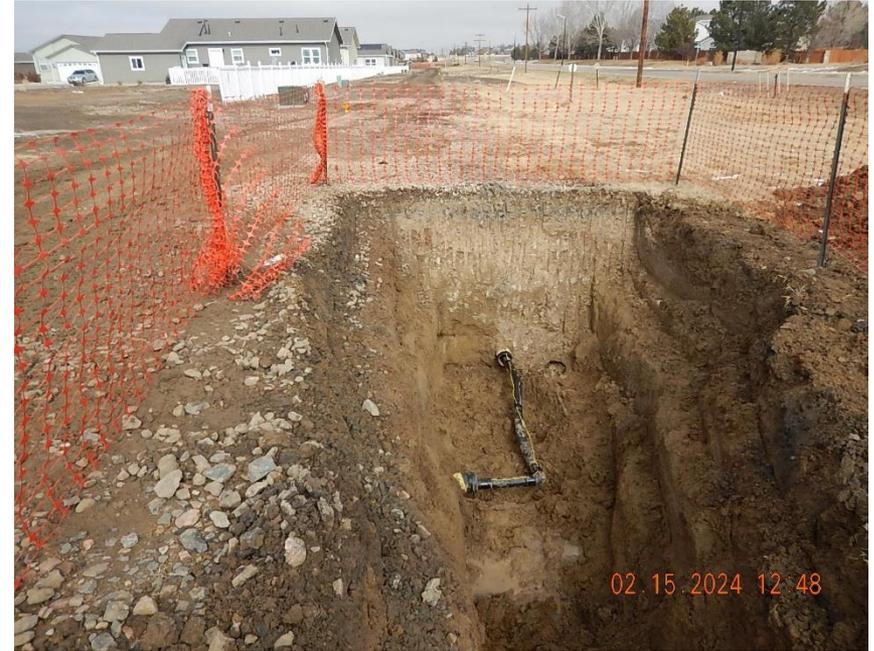
Fenced excavation at south flowline bellhole; 3" HDPE flowline turns west in the excavation. View looking North.
