## Inspection Photos

Location Name: TEP ROCKY MOUNTAIN LLC, CHEVRON-66S96W/8NWSW

Location ID: 335619

Date: 2/20/2024

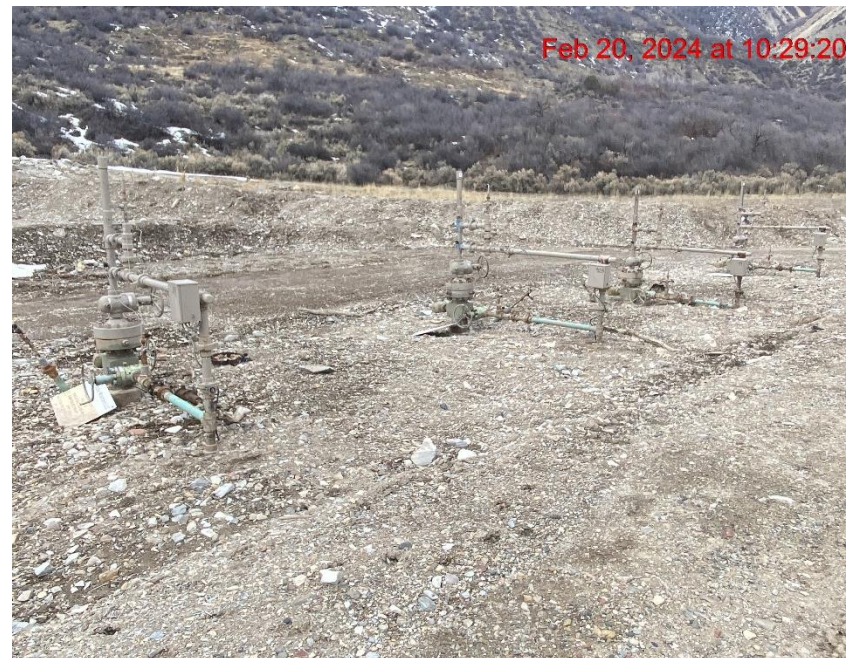
**Wellhead/Signs Not Posted or Visible – Photo #09335**

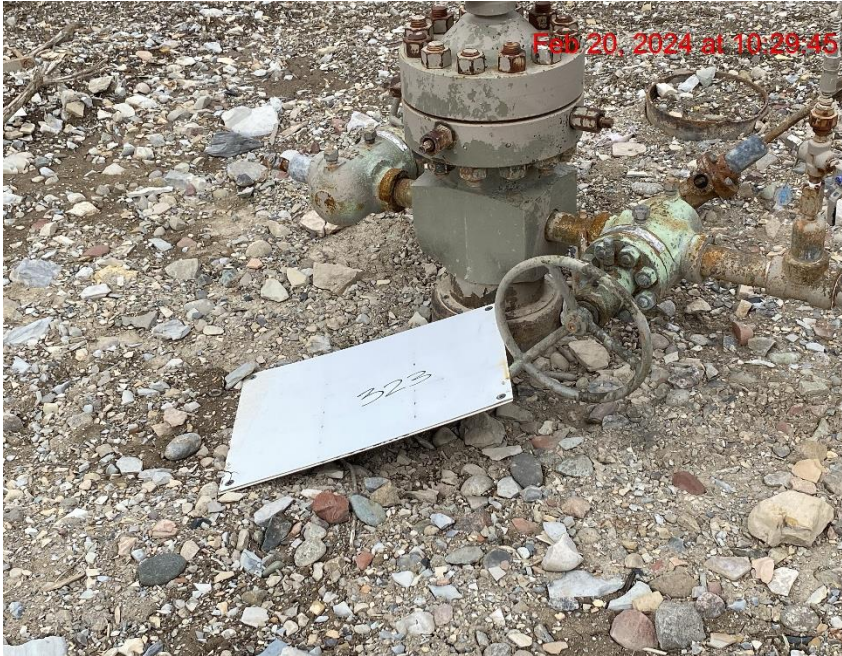
**Wellhead Signs Not Posted/Visible – Photo #09337**

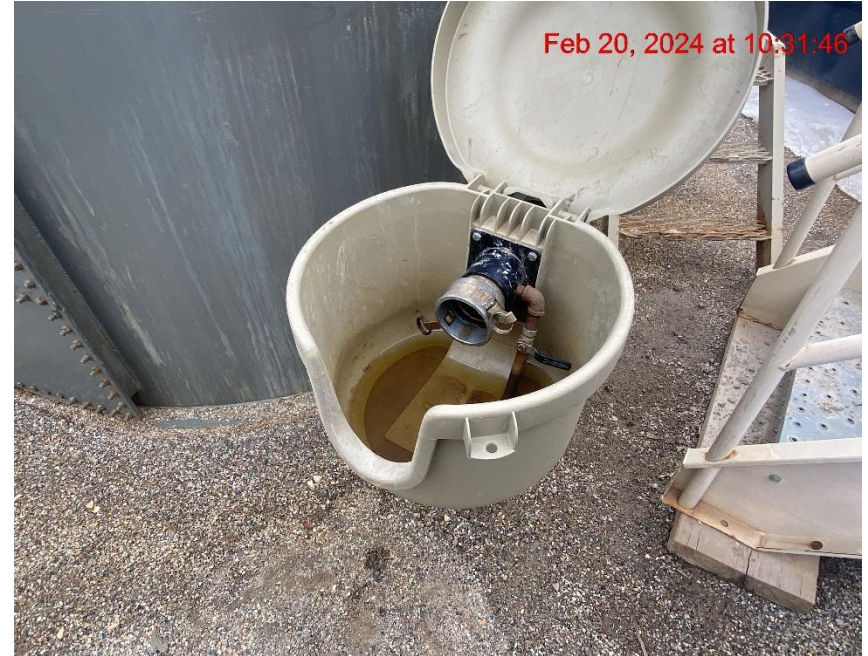
**Open-Ended Load Line – Photo #09340**

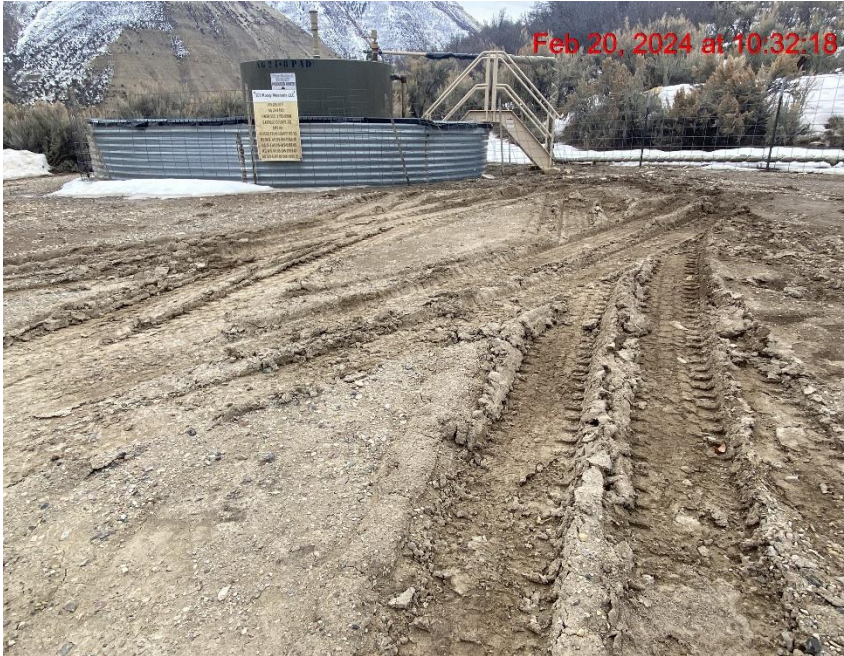
**Lack of Stabilization – Photo #09341**

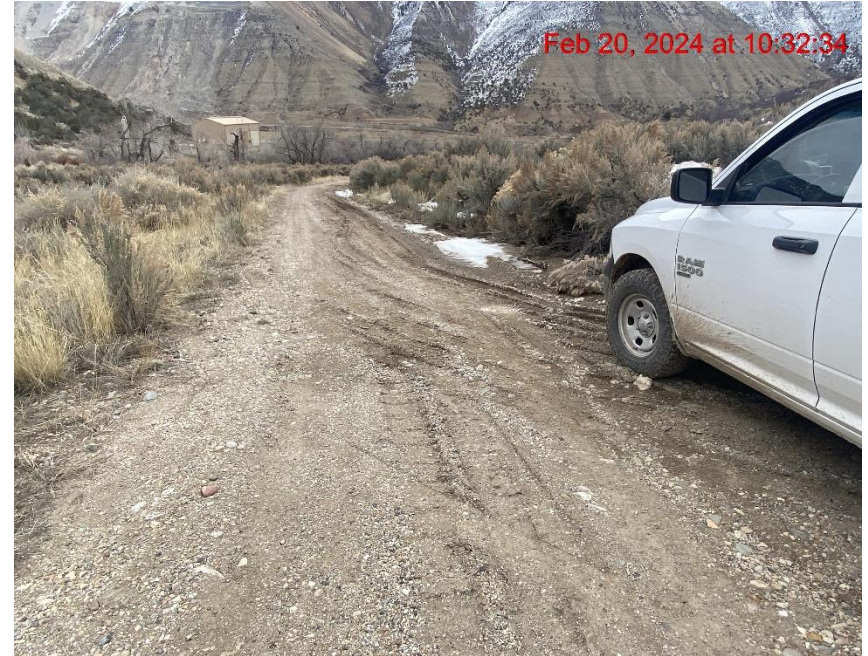
**Insufficient Vehicle Tracking BMPs at Location Entrance/Exit  
– Photo #09342**

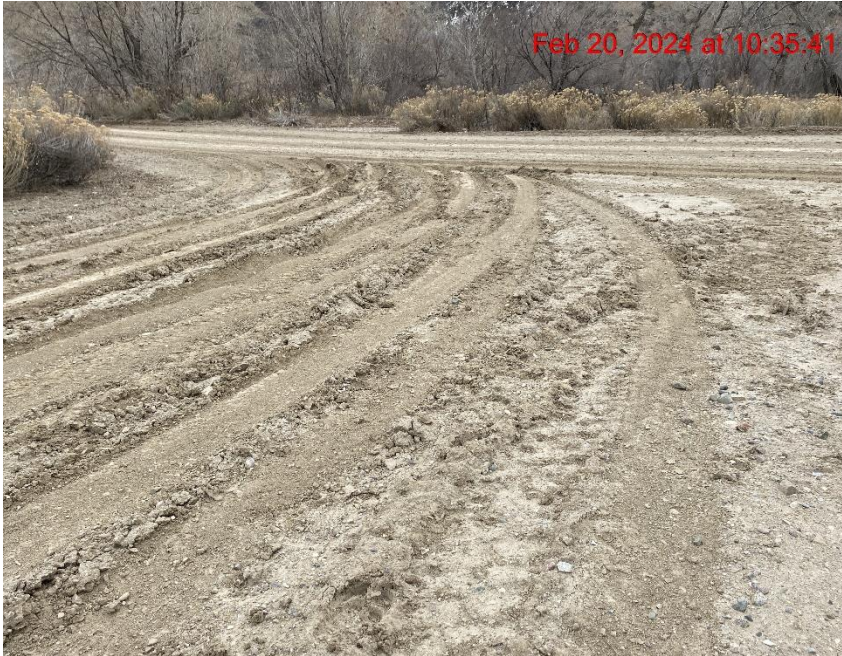
Insufficient Vehicle Tracking BMPs at Location Entrance/Exit  
– Photo #09344

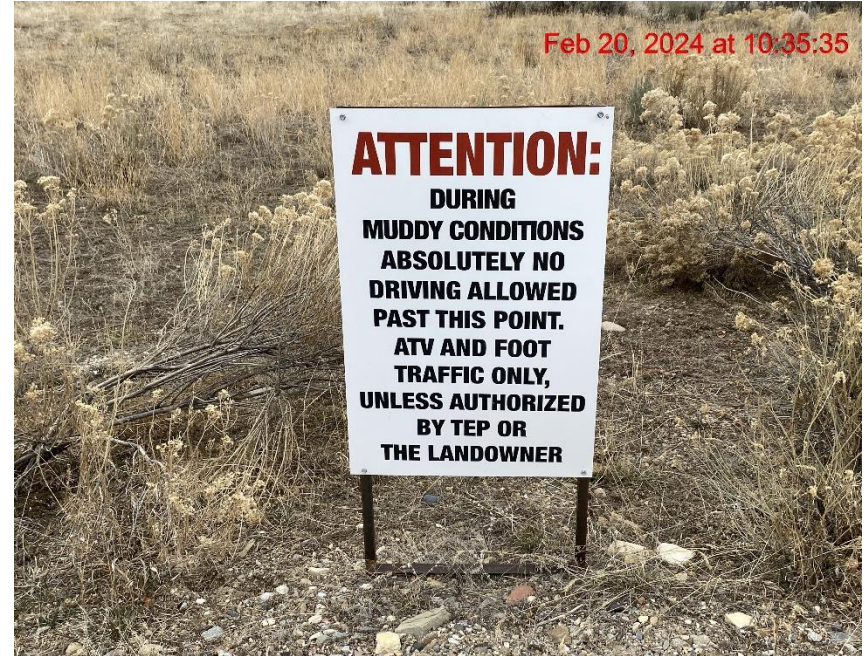
Insufficient Administrative Controls – Photo #09343
