Inspection Photos
Location: Weco-William 13-11 # 1
Facility ID: 321674

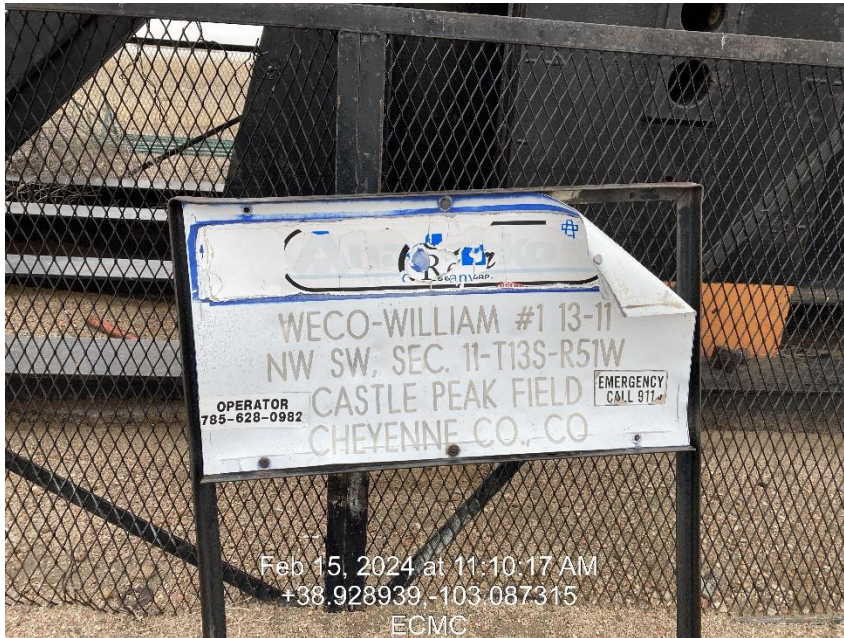
Photo 1 – Well placard

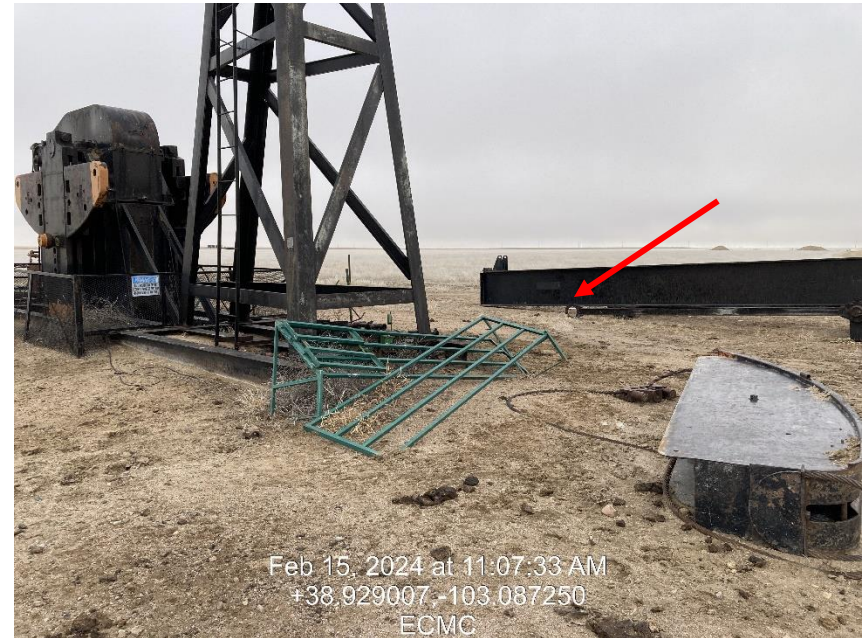
Photo 2 – Area of historical wellhead. Unused equipment throughout location

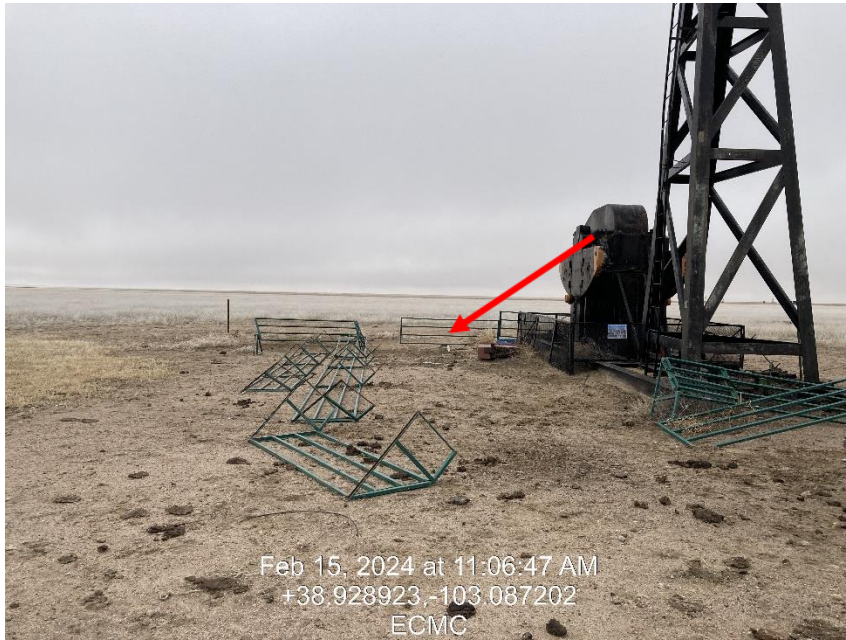
Photo 3 – Machine Guarding not maintained.

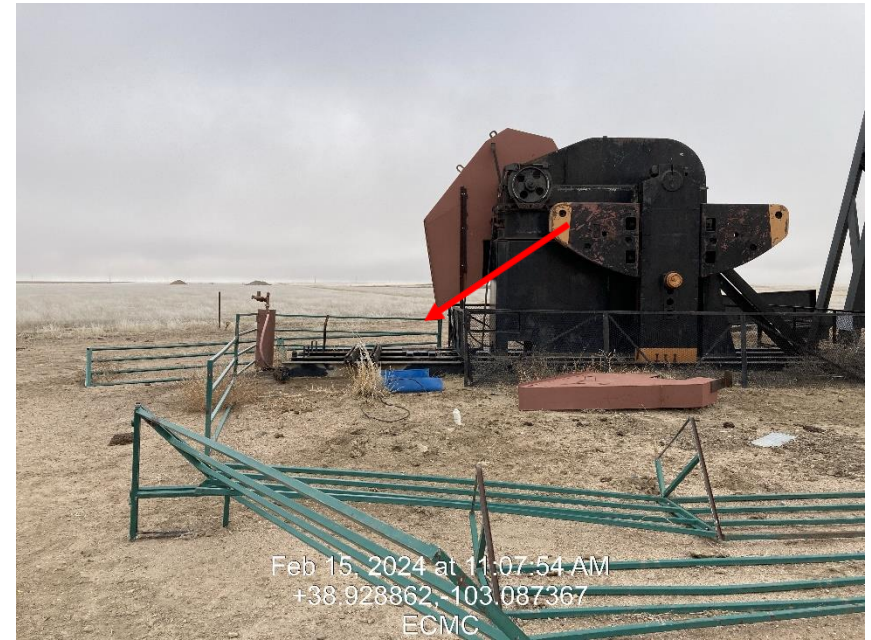
Photo 4 – Unused equipment and debris

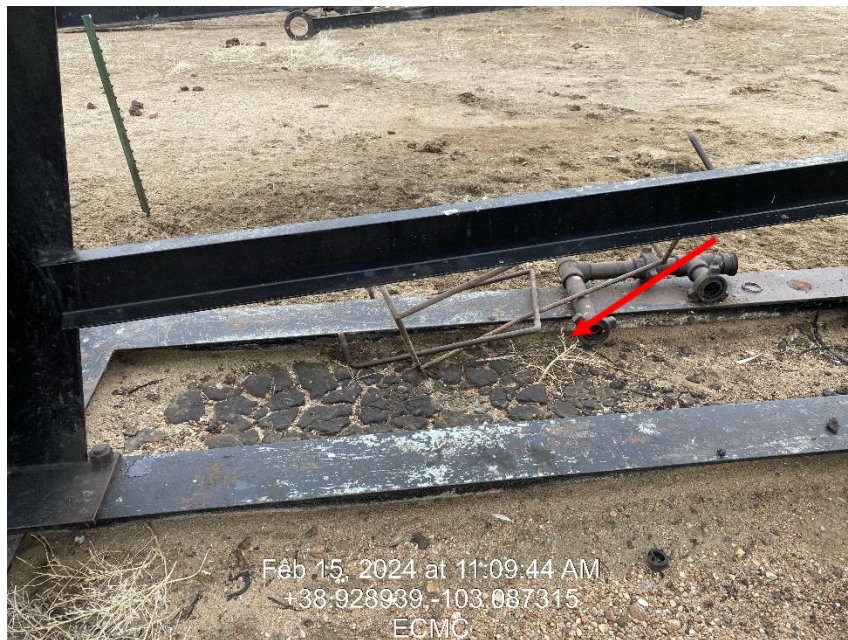
Photo 5 – Oil stained soils

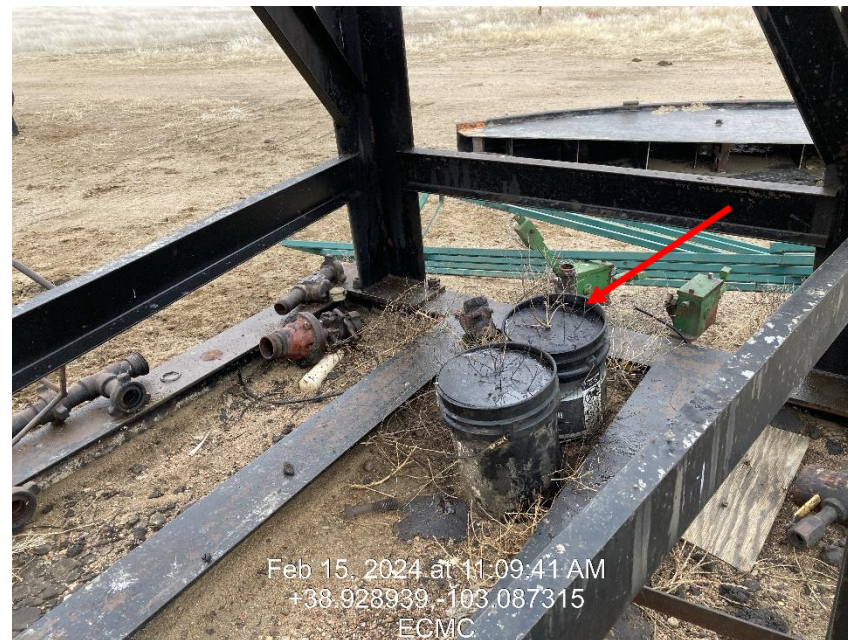
Photo 6 – Unused equipment, buckets with oily liquids

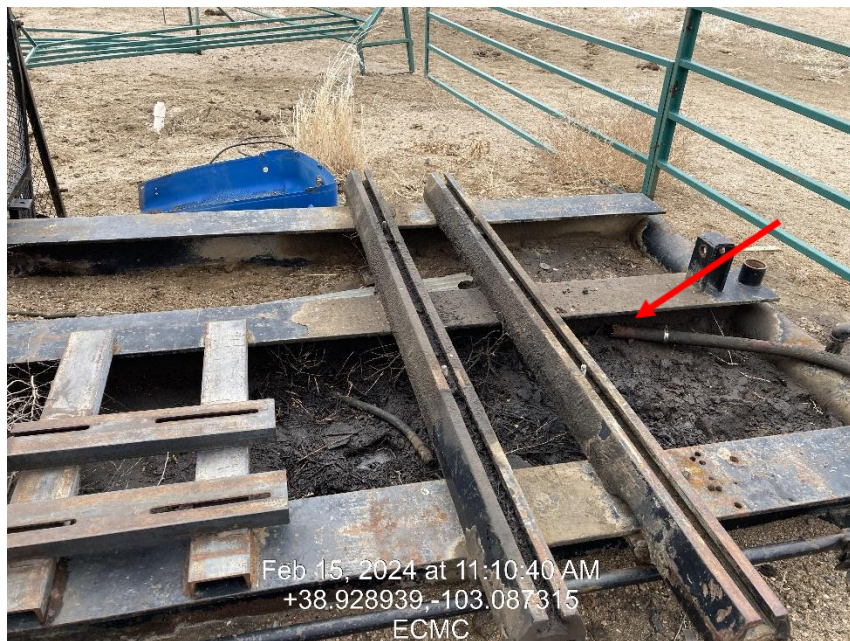
Photo 7 – Oil stained soils, Pumping Unit frame

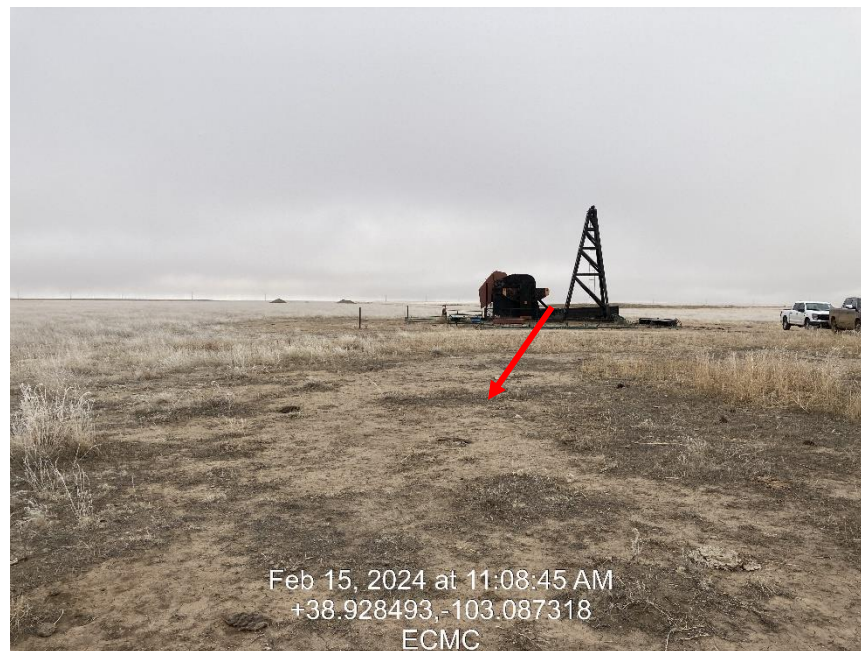
Photo 8 – Area of potential impacted soils

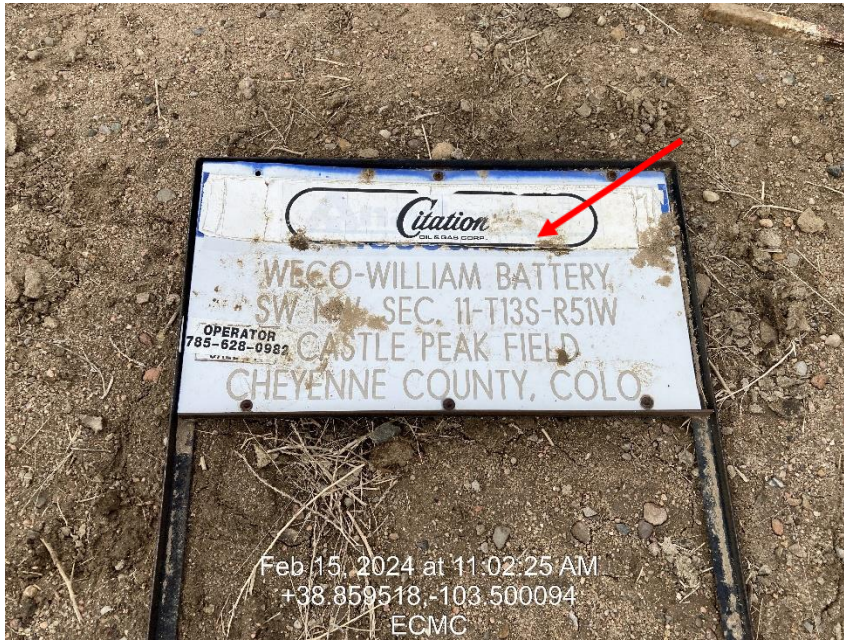
Photo 9 – Placard at Tank Battery

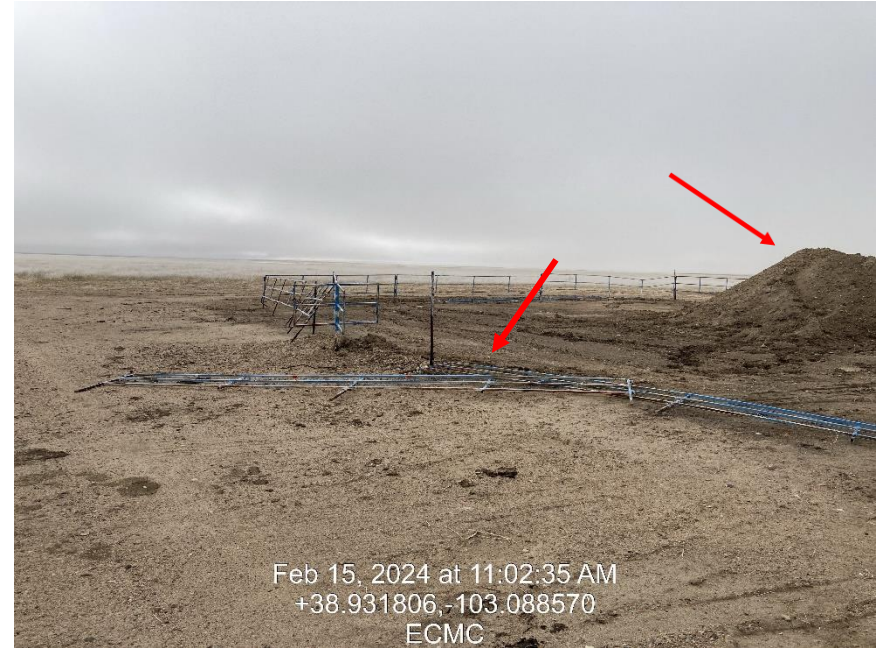
Photo 10 – Soil pile, Fencing/Guarding not maintained

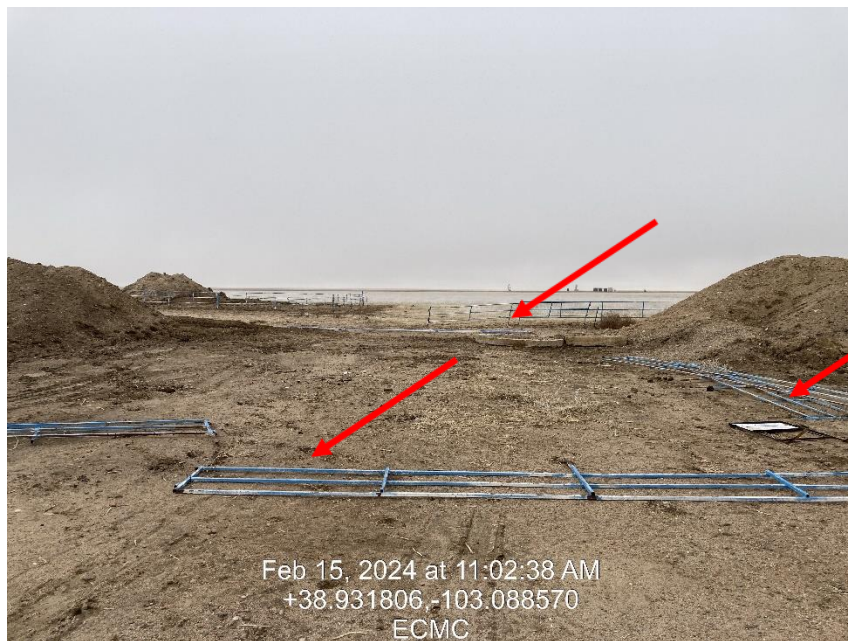
Photo 11 – Fencing/Guarding not maintained

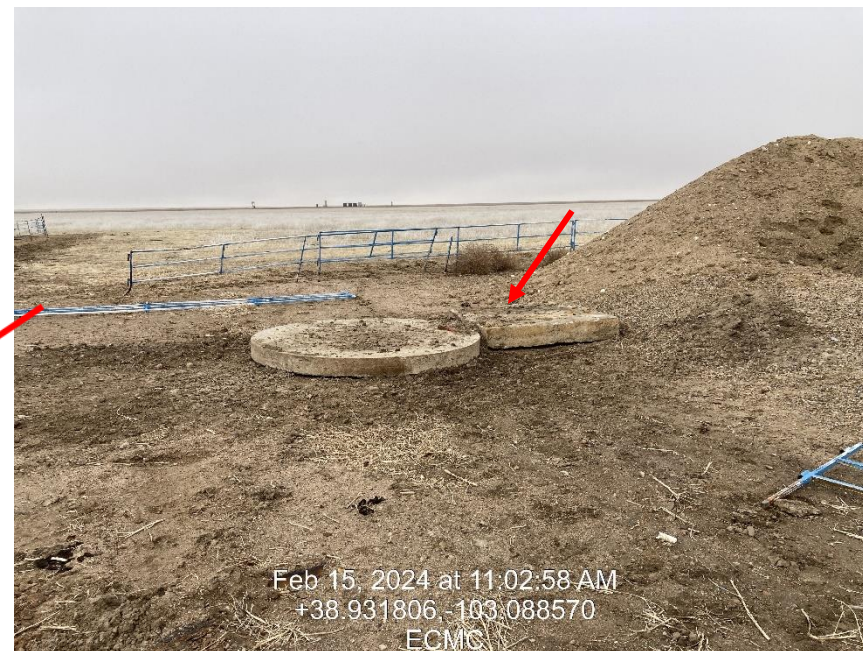
Photo 12 – Cement

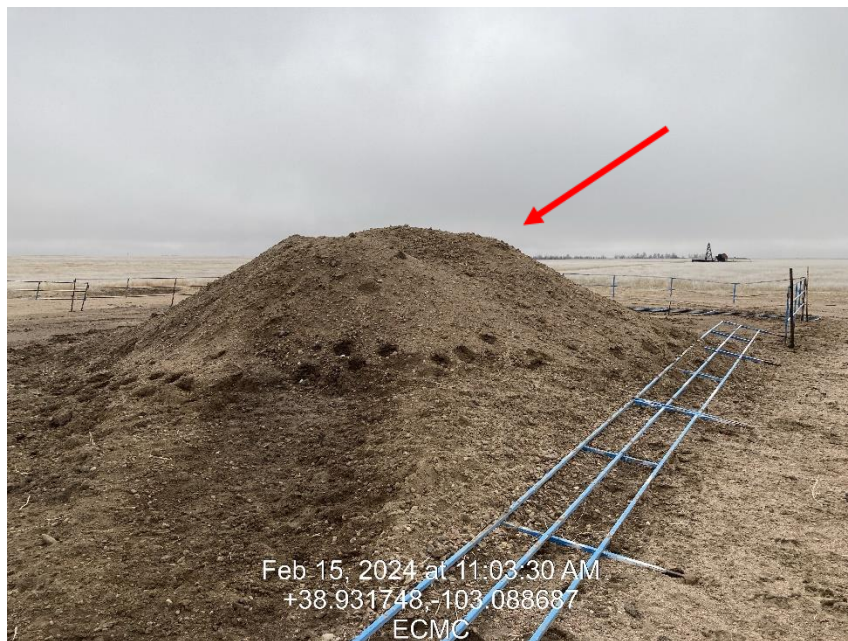
Photo 13 – Soil Pile

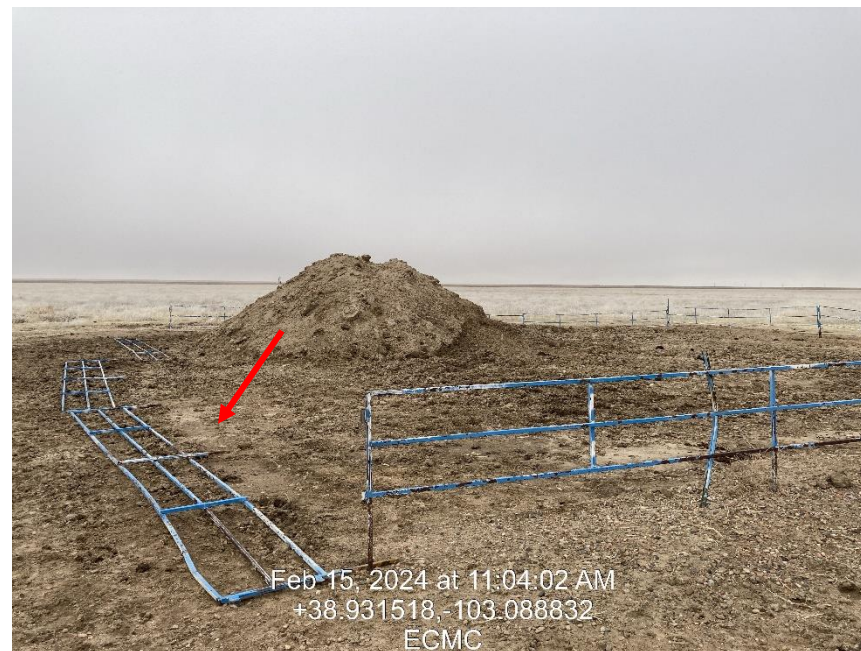
Photo 14 – Fencing/Guarding not maintained
