# Inspection Photos

API: 099-06045

Operator: RENEGADE OIL & GAS COMPANY LLC

Inspection Date: 2/21/2024

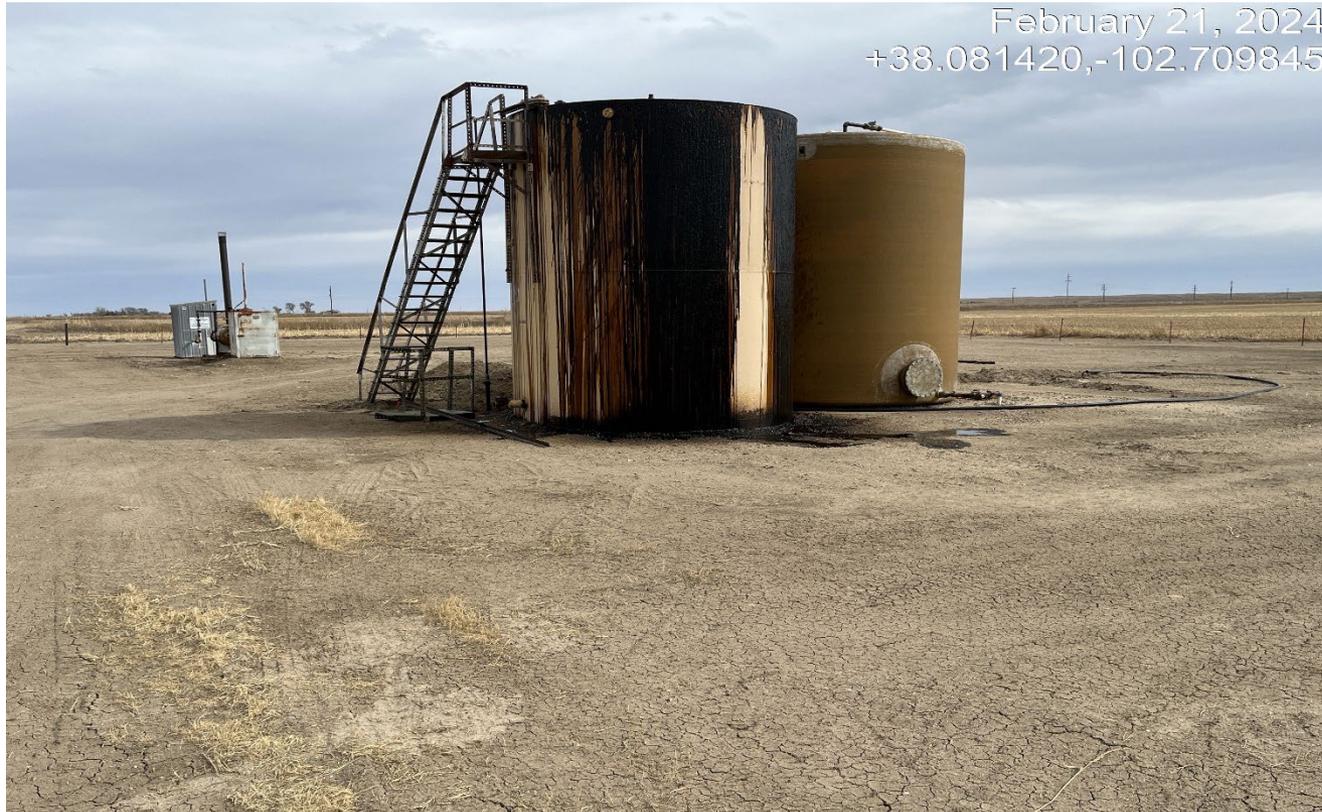
**Photo 1.** Facing southeast toward the tank battery. There is a new tank being installed which will need to follow the 603.k.o. requirements. Previous corrective action was not completed.

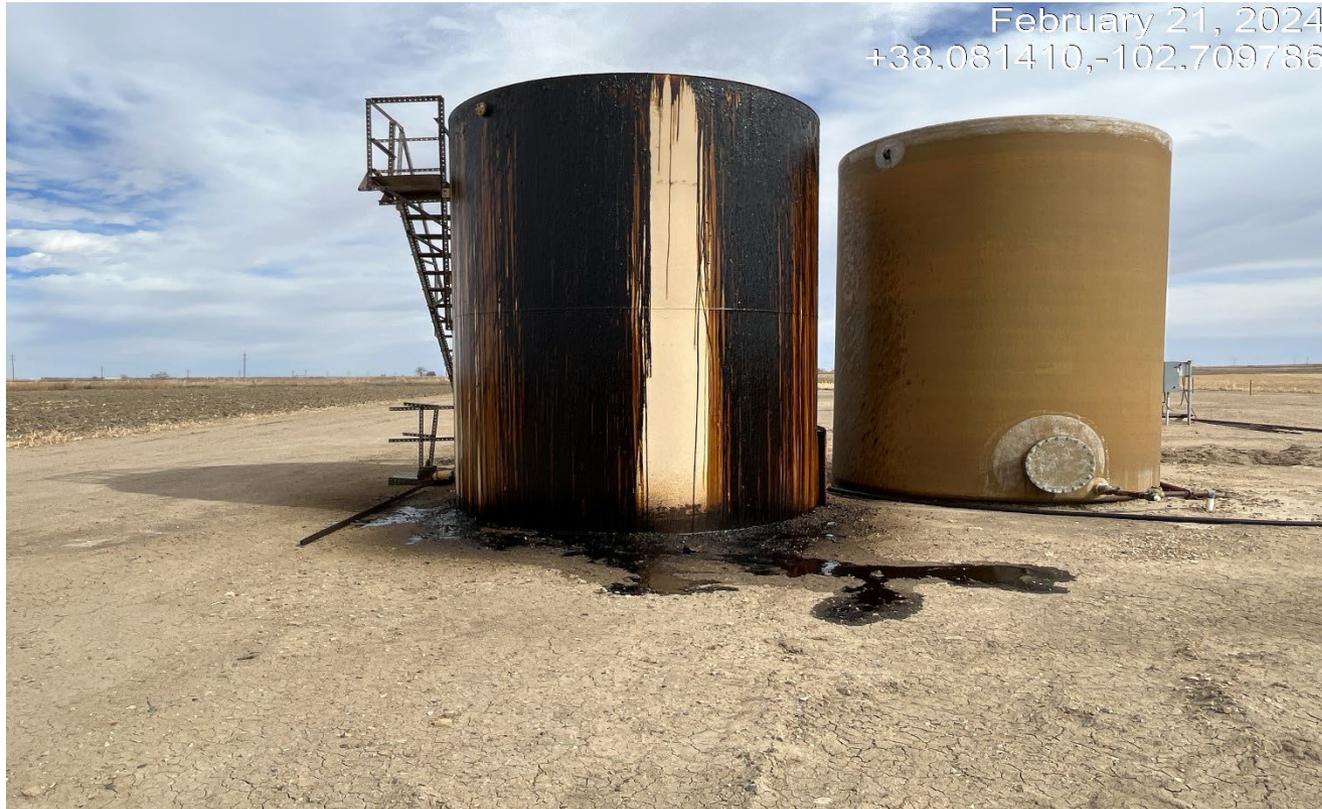
**Photo 2.** This tank was leaking crude oil at the time of inspection. The operator was immediately notified by phone call. There is no secondary containment to contain the spill as was required by previous inspection.

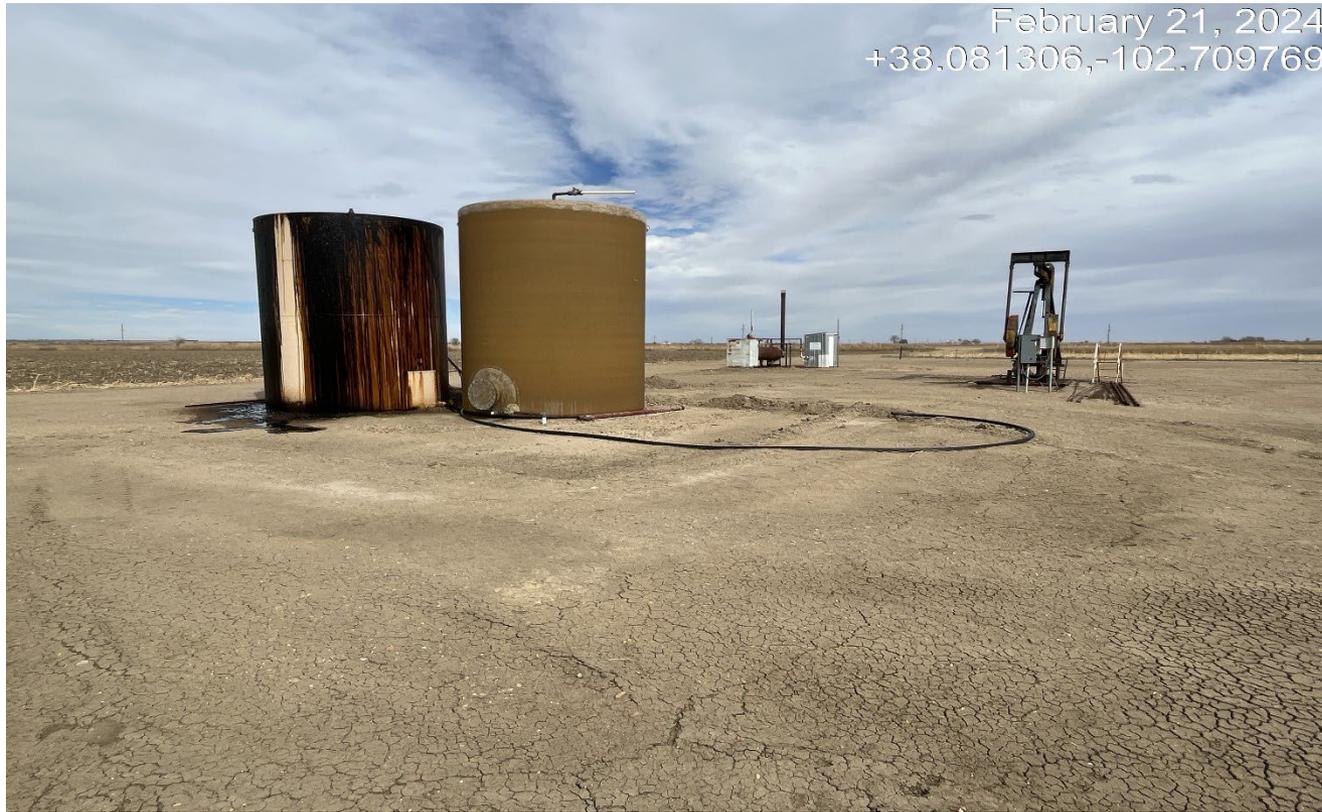
**Photo 3.** Facing northeast at the location.

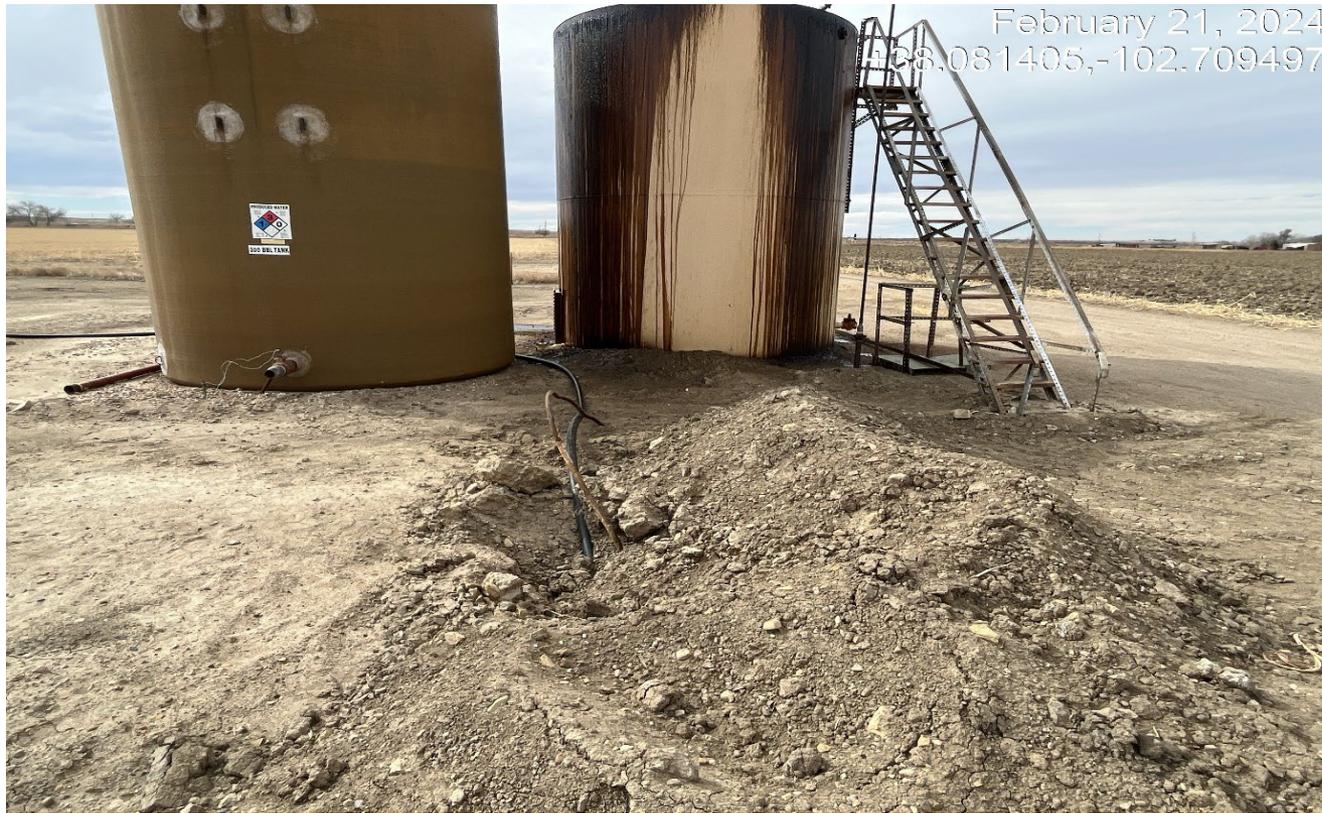
**Photo 4.** Facing west toward the tank battery which had been significantly remodified and requires secondary containment per Rule 603.o.

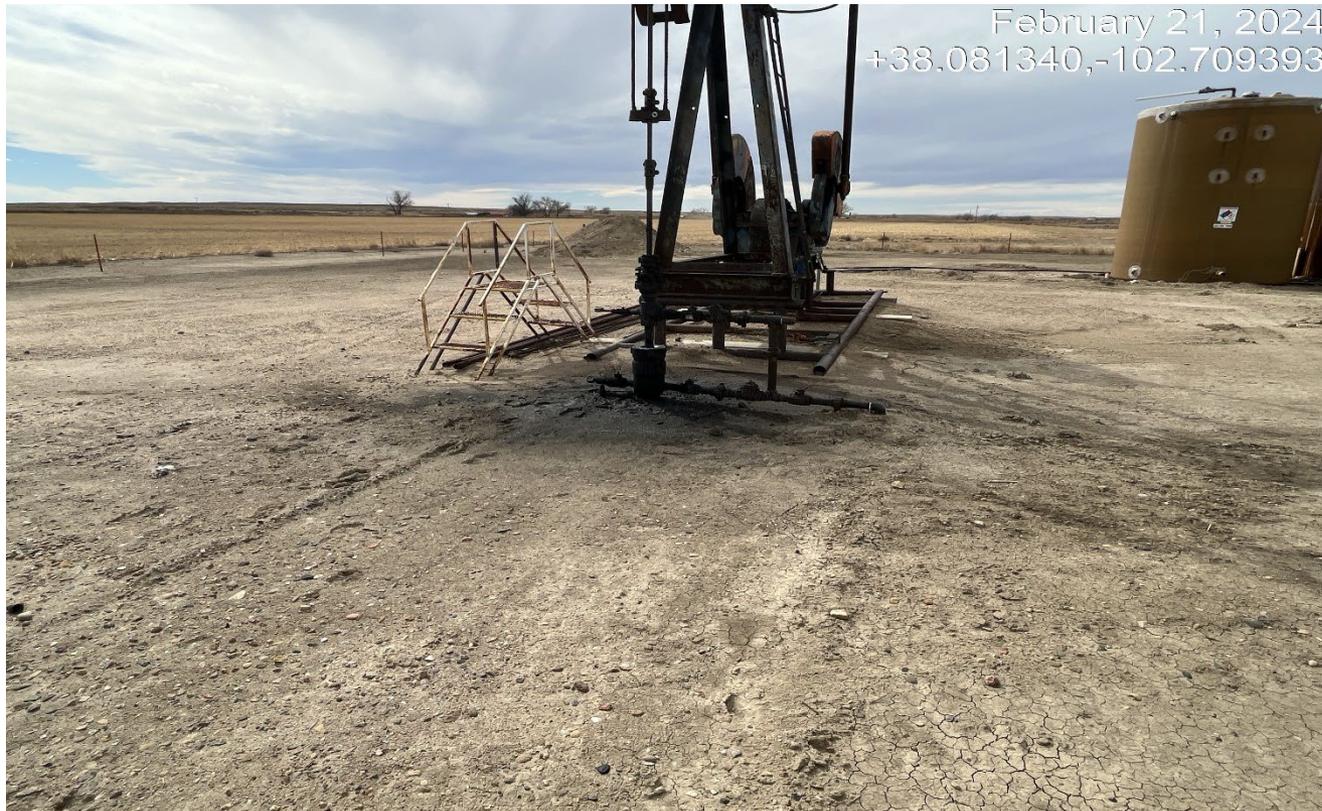
**Photo 5.** There is oil that has leak and sprayed out of the wellhead that needs to be cleaned up.

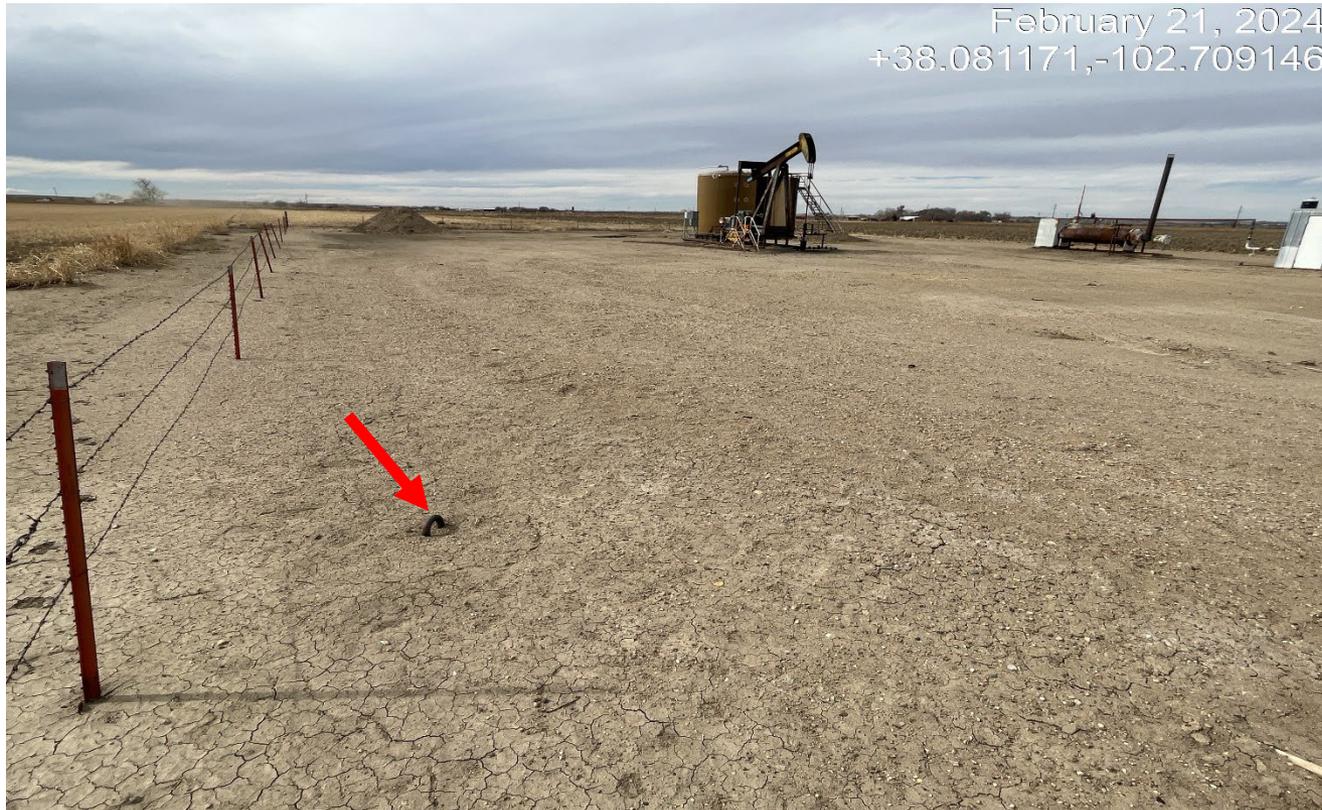
**Photo 6.** Facing west at the south side of the location. Red arrow points to the unmarked guyline anchor.

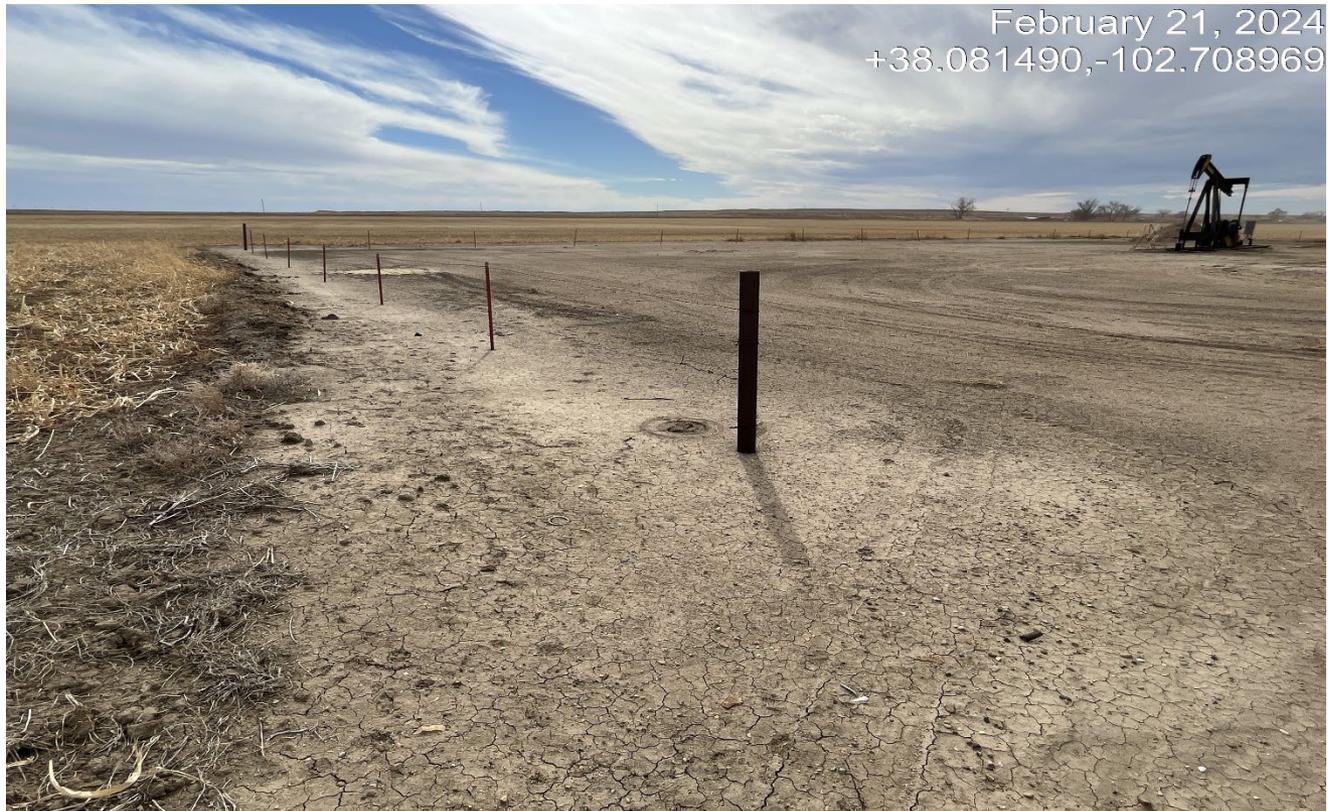
**Photo 7.** Facing southwest at the location. Unused areas of the location are not reclaimed.

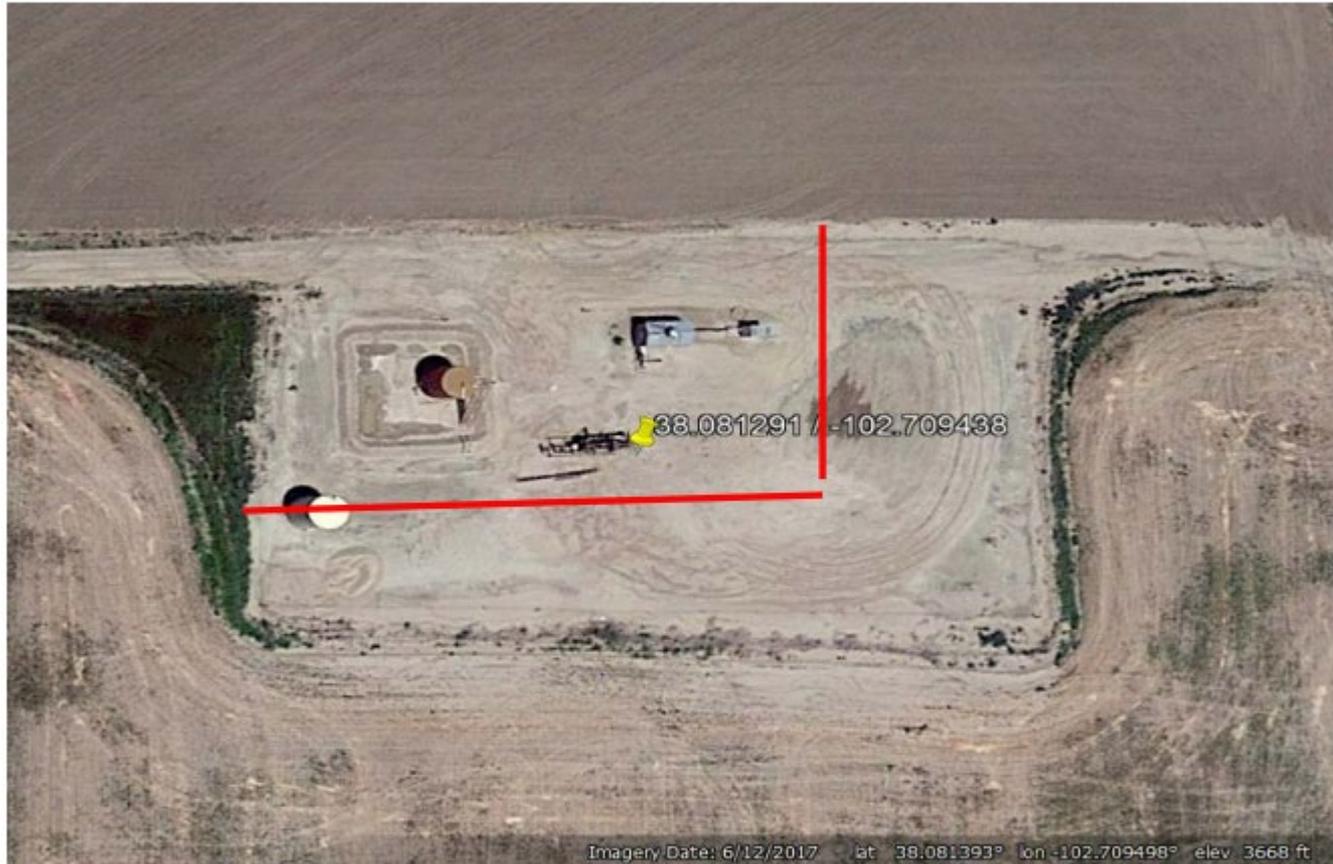
**Photo 4.** Aerial view of the location shows unused areas of the location below and to the right of red line could be put back into cropland.
