Inspection Photos

API: 099-06248

Operator: MURFIN DRILLING COMPANY INC

Inspection Date: 2/21/2024

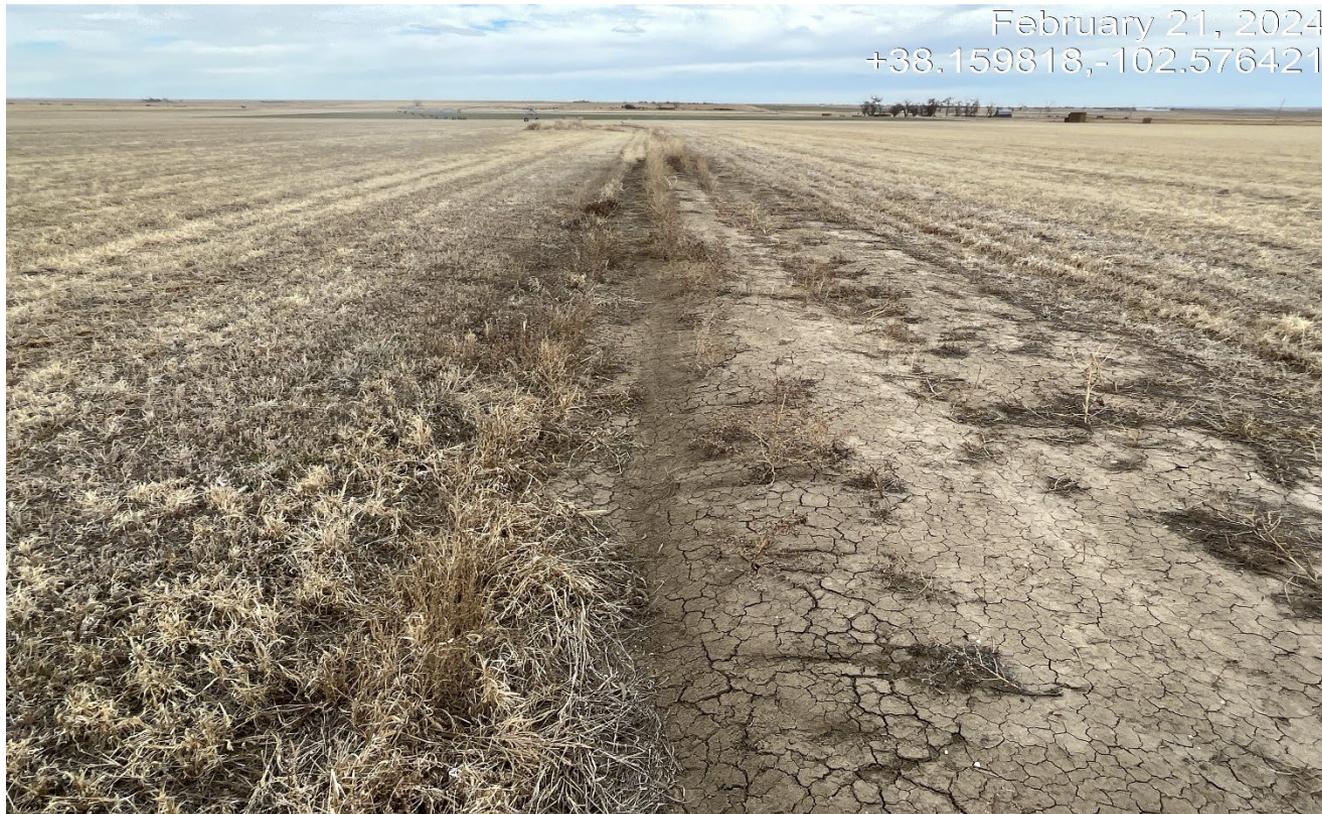
Photo 1. Facing east toward the access road. The road needs to be regraded and decompacted.

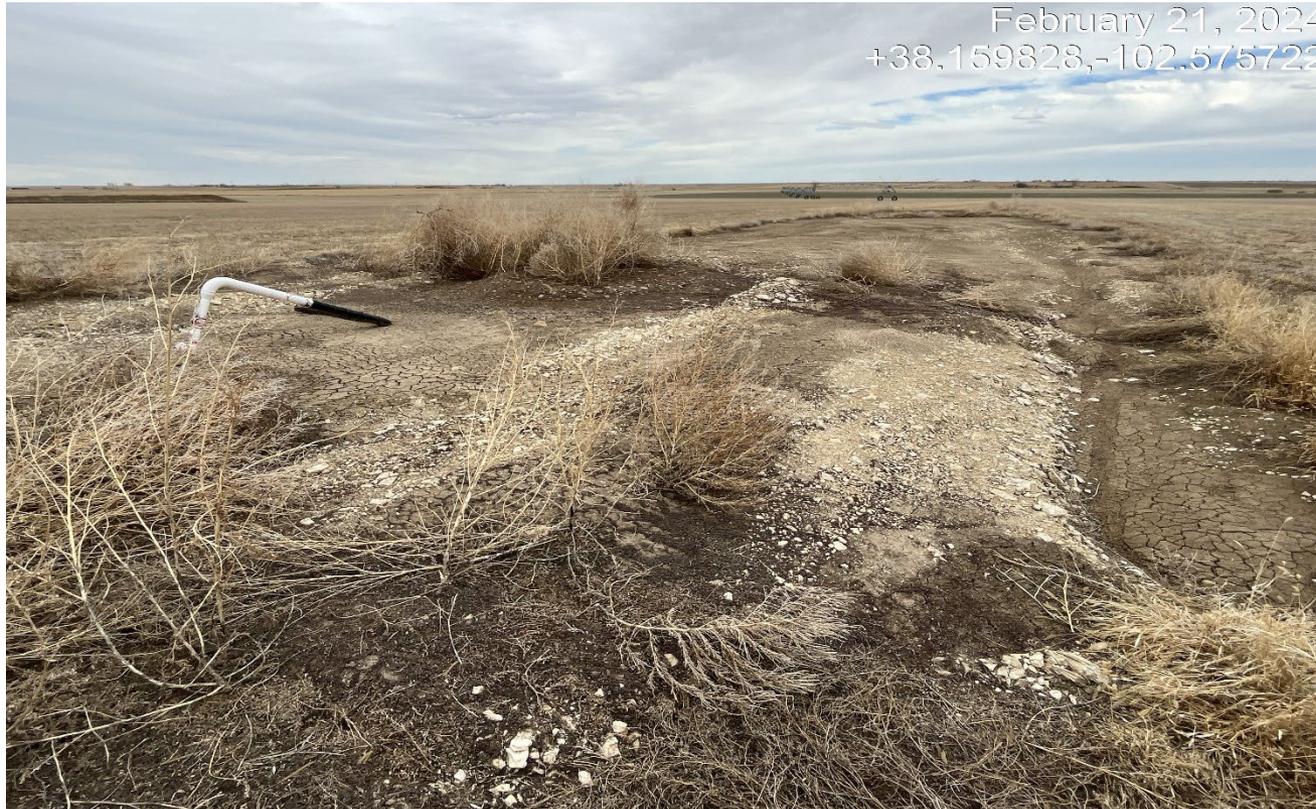
Photo 2. Facing toward the abandoned wellsite. There is a flowline pipe that needs to be removed.

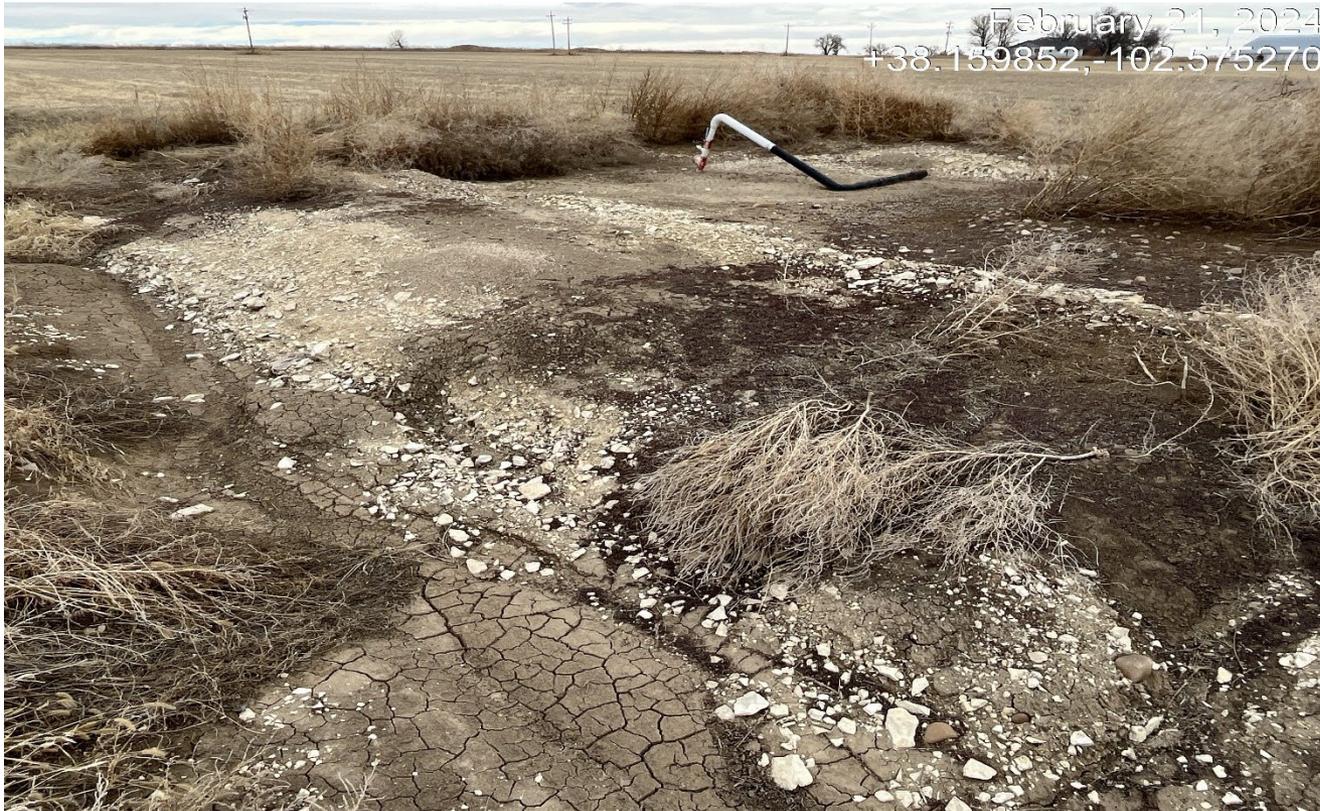
Photo 3. Facing northwest. The rock debris needs to be picked up and removed so it wont interfere with farming operations.

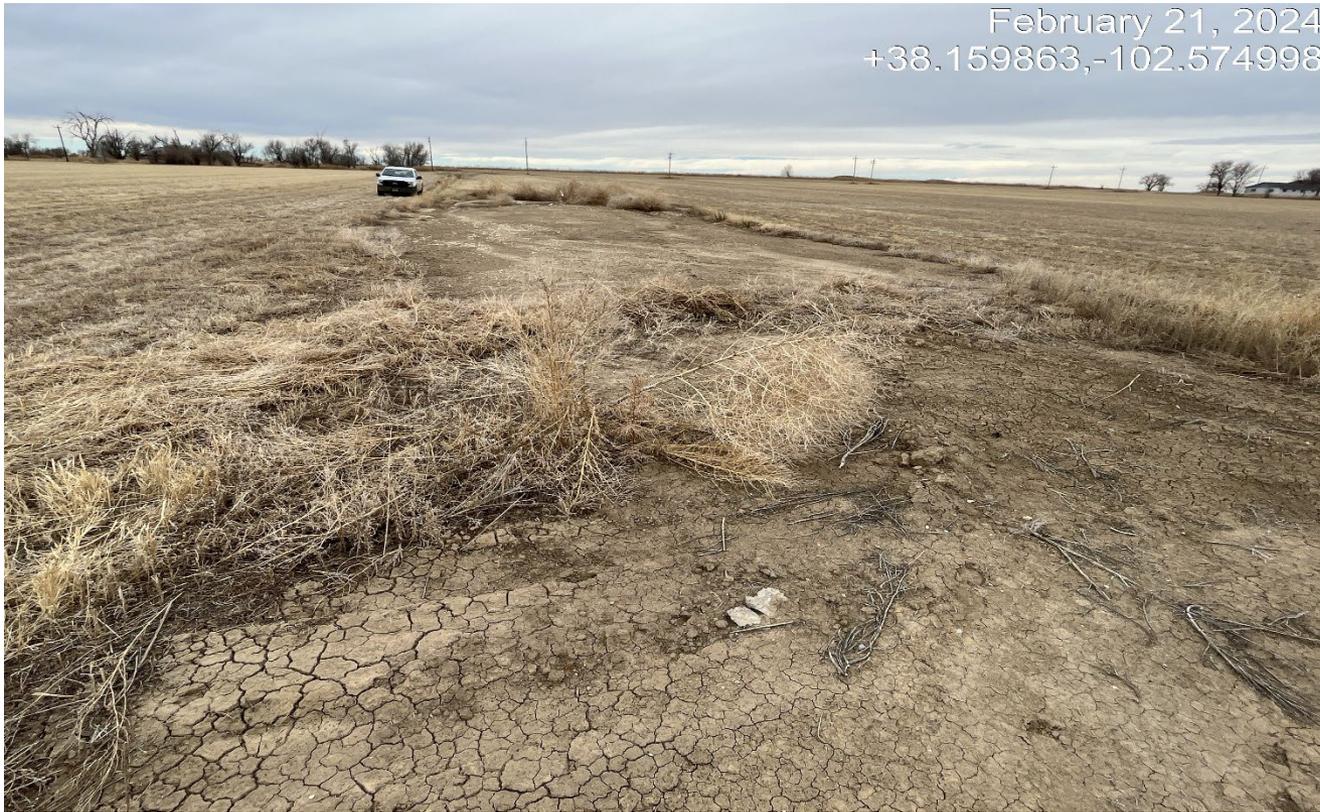
Photo 4. Facing back west at the abandoned location. Soils need to be decompacted by cross ripping to at least 18 inches.
