Gadeco LLC
Hiawatha State 2-36
Location ID: 313297

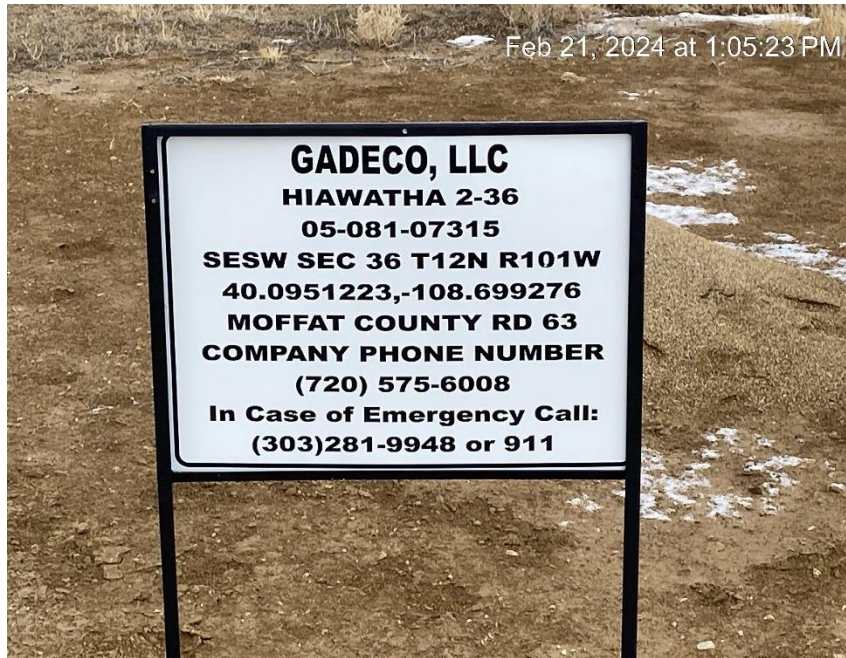
As signs are replaced additional information will be required

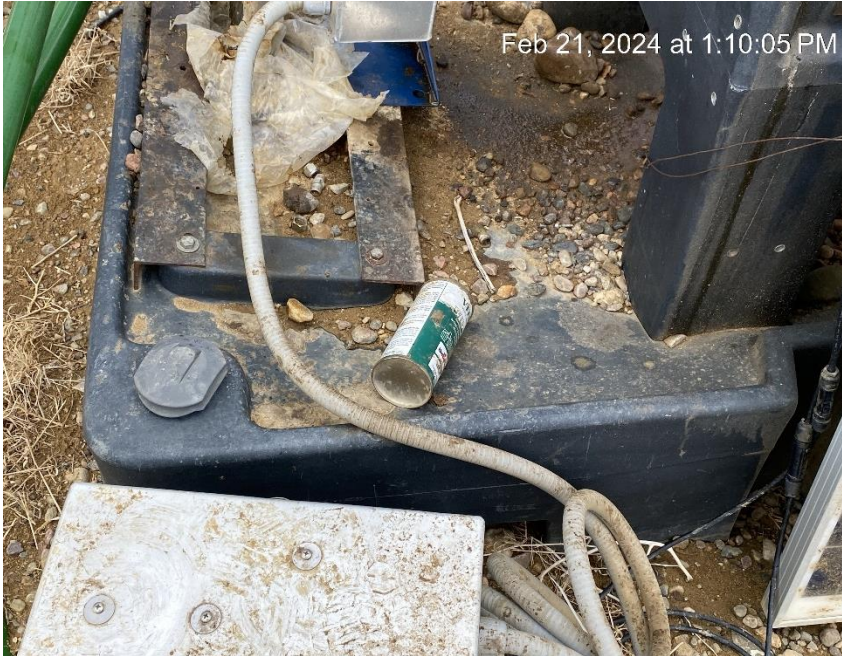
Debris

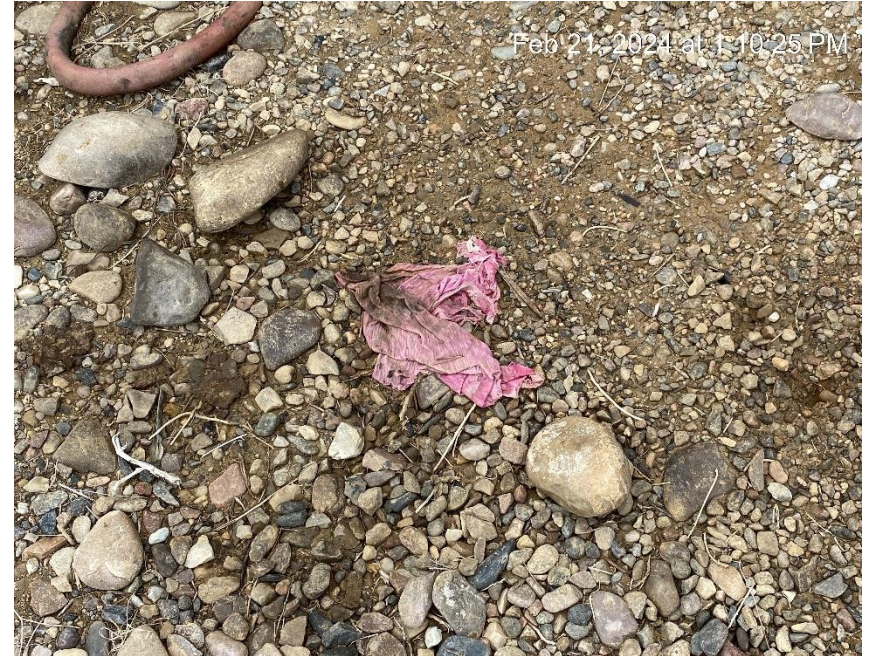
Debris

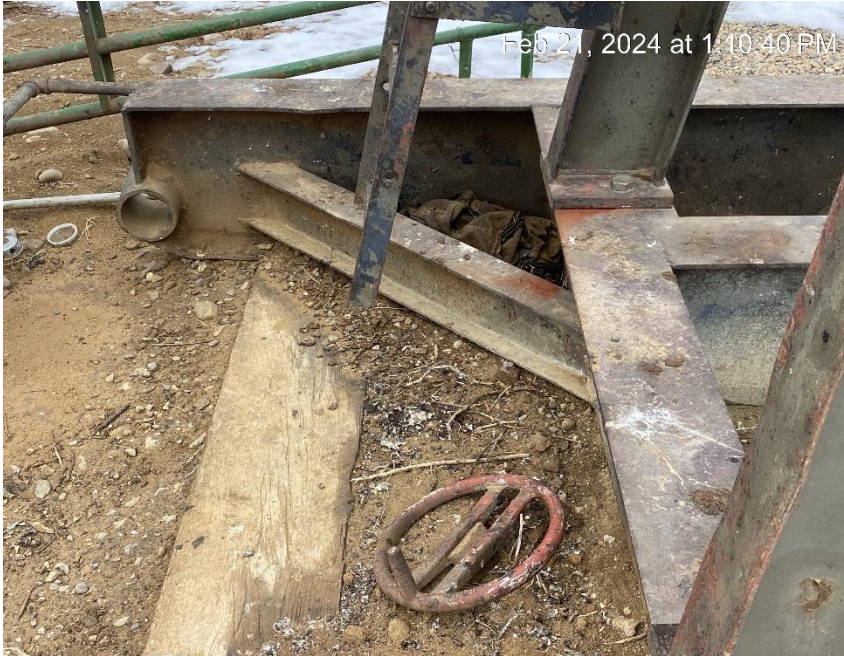
Debris

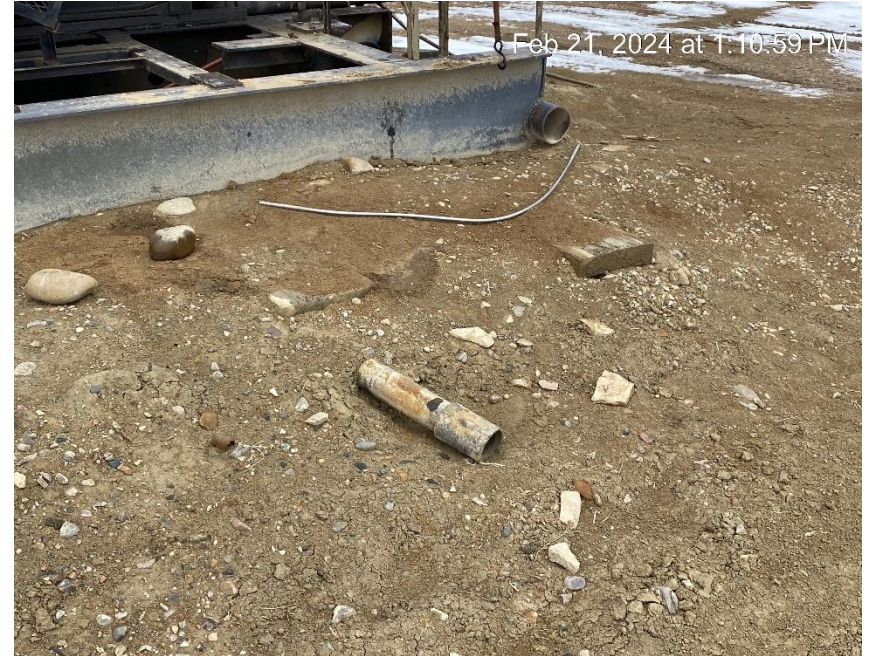
Debris

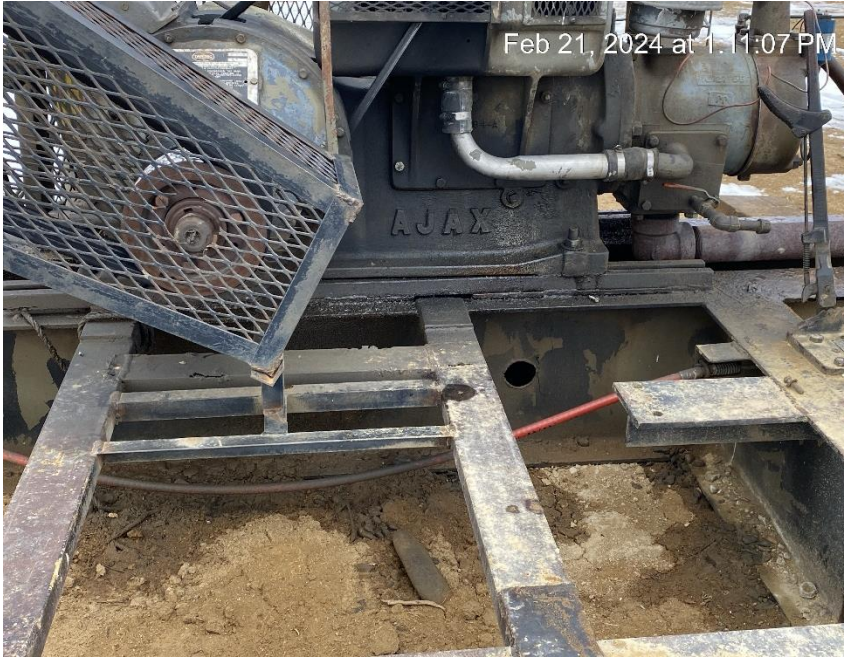
Equipment leaks and stained soil

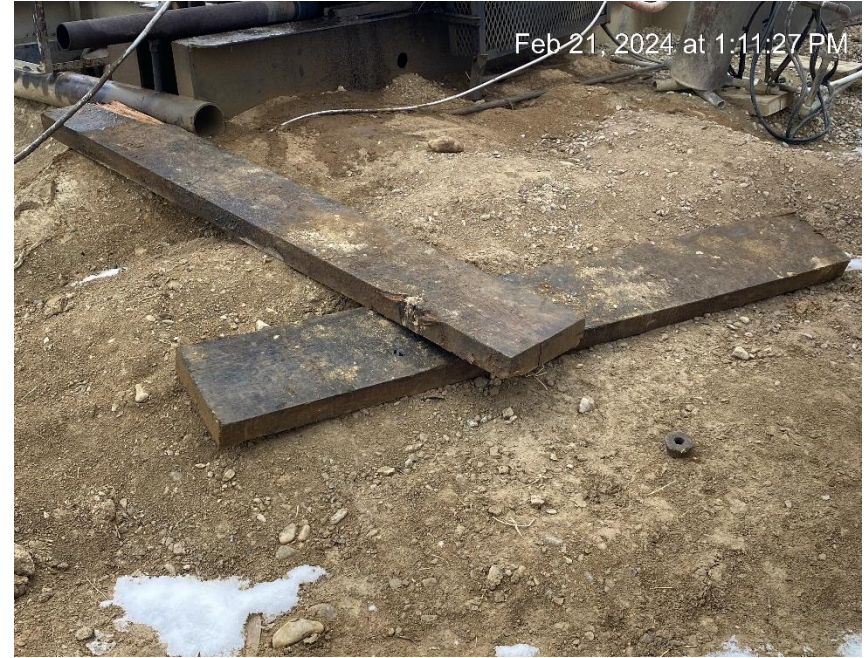
Debris

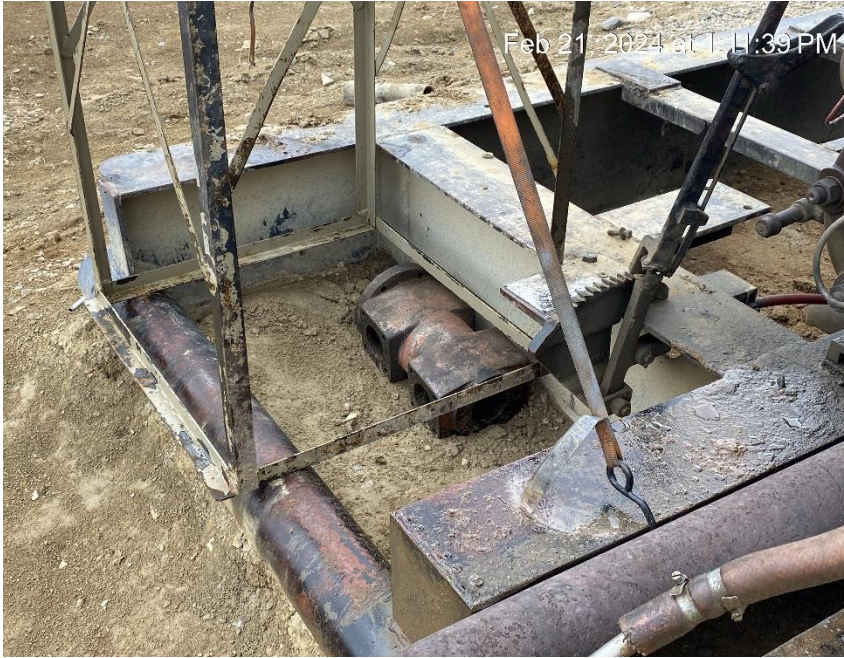
Debris. No containment.

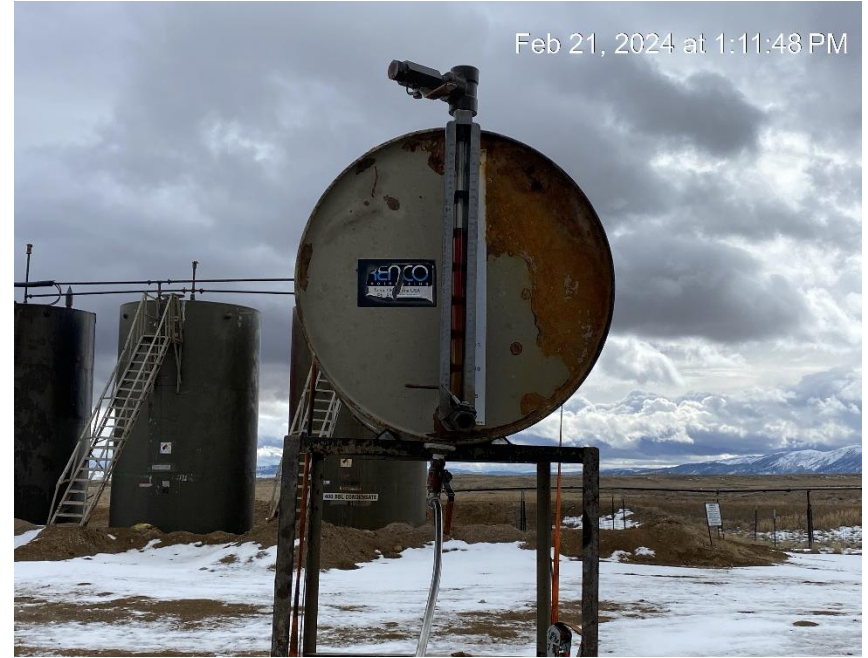
Unidentified contents. No containment.

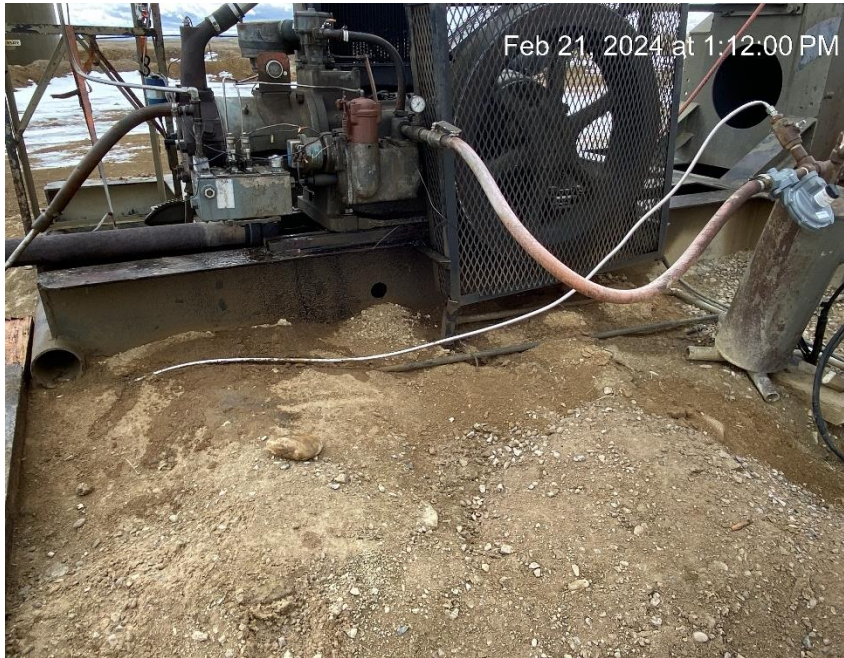
Leaking equipment and stained soil

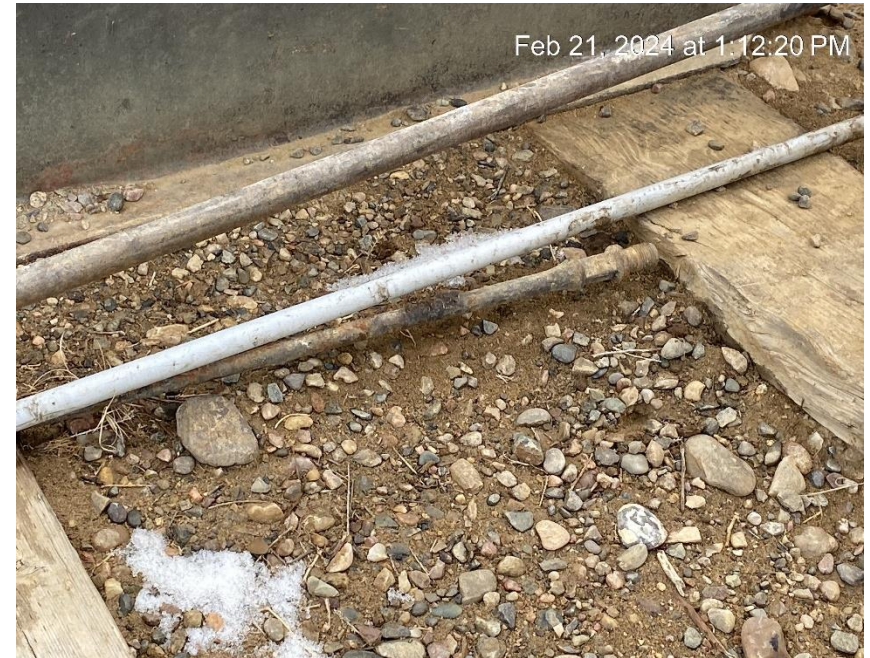
Sucker rod alongside unit

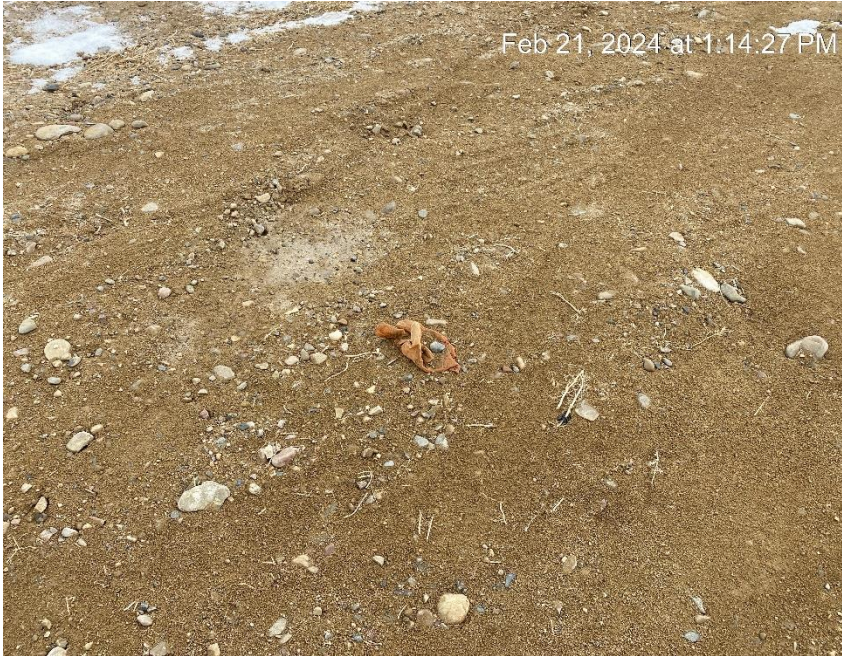
Debris

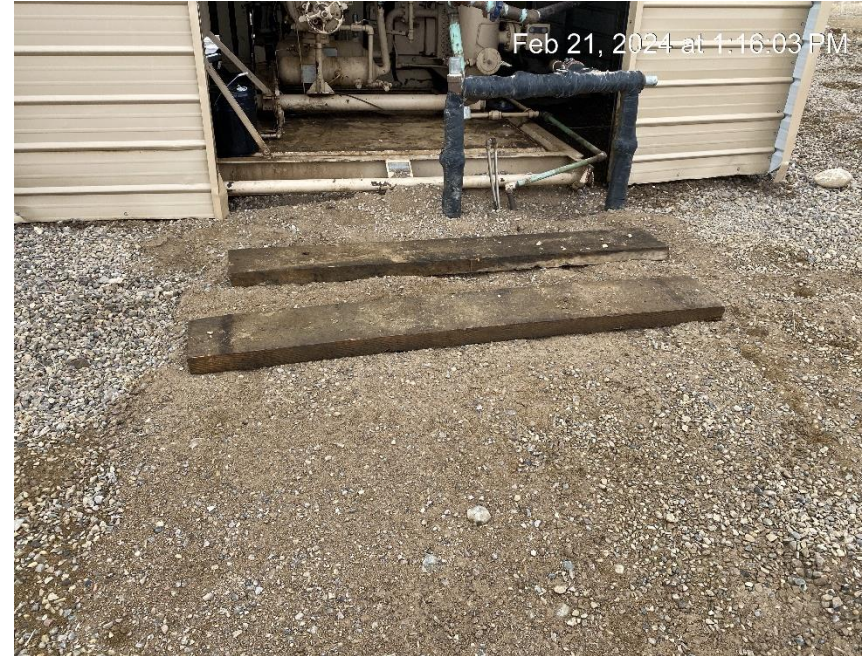
Debris

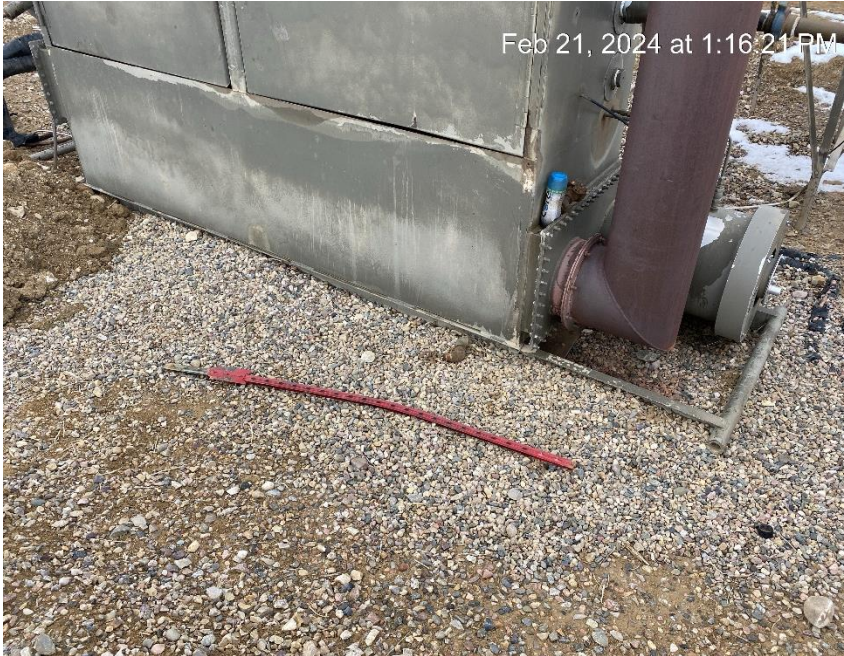
Debris

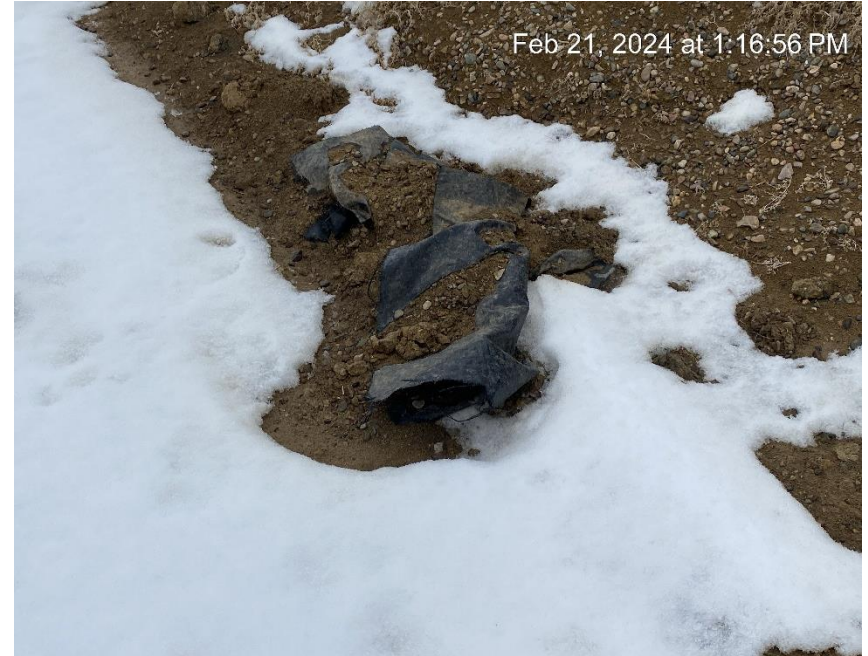
Debris

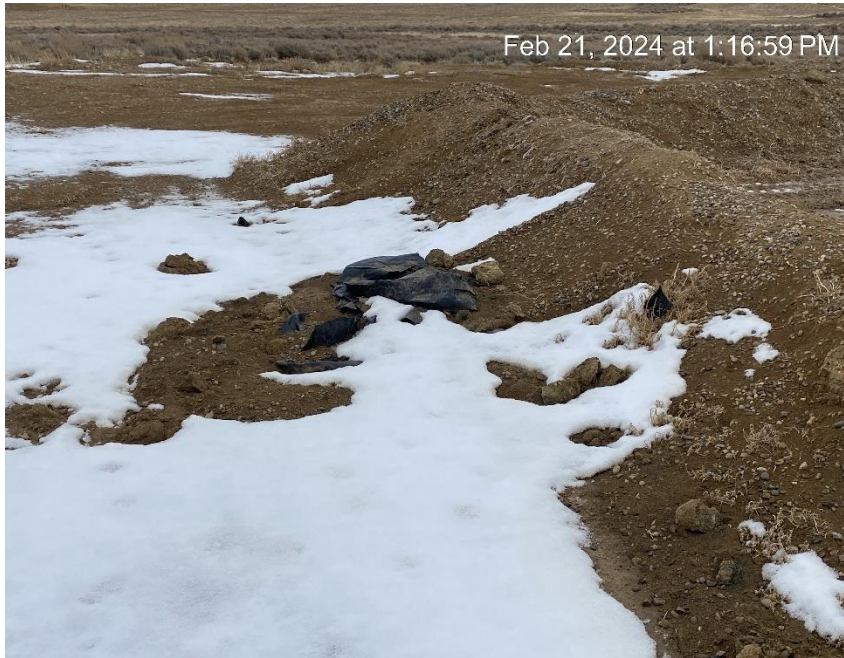
Debris

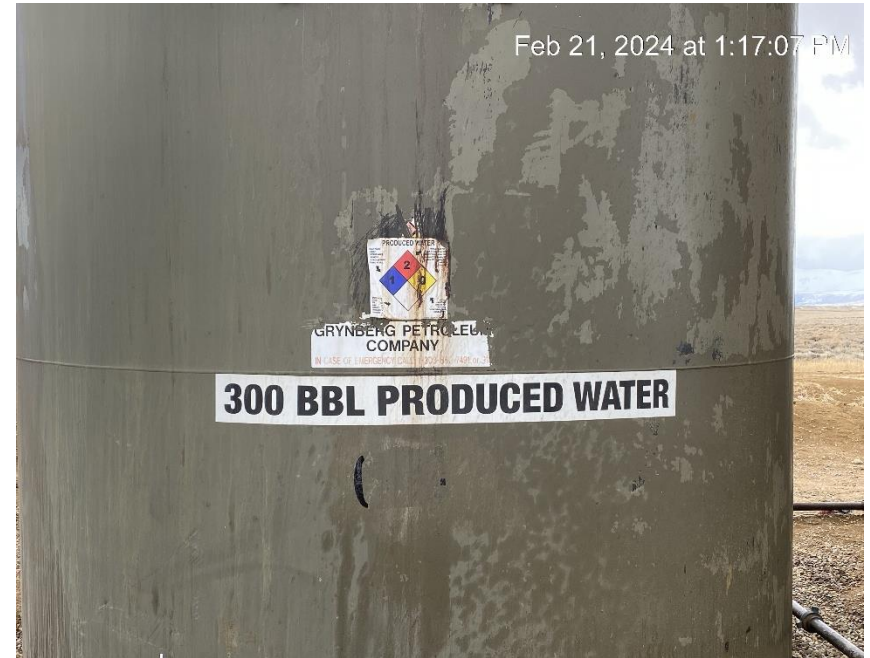
Tank labels missing required information

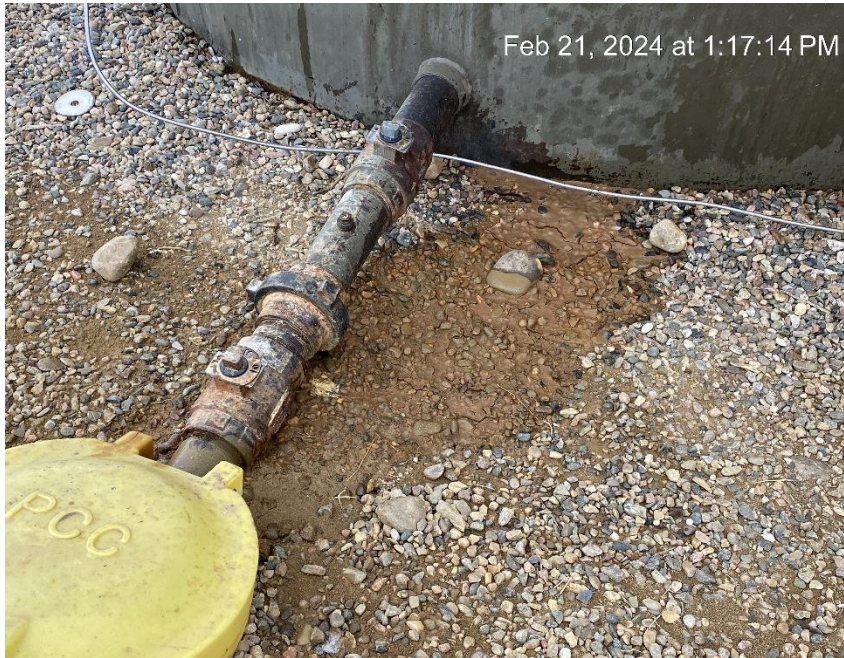
Oily waste and stained soil

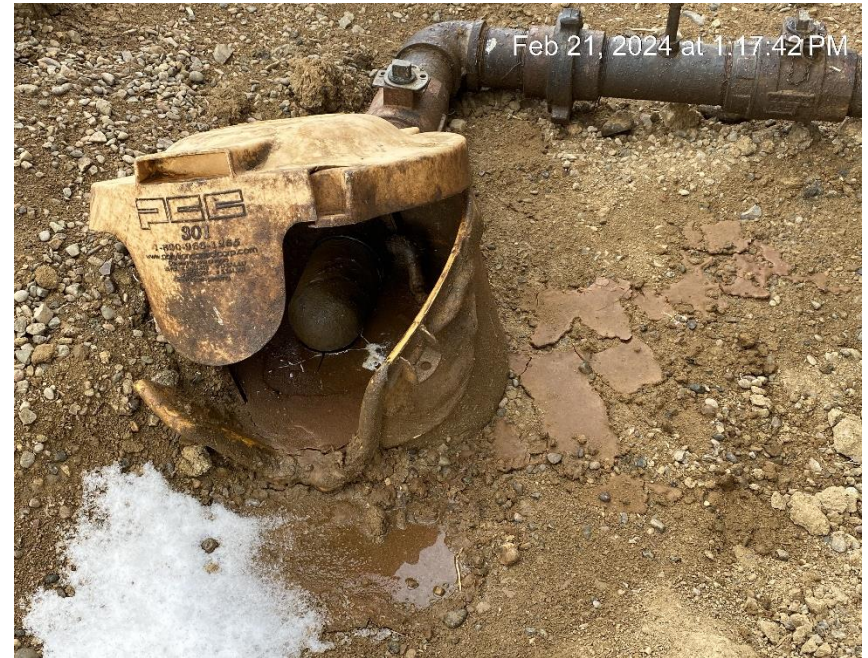
Oily waste and stained soil

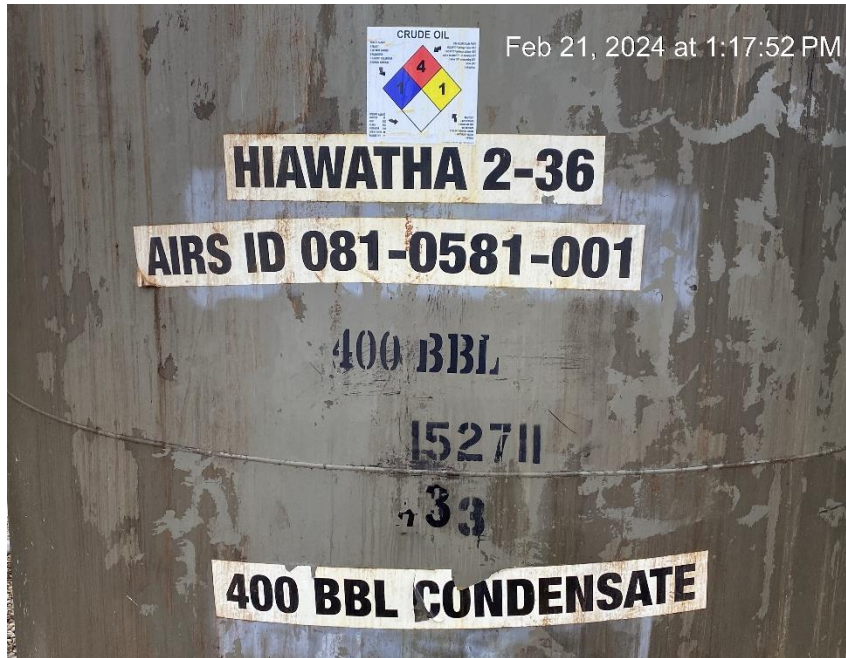
Tank labels missing required information

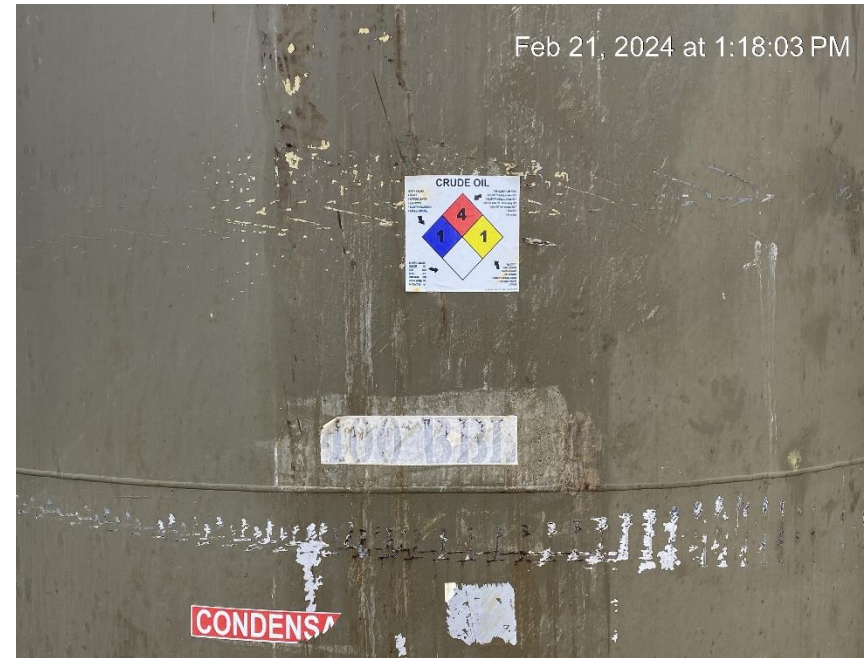
Tank labels missing required information

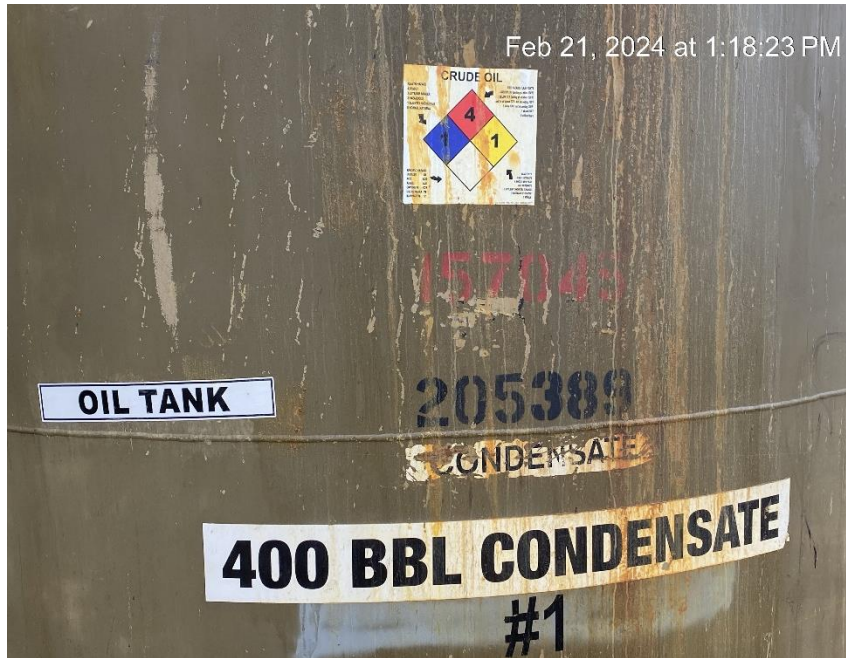
Tank labels missing required information

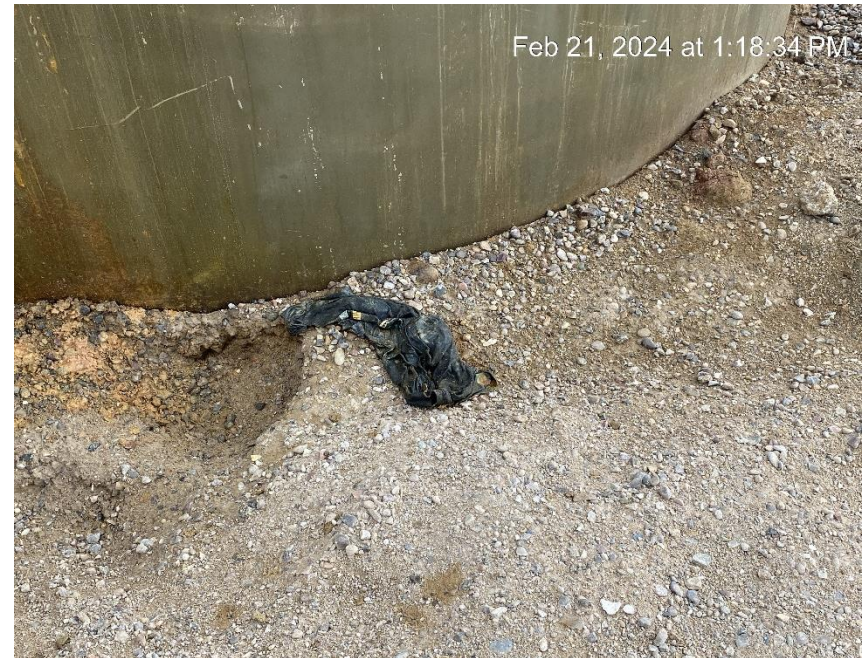
Debris. Oily waste.

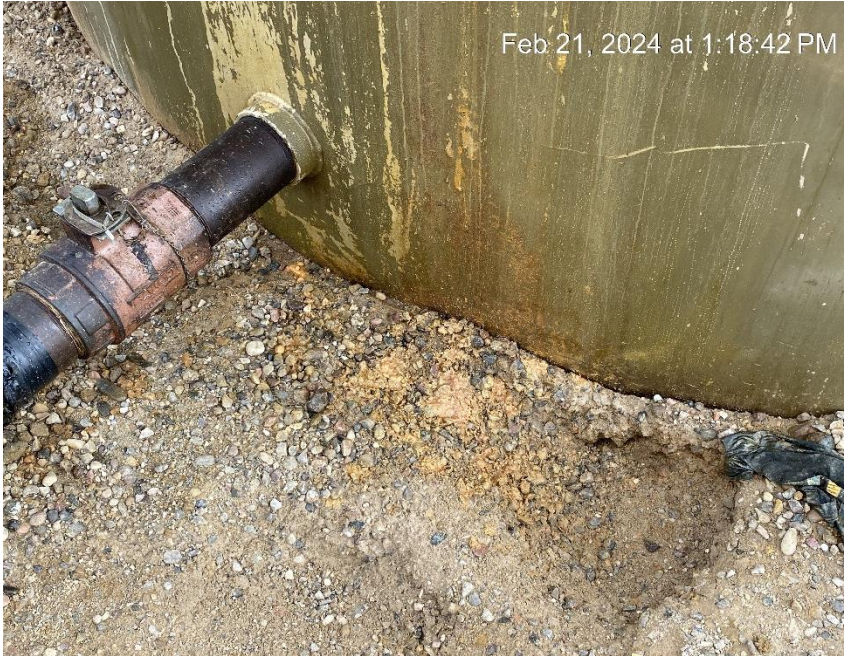
Oily waste

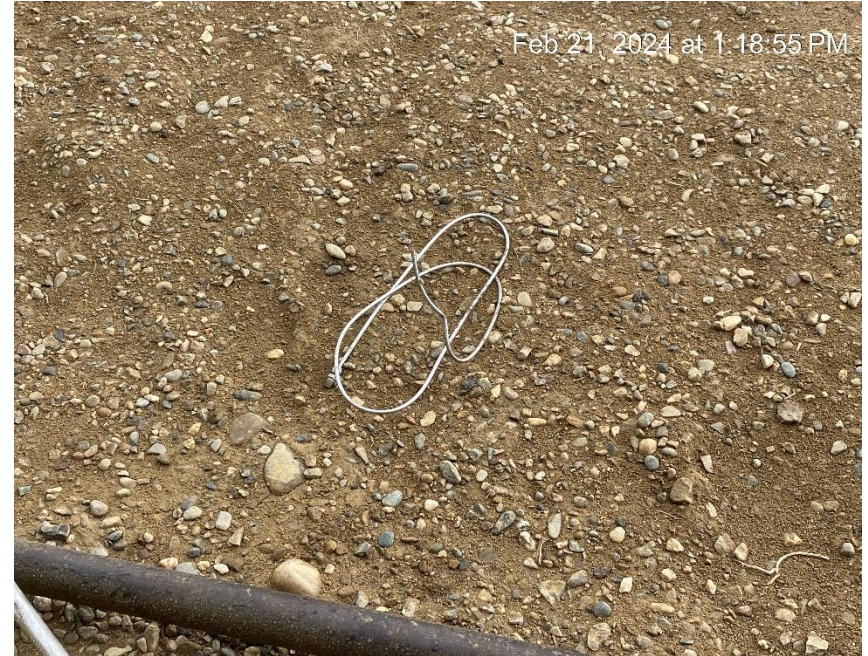
Debris

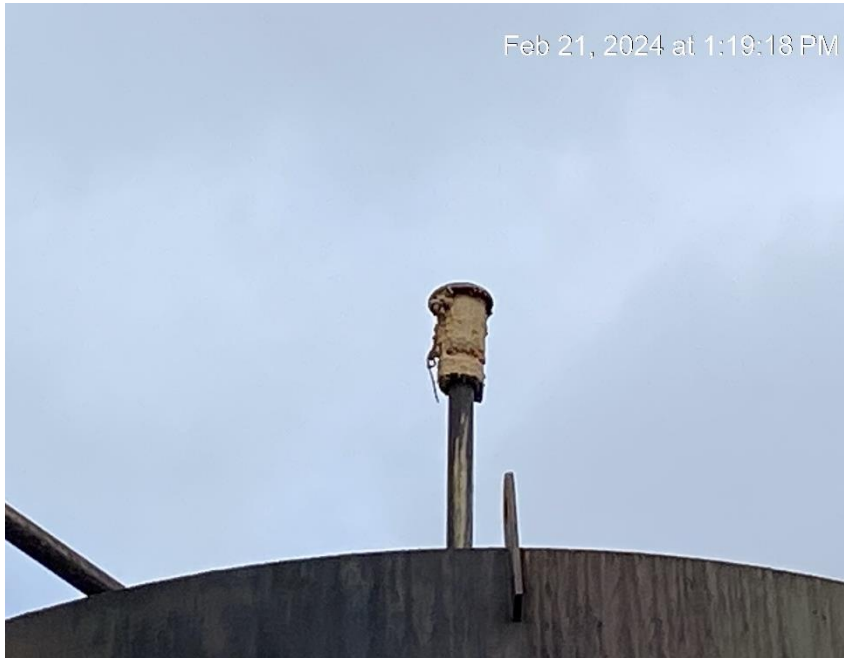
Oily waste covering relief valves

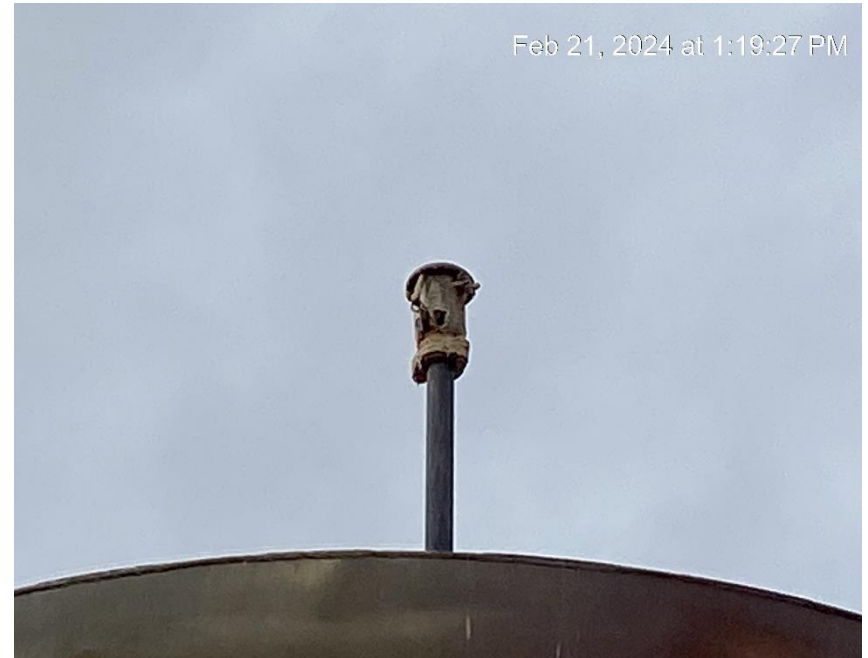
Oily waste covering relief valves

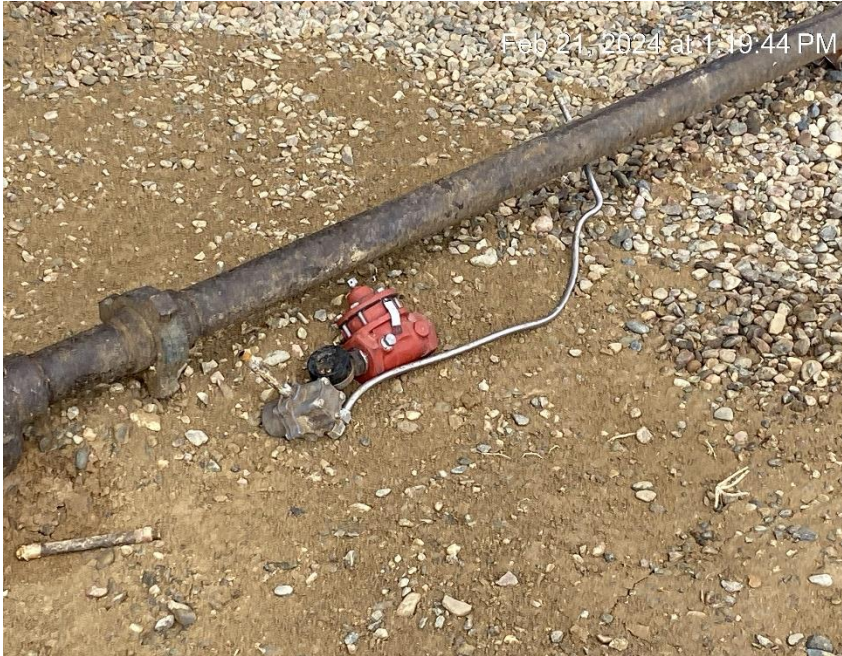
Debris

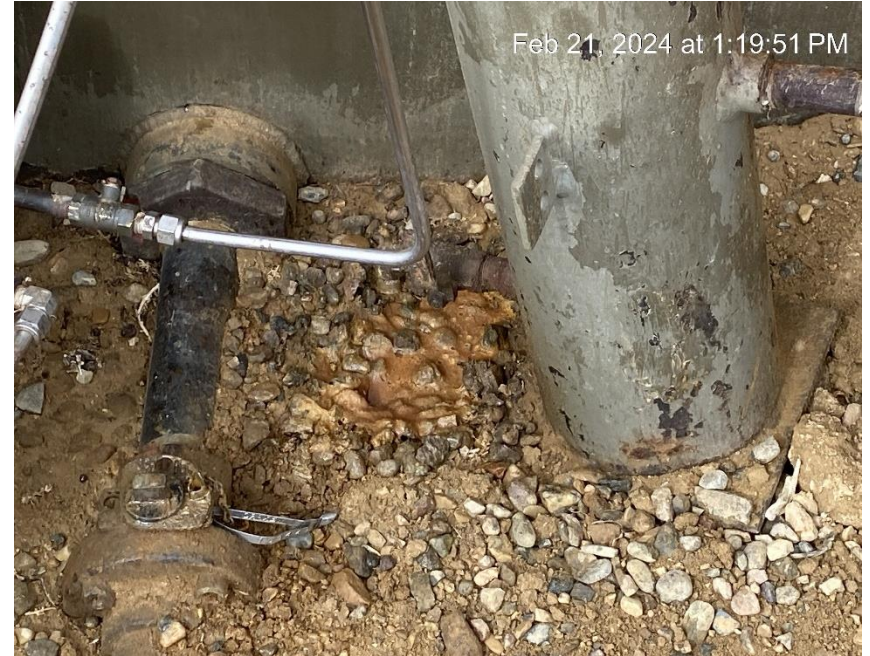
Oily waste and stained soil

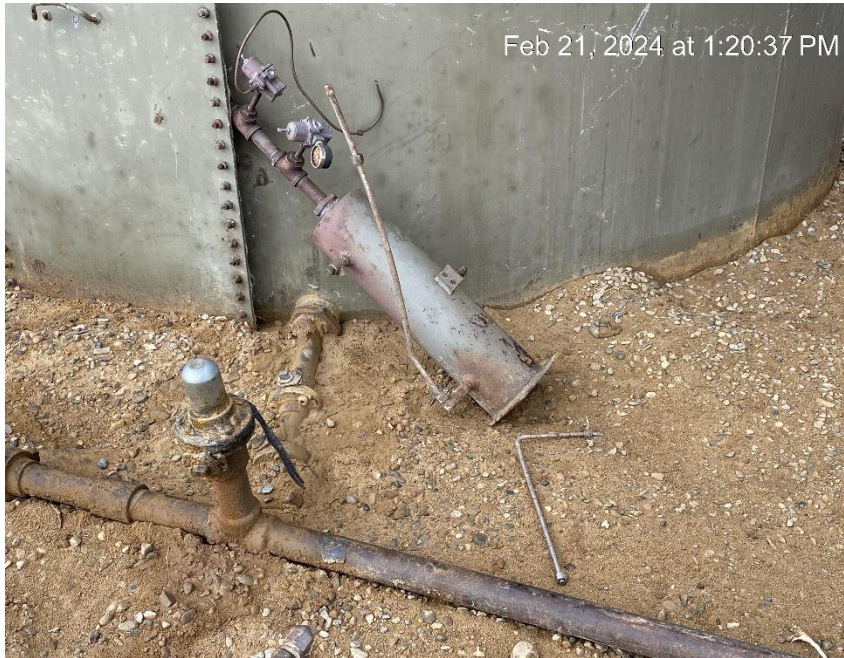
Debris

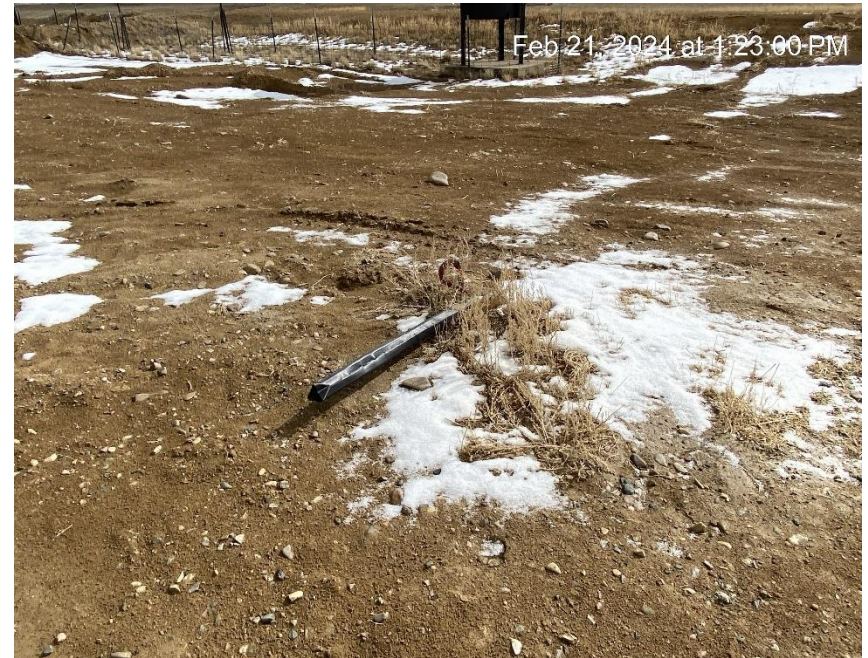
Unmarked anchor
