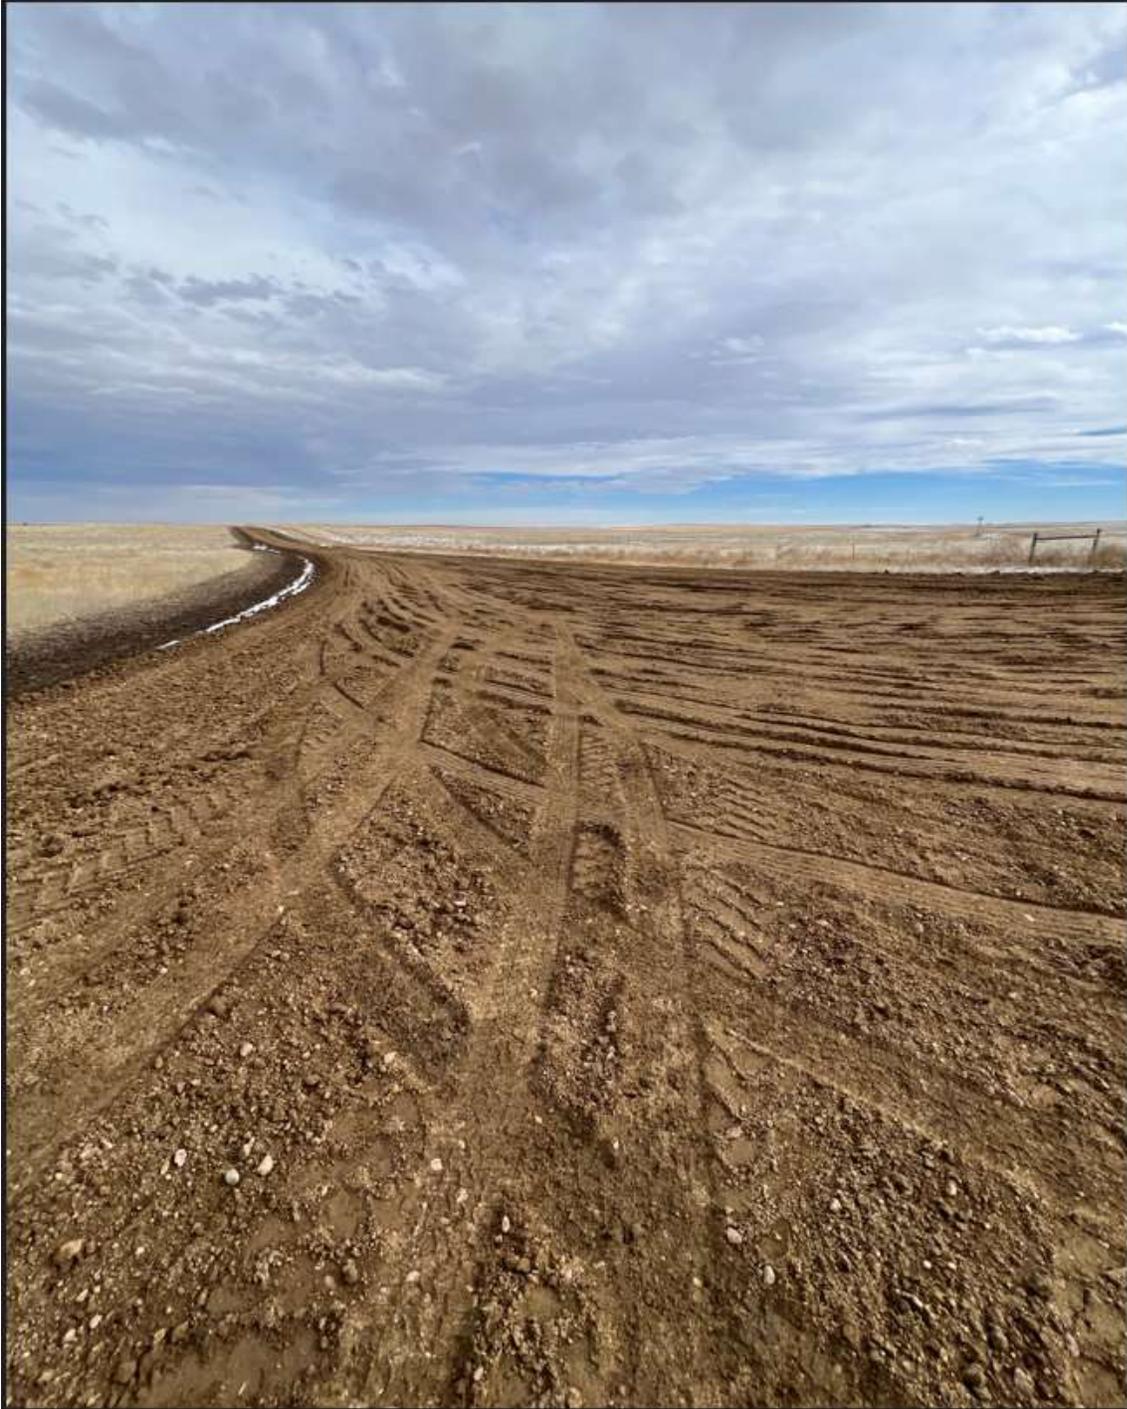
Photo 1. Taken from the start (west end) of the access road. Before the first inspection 3" of topsoil was stripped from the access road and pushed to the side to be used in the v-ditches and slopes of the road. After the first inspection an additional 3" of topsoil was stripped from the road and used to topsoil the cut slopes, fill slopes, berms, and detention pond on pad.

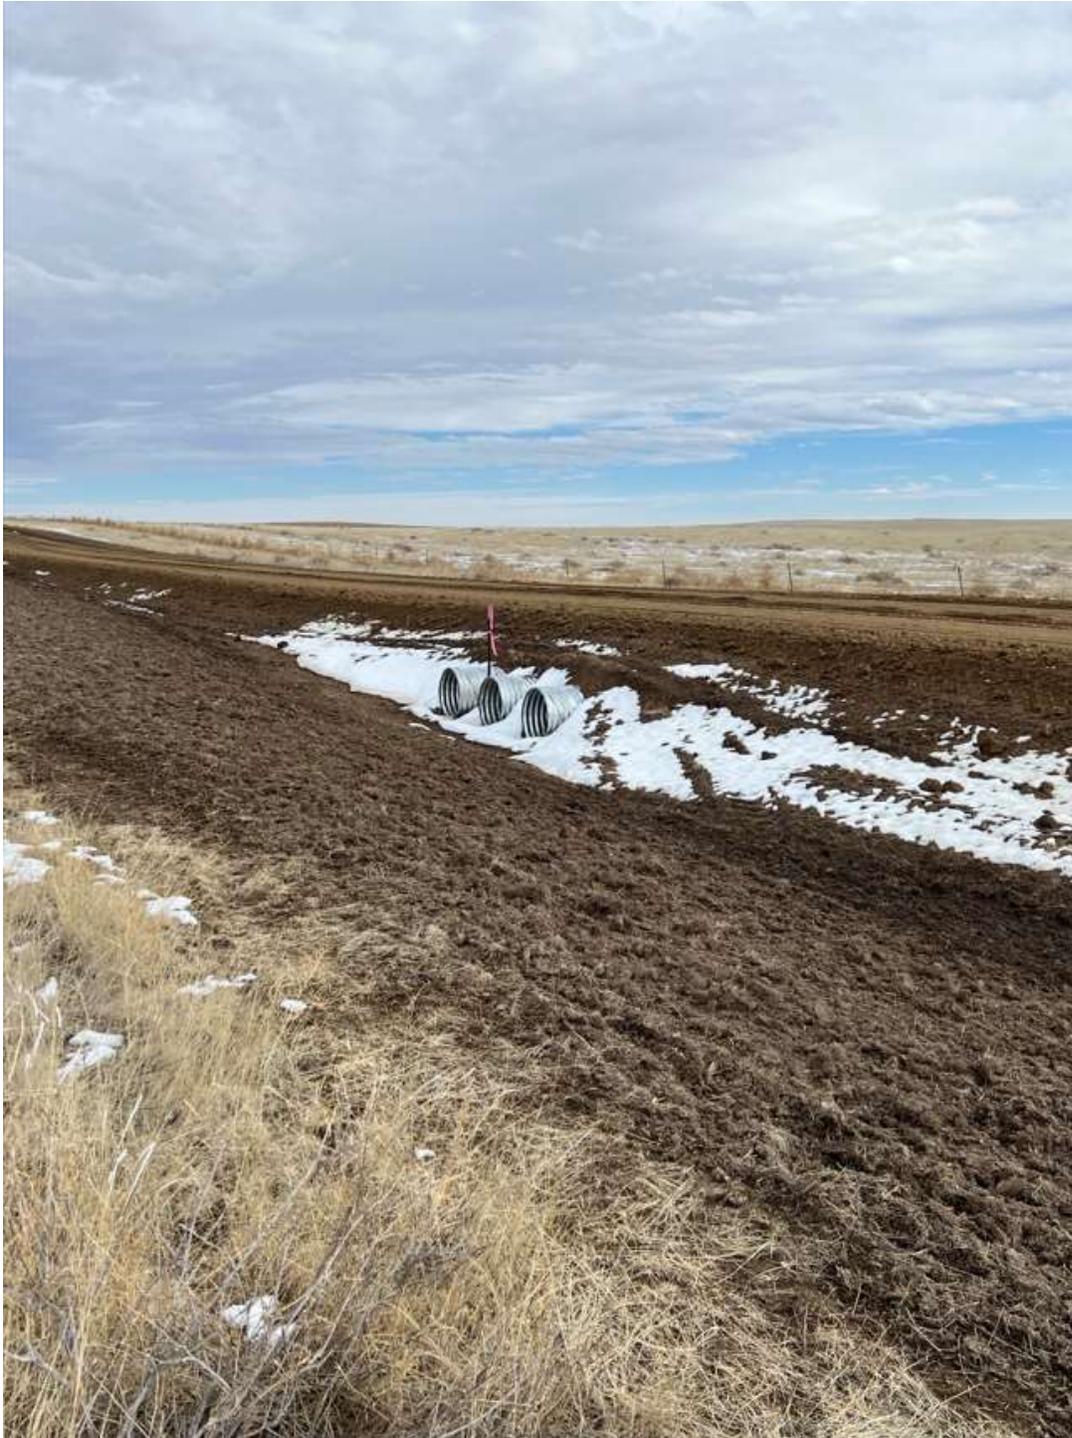
Photo 2. Taken near the west culvert crossing (north side). There was no further topsoil to salvage from this crossing, as we had already taken it out prior to setting culverts. Topsoil was not used as backfill for culverts. Excess fill material from pad was used as backfill.

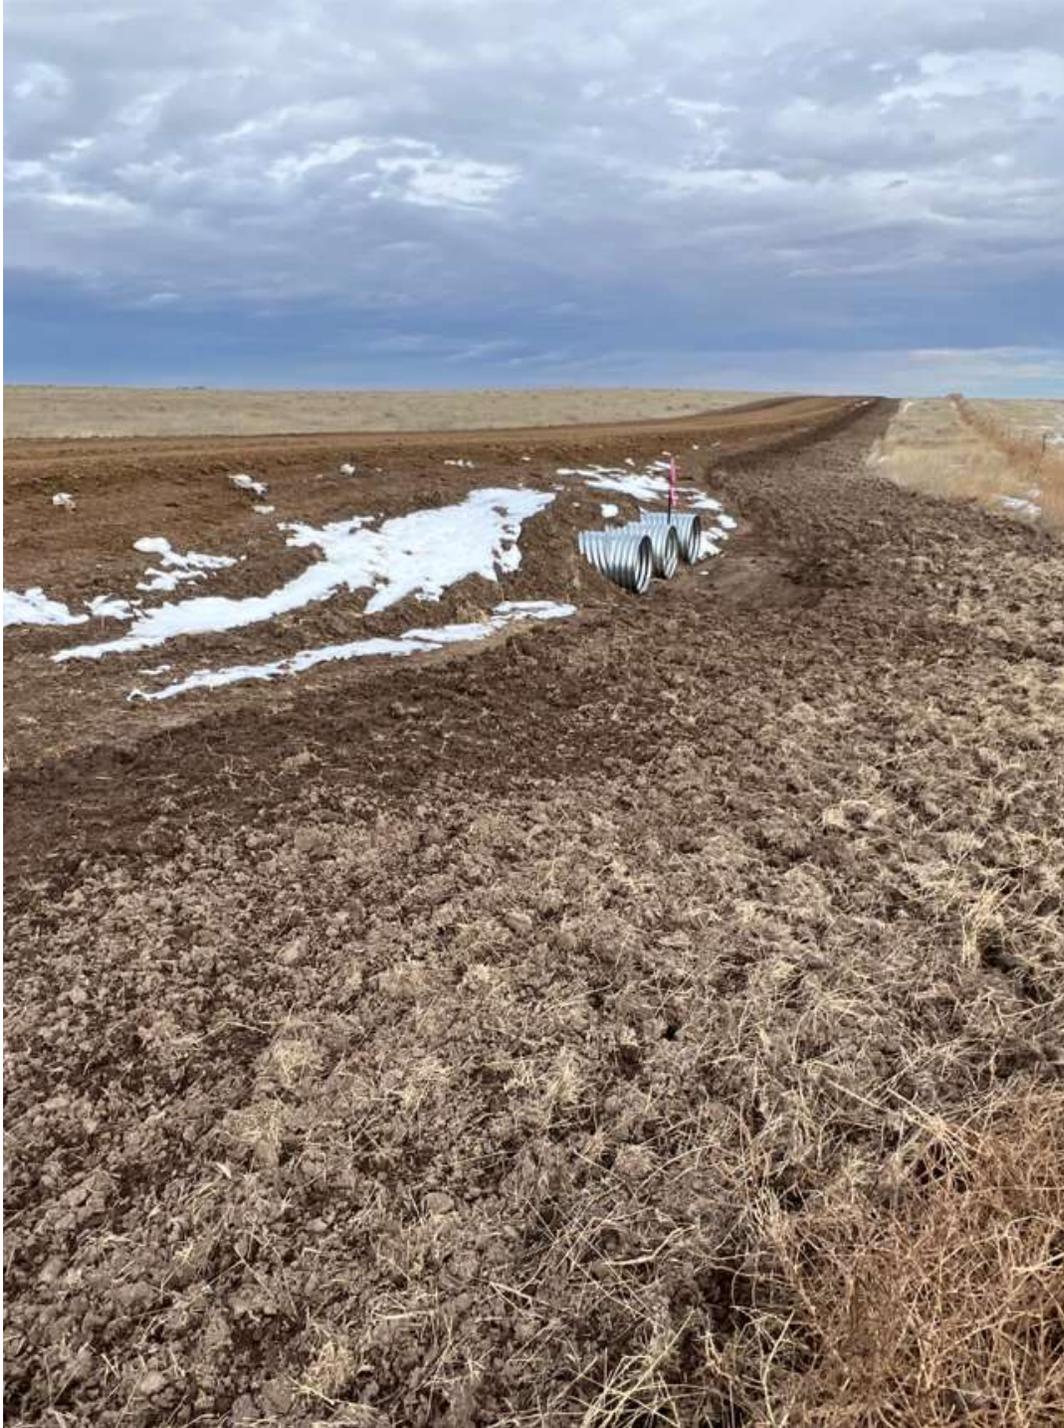
Photo 3. Taken near the west culvert crossing (south side). There was no further topsoil to salvage from this crossing, as we had already taken it out prior to setting culverts. Topsoil was not used as backfill for culverts. Excess fill material from pad was used as backfill.

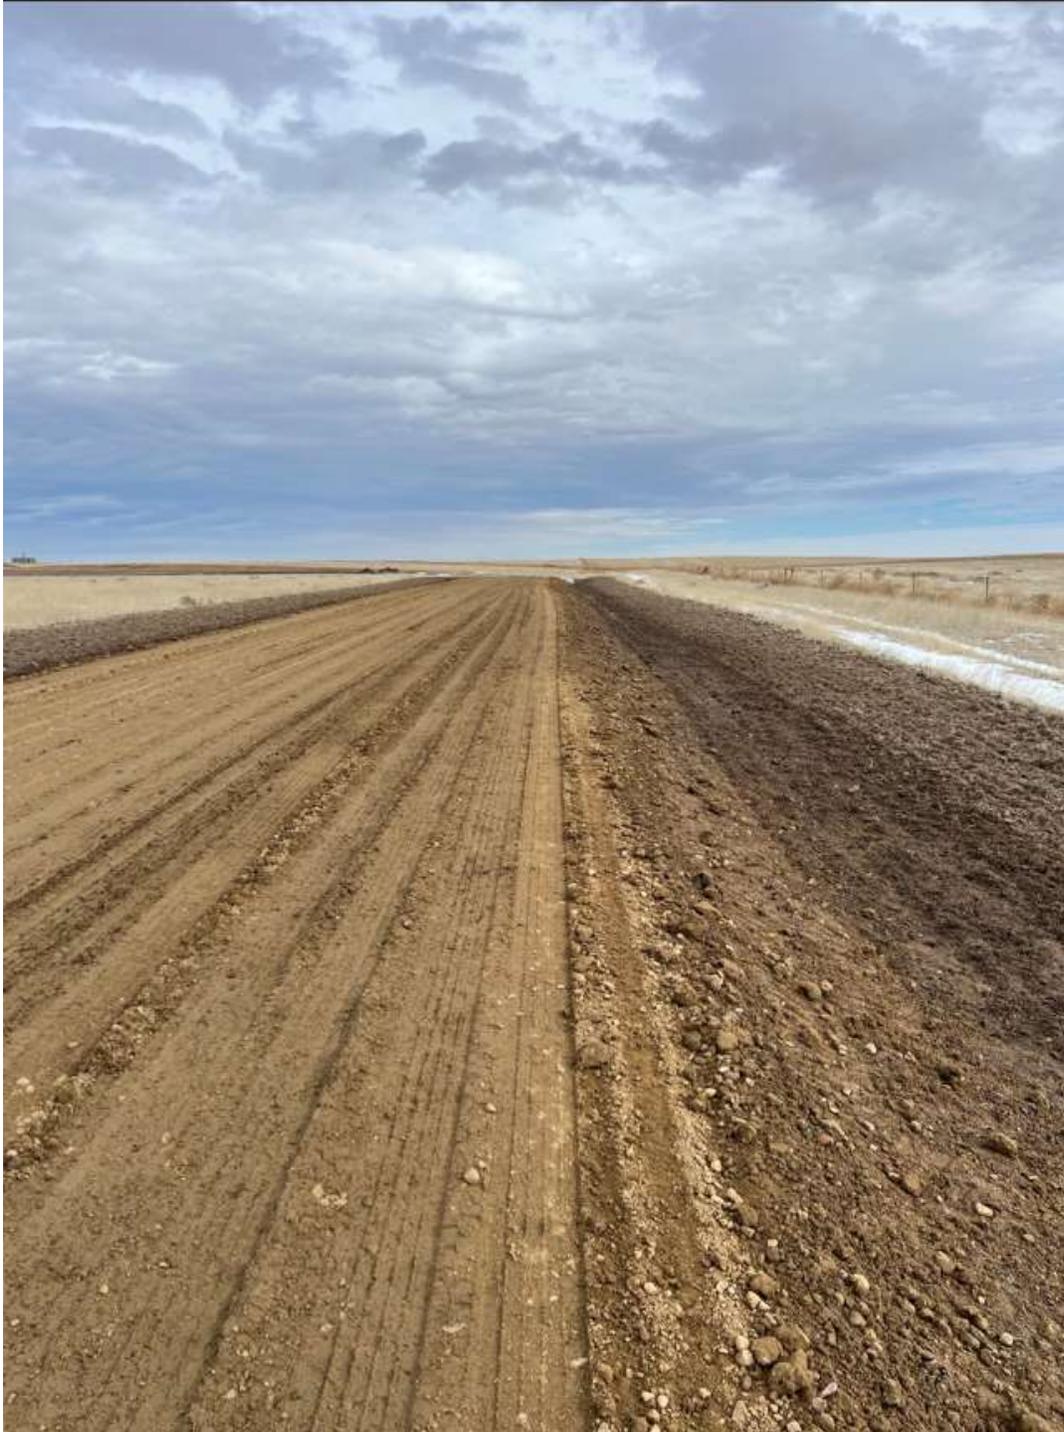
Photo 4. Taken from the middle portion (between the two culverts) of the access road. Before the first inspection 3" of topsoil was stripped from the access road and pushed to the side to be used in the v-ditches and slopes of the road. After the first inspection an additional 3" of topsoil was stripped from the road and used to topsoil the cut slopes, fill slopes, berms, and detention pond on pad.

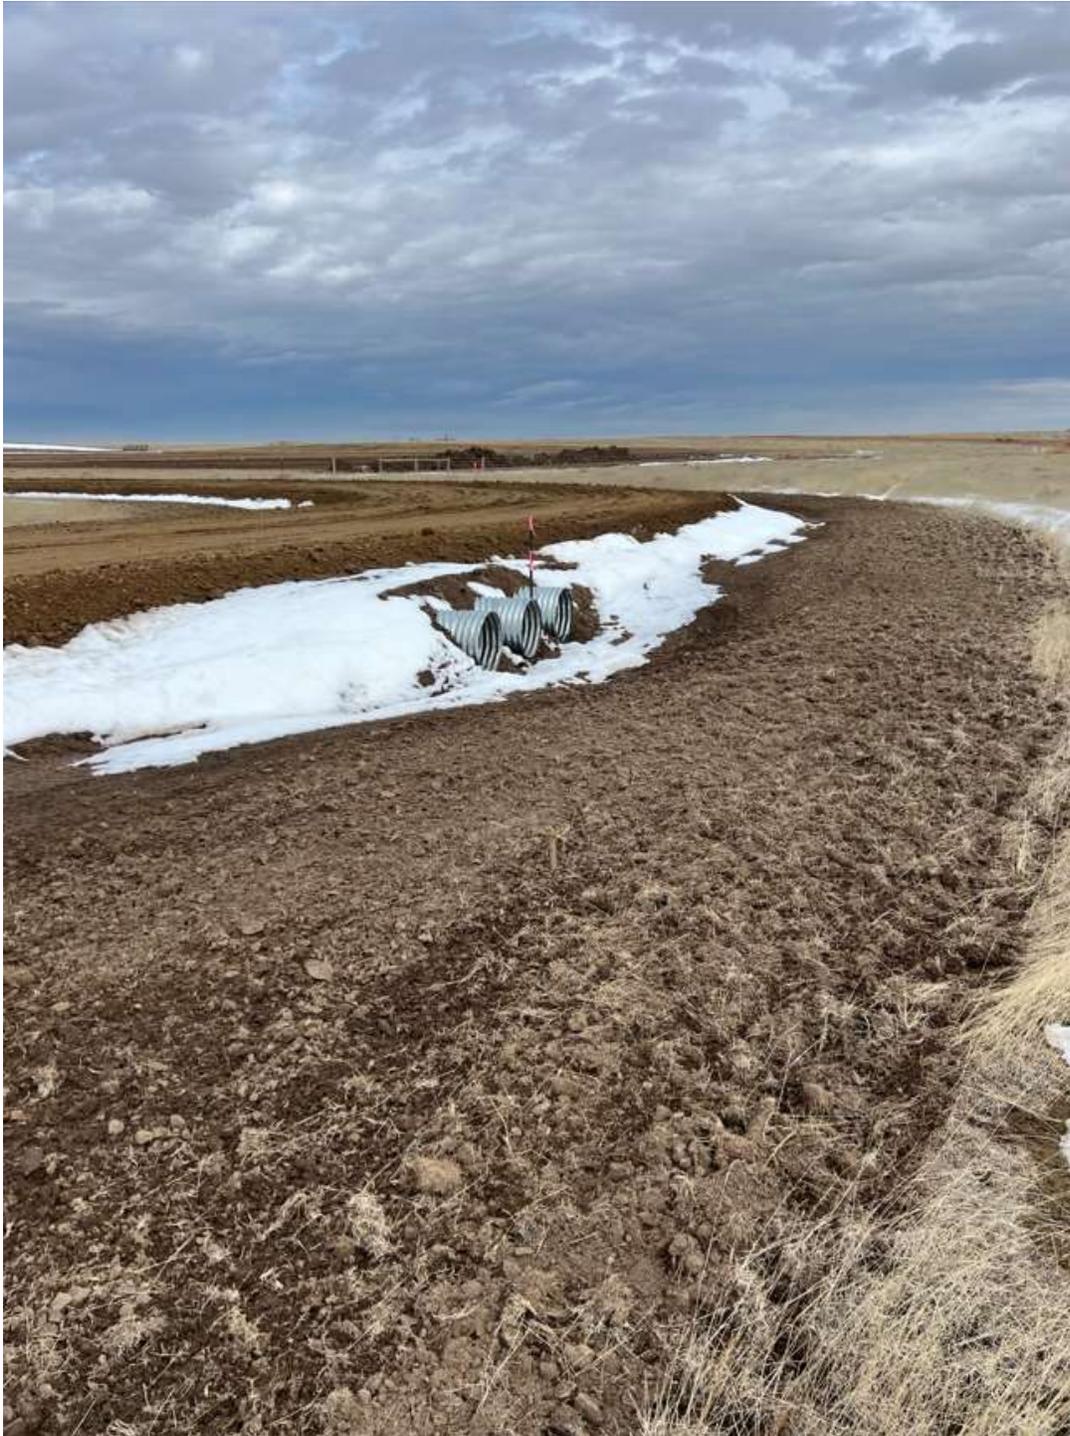
Photo 5. Taken near the east culvert crossing (south side). There was no further topsoil to salvage from this crossing, as we had already taken it out prior to setting culverts. Topsoil was not used as backfill for culverts. Excess fill material from pad was used as backfill.

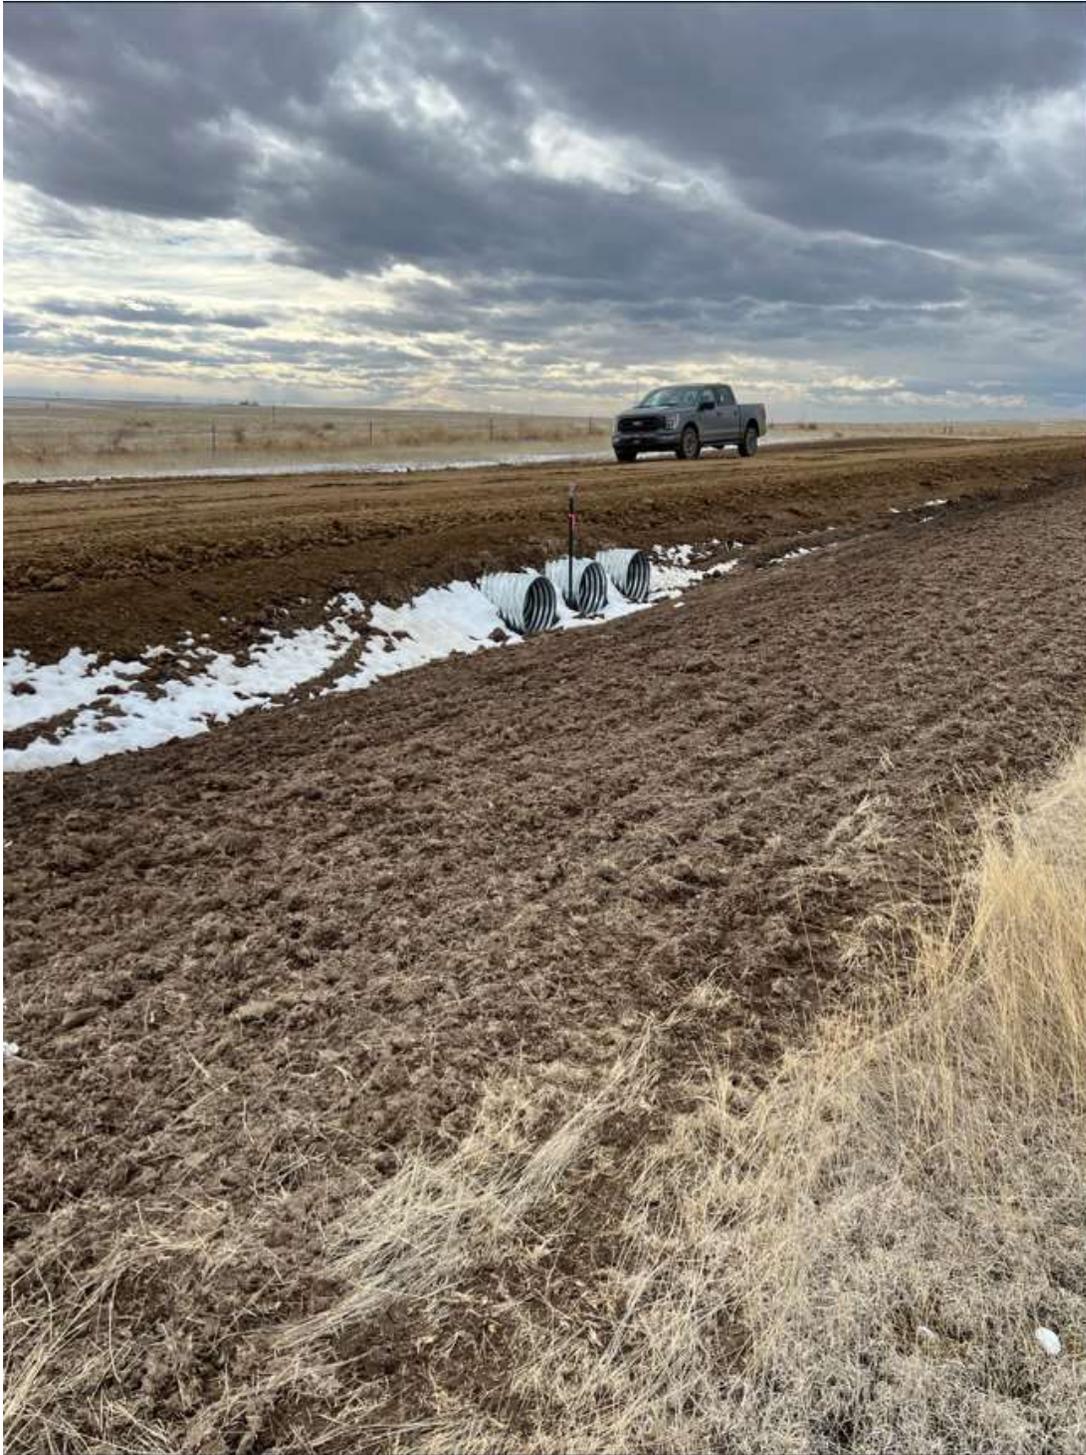
Photo 6. Taken near the west culvert crossing (north side). There was no further topsoil to salvage from this crossing, as we had already taken it out prior to setting culverts. Topsoil was not used as backfill for culverts. Excess fill material from pad was used as backfill.

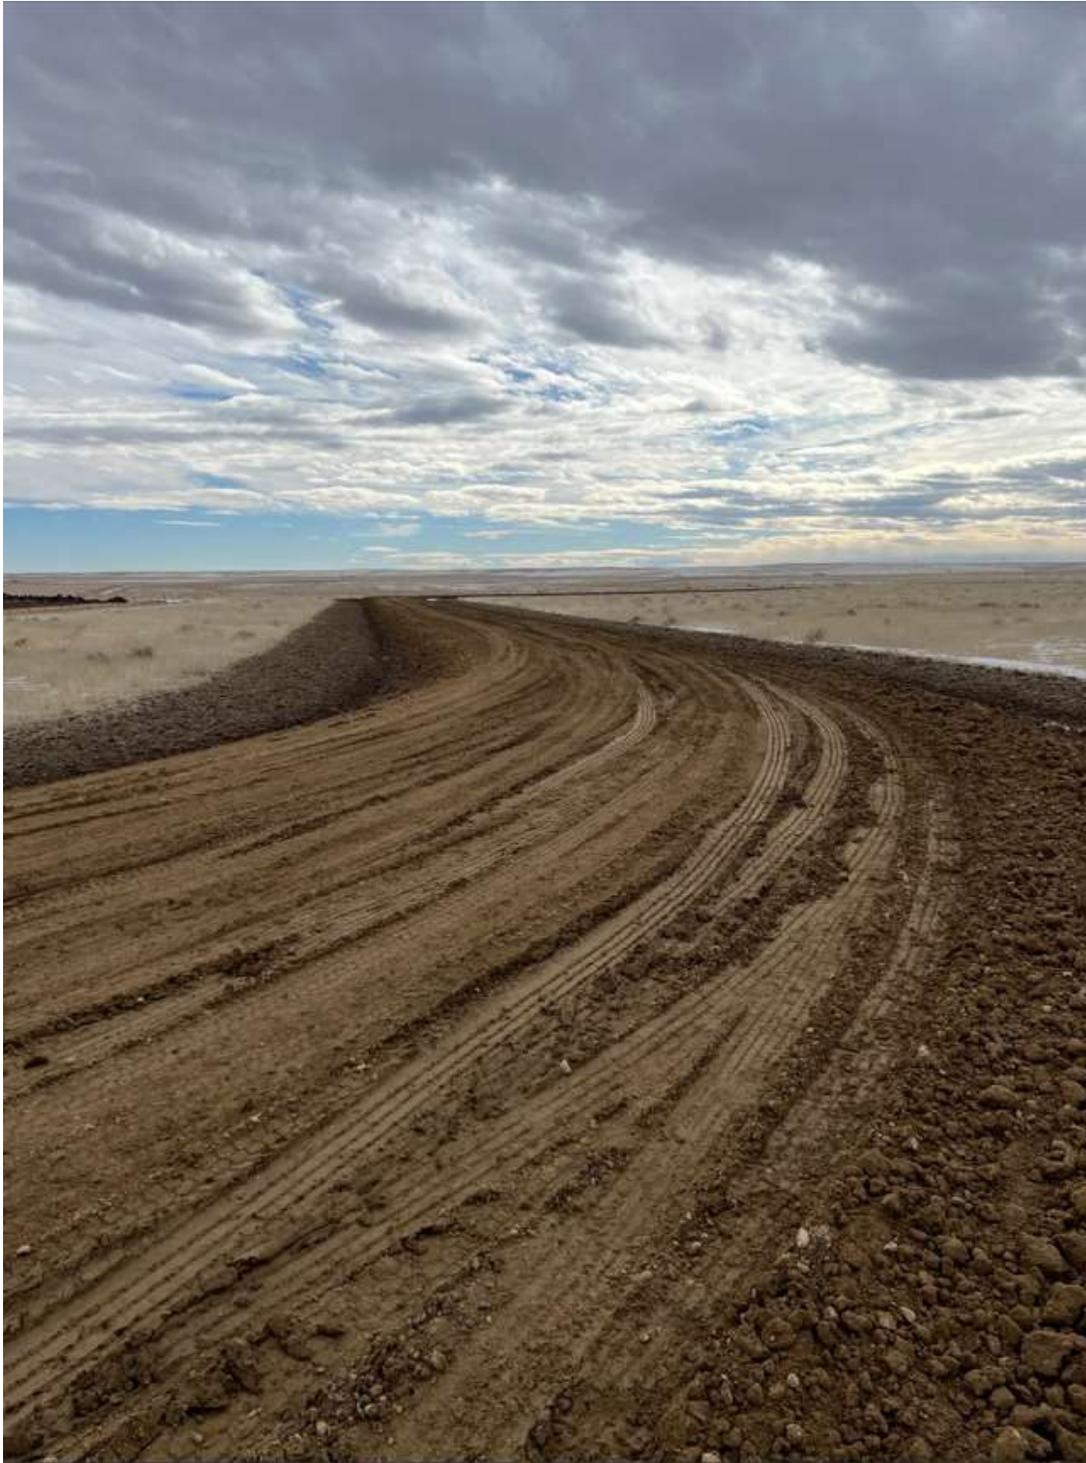
Photo 7. Taken near the entrance to the drilling pad and the access road. Before the first inspection 3" of topsoil was stripped from the access road and pushed to the side to be used in the v-ditches and slopes of the road. After the first inspection an additional 3" of topsoil was stripped from the road and used to topsoil the cut slopes, fill slopes, berms, and detention pond on pad.

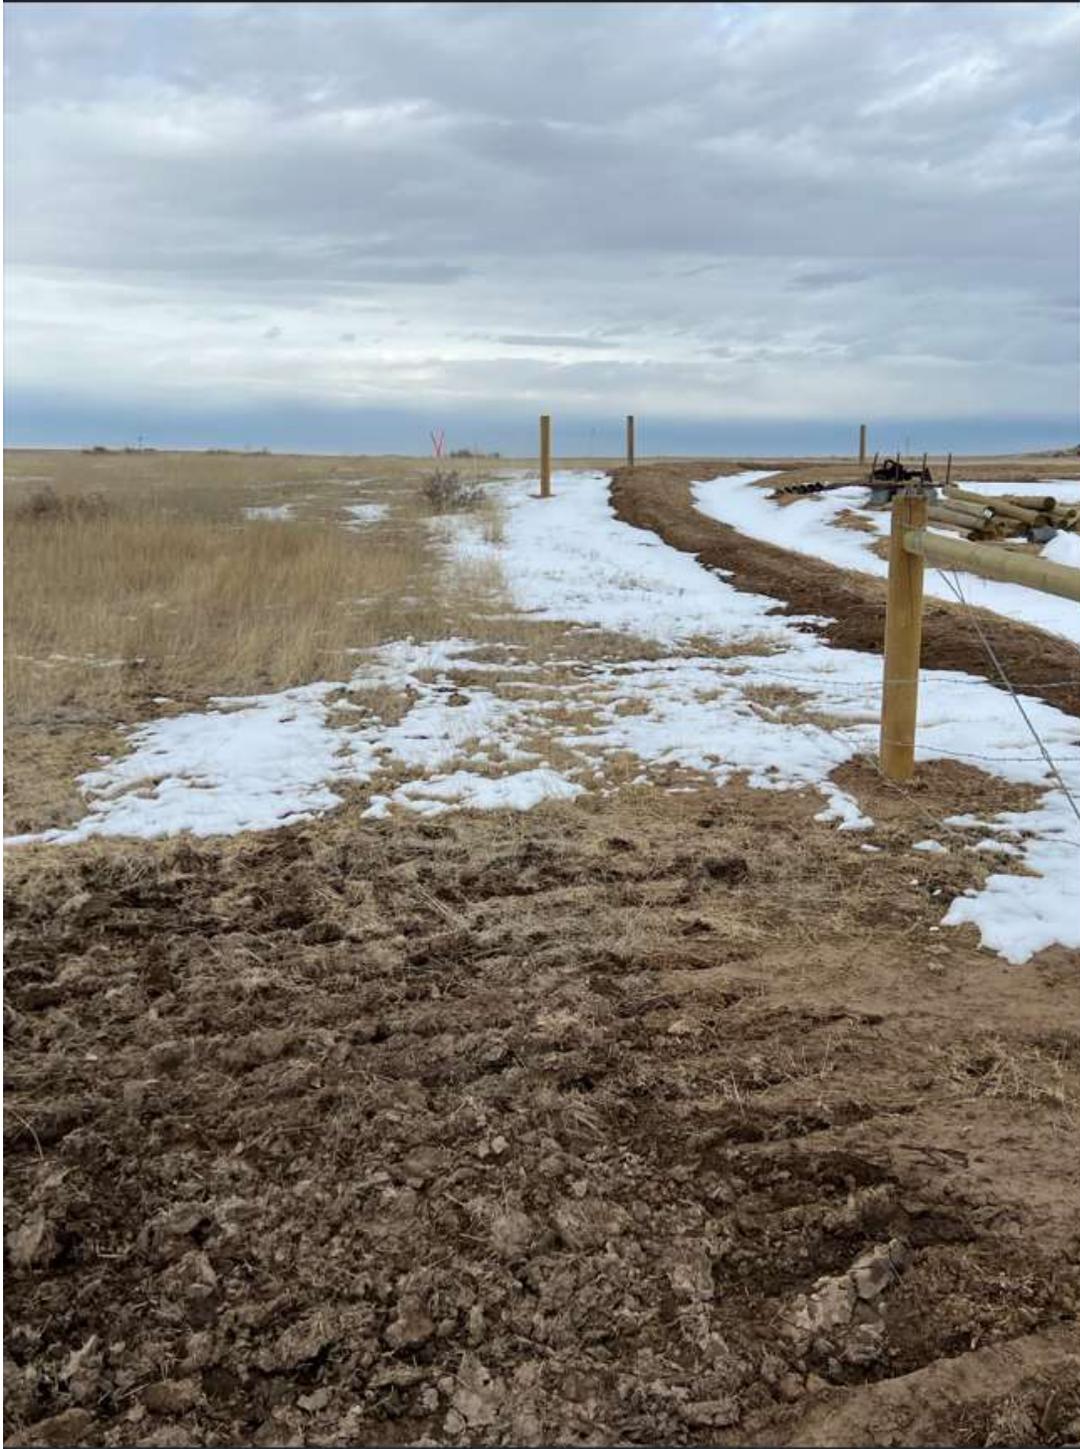
Photo 8. Taken near the location entrance. Trash was removed throughout the location.

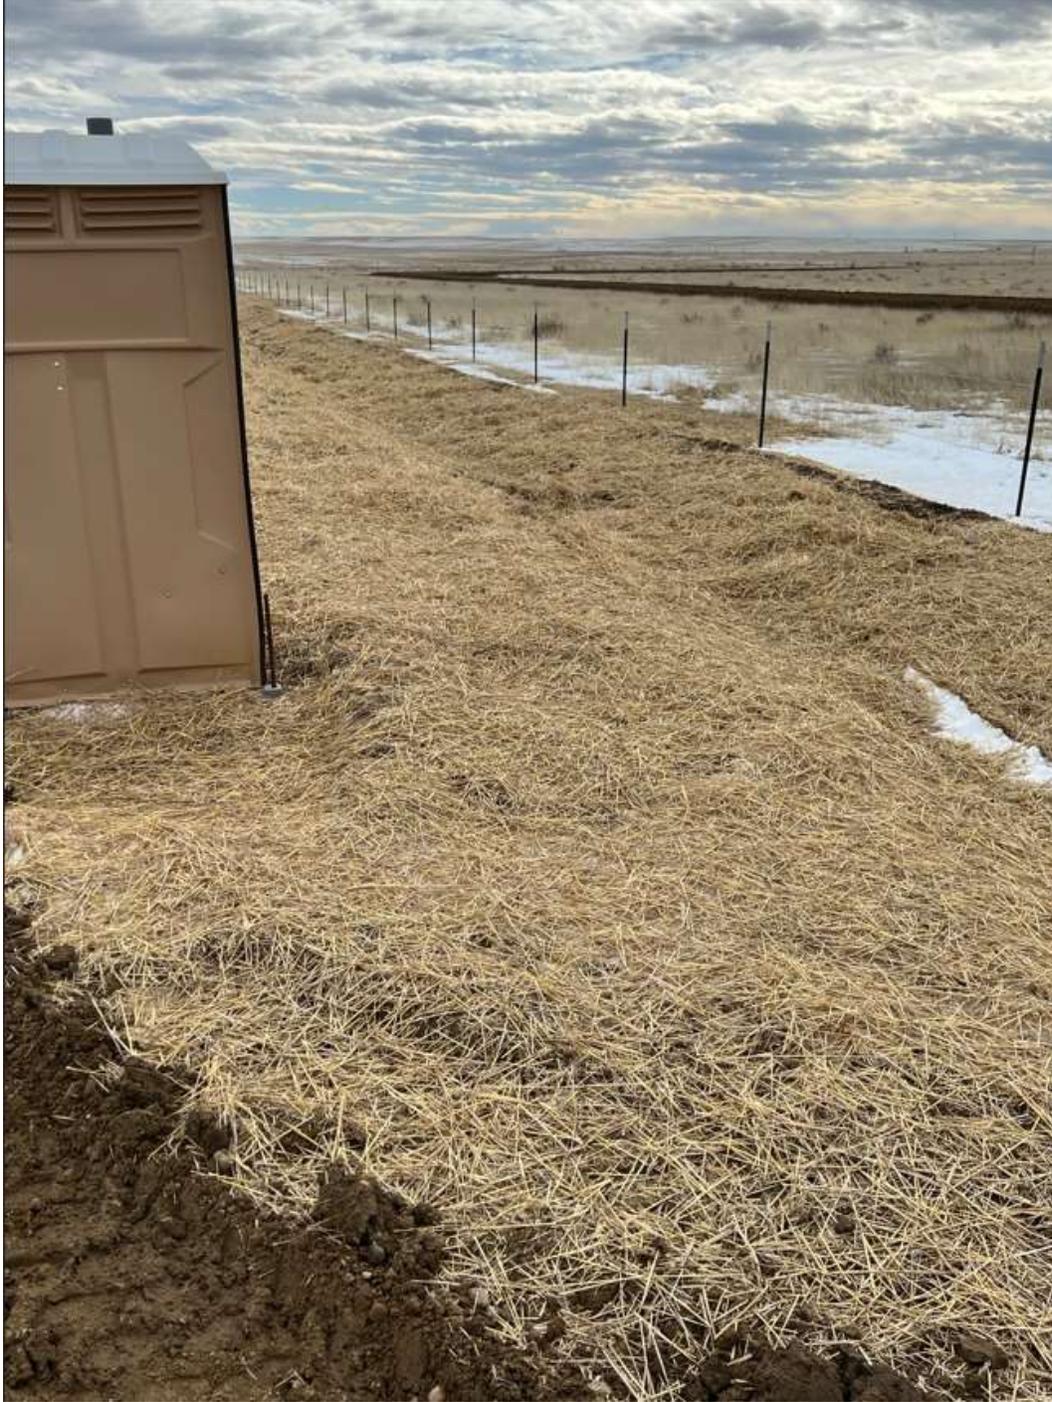
Photo 9. 5 gallon bucket of oil has been removed.

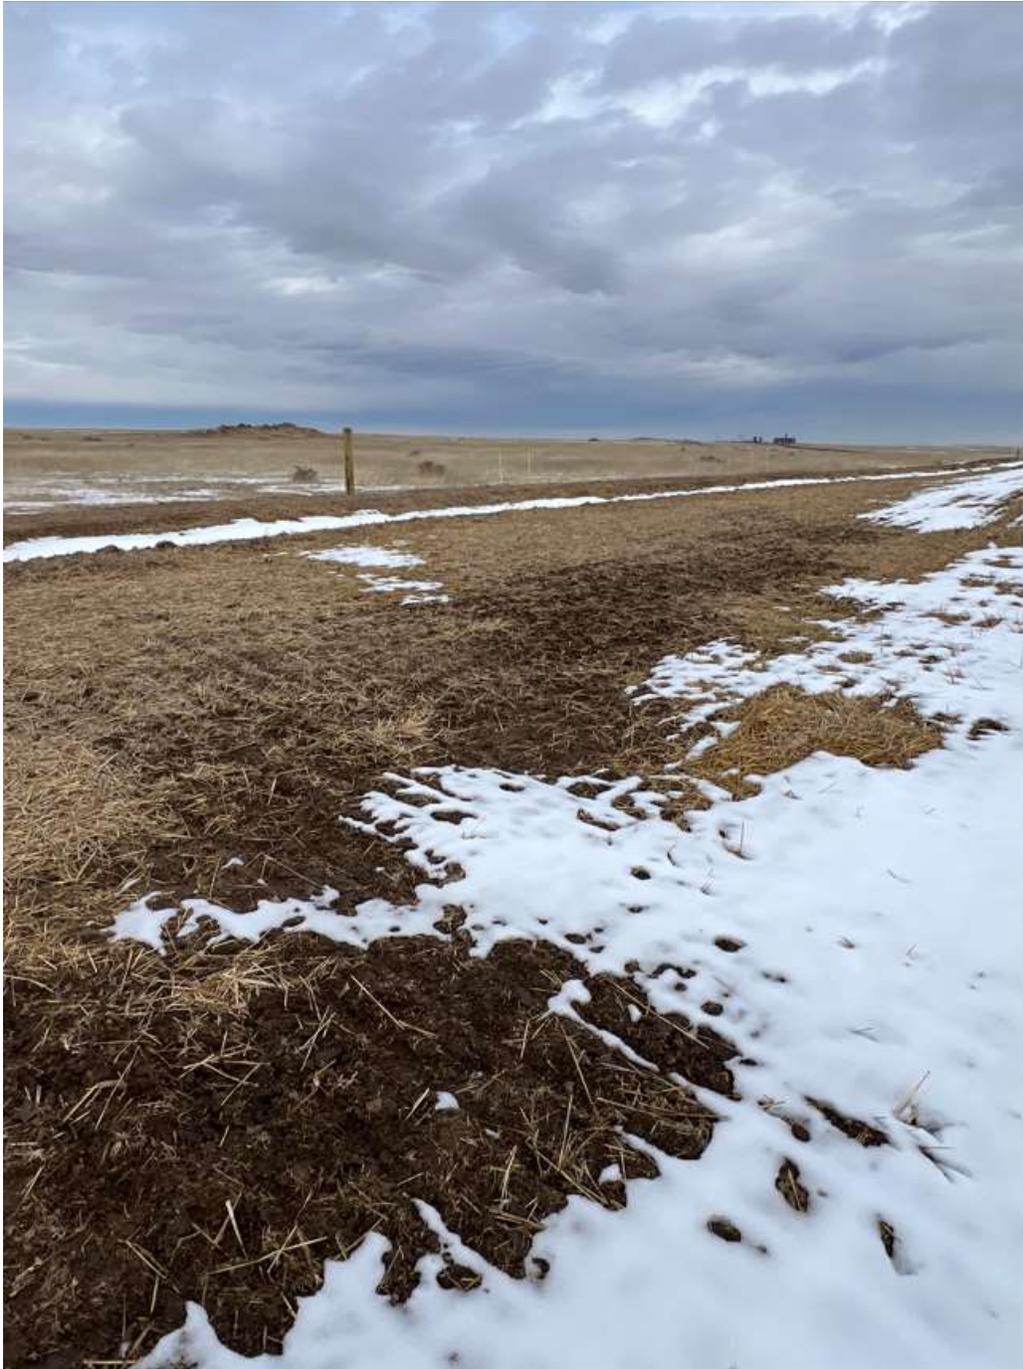
Photo 10. Trash was removed near the northwest corner of the location.

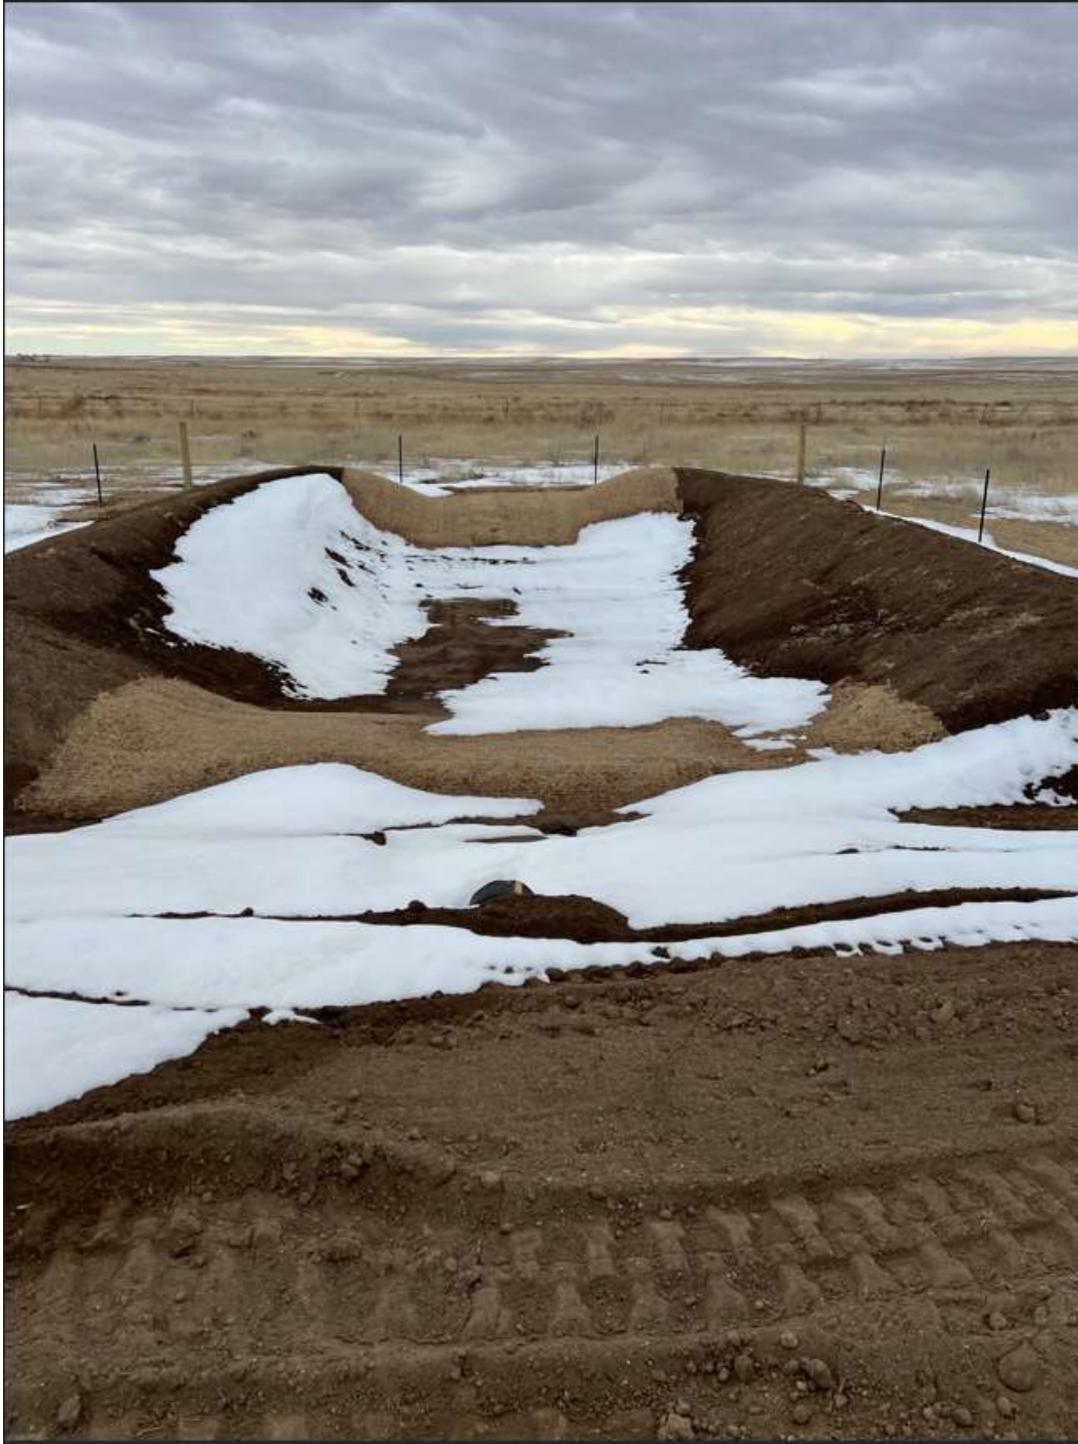
Photo 13. Northeast sediment trap is still under construction. Will be completed once weather permits.

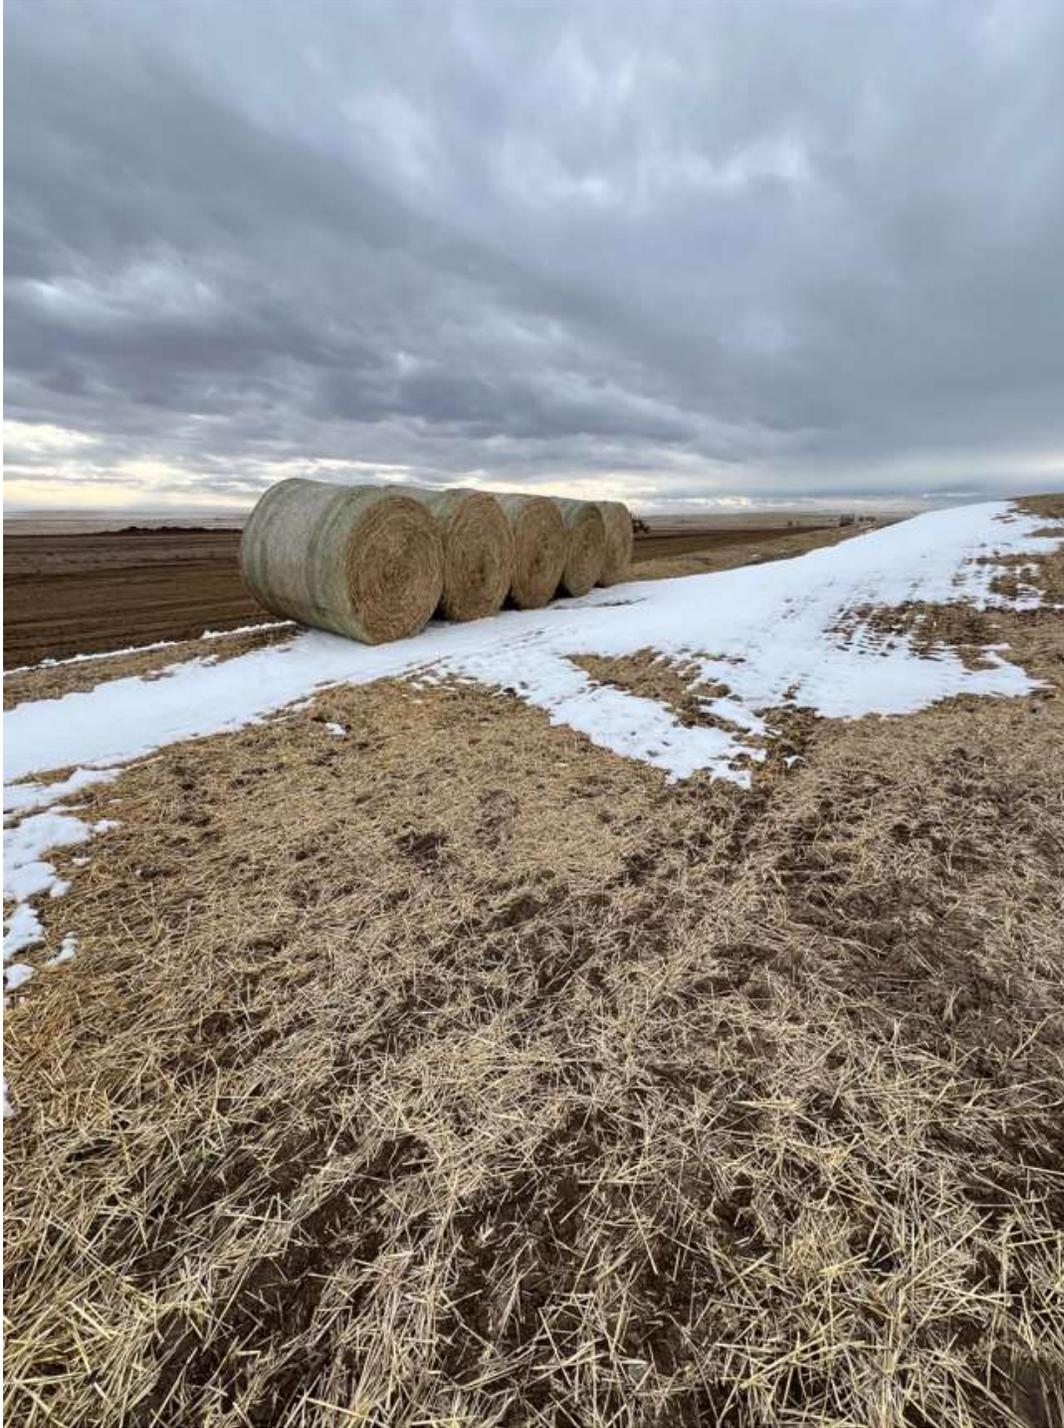
Photo 14. Trash located on the eastern side of the topsoil stockpile has been removed.

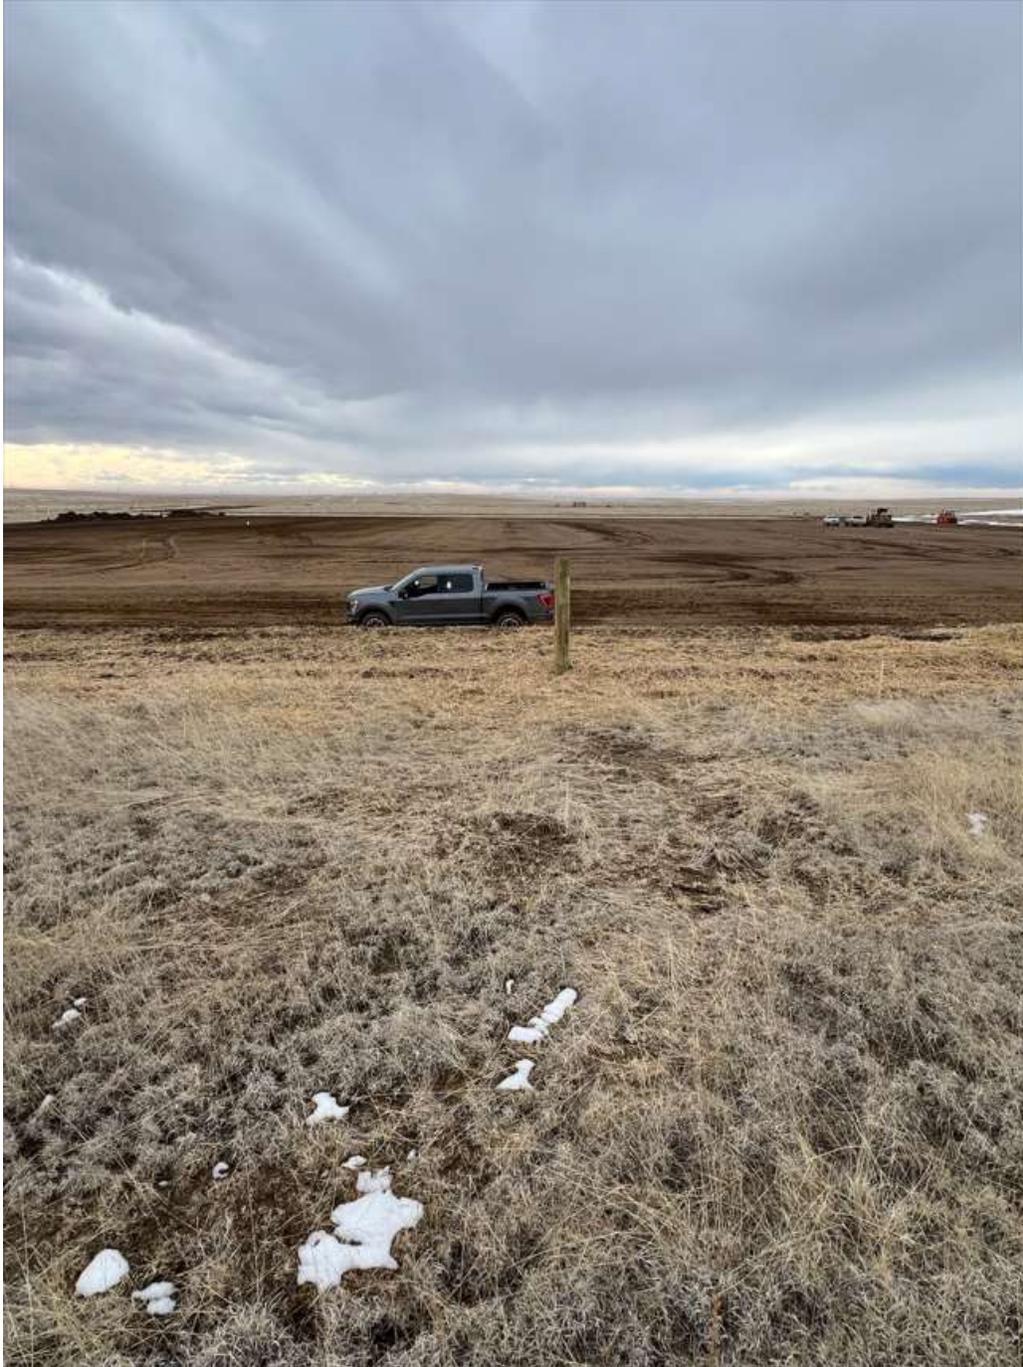
Photo 16. East side of location. Bands/clips from t-post bundles were removed throughout the perimeter of the location.

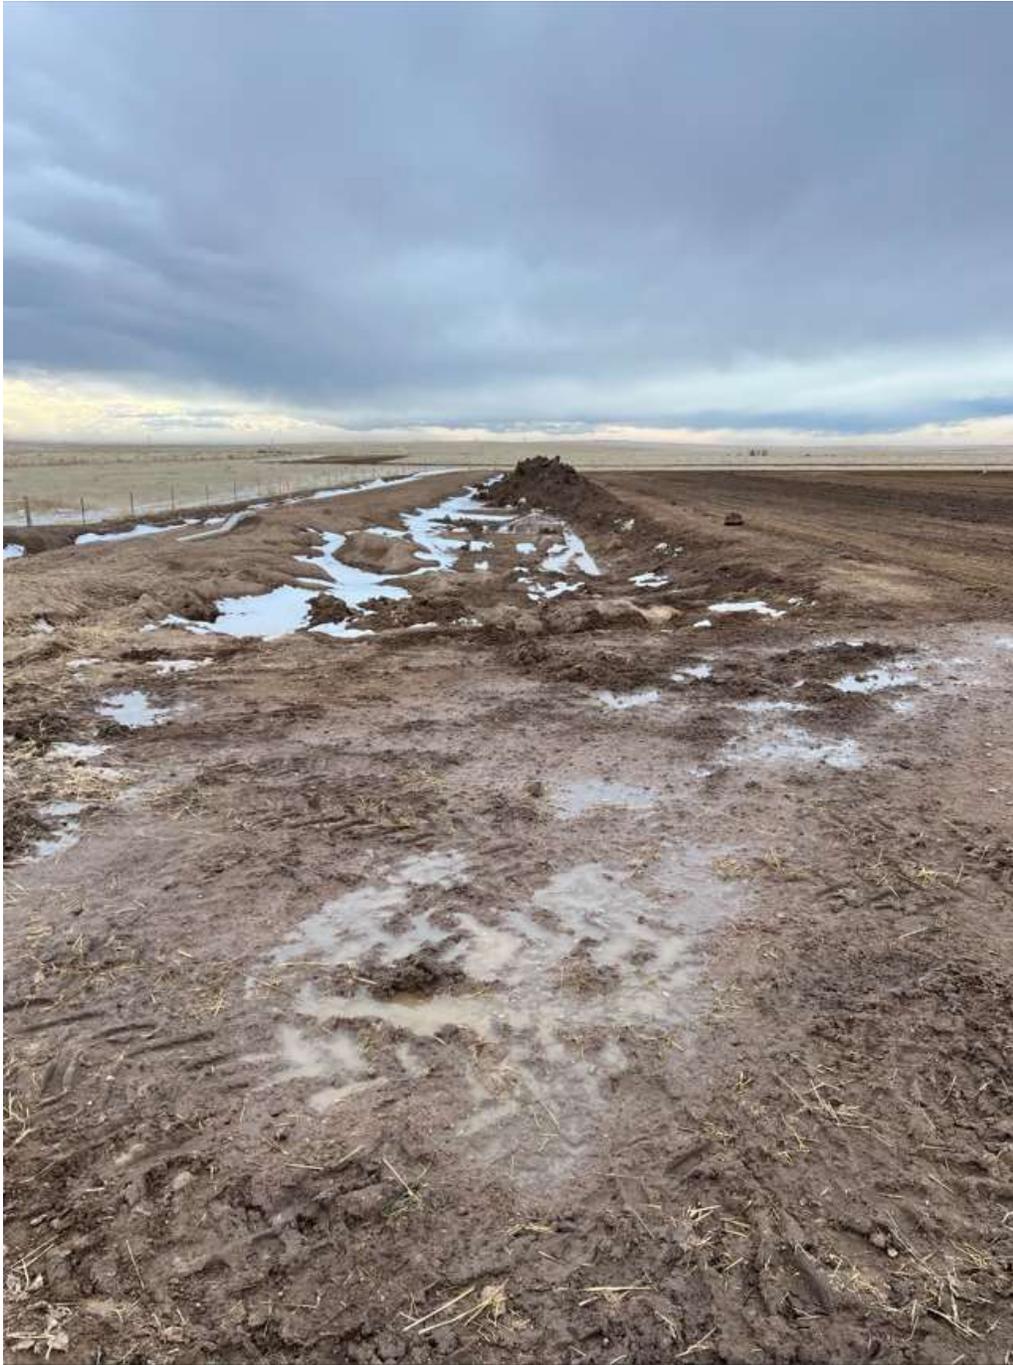
Photo 17. Erosion degradation has been fixed near the southern sediment trap.

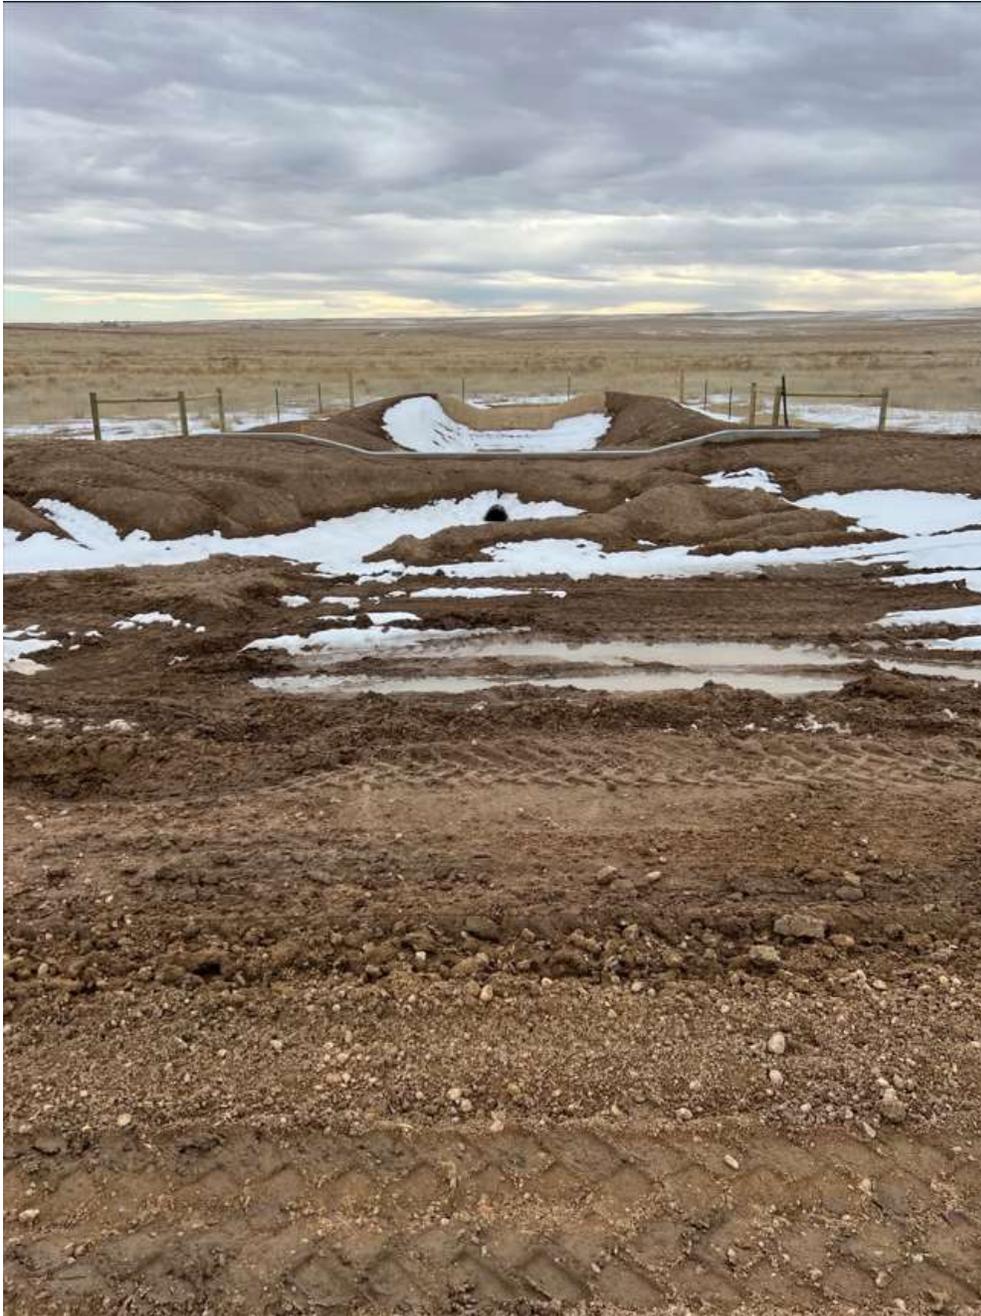
Photo 18. Erosion degradation has been fixed near the southern sediment trap. The southern sediment trap is still being constructed and will be completed once weather permits.
