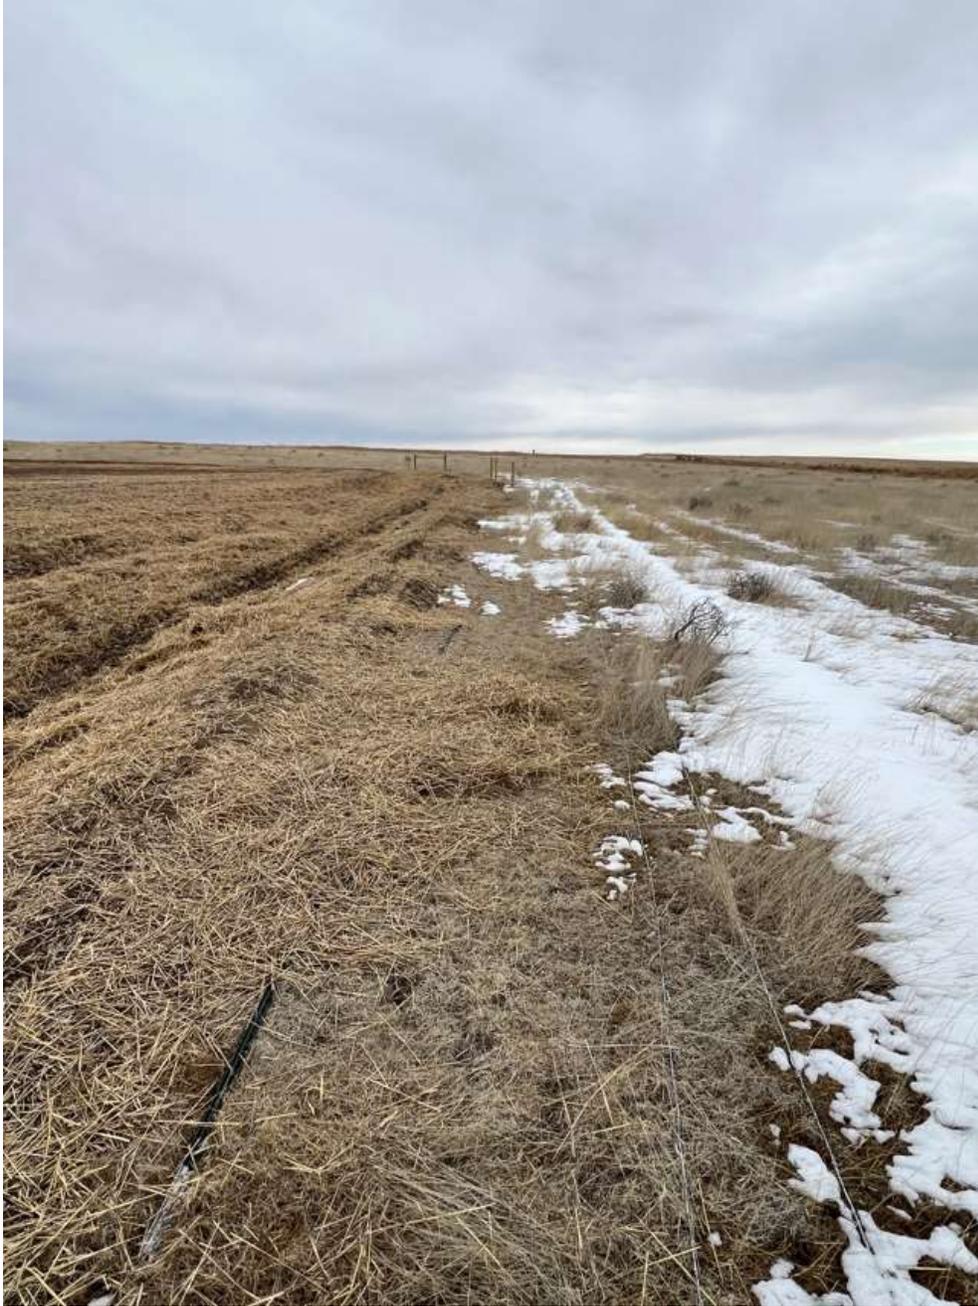
Photo 20. South side of location. Bands/clips from t-post bundles were removed throughout the perimeter of the location.

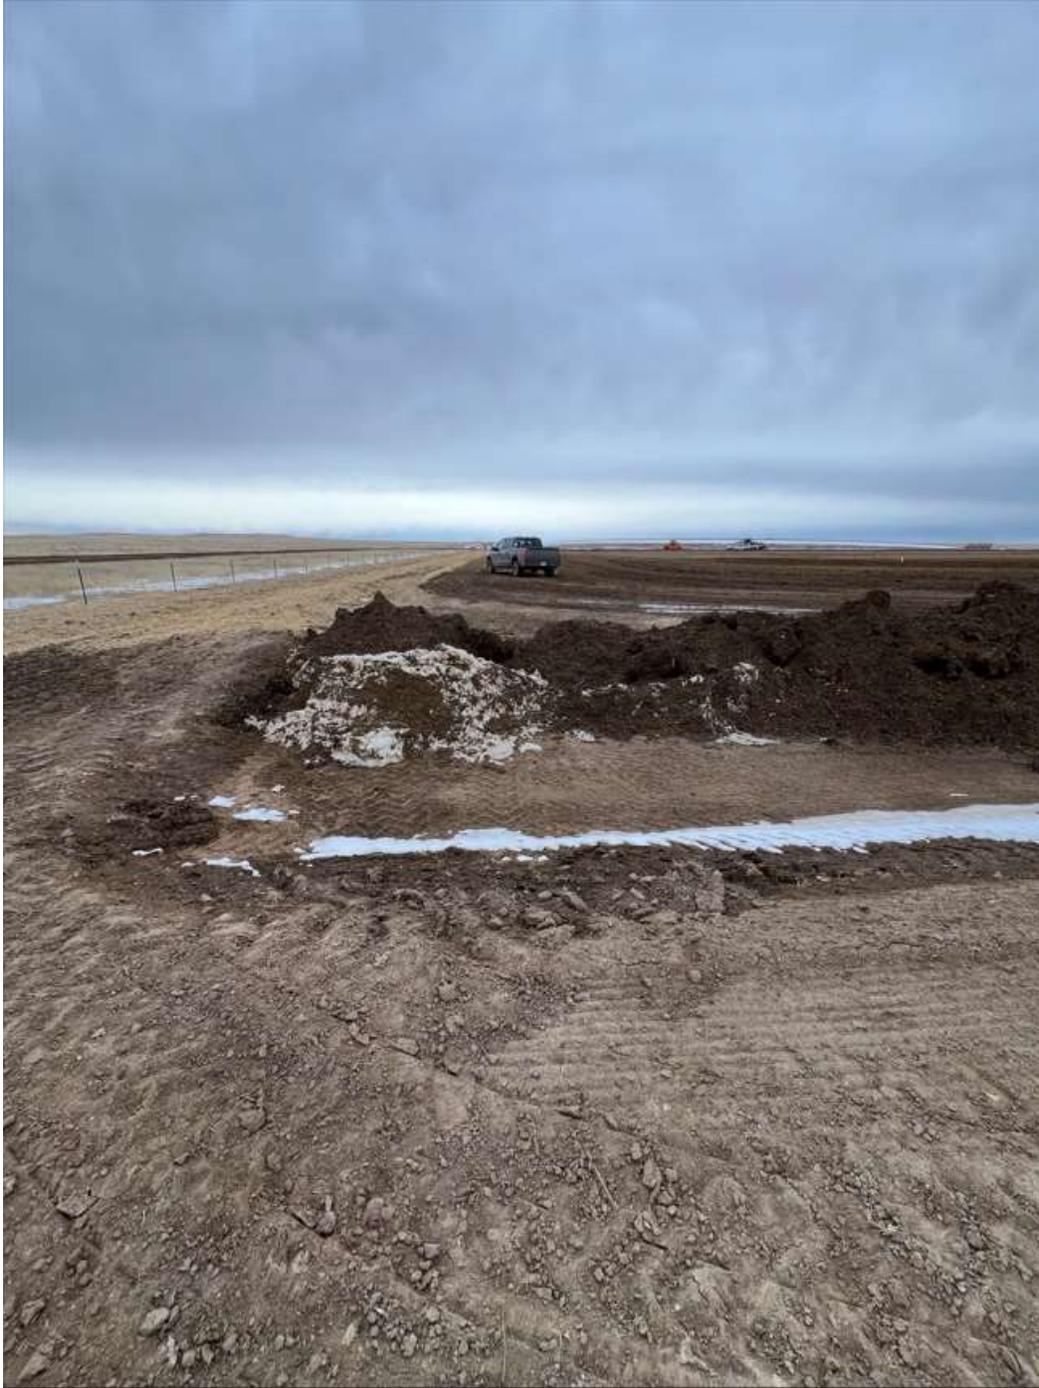
Photo 21. Erosion degradation has been fixed in the southwest corner of the drilling pad.

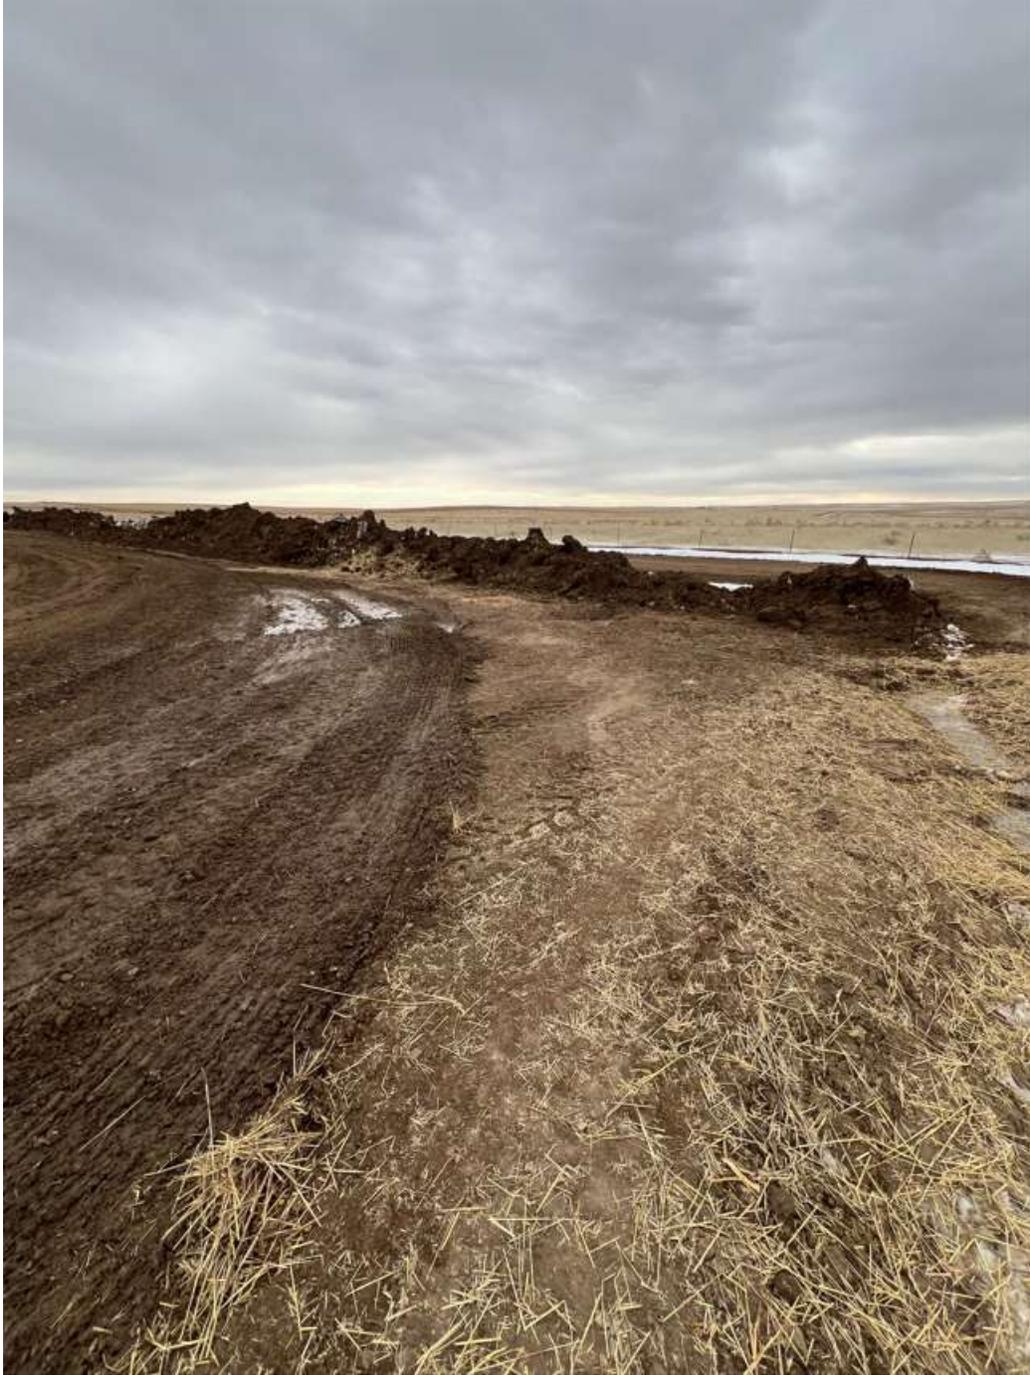
Photo 22. Erosion degradation and sediment transport has been fixed in the southwest corner of the drilling pad.

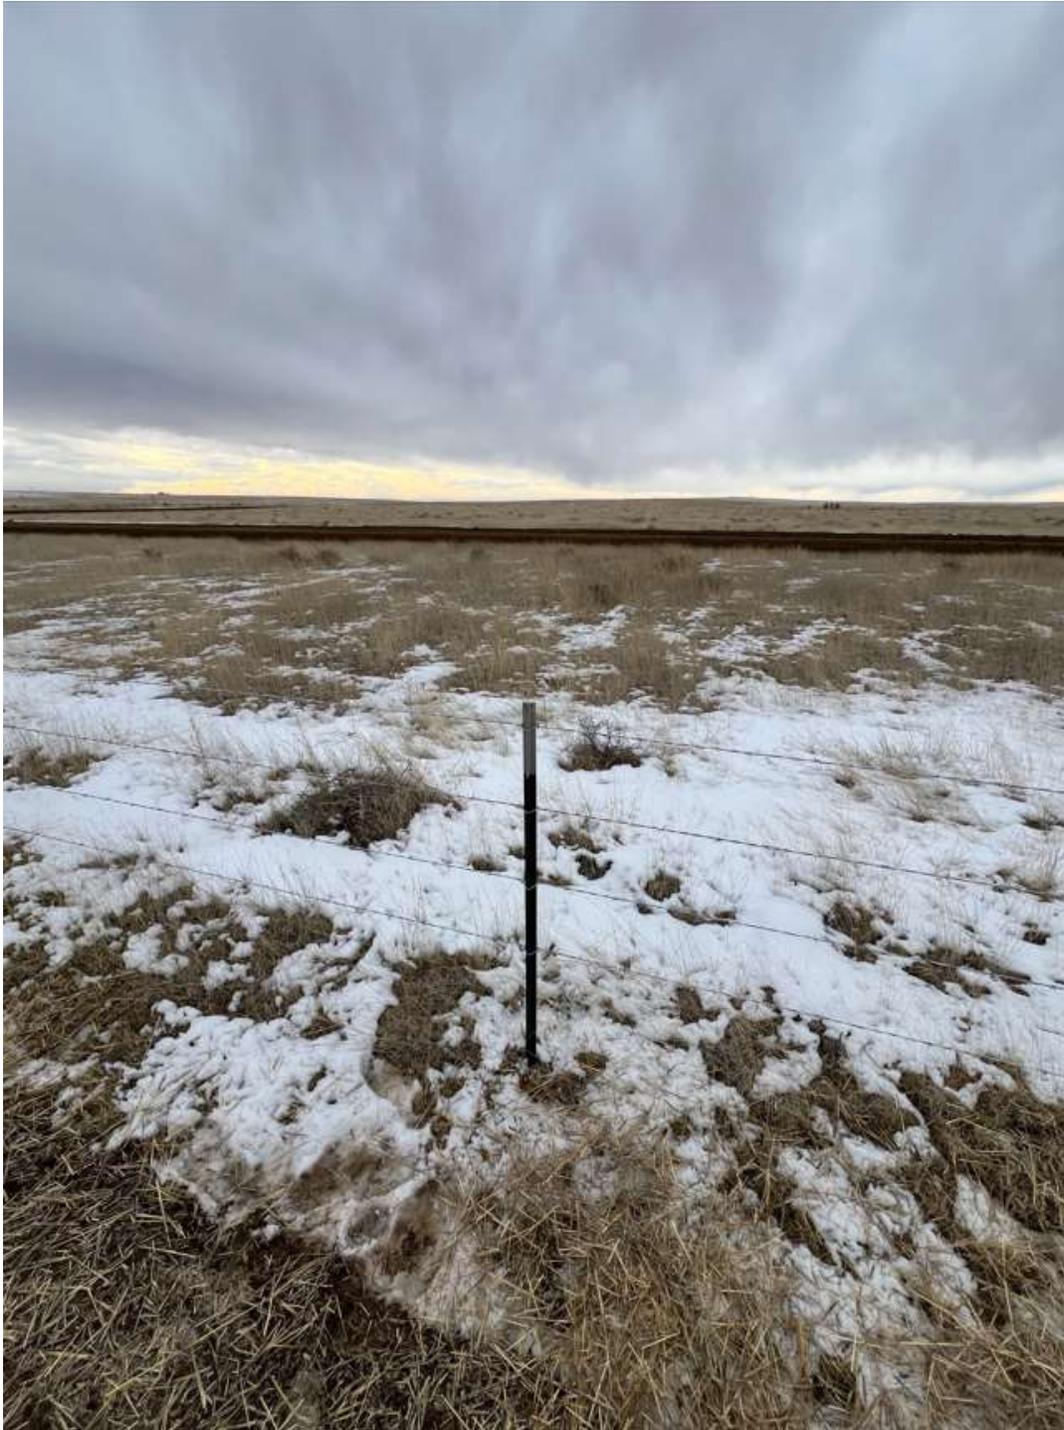
Photo 23. West side of location. Trash from fence construction has been removed throughout the perimeter of the location.
