Interim Reclamation and Stormwater Inspection

Date: 02/22/2024

Operator: PDC ENERGY INC - 69175

Location ID: 429507

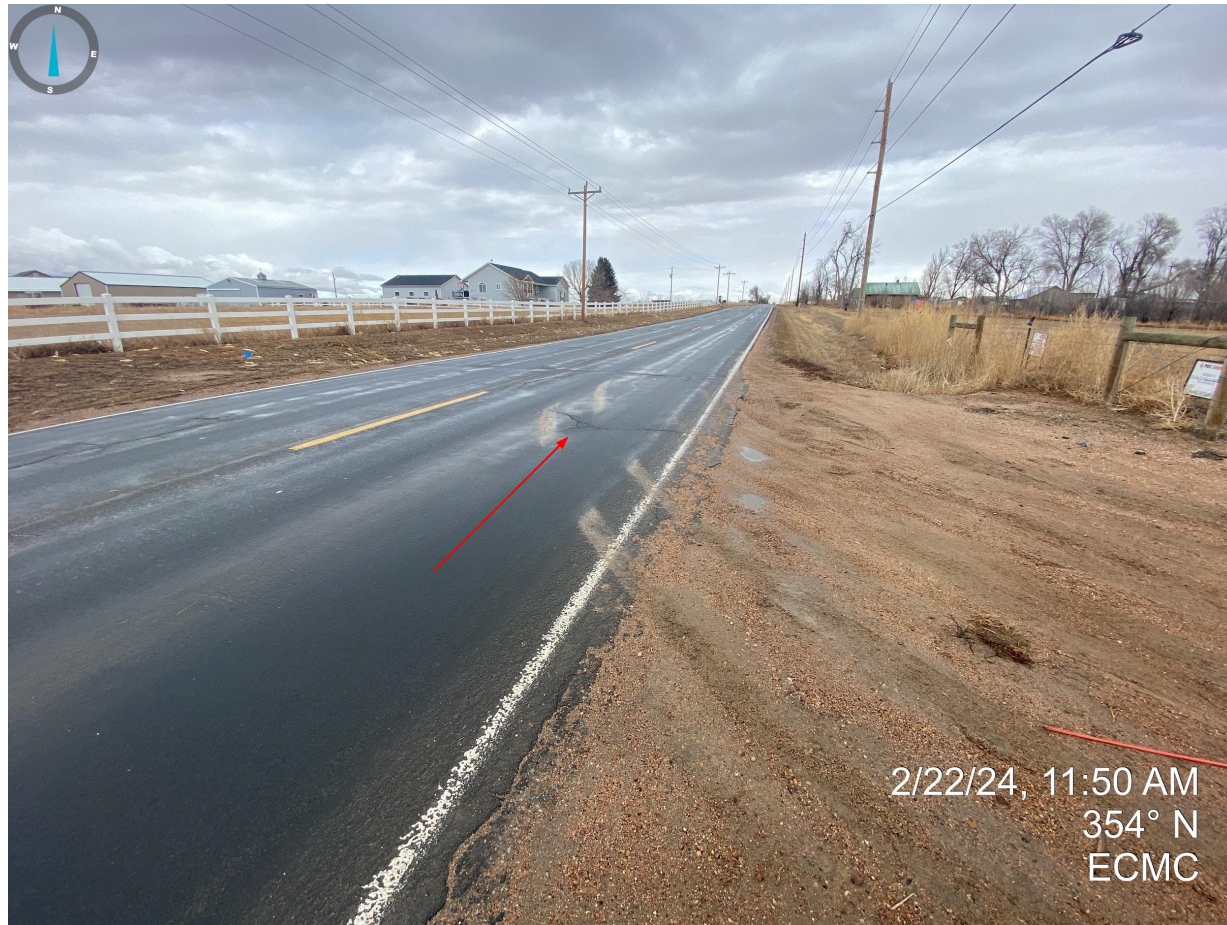
Photo 1. Taken from the location entrance; vehicle track out observed on County Road 19 (north bound lane).

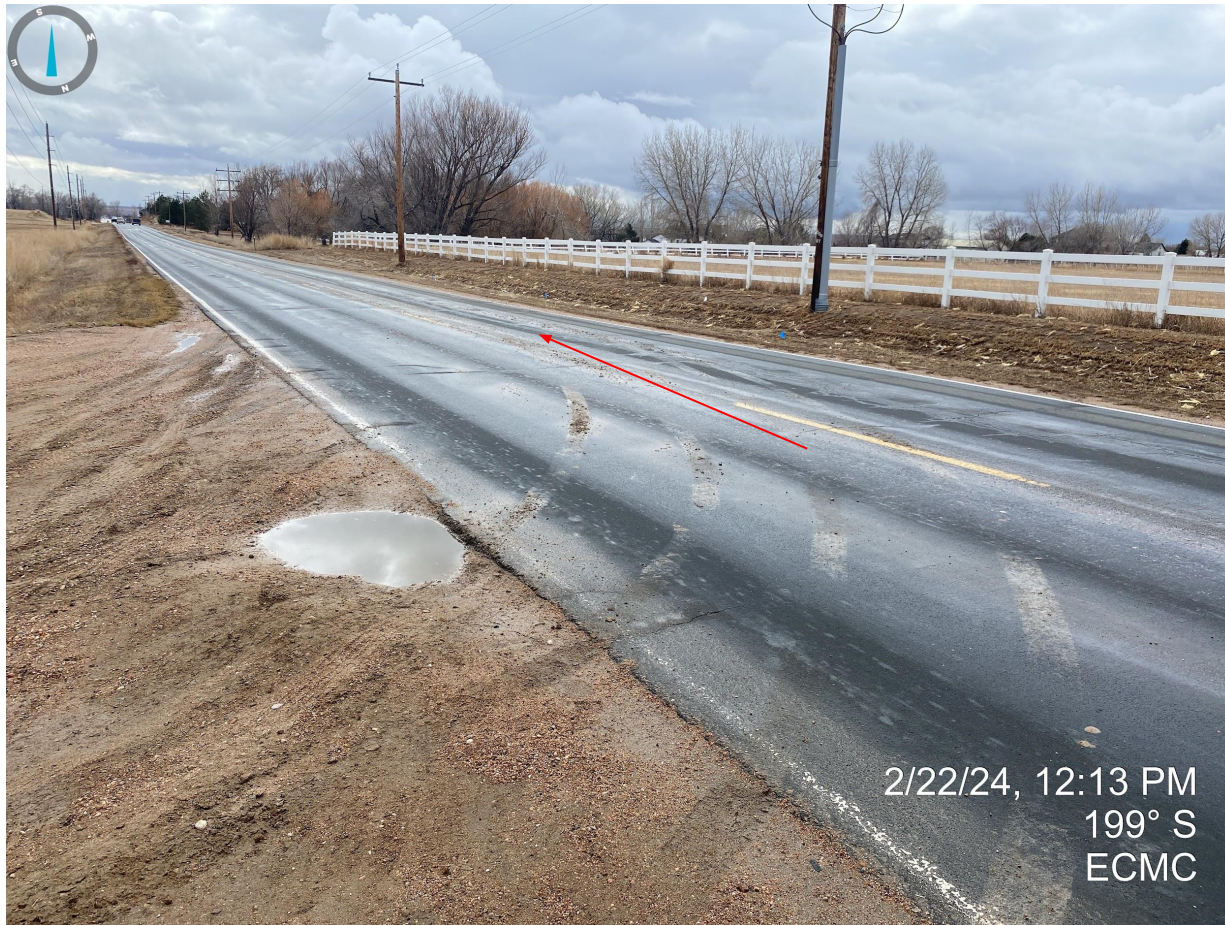
Photo 2. Taken from the location entrance; vehicle track out observed on County Road 19 (south bound lane).

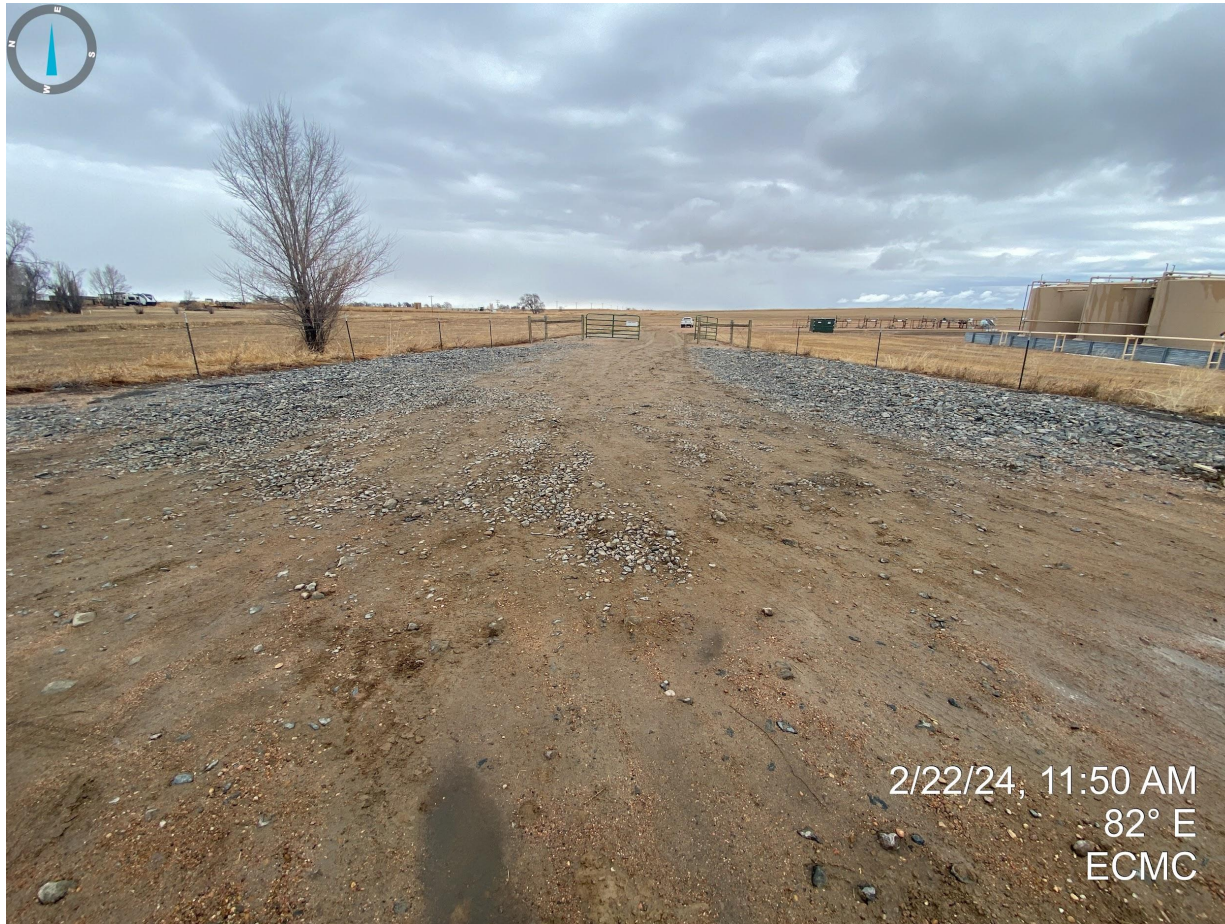
Photo 3. Vehicle track out pad requires maintenance.

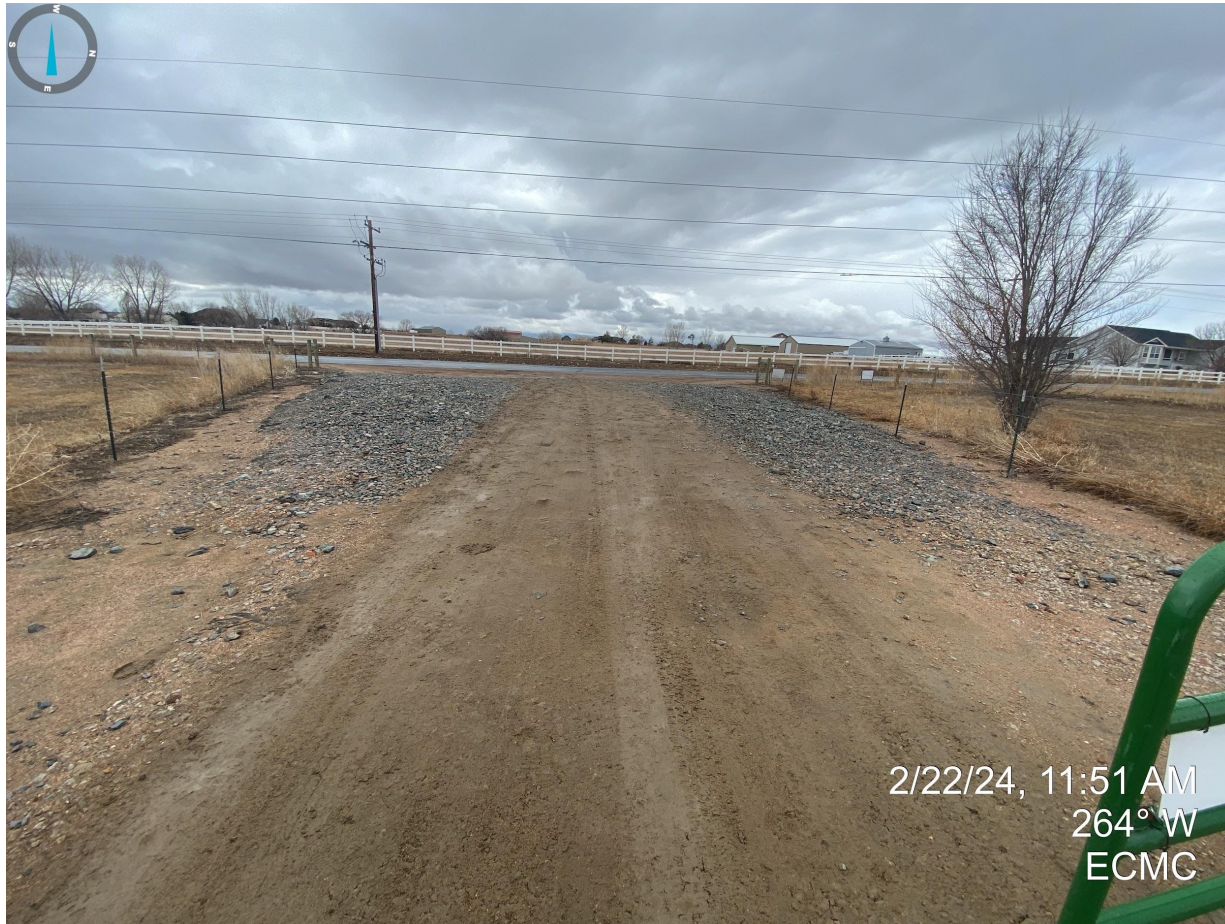
Photo 4. Vehicle track out pad requires maintenance.

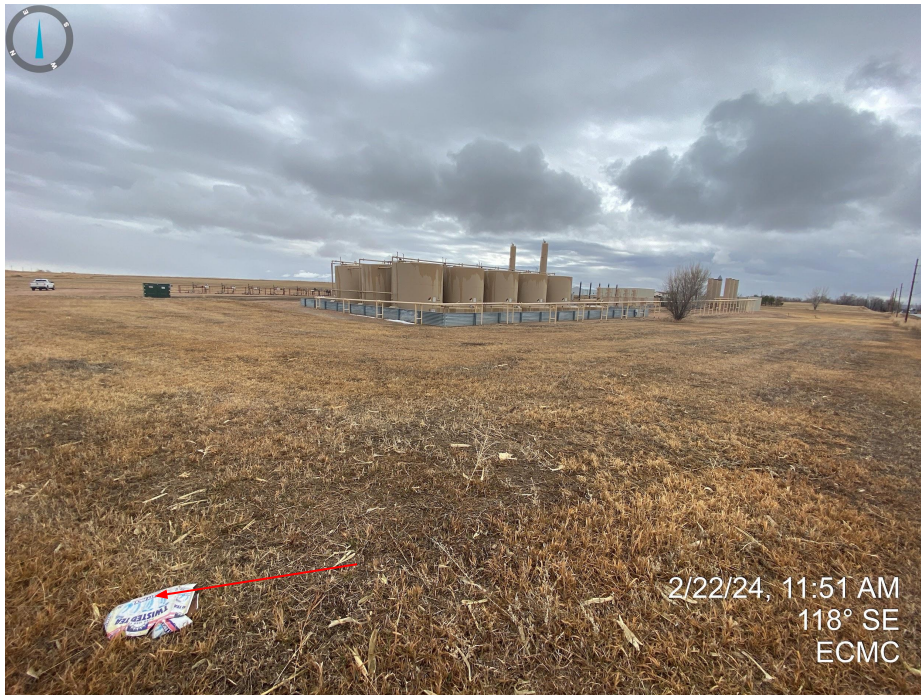
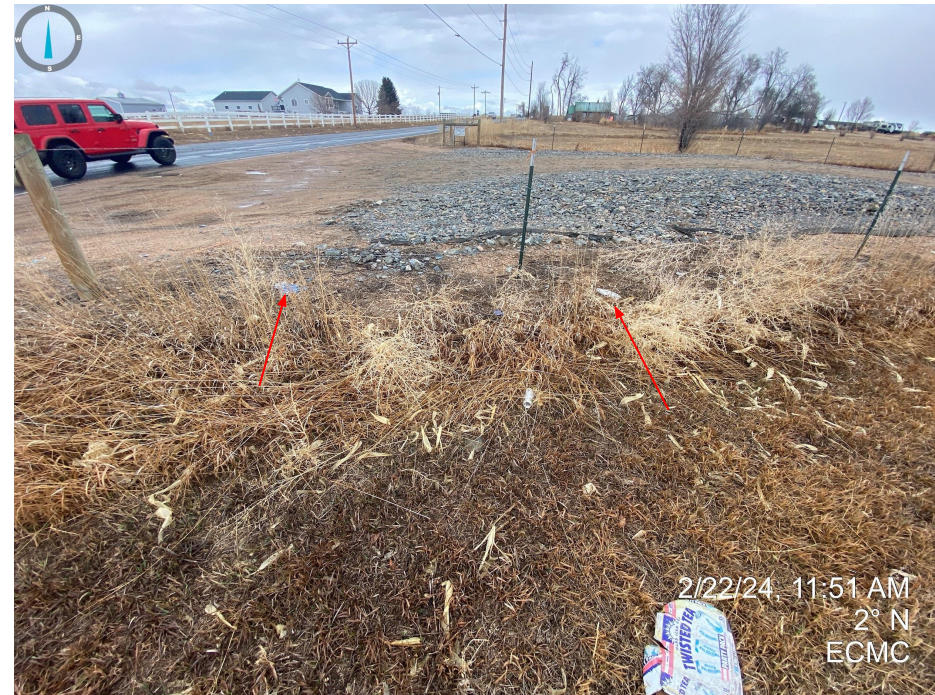
Photos 5 & 6. Tash observed throughout the location (photos taken from the western side of the location).

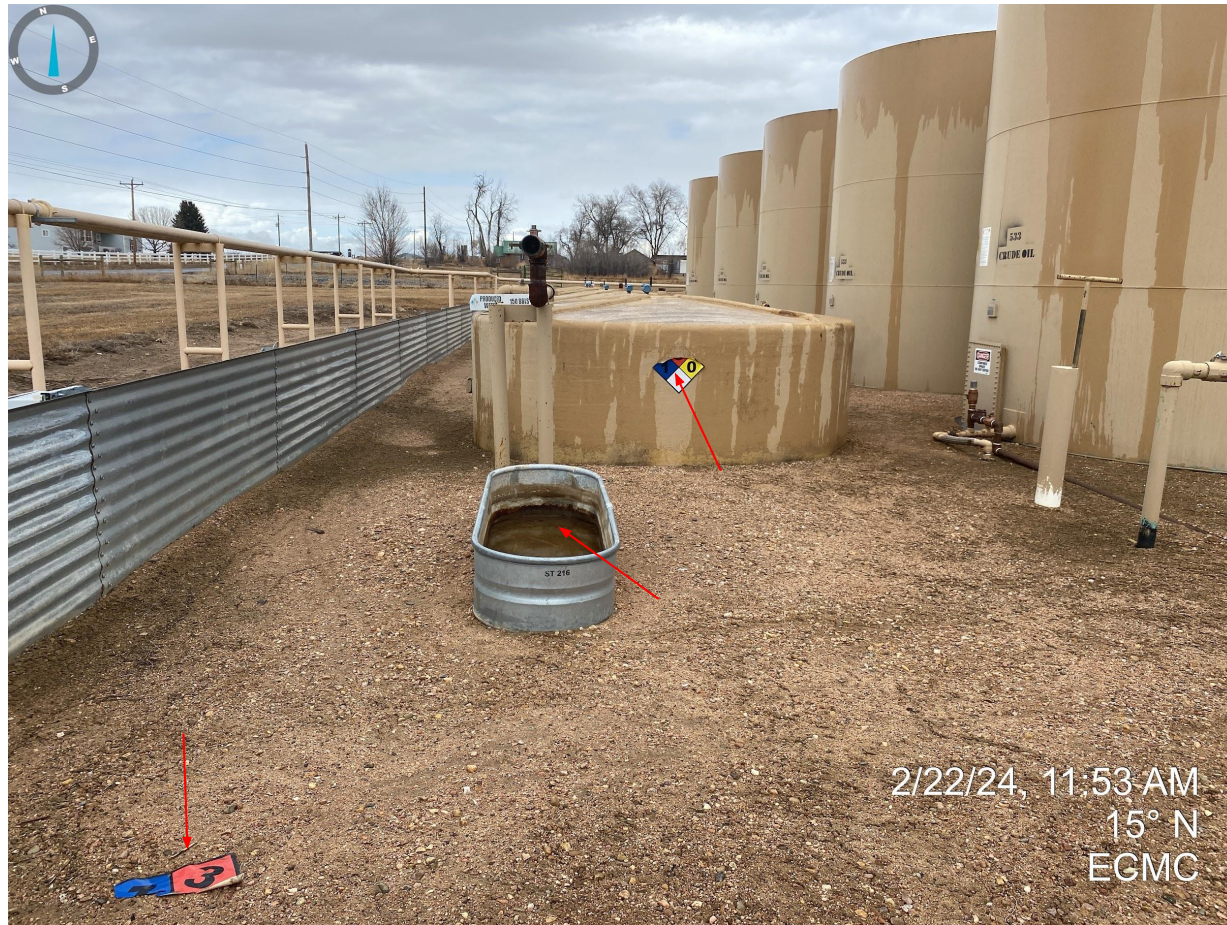
Photo 7. NFPA placard illegible at produced water tank and secondary containment without wildlife protection BMP.

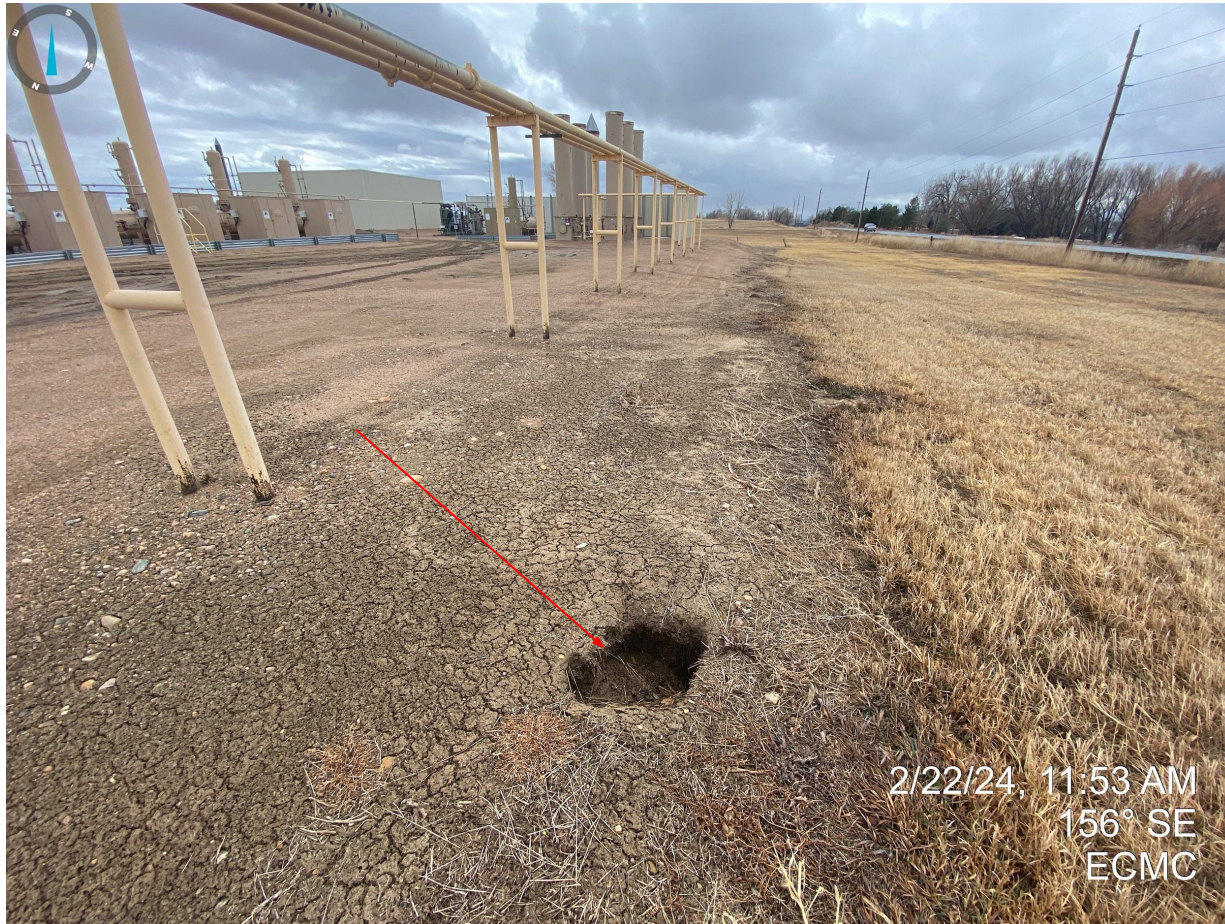
Photo 8. Hole/subsidence observed on the western side of the production areas (south of tank battery).

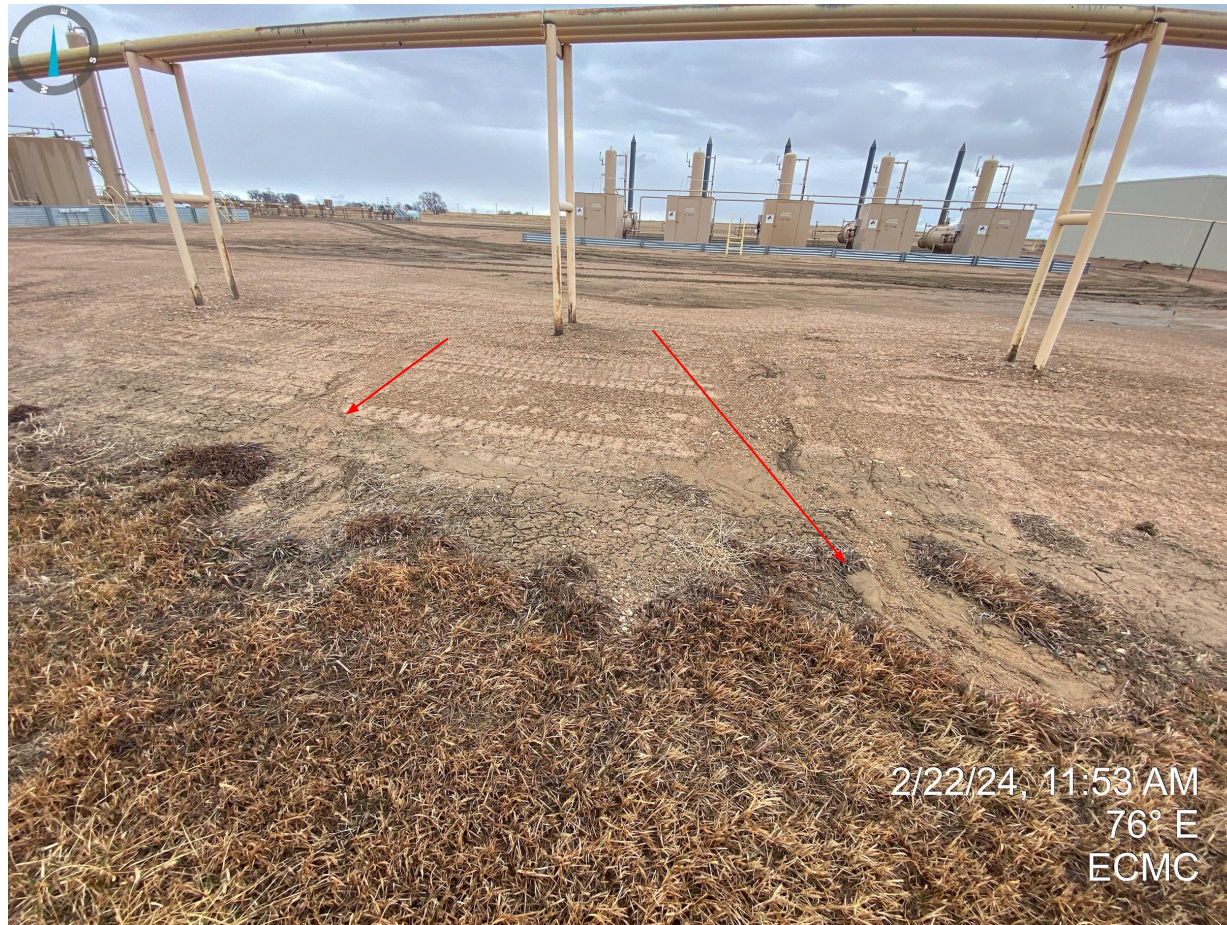
Photo 9. Erosion degradation occurring on the western side of the production areas.

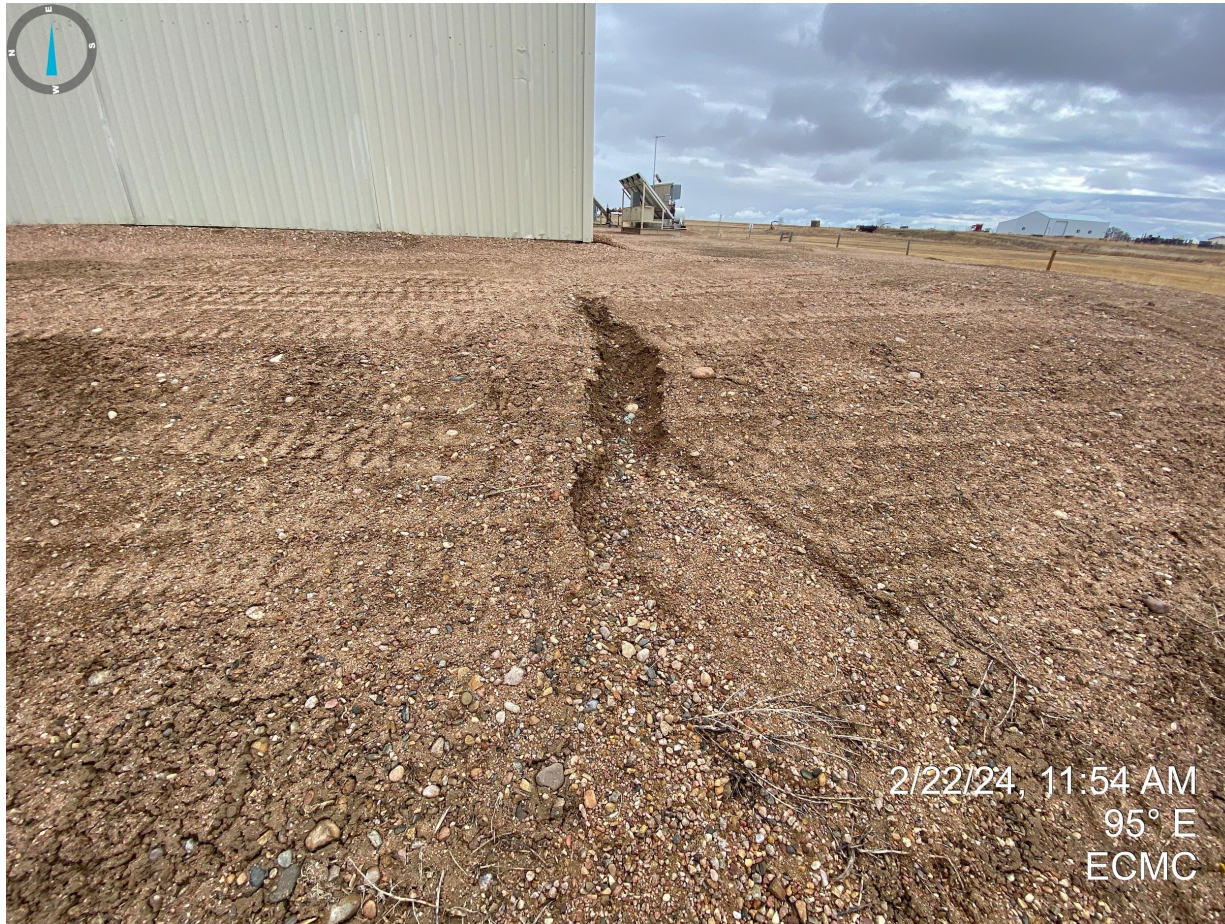
Photo 10. Erosion degradation occurring near the southwestern corner of the production areas.

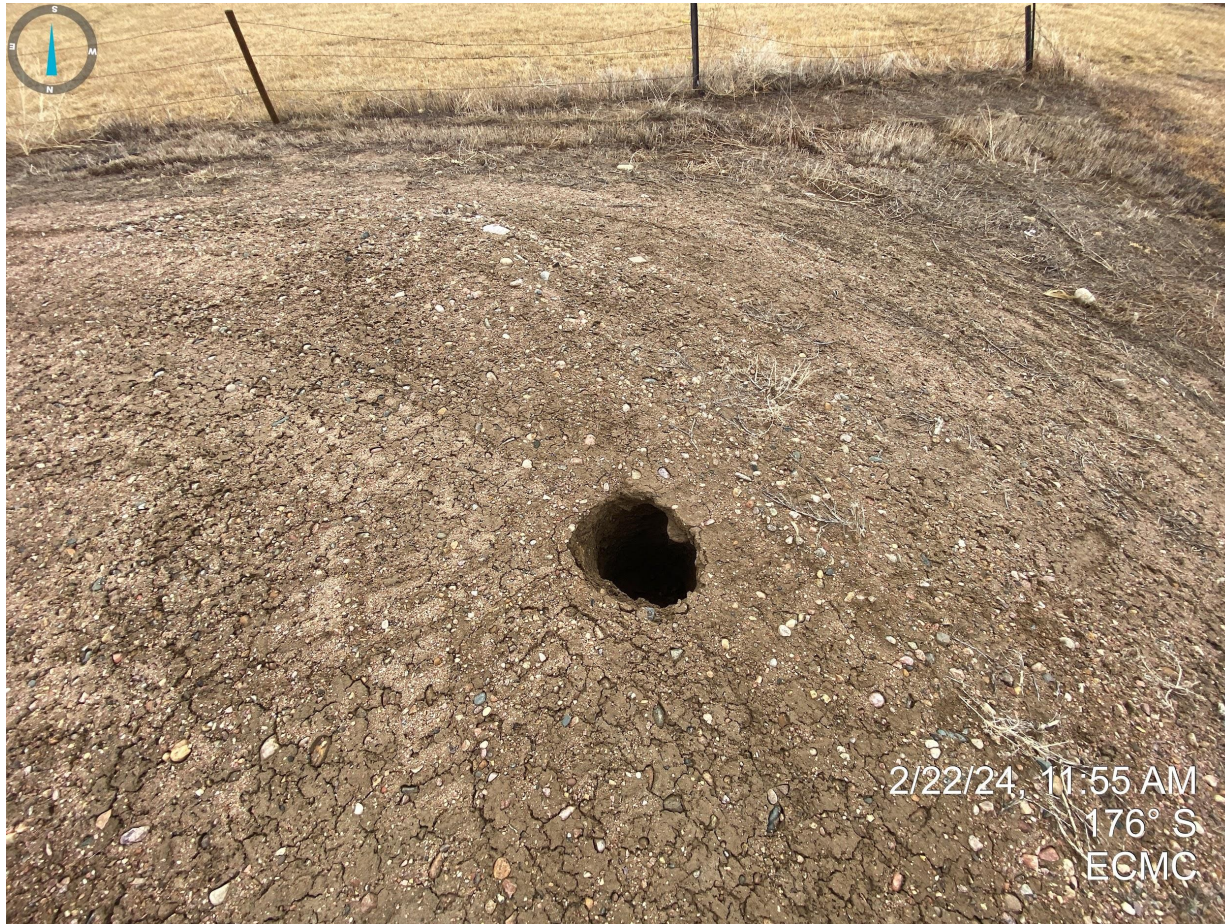
Photo 11. Hole/subsidence observed on the southwestern corner of the production areas.

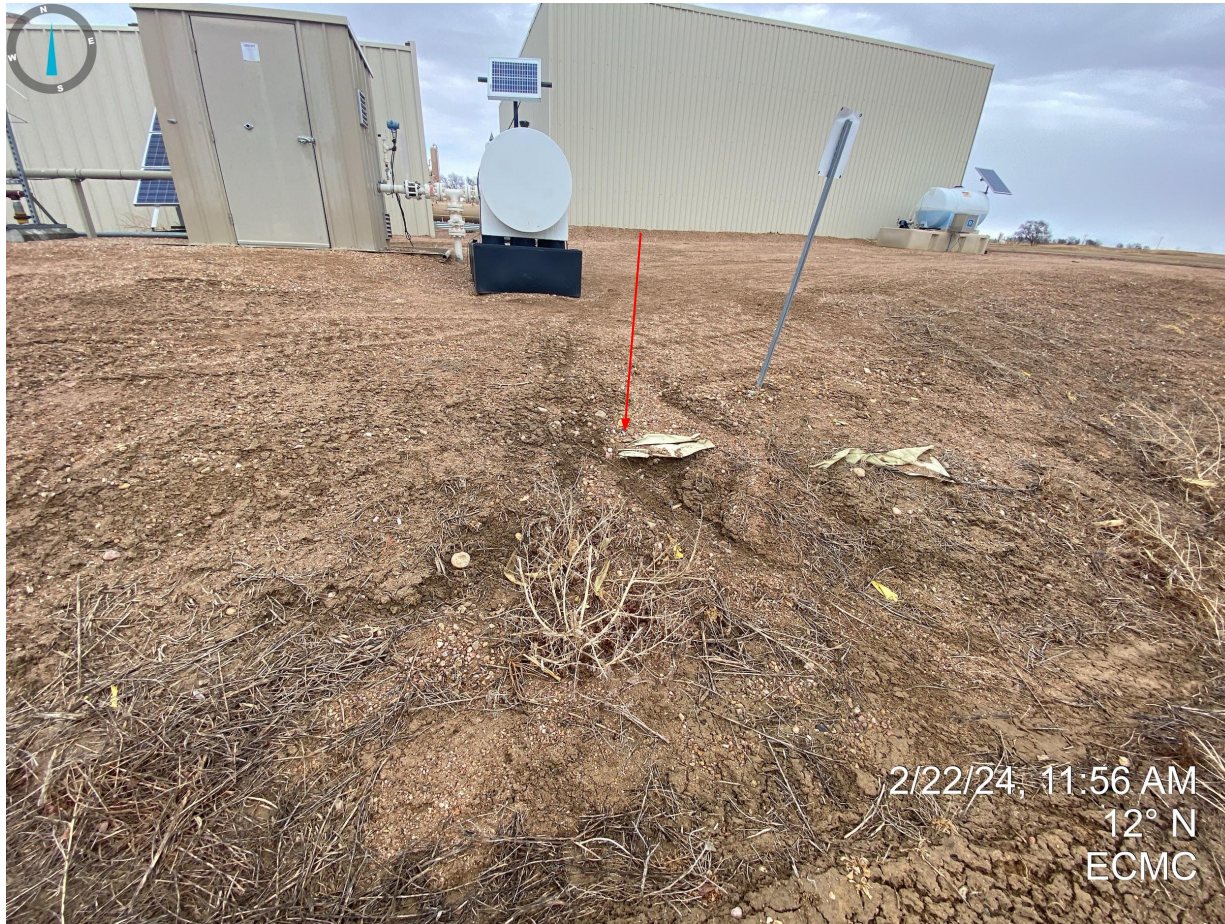
Photo 12. Erosion degradation occurring on the southern side of the production areas.

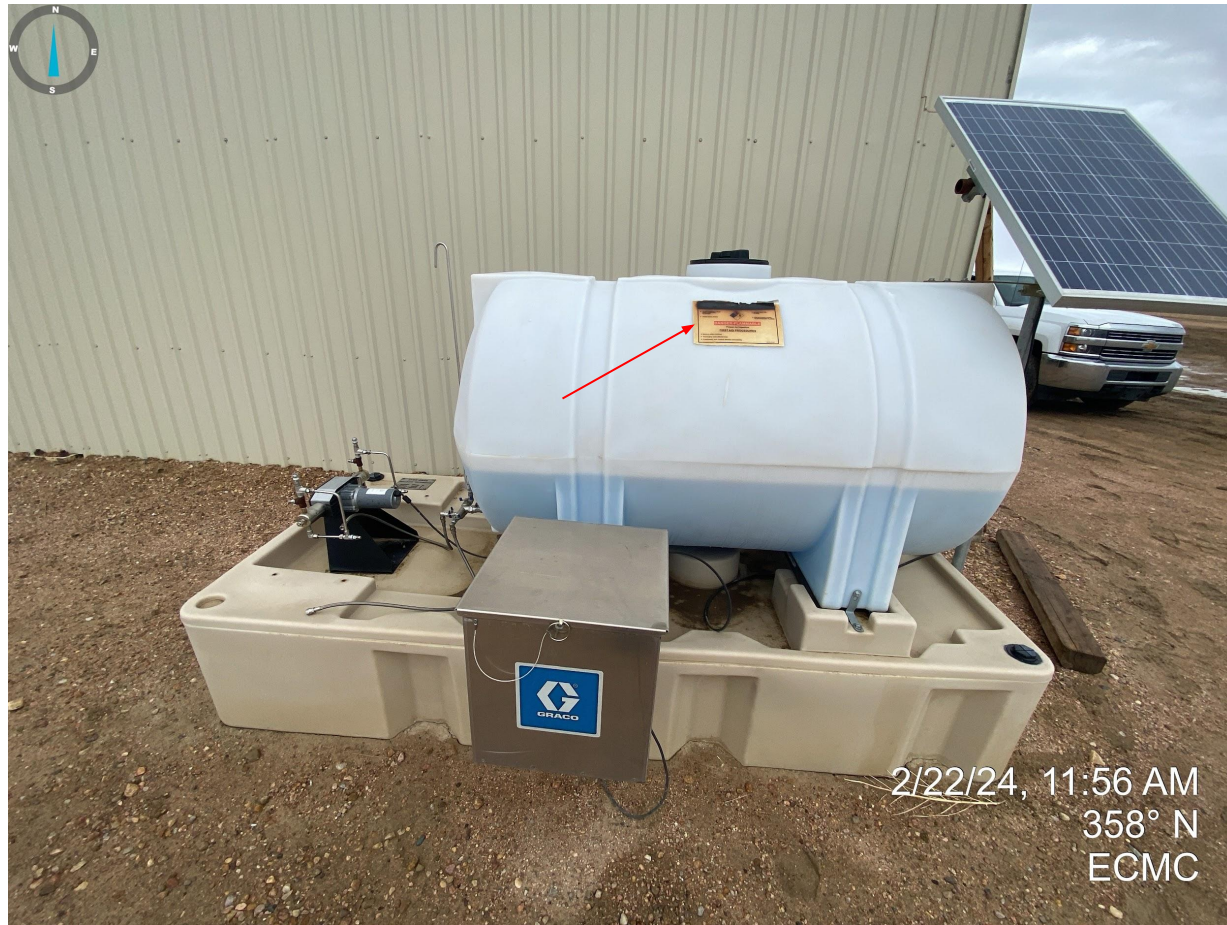
Photo 13. Tank labels are not legible (peeling, faded, cracked, etc).

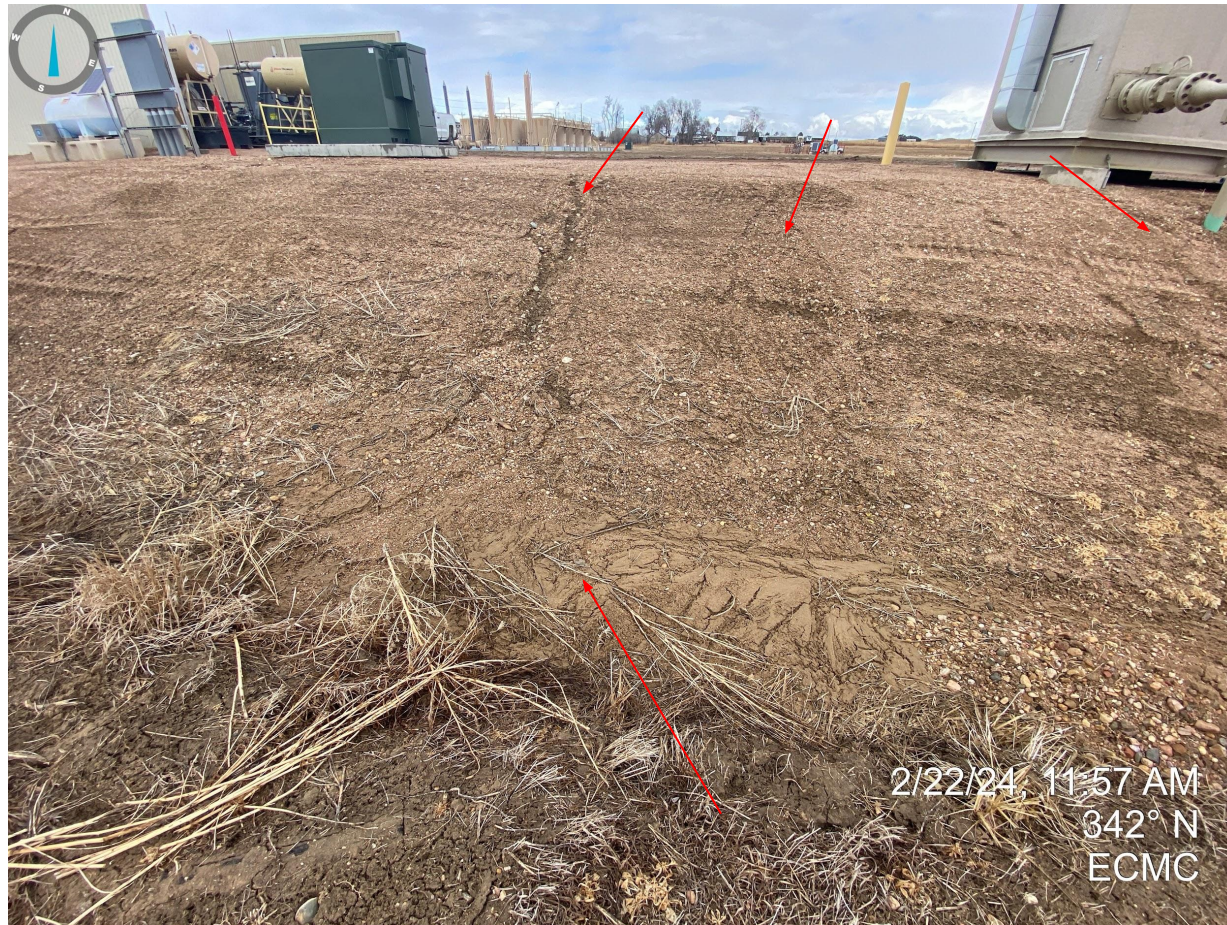
Photo 14. Erosion degradation occurring on the southern side of the production areas.

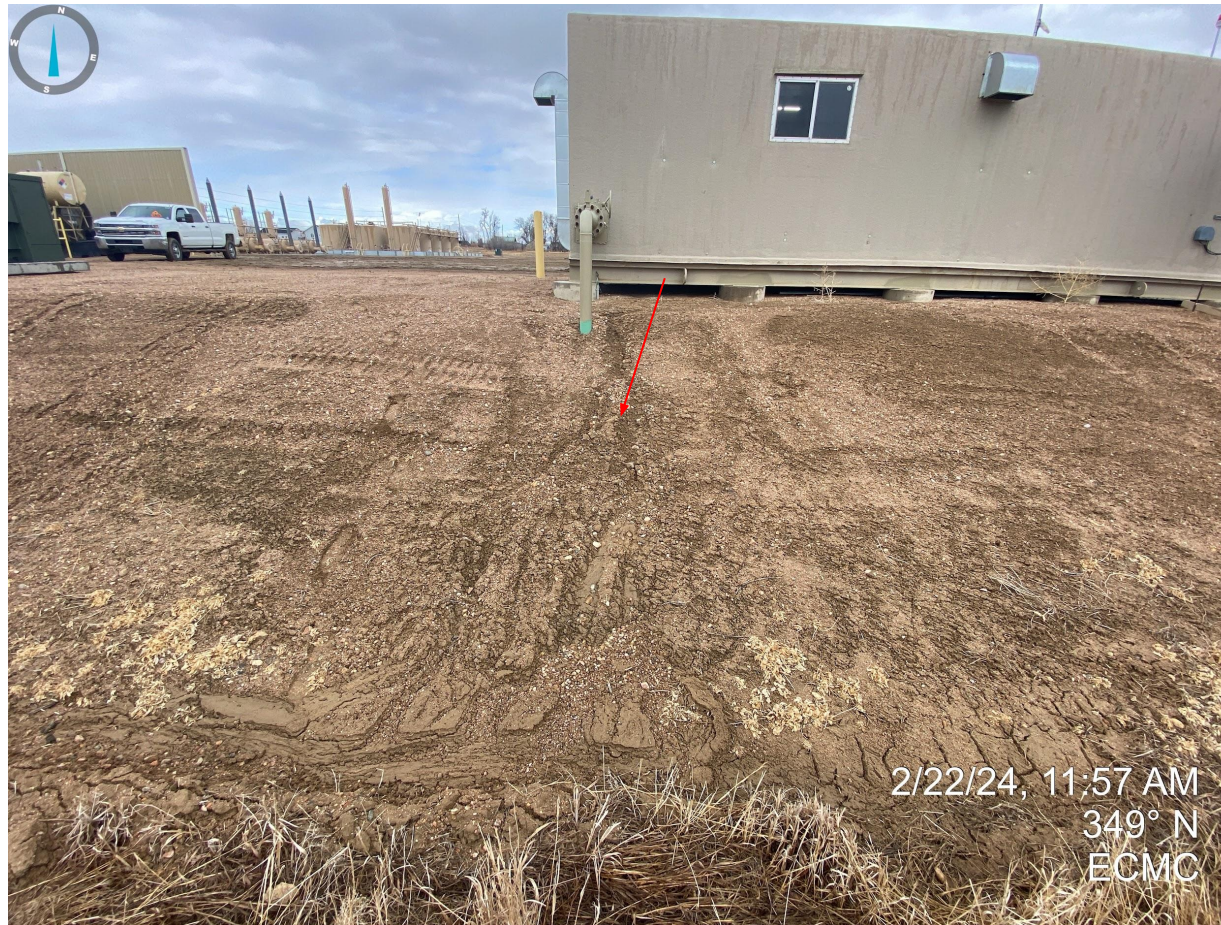
Photo 15. (Continued from Photo 14) Erosion degradation occurring on the southern side of the production areas.

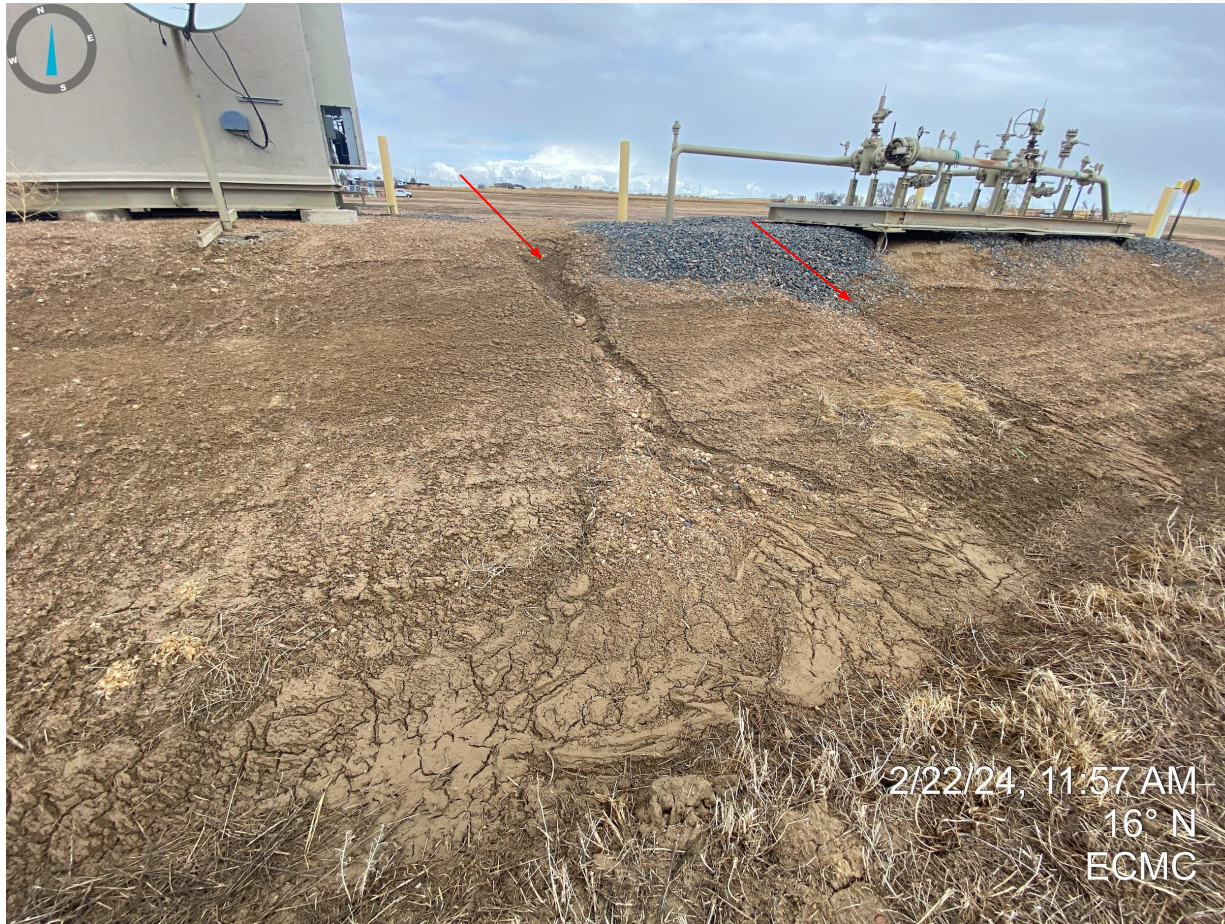
Photo 16. (Continued from Photo 15) Erosion degradation occurring on the southern side of the production areas.

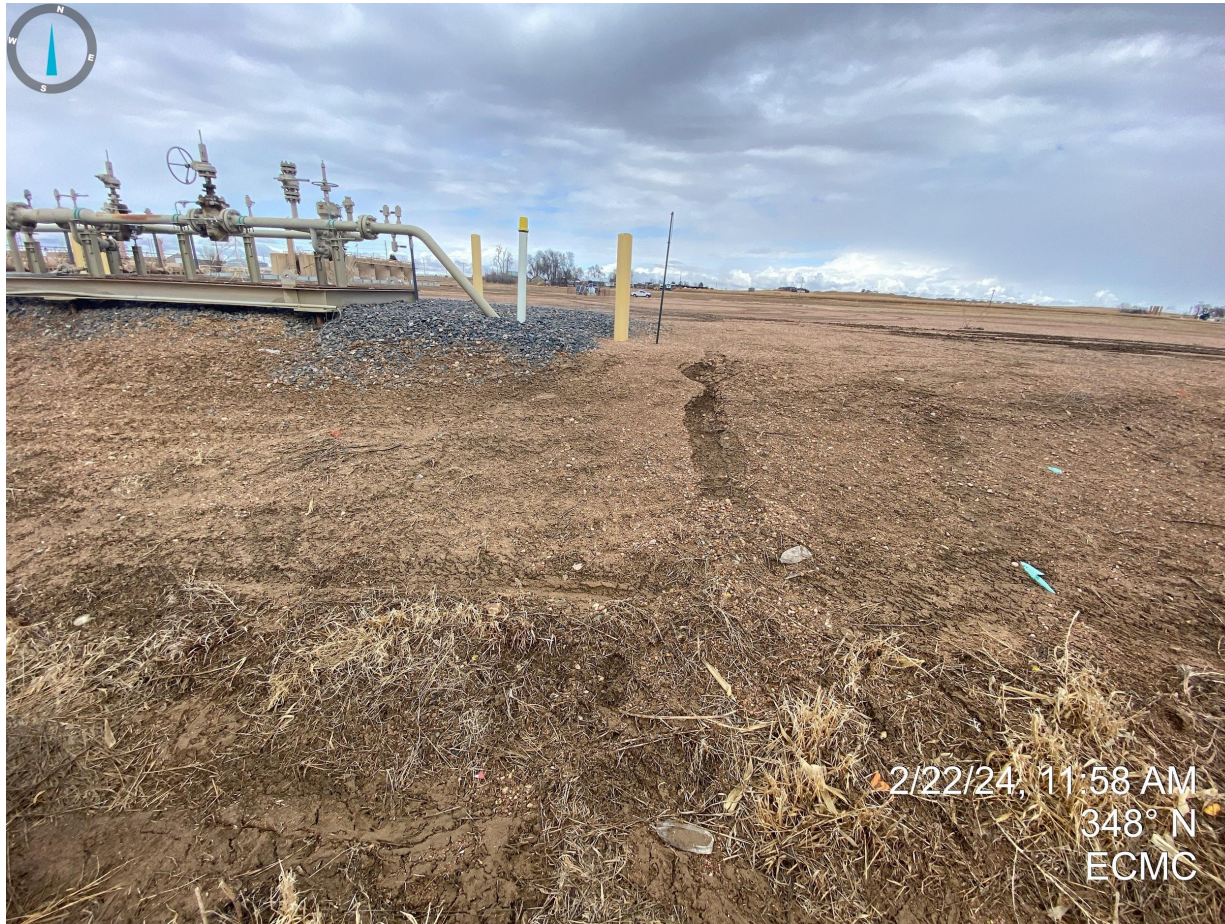
Photo 17. (Continued from Photo 16) Erosion degradation occurring on the southern side of the production areas.

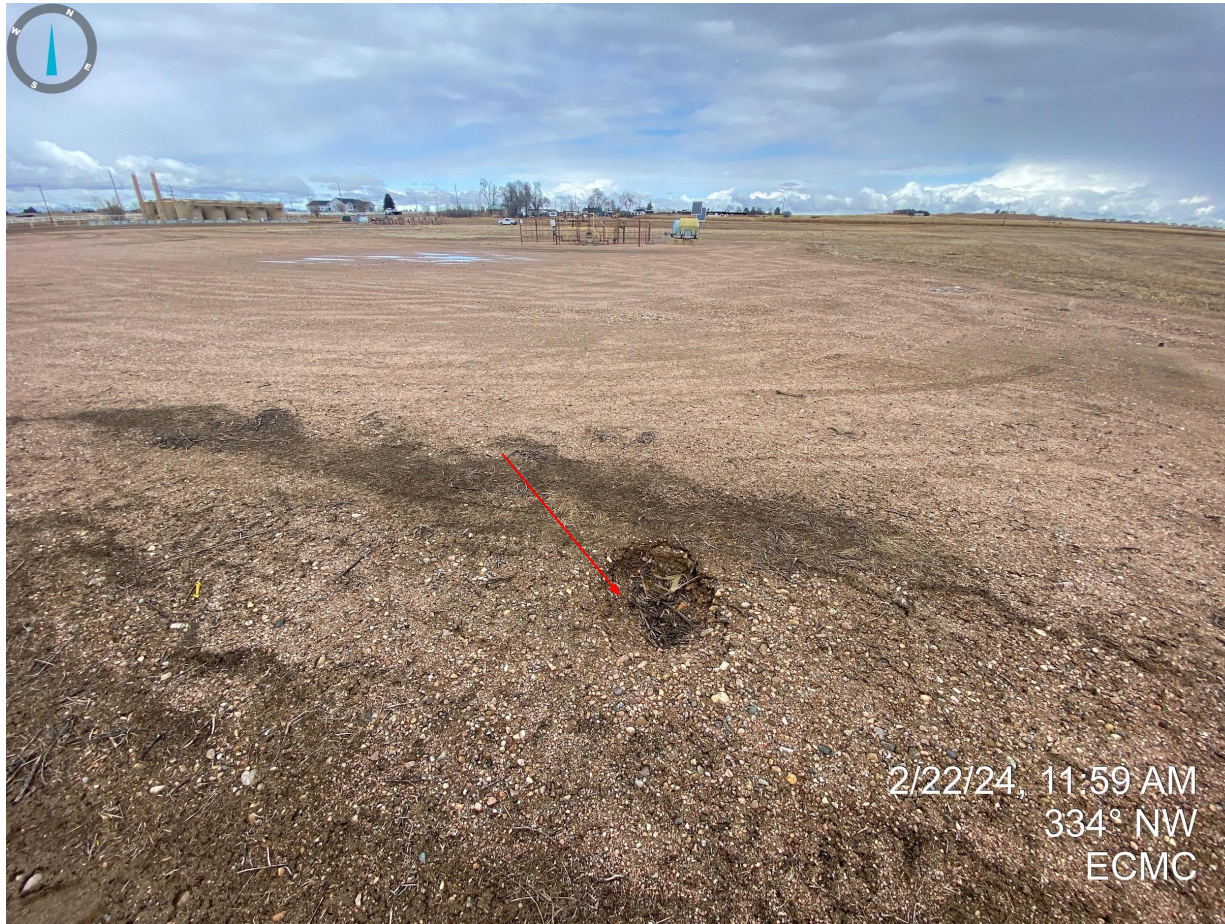
Photo 18. Hole/subsidence observed on the southeastern corner of the production areas.

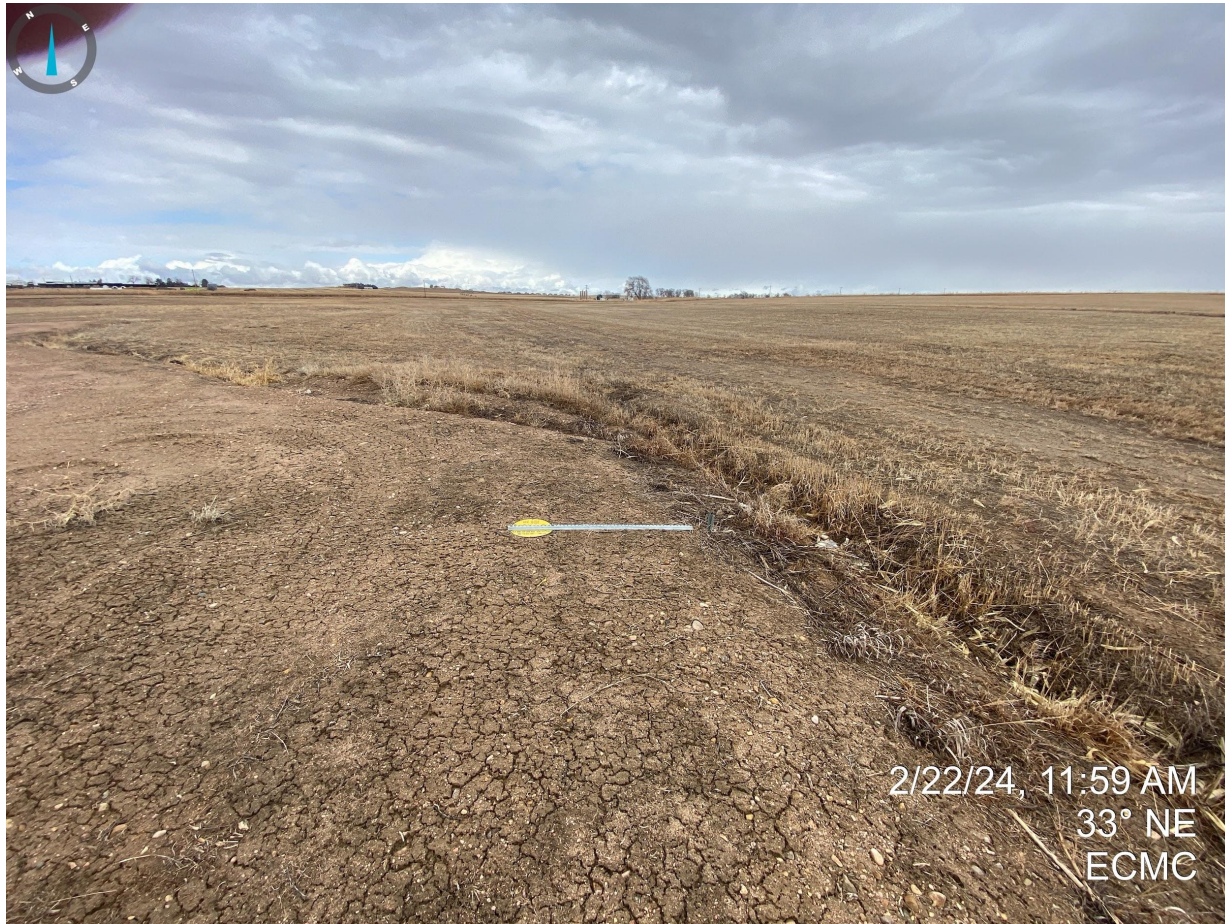
Photo 19. Debris on the southeastern side of the production areas. Remove or reinstall signage.

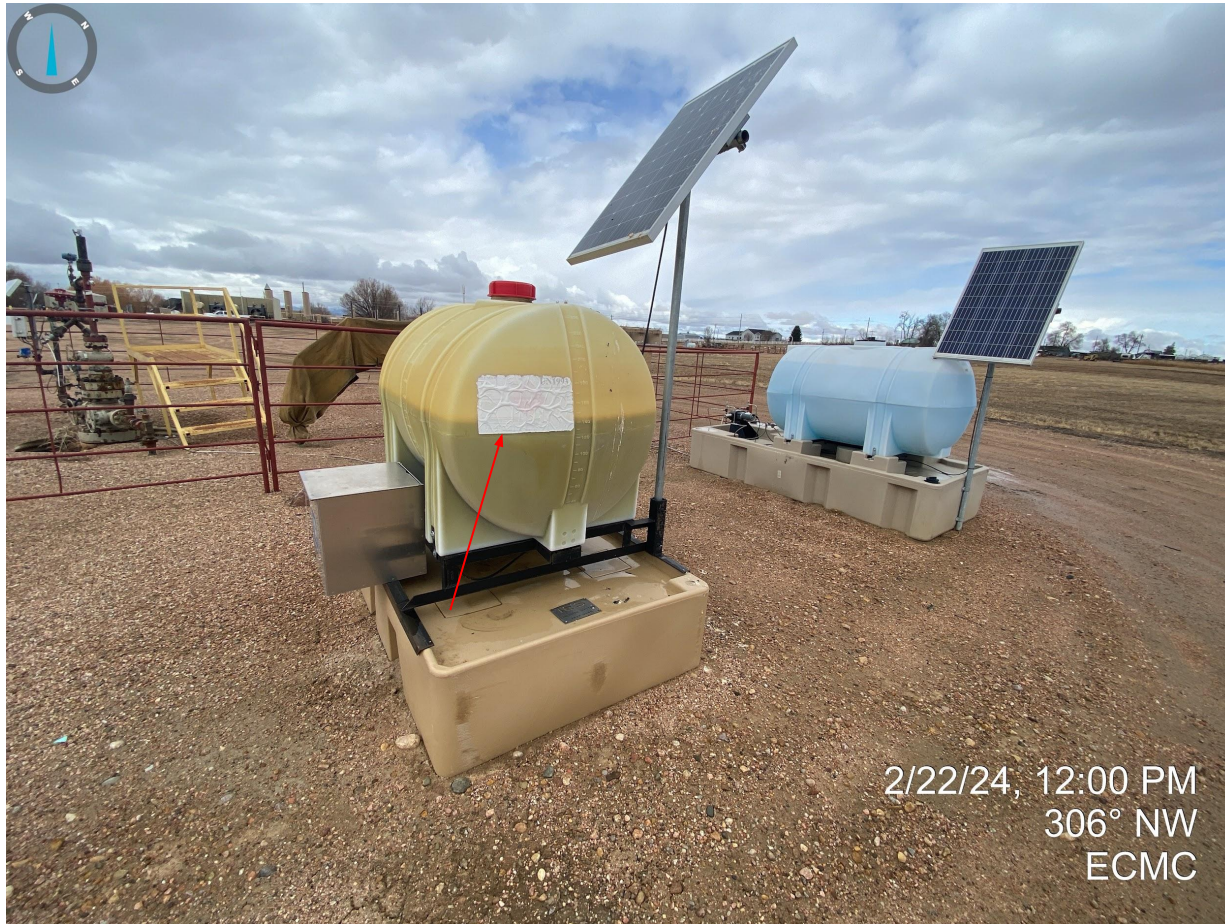
Photo 20. Tank labels are not legible (peeling, faded, cracked, etc).

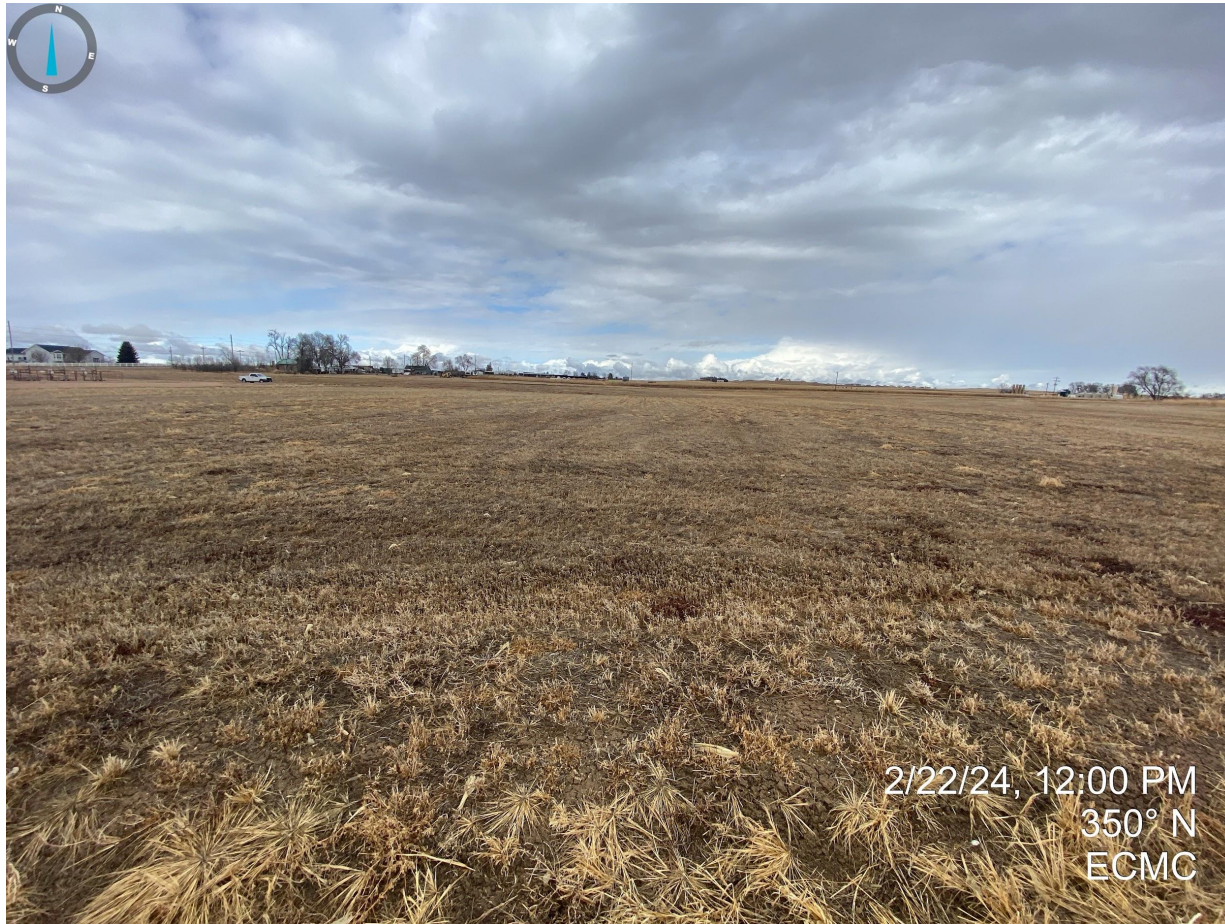
Photo 21. Eastern interim reclamation areas appear to be irrigated cropland (alfalfa observed throughout). A follow-up inspection will be conducted at a future date to verify vegetation compliance with Rule 1003.
