Interim Reclamation and Stormwater Inspection

Date: 02/22/2024

Operator: PDC ENERGY INC - 69175

Location ID: 429507

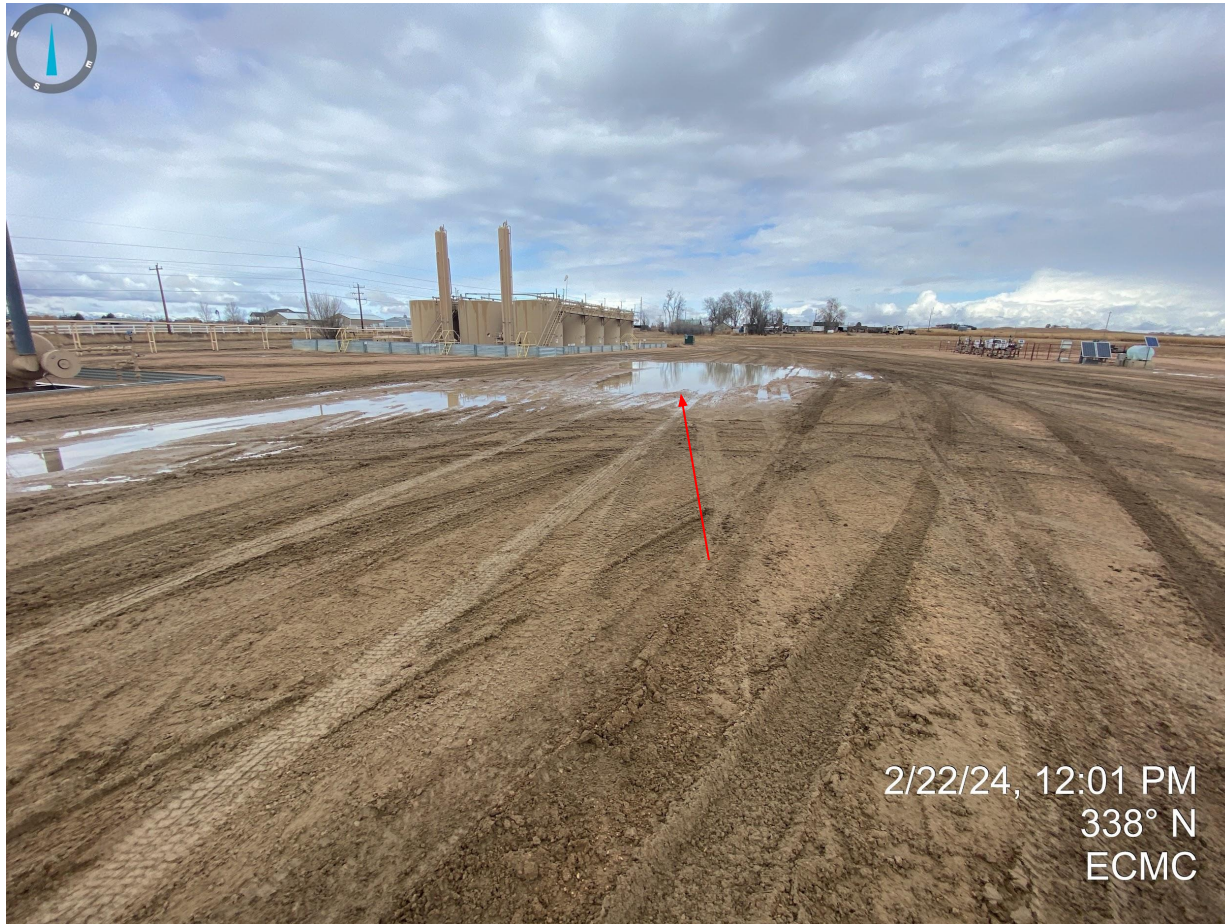
Photo 22. Unstabilized production areas require additional maintenance to prevent vehicle trackout.

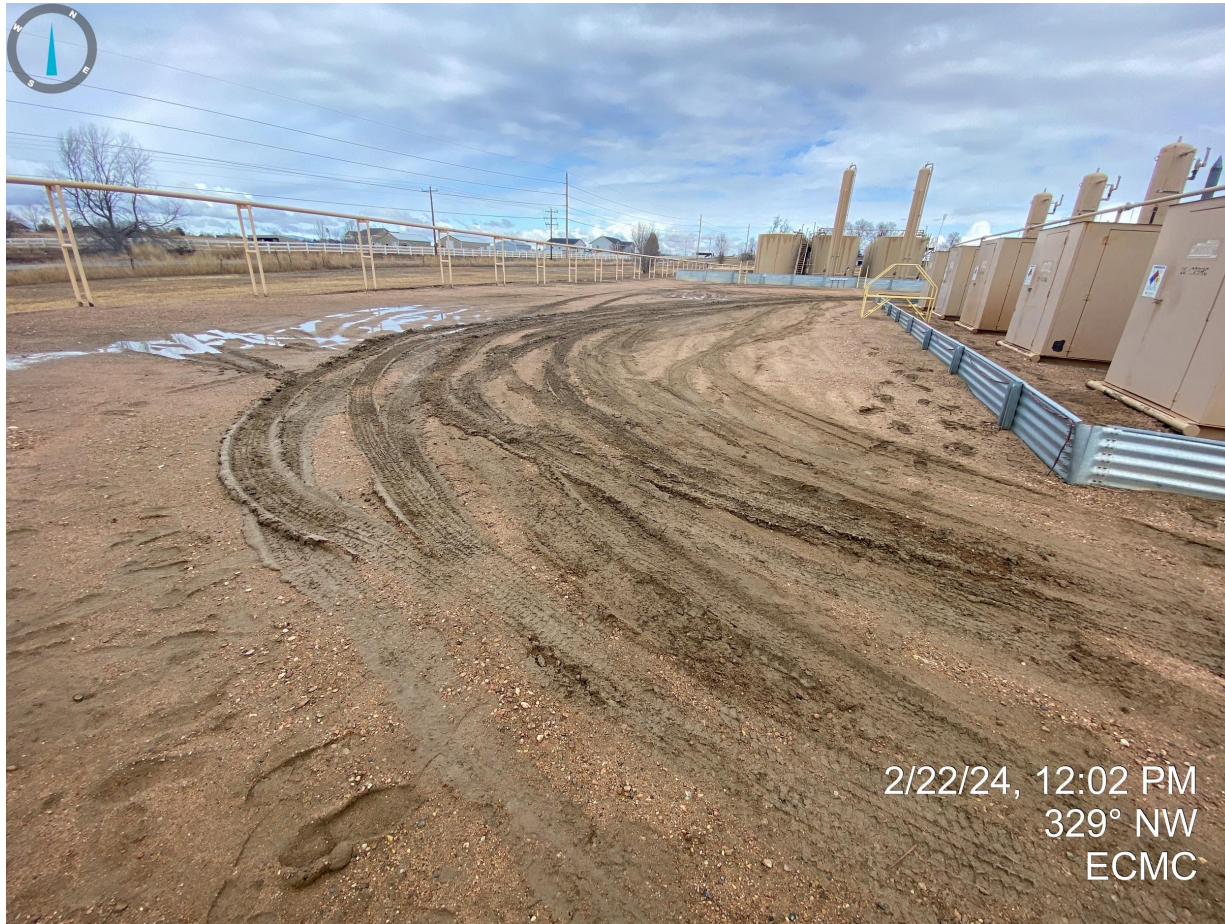
Photo 23. Unstabilized production areas require additional maintenance to prevent vehicle trackout.

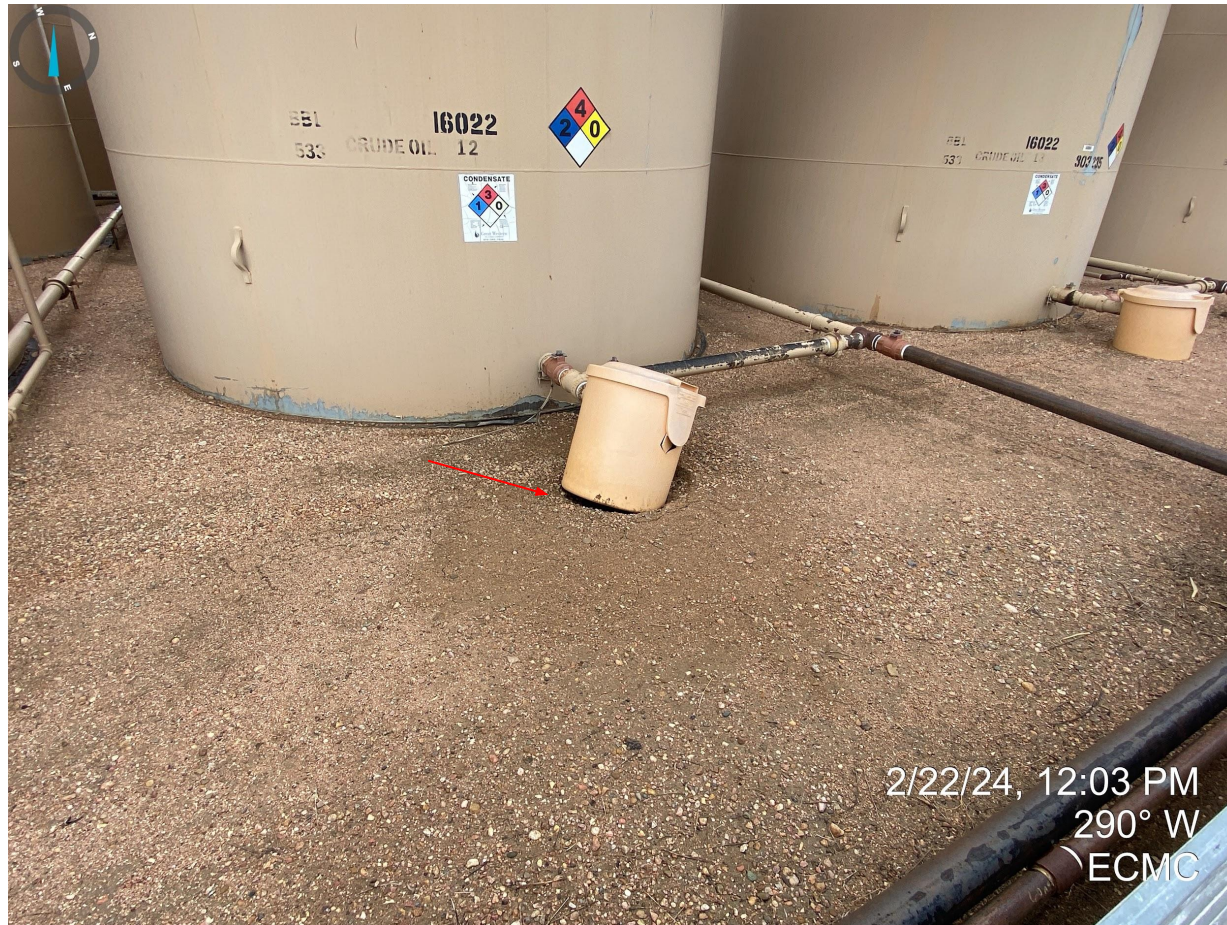
Photo 24. Subsidence located underneath loadout collection point.

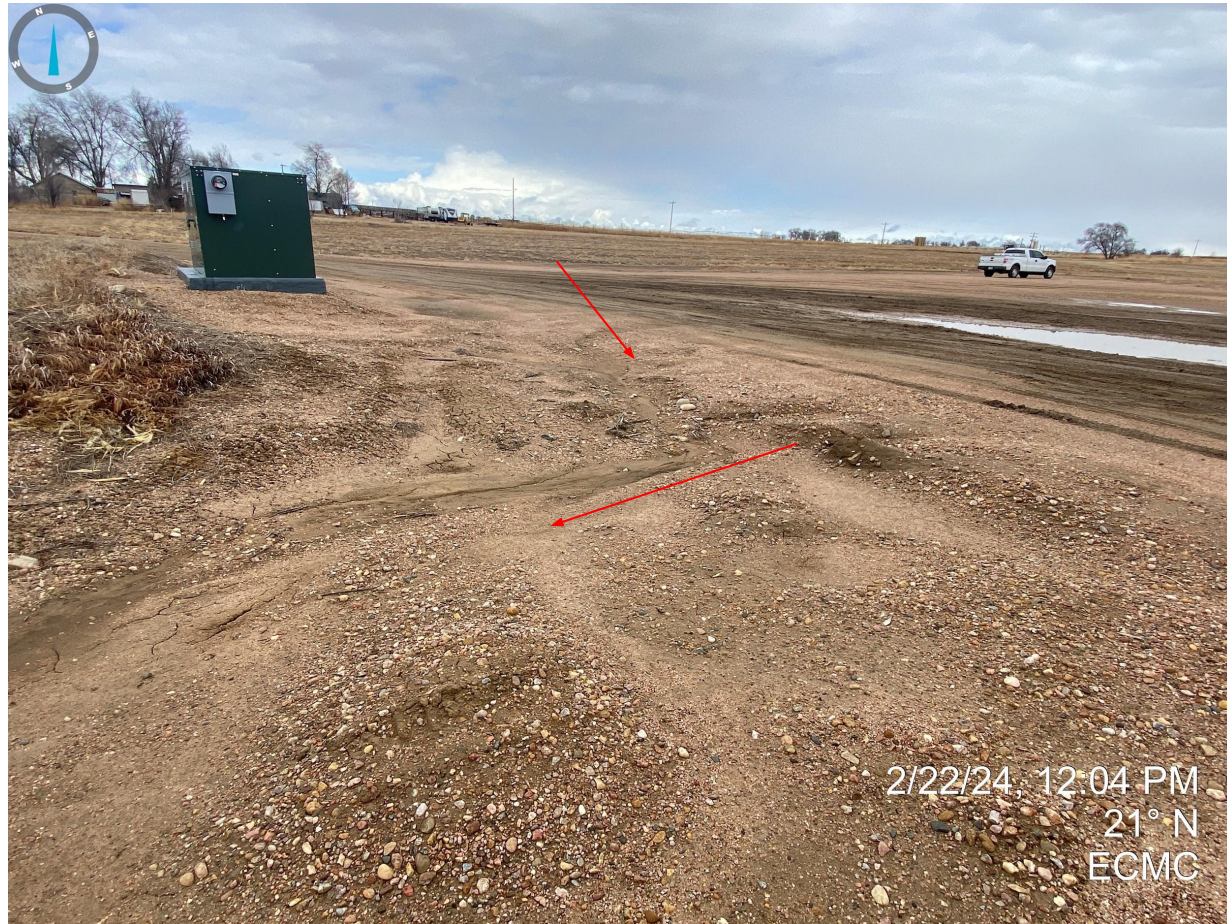
Photo 25. Erosion degradation located near the northern portion of the tank battery.

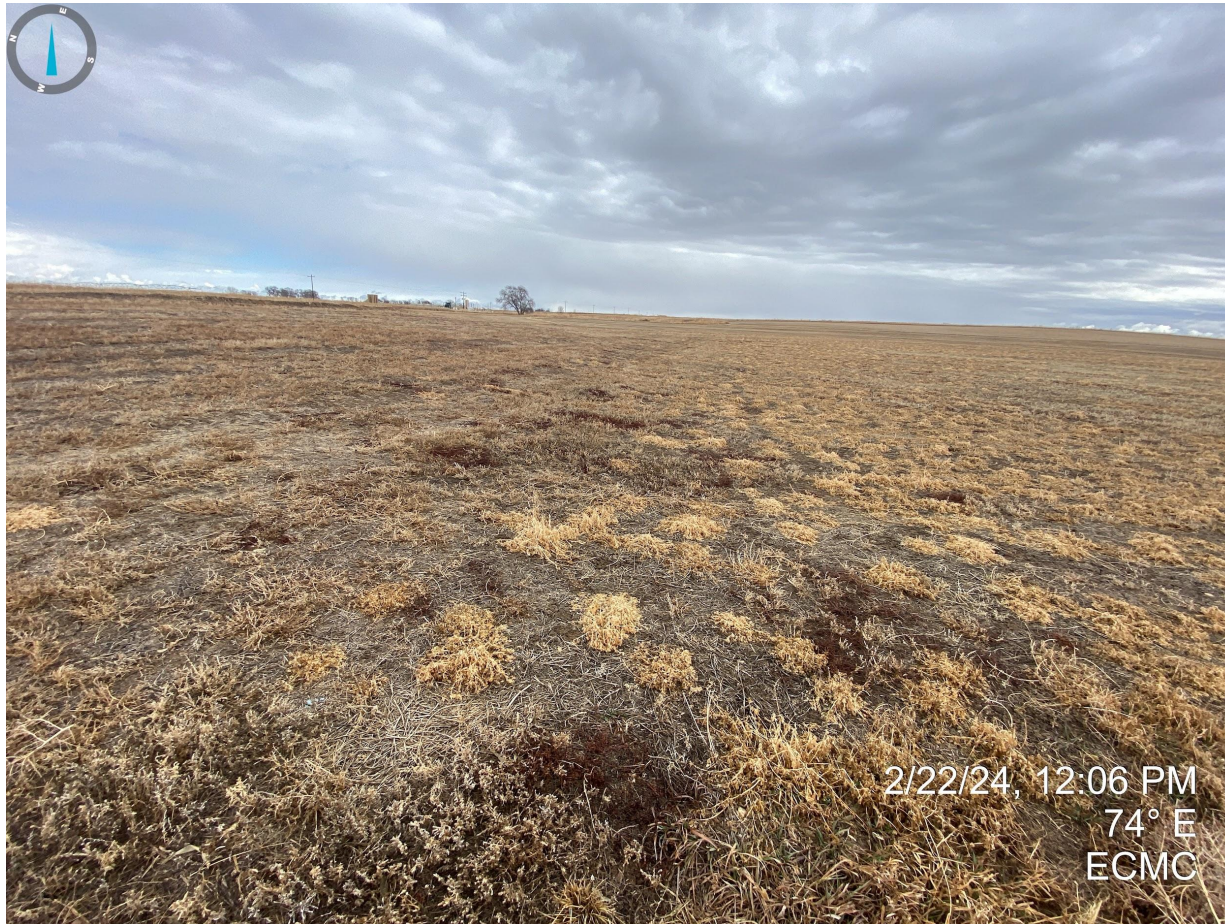
Photo 26. Northern interim reclamation areas appear to be irrigated cropland (alfalfa observed throughout). A follow-up inspection will be conducted at a future date to verify vegetation compliance with Rule 1003.
