Inspection Photos

Location Name: CAERUS PICEANCE LLC, FEDERAL-68S96W/13SWSW

Location ID: 334154

Date: 2/26/2024

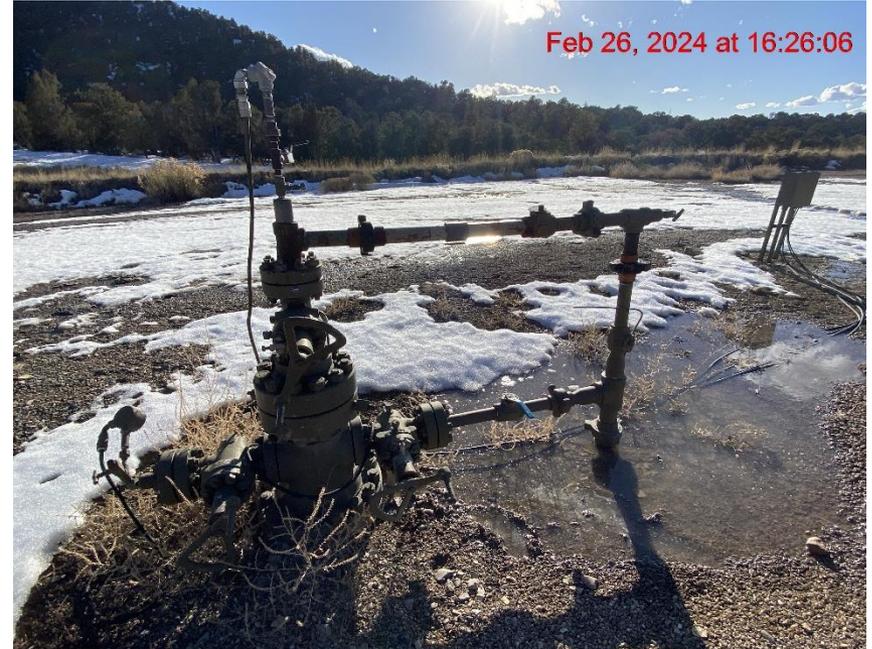
Wellhead/Weeds – Photo #09546

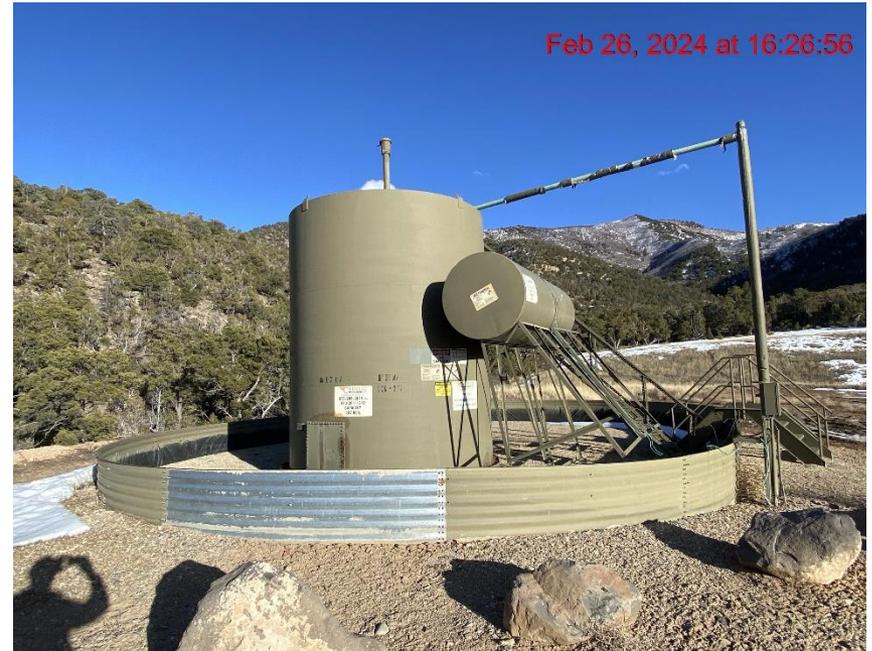
Tank Battery/No Battery Sign Posted – Photo #09547

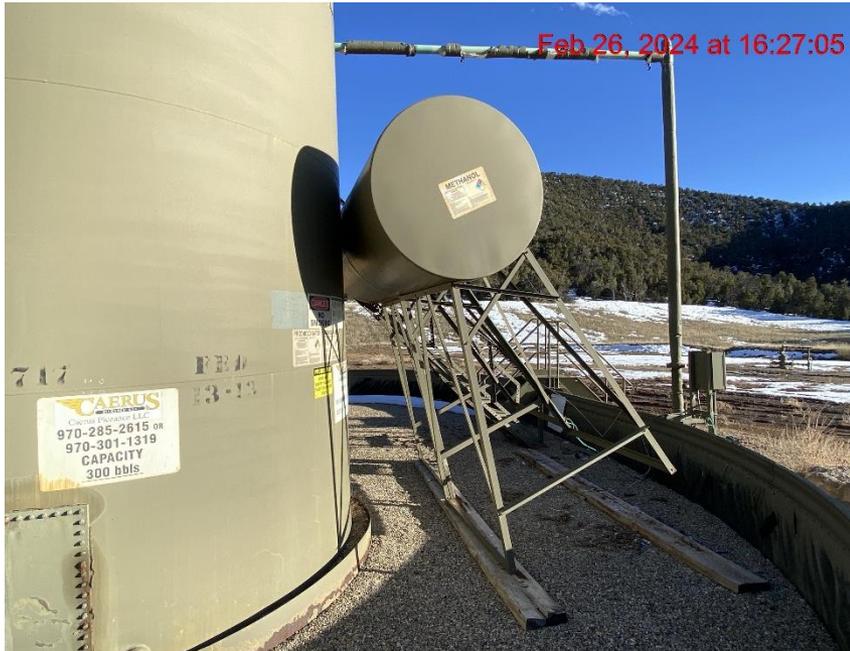
Methanol Tank Tipped Against Condensate Tank/General Safety – Photo #09548

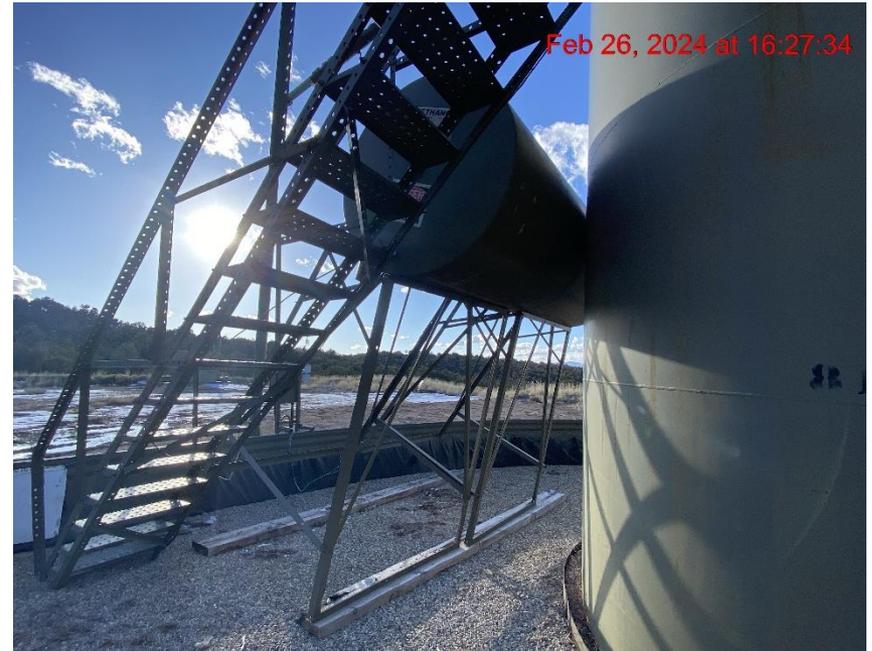
Methanol Tank Tipped Against Condensate Tank/General Safety – Photo #09549

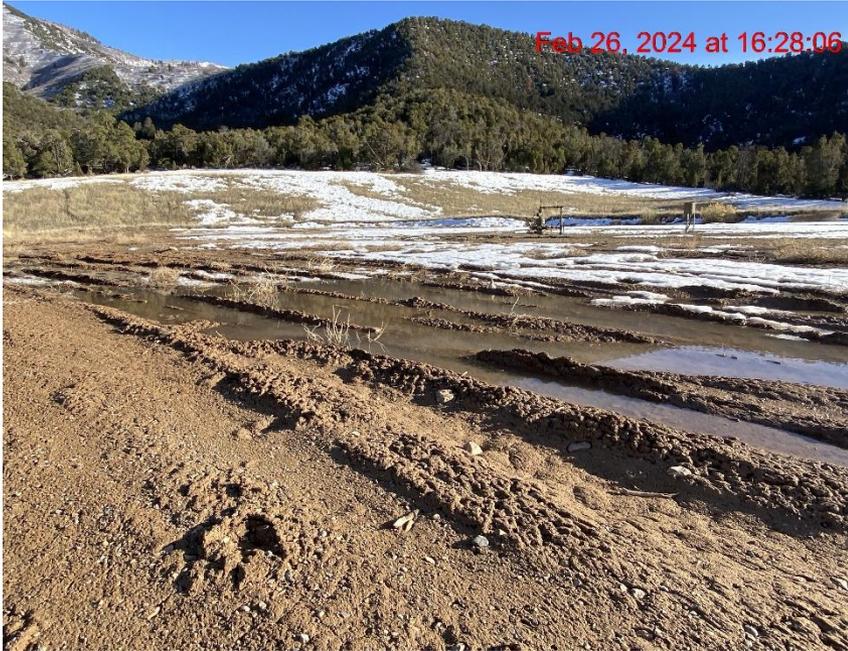
Lack of Stabilization – Photo #09550

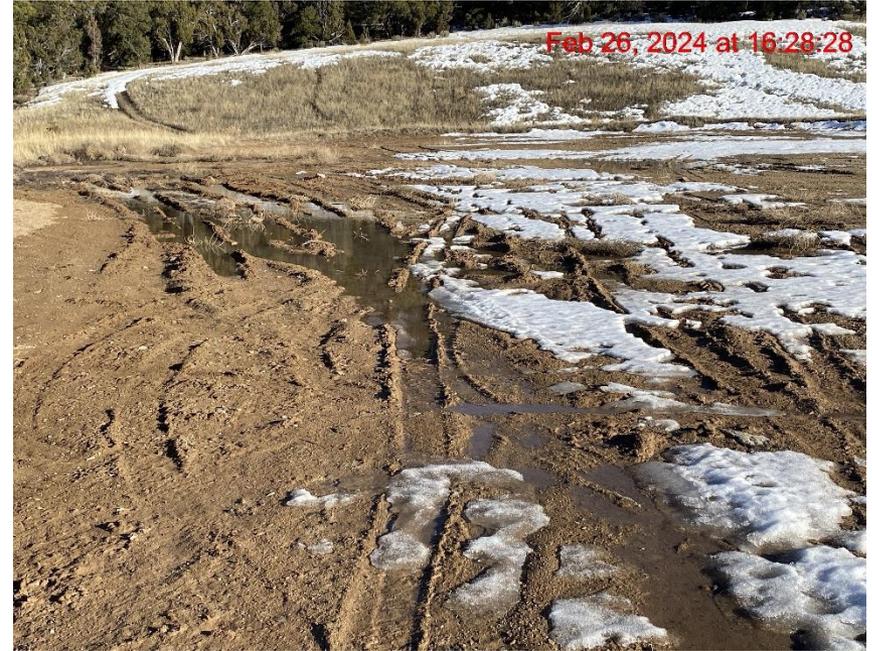
Lack of Stabilization – Photo #09551

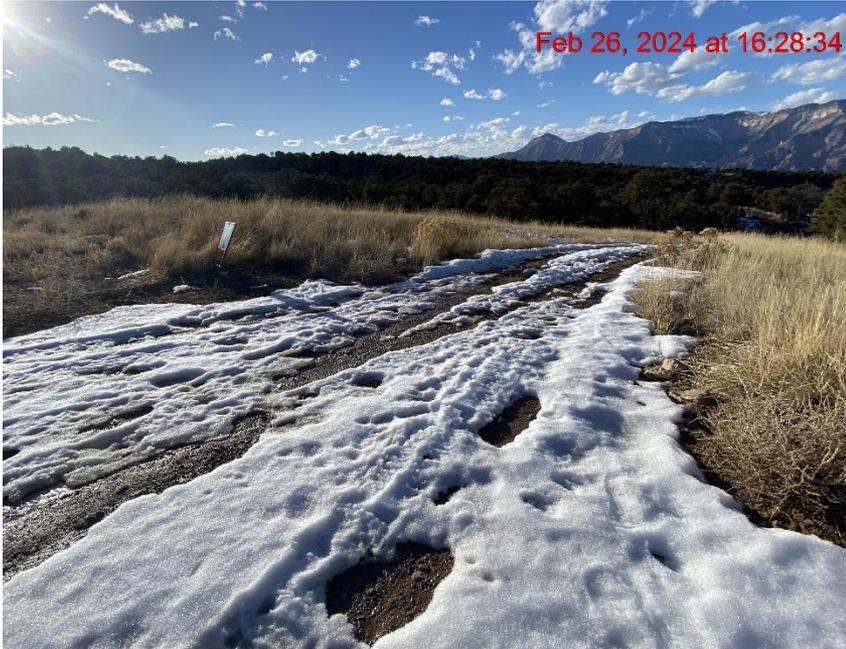
**Insufficient Vehicle Tracking BMPs at Location Entrance/Exit
– Photo #09552**
