Inspection Photos
Location Name: State 44-36
Location ID:306091

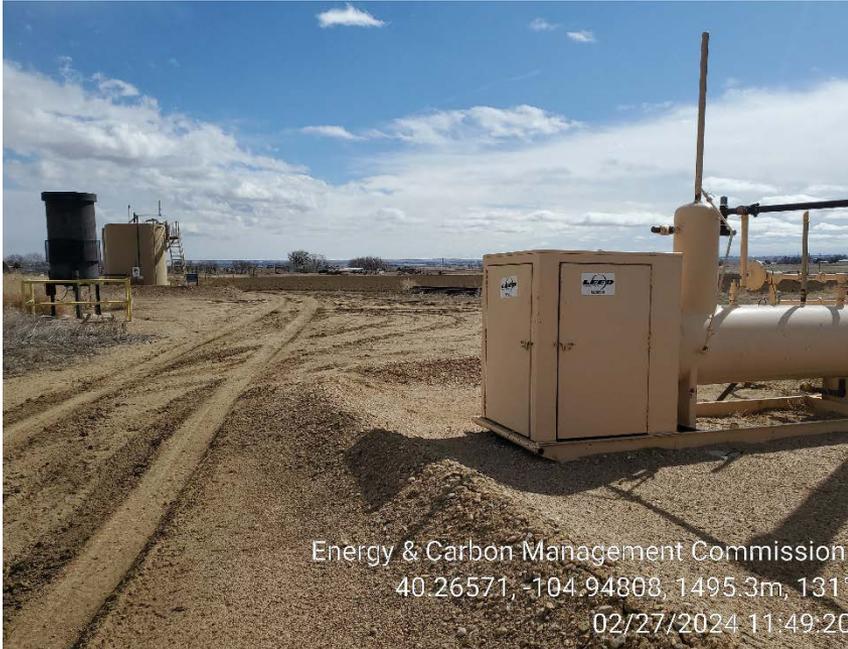
Production facility

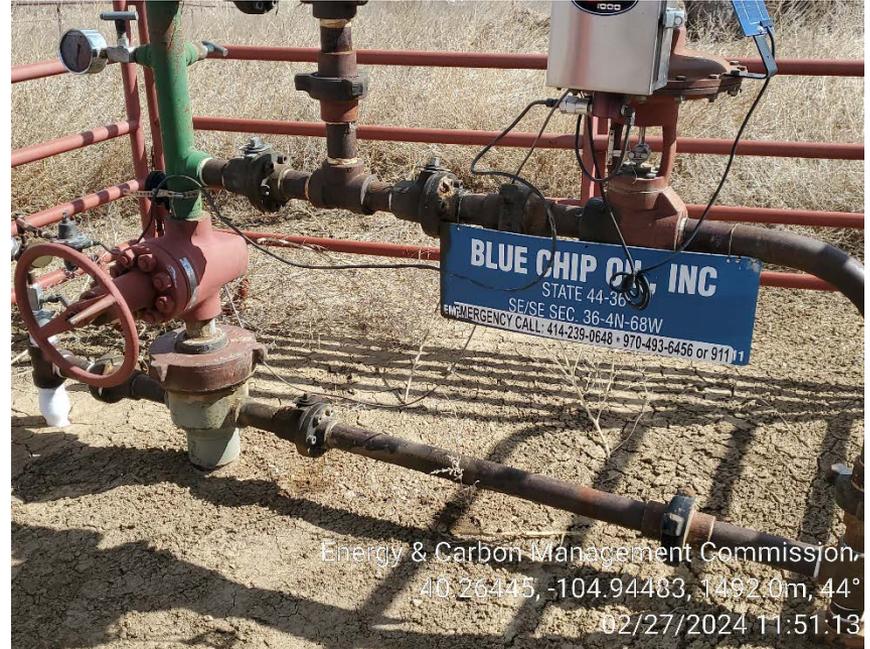
Wellhead

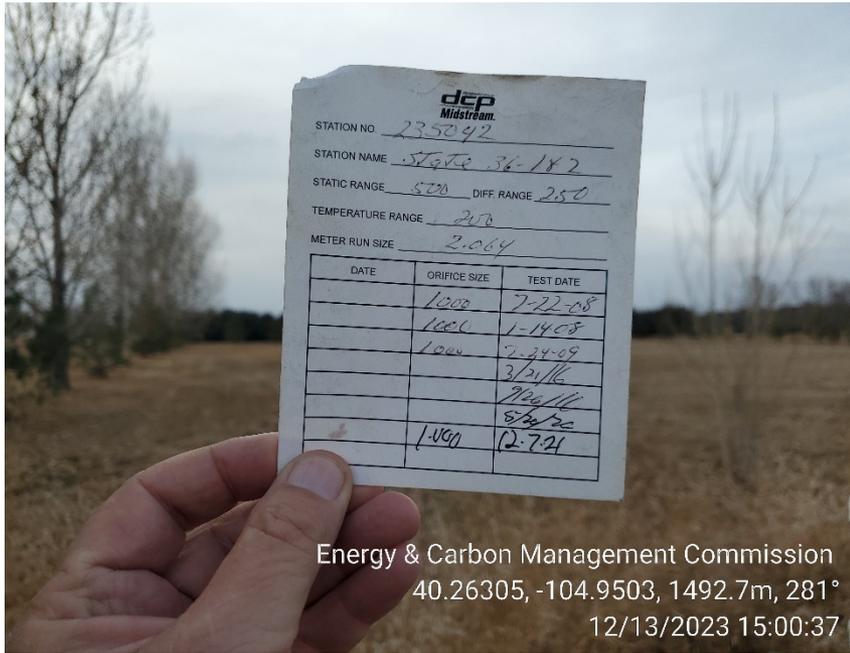
Calibration card on 12/13/2023

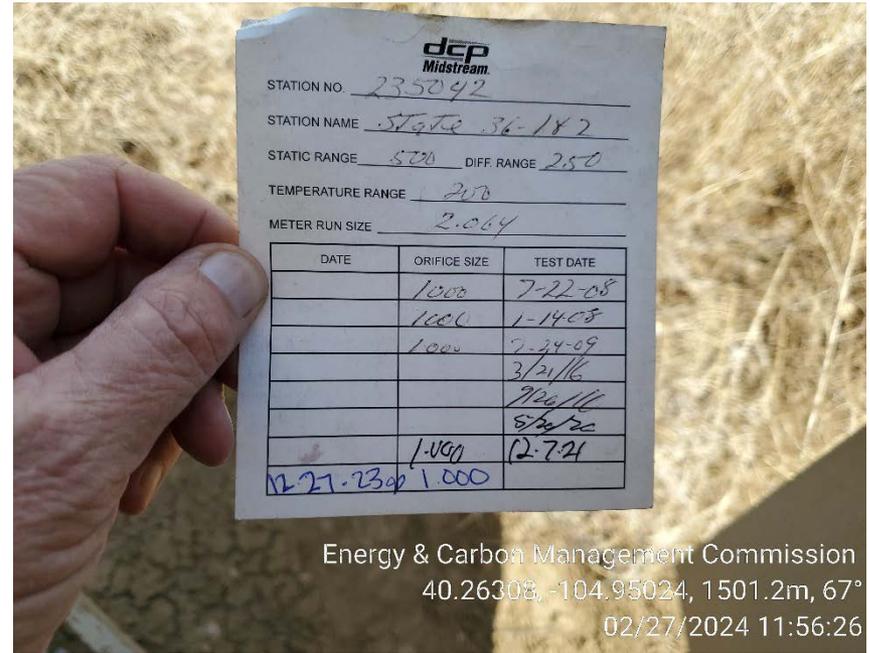
Calibration card on 2/27/2024
