Inspection Photos

API: 061-06296

Operator: STRACHAN EXPLORATION INC

Inspection Date: 2/27/2024

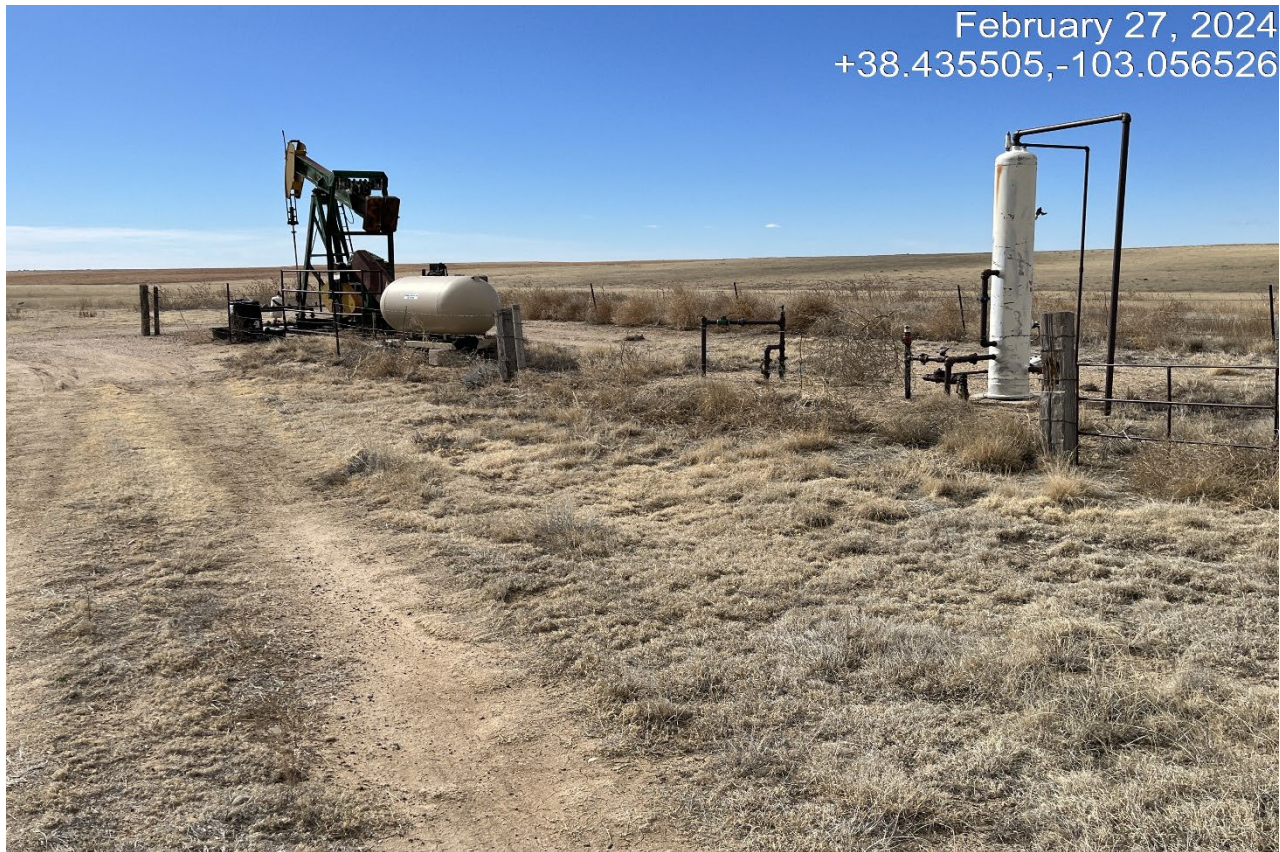
Photo 1. Facing toward the wellsite.

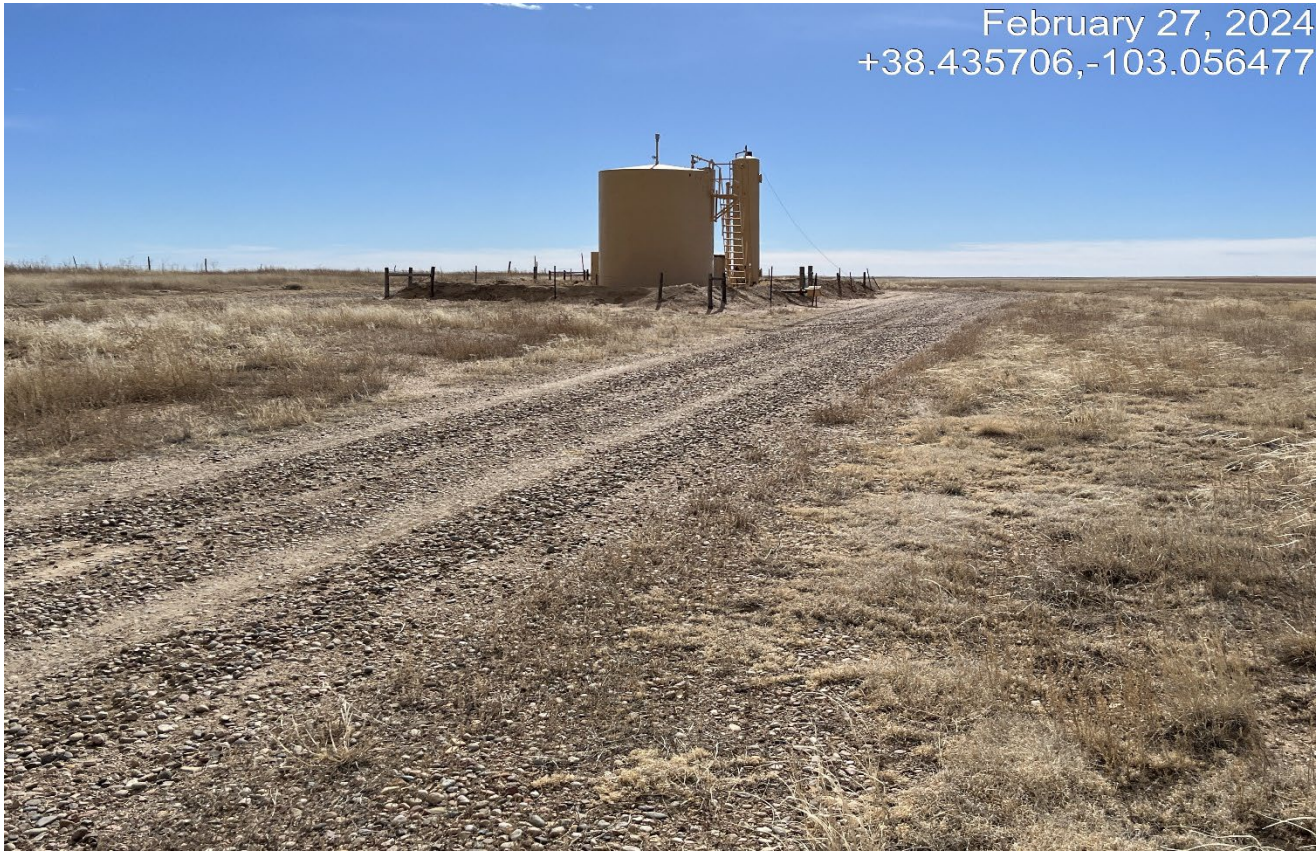
Photo 2. Facing east toward the tank battery.

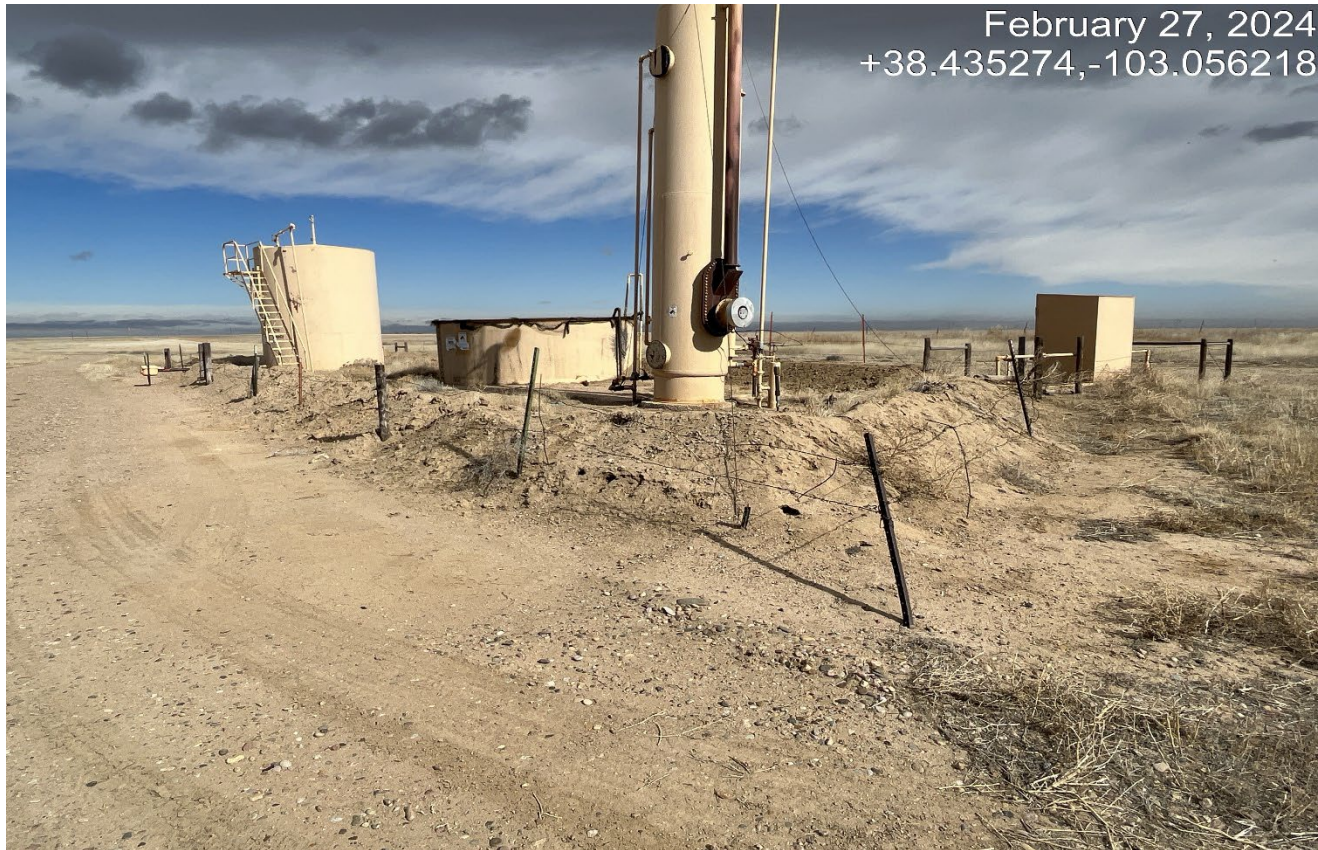
Photo 3. The fence around the tank battery is inadequate to prevent livestock entry and is not maintained. Previous corrective action was not completed.

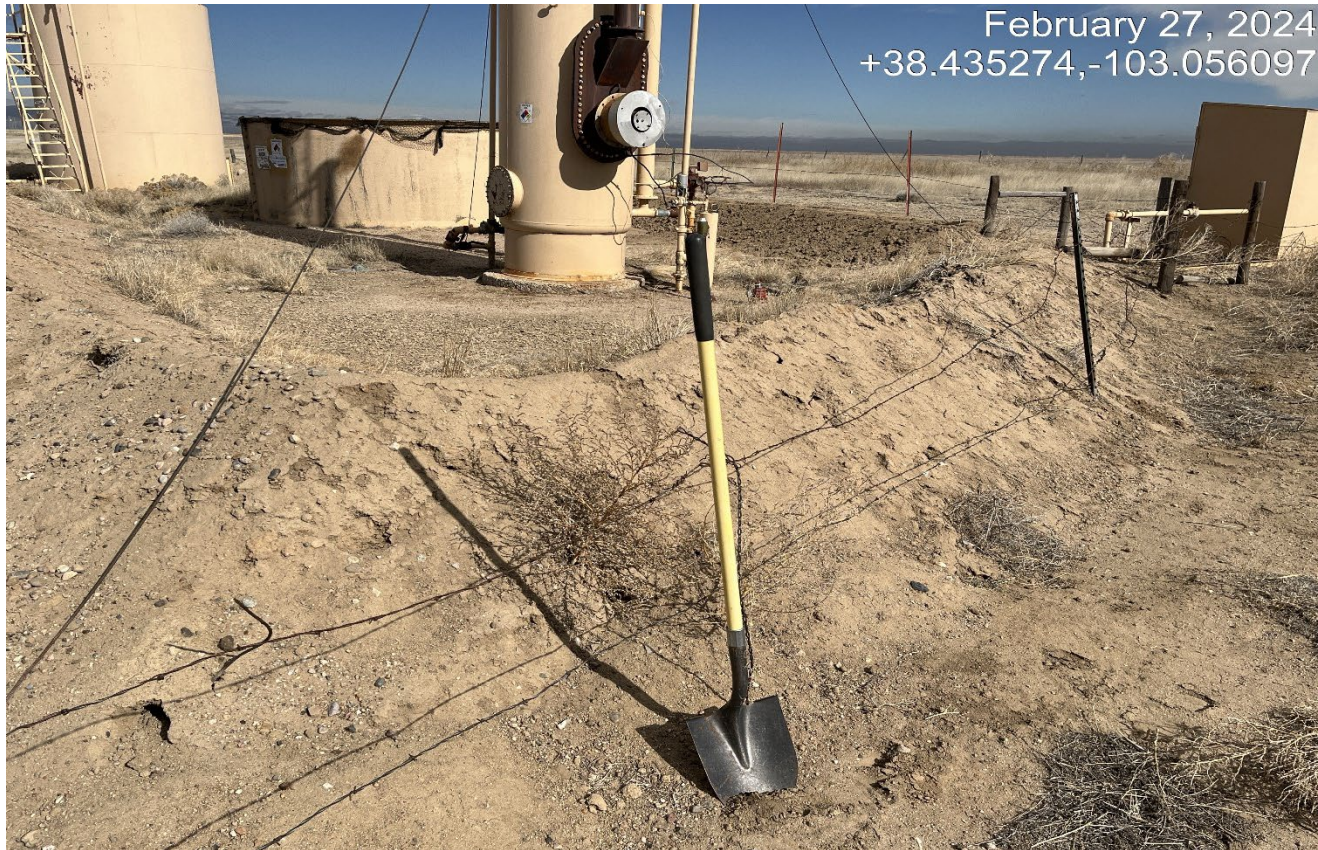
Photo 4. The 4 ft shovel shows loose wires are low only about 2 ft. which livestock can step over and into the fenced area.

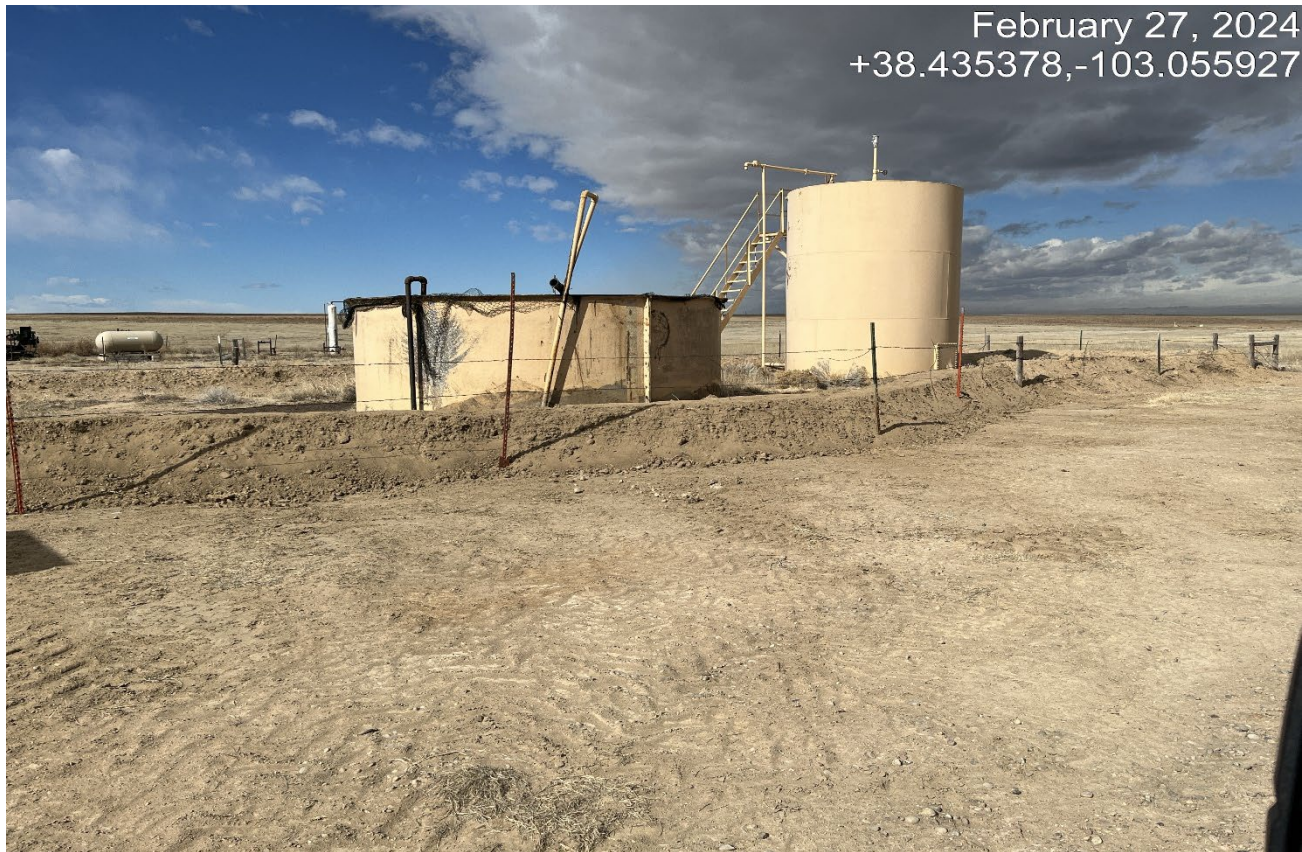
Photo 5. The berm at the open top tank has been rebuilt for containment.
