Inspection Photos

API: 061-06394

Operator: STRACHAN EXPLORATION INC

Inspection Date: 2/27/2024

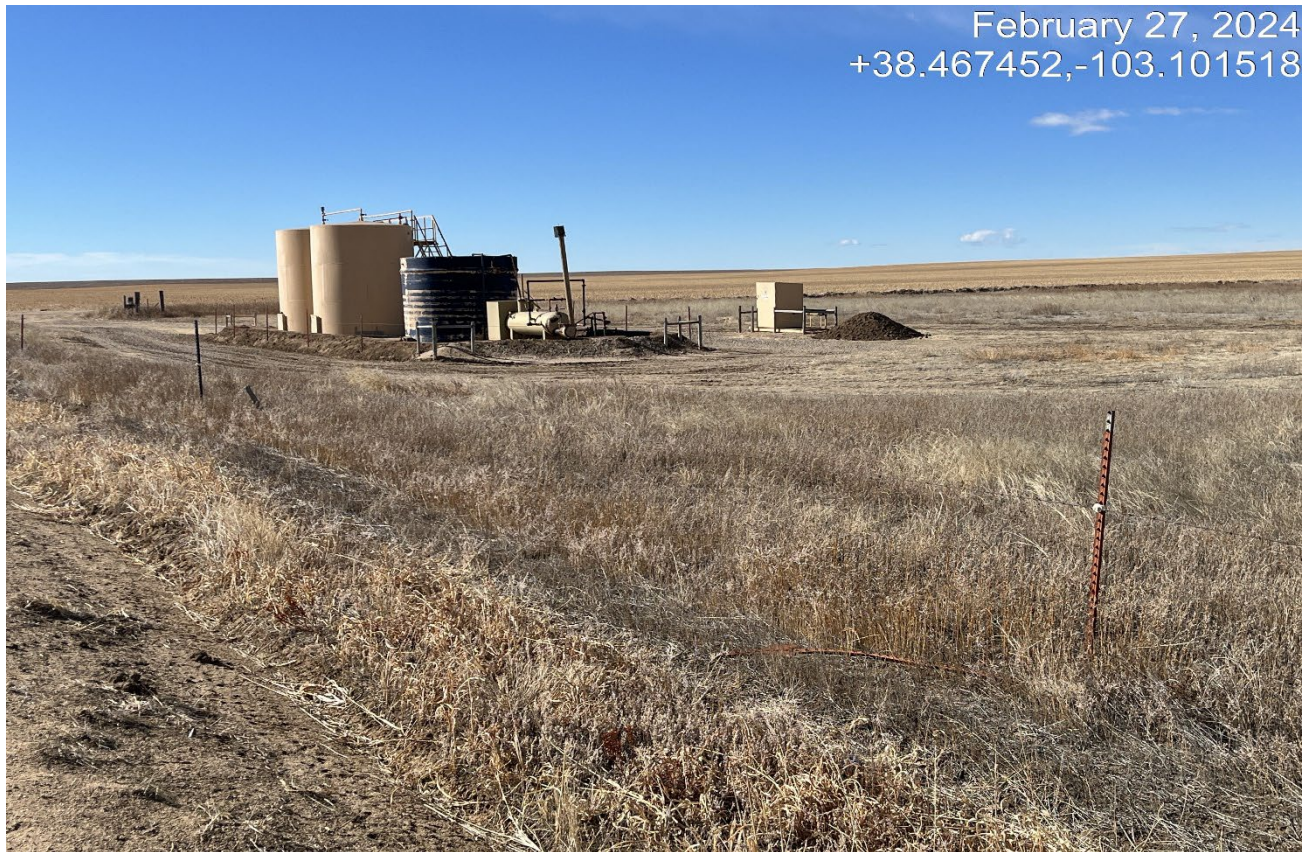
Photo 1. Facing southwest toward the offsite tank battery location. The unused tank has been removed.

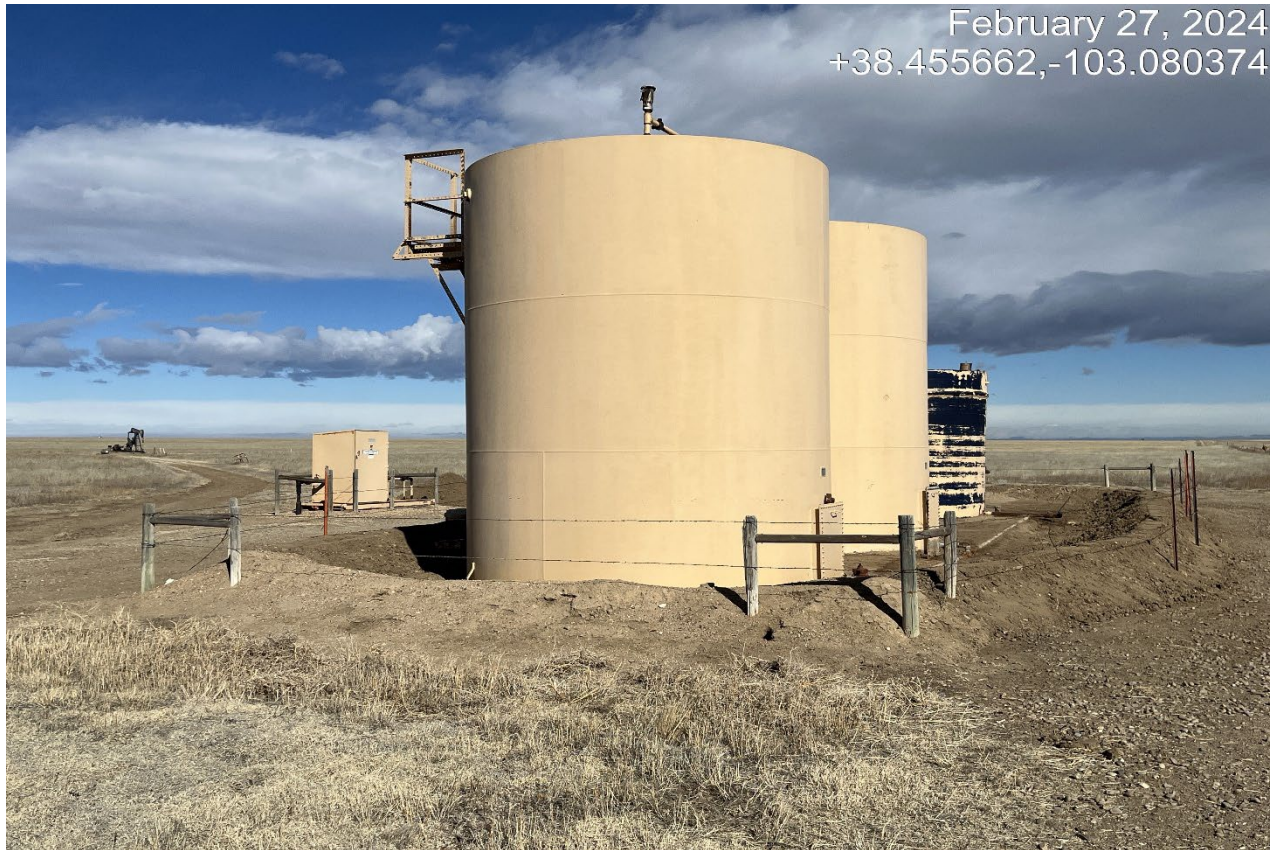
Photo 2. The fence around the tank has been repaired. The wires are tight however there are only 2 wires which may not keep livestock out.

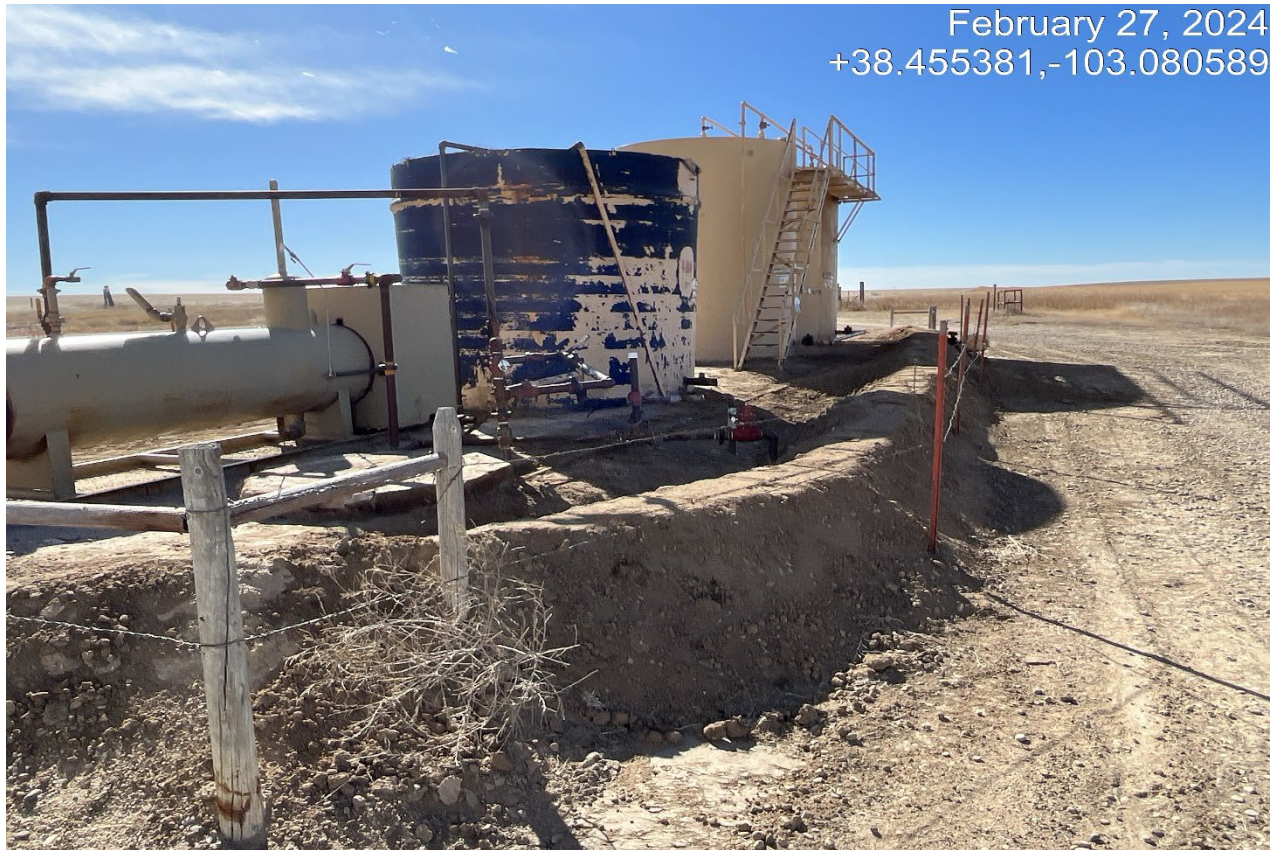
Photo 3. Facing south toward the tank battery. The secondary containment has been repaired.

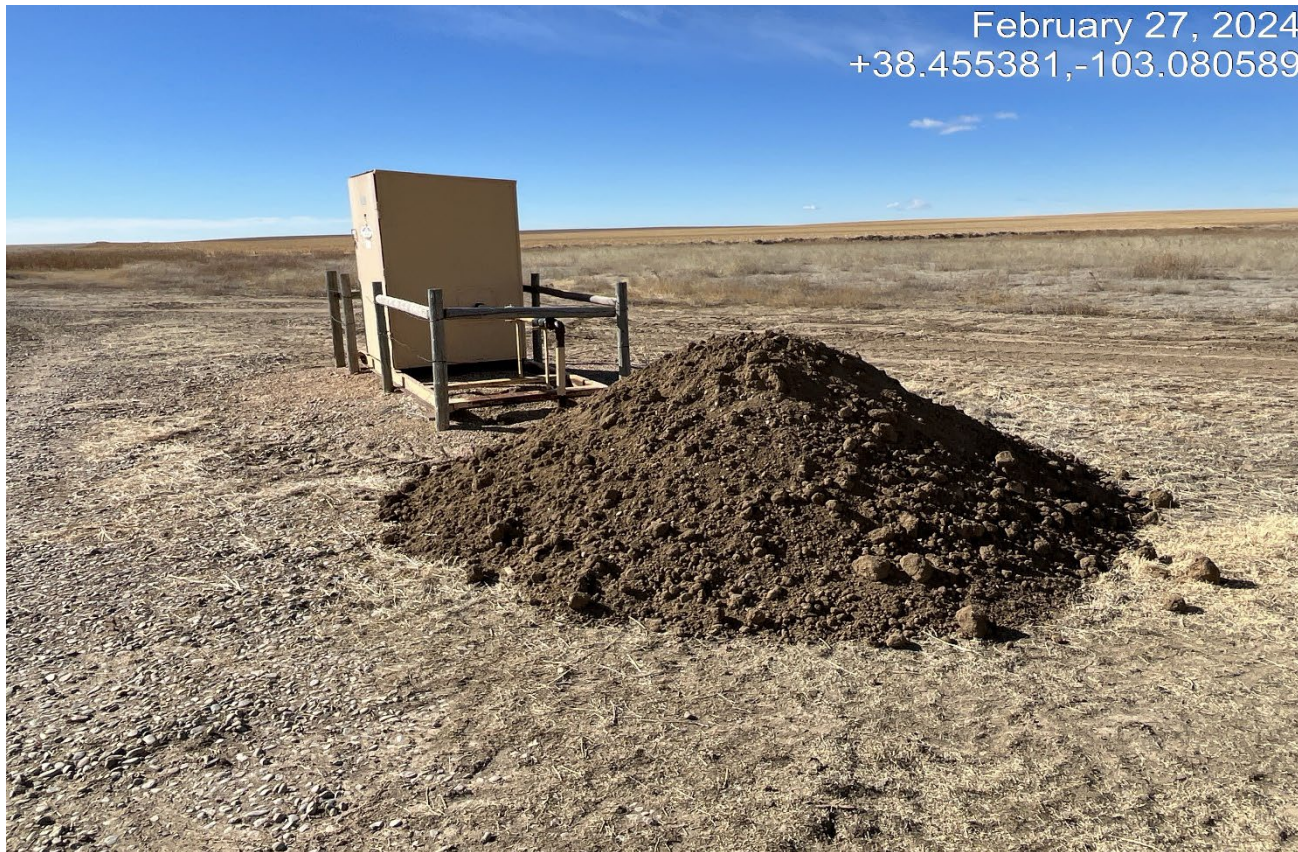
Photo 4. Facing southwest at the meter shed. This pile of soil contains impacted soils with a hydrocarbon odor. This pile needs to be properly disposed.

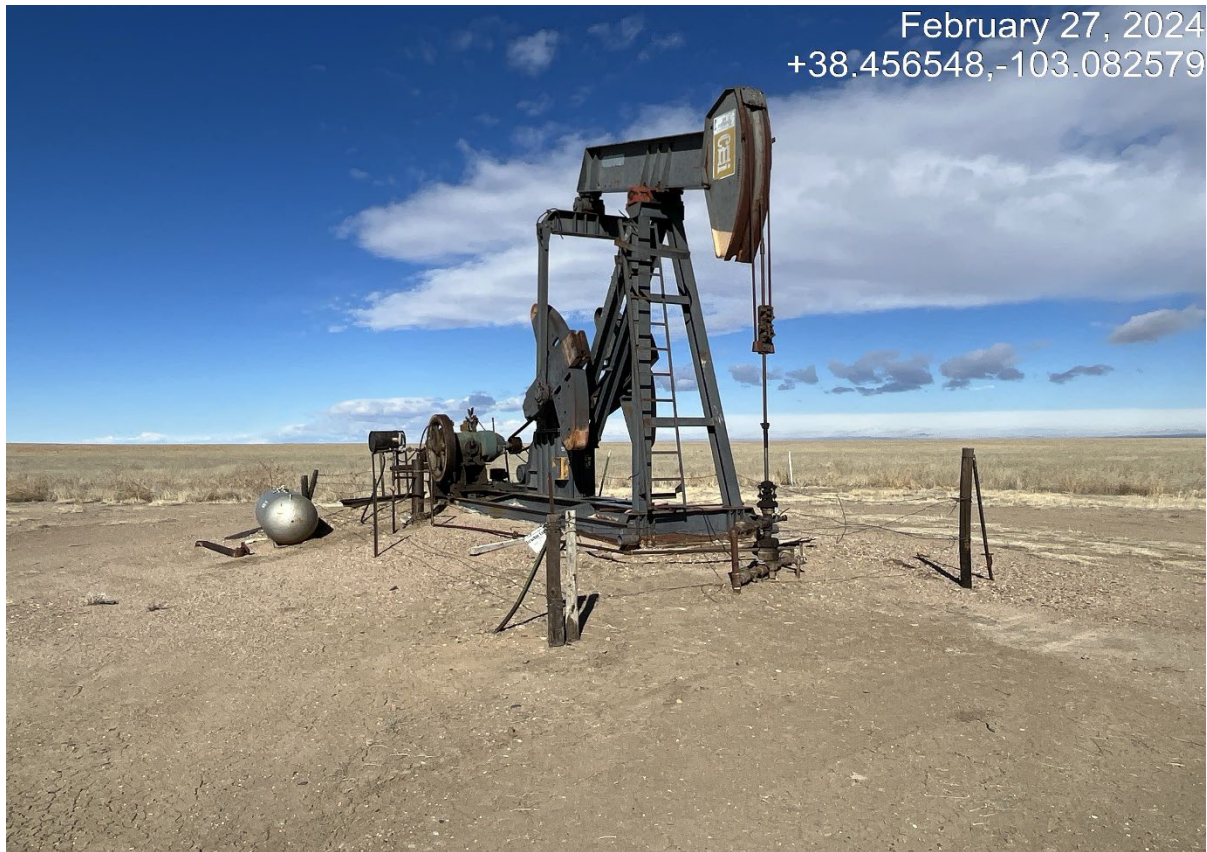
Photo 5. Facing northwest toward the wellsite. The fence around the pumpjack is in disrepair and won't prevent livestock entry.

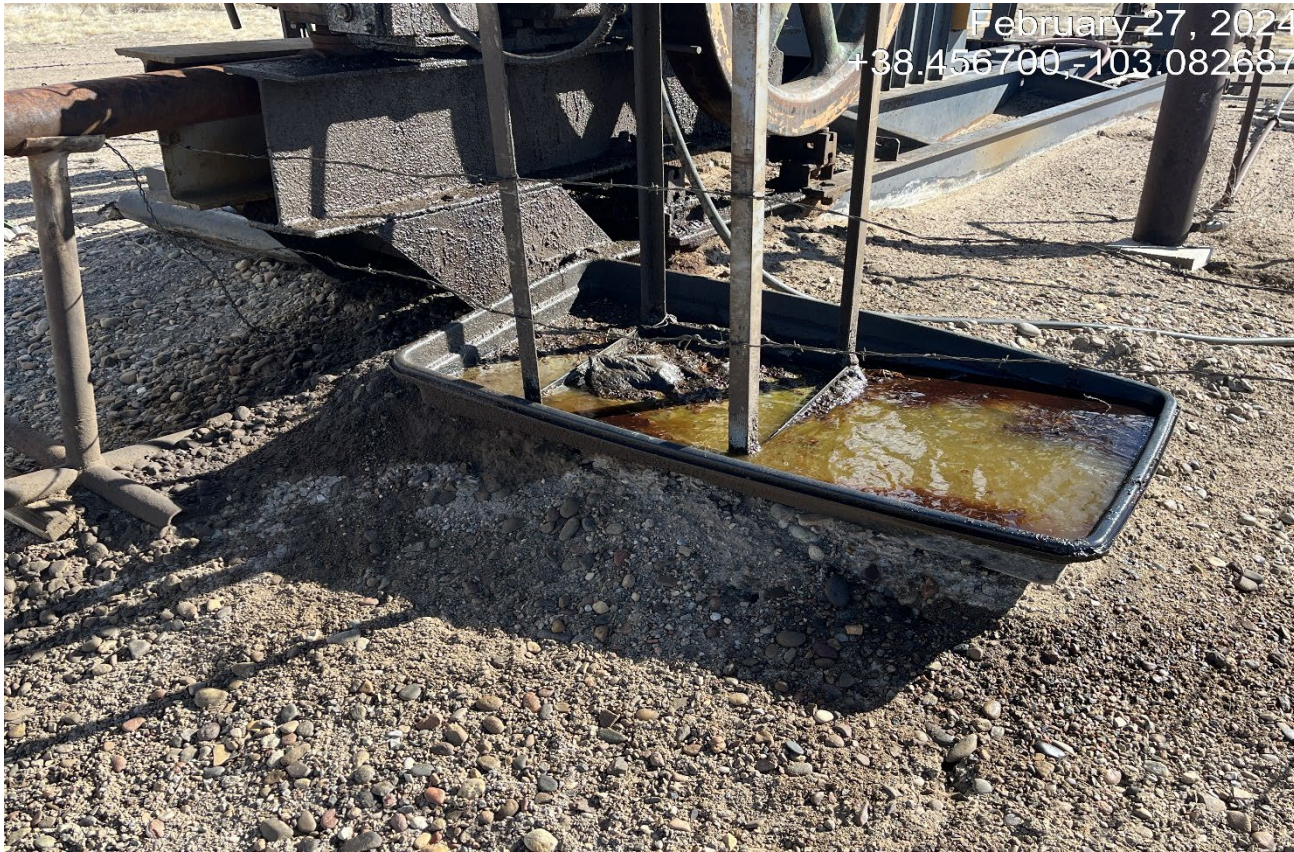
Photo 6. There is oily fluid in the containment next to the pump jack. Oily fluid has spilled onto the ground and needs to be cleaned up. Previous corrective action was not completed. Netting must be installed to prevent wildlife entry.
