**SITE-SPECIFIC QUALITY ASSURANCE
& QUALITY CONTROL AUDIT**

PERMIT CLOSURE REPORT – CROPLAND

Location ID 329854

Location Name KAMMERZELL-65N66W/29NWNW

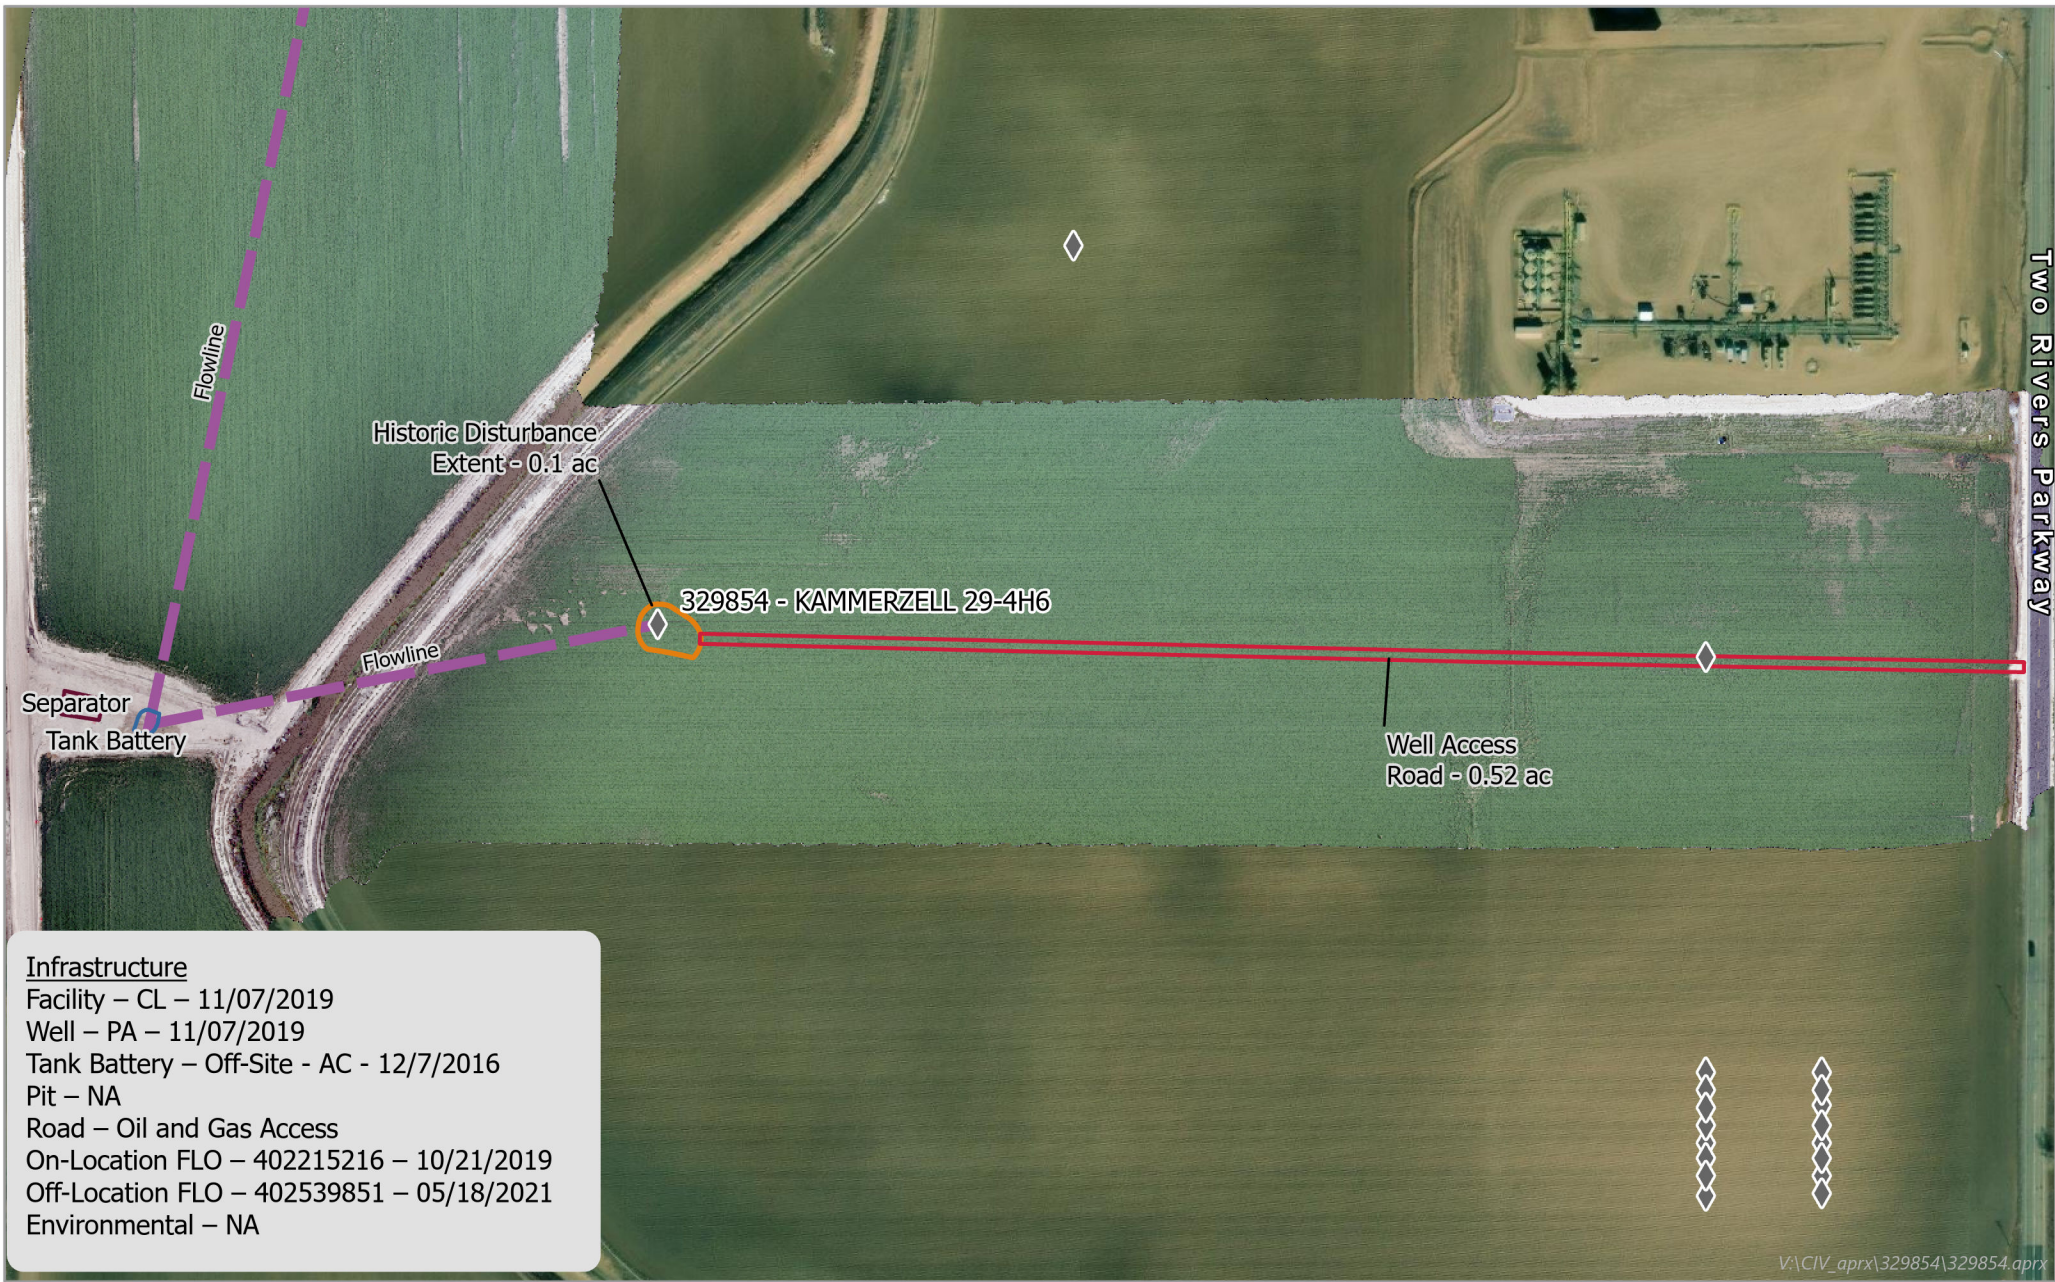
**CIV - 329854 - Kammerzell 29-4H6
 Map Extent - Post-Plugging Road
 Overview**

Soil Sage drone imagery confirms that no equipment was left on site at this location after reclamation activities occurred.

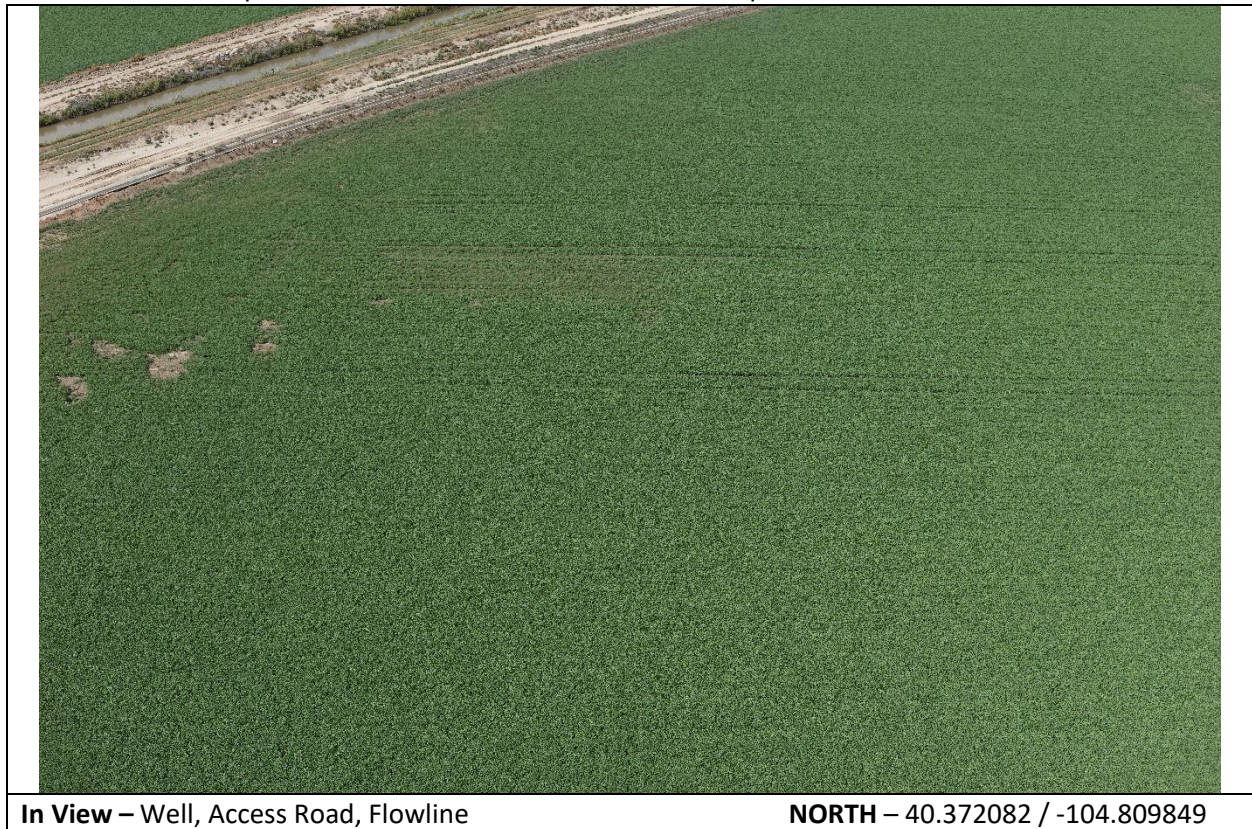
NORTH – 40.372082 / -104.809849

In View – Well, Access Road, Flowline

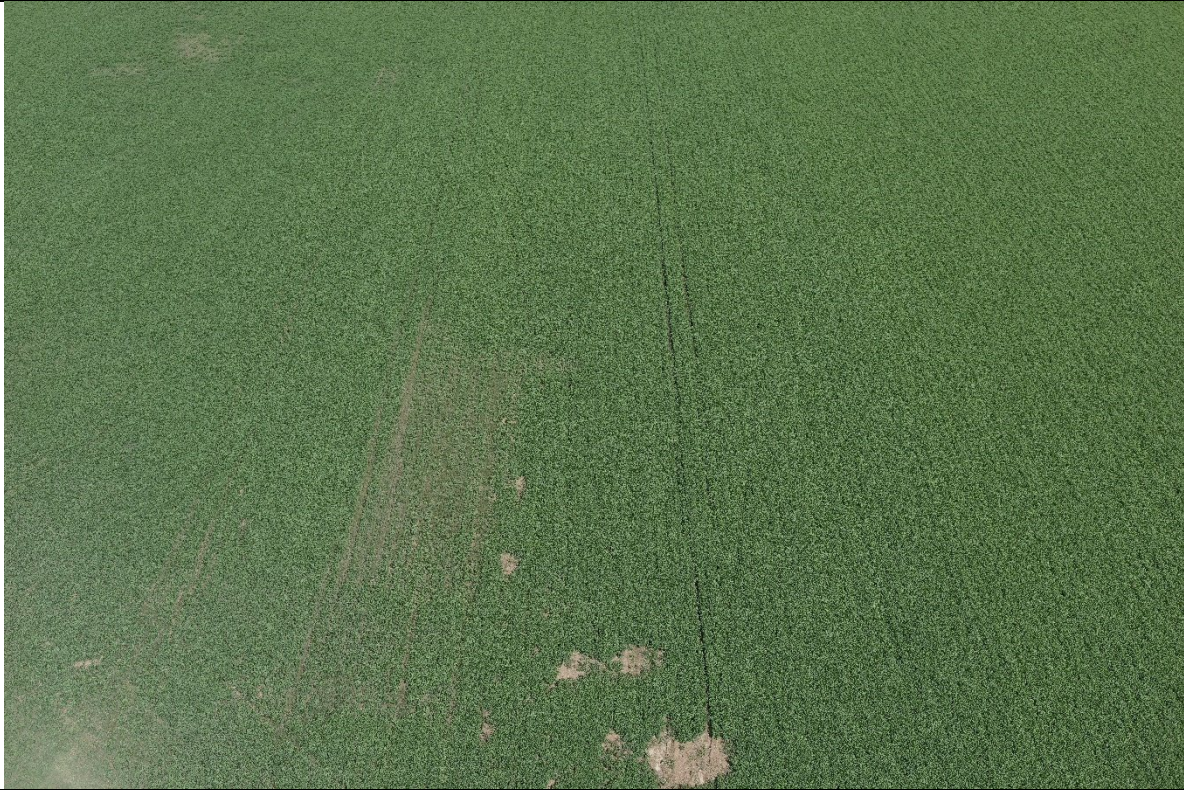
EAST – 40.372846 / -104.810769

In View – Well, Access Road, Flowline

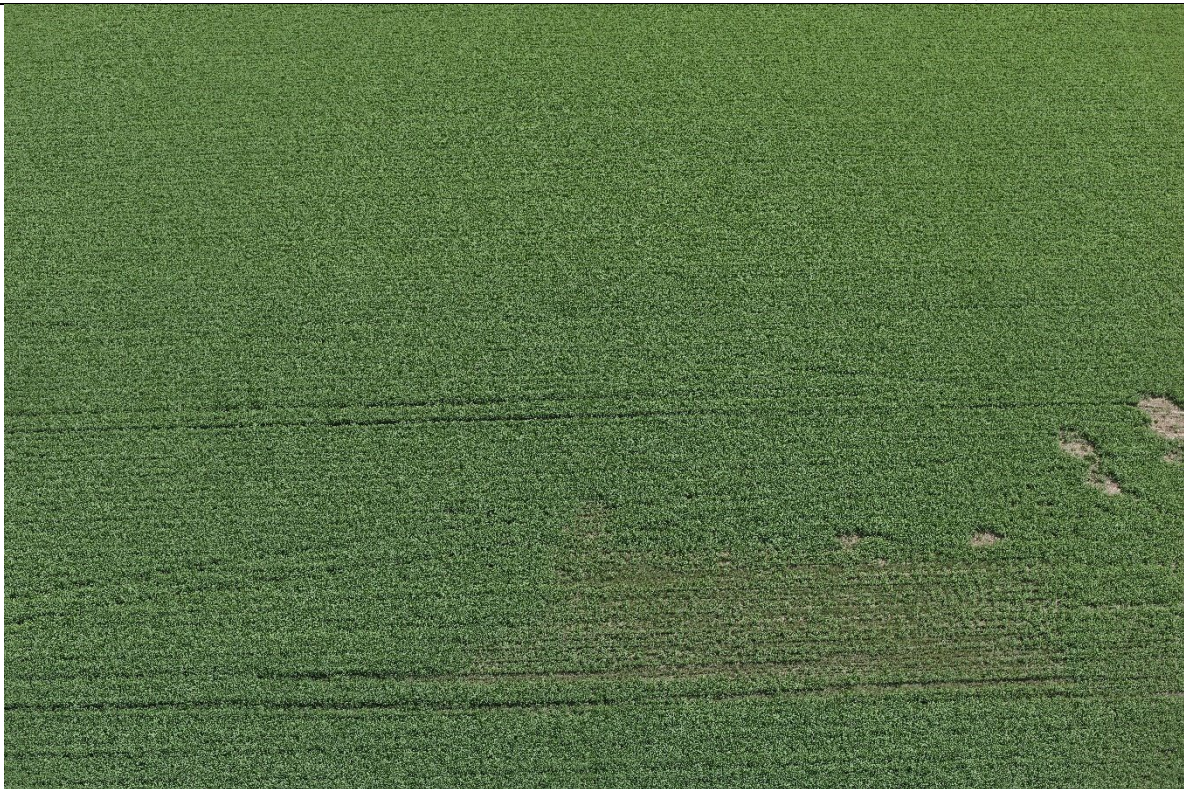
SOUTH – 40.373331 / -104.809820

In View – Well, Access Road, Flowline

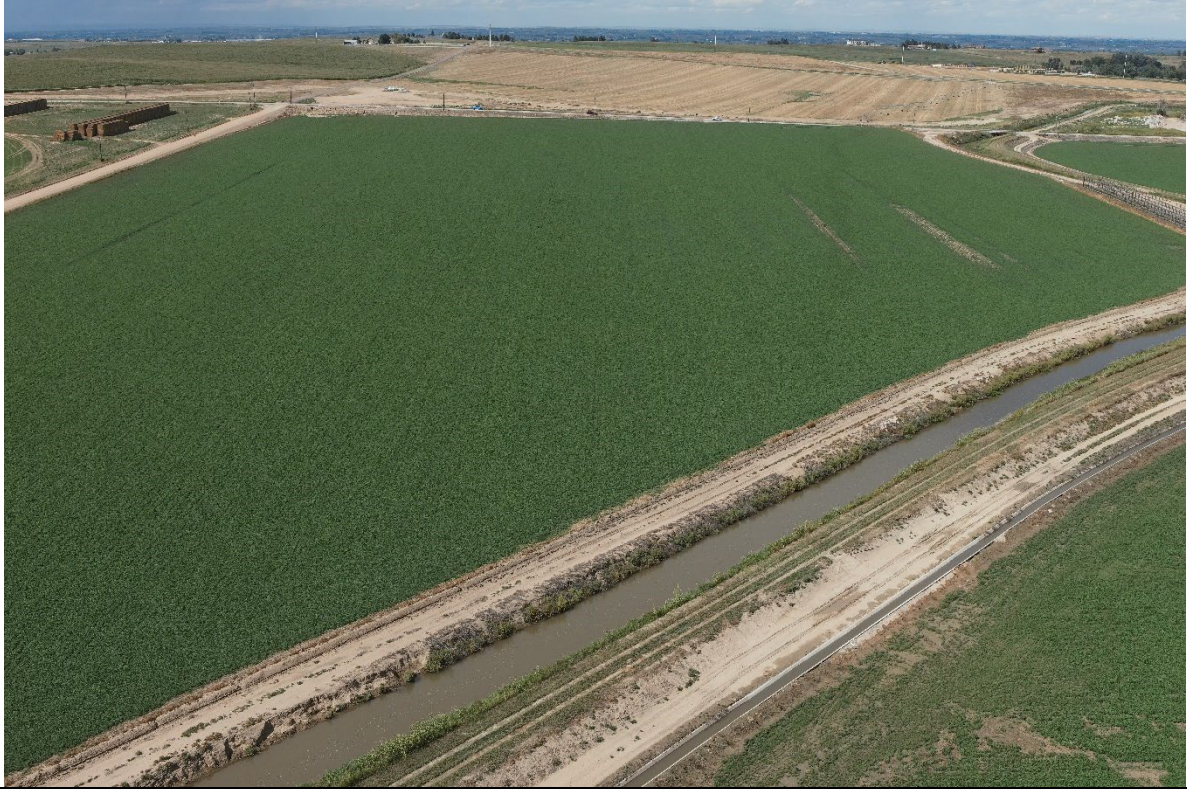
SOUTH – 40.372095 / -104.810903

In View – Well, Access Road, Flowline

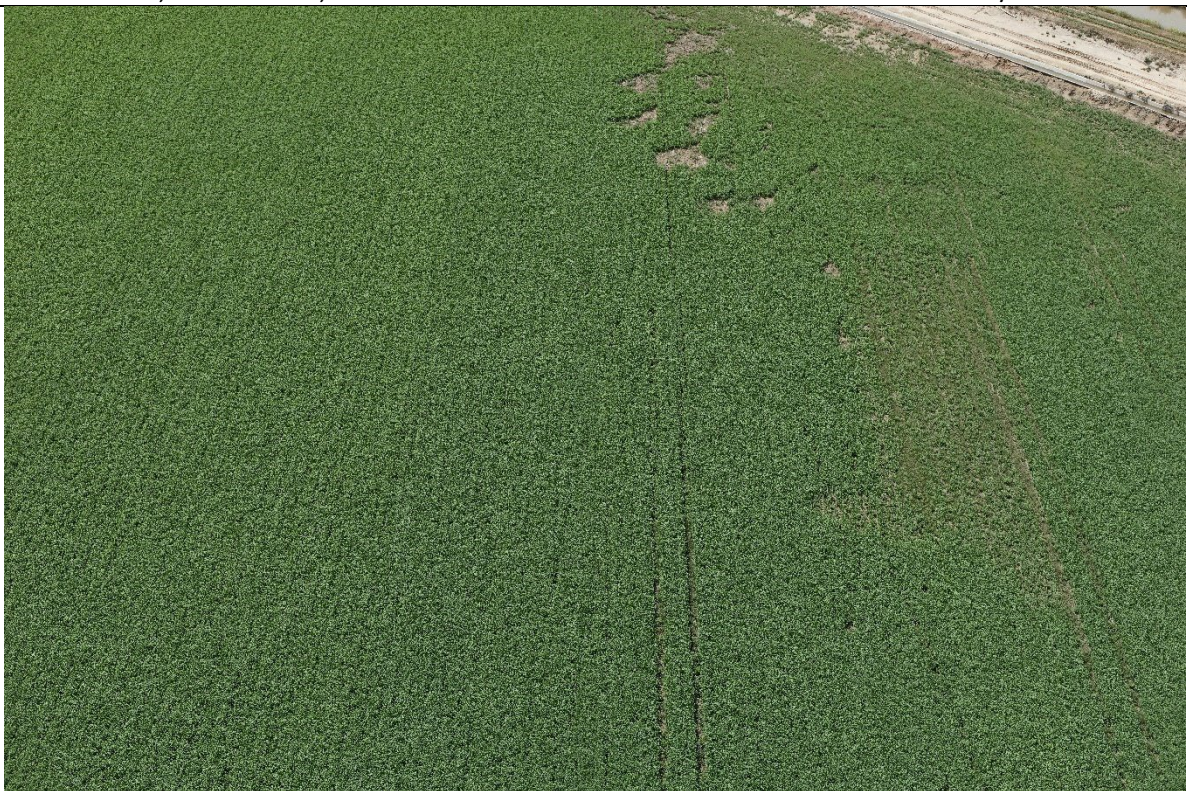
WEST – 40.372758 / -104.809274

In View – Well, Access Road, Flowline

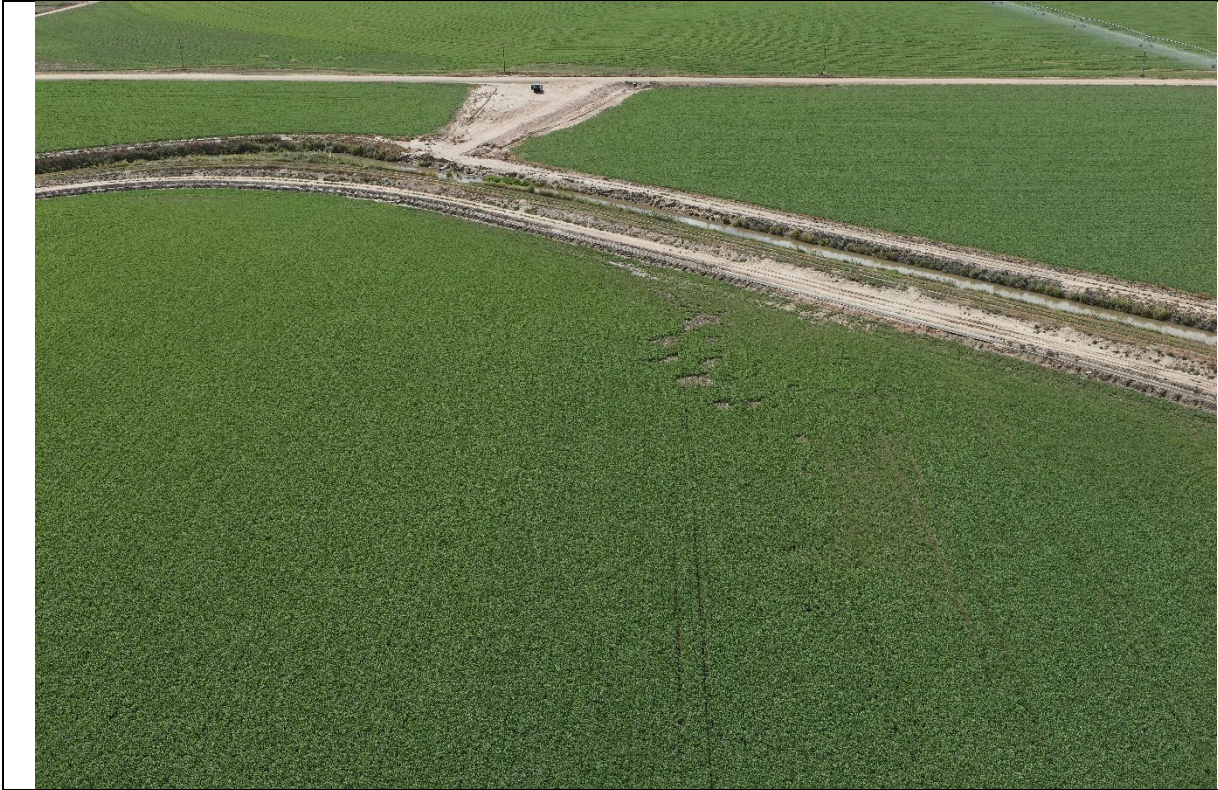
WEST – 40.372758 / -104.808796

In View – Well, Tank Battery, Access Road, Flowline

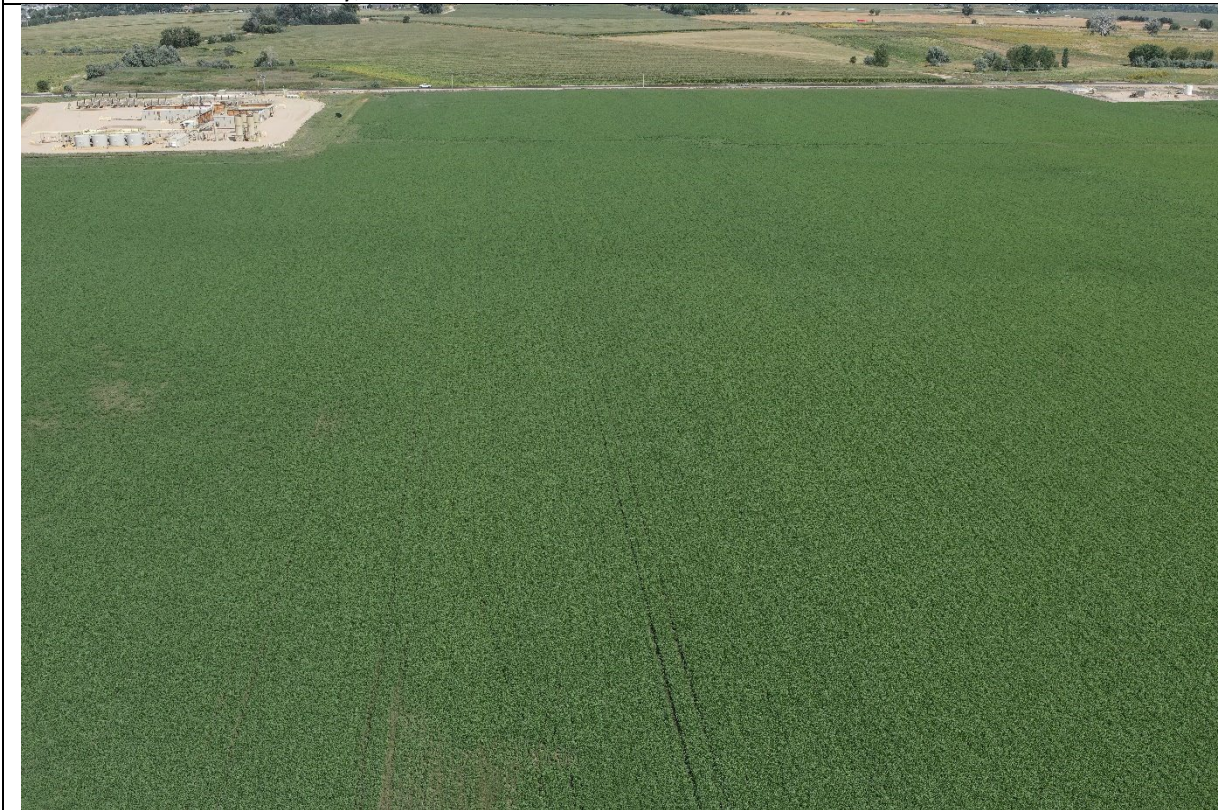
EAST – 40.372908 / -104.810676

In View – Well, Access Road, Flowline

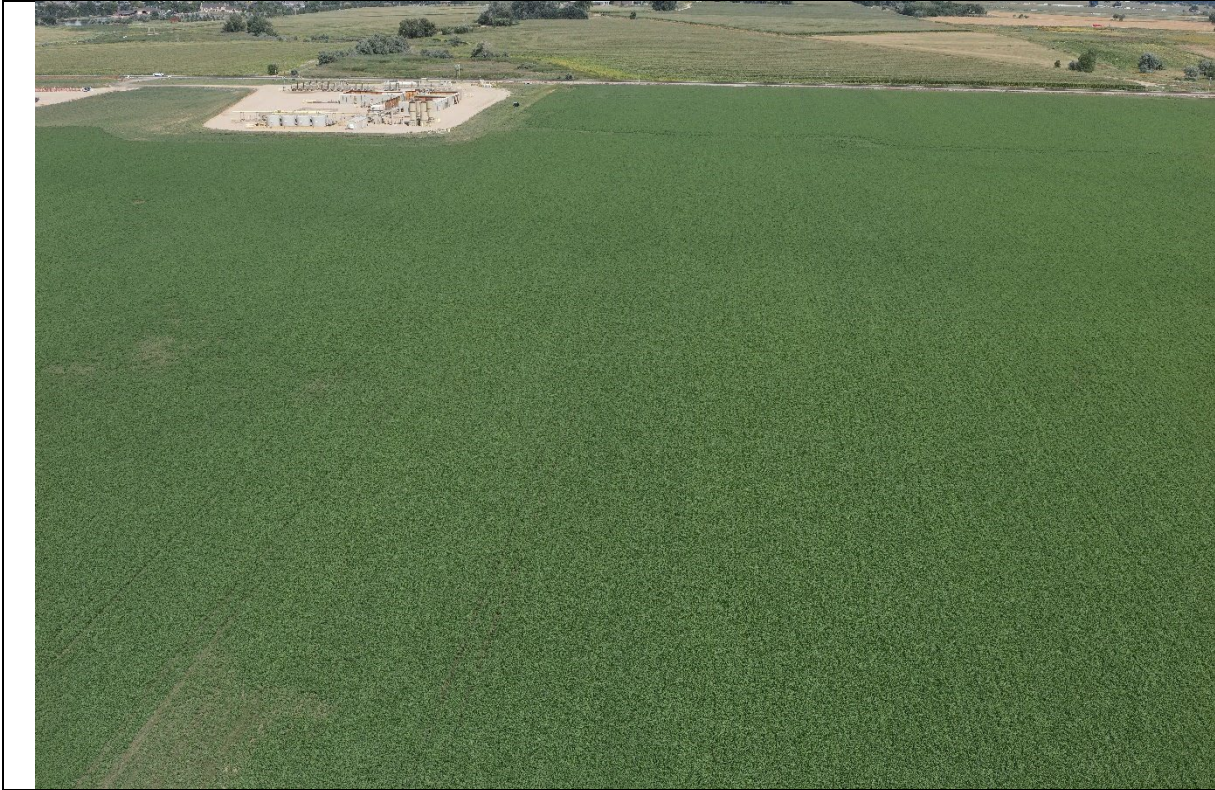
EAST – 40.372608 / -104.810684

In View – Well, Access Road, Flowline

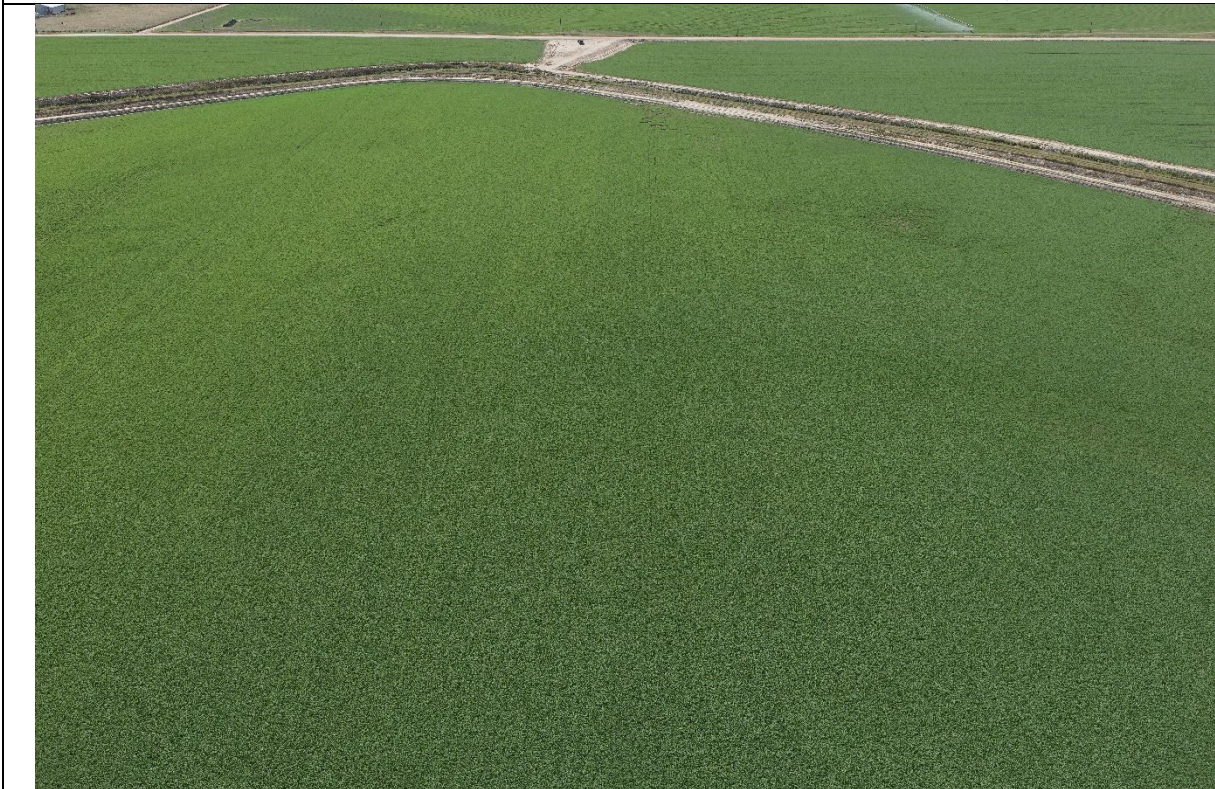
WEST – 40.372757 / -104.805356

In View – Well, Tank Battery, Access Road, Flowline

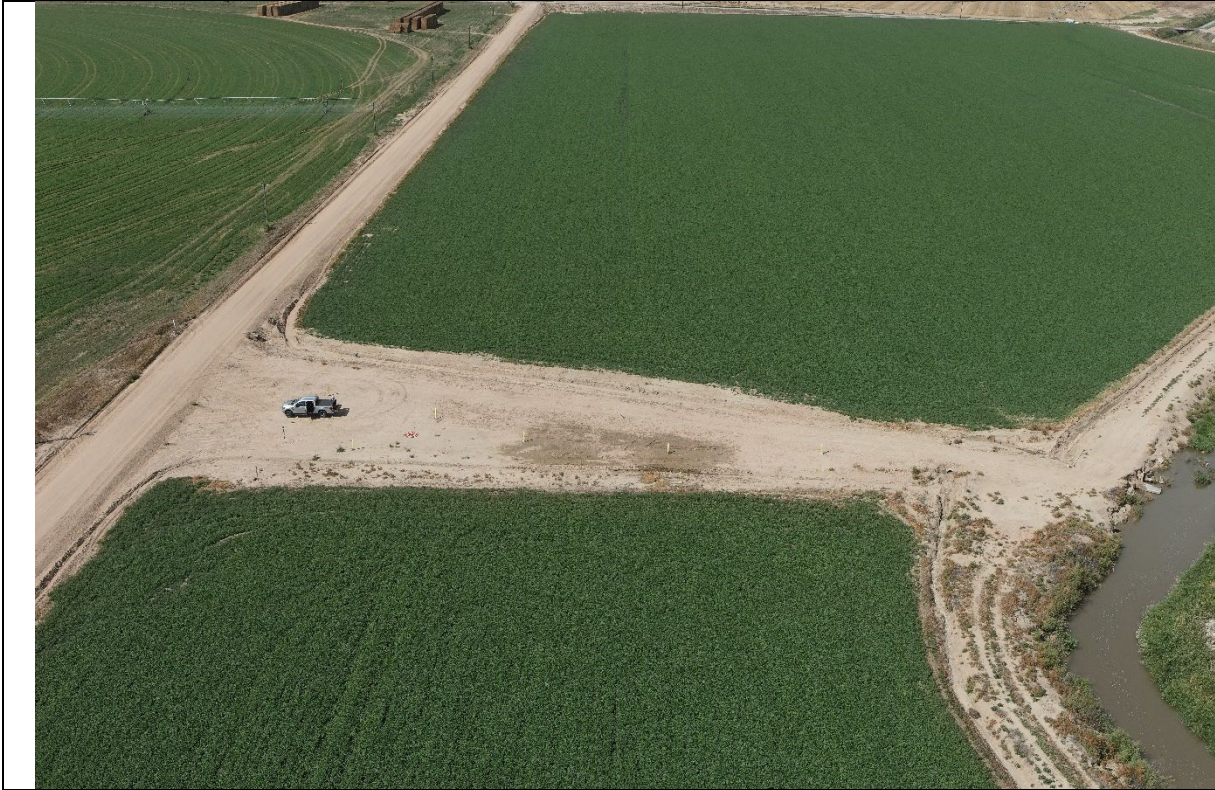
NORTH – 40.371418 / -104.812191

In View – Tank Battery, Flowline

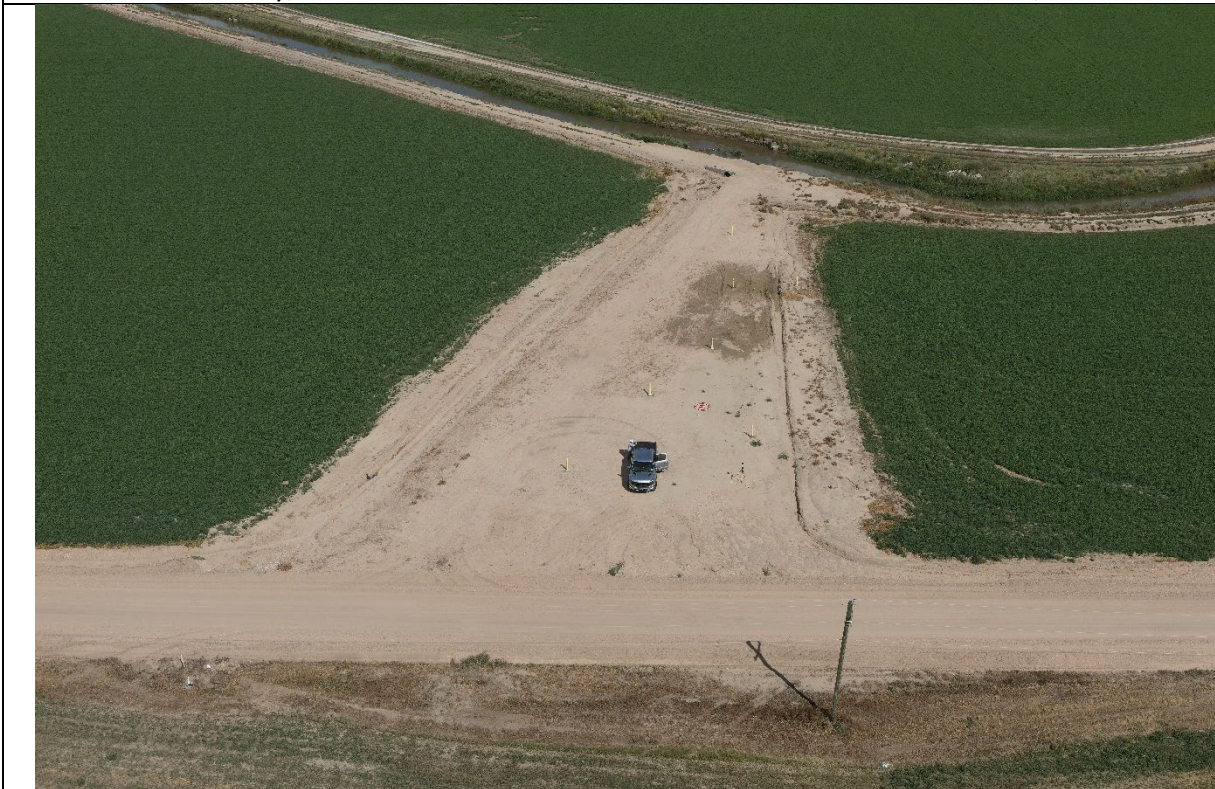
EAST – 40.372449 / -104.813546

In View – Tank Battery, Flowline

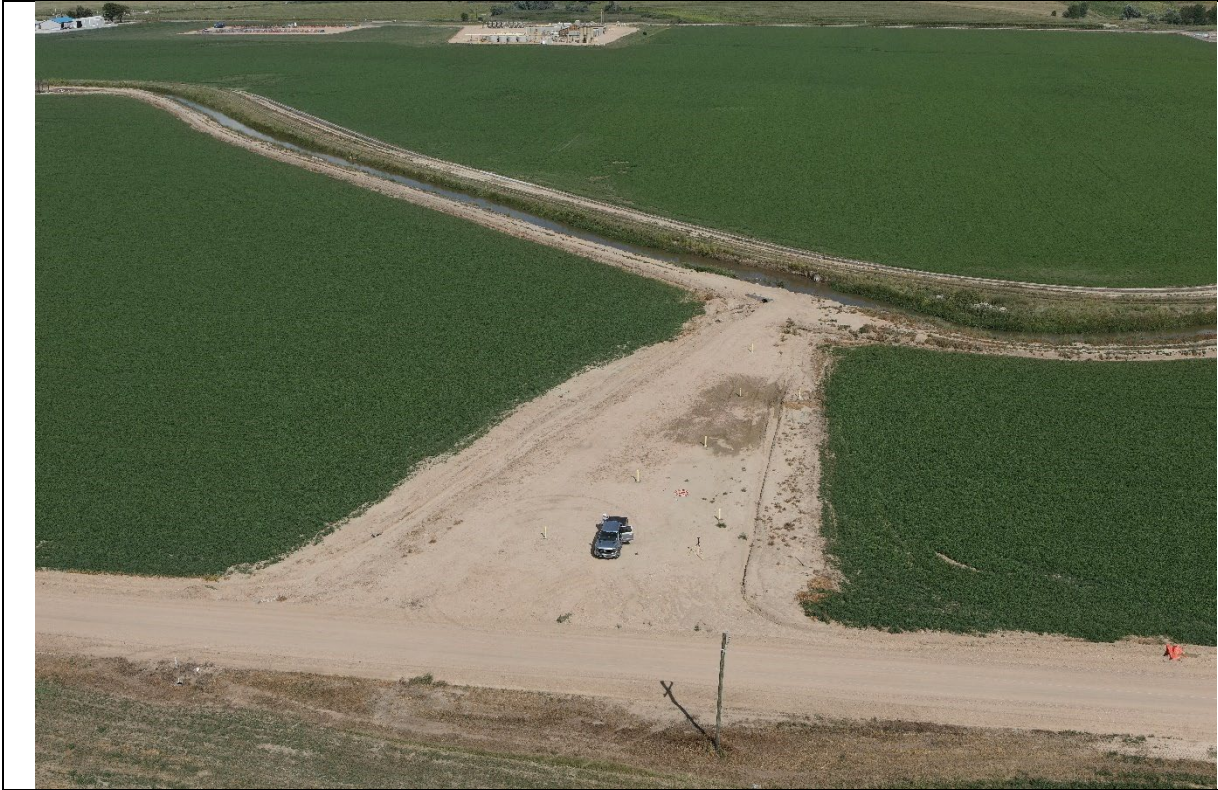
EAST – 40.372323 / -104.813675

In View – Tank Battery, Flowline

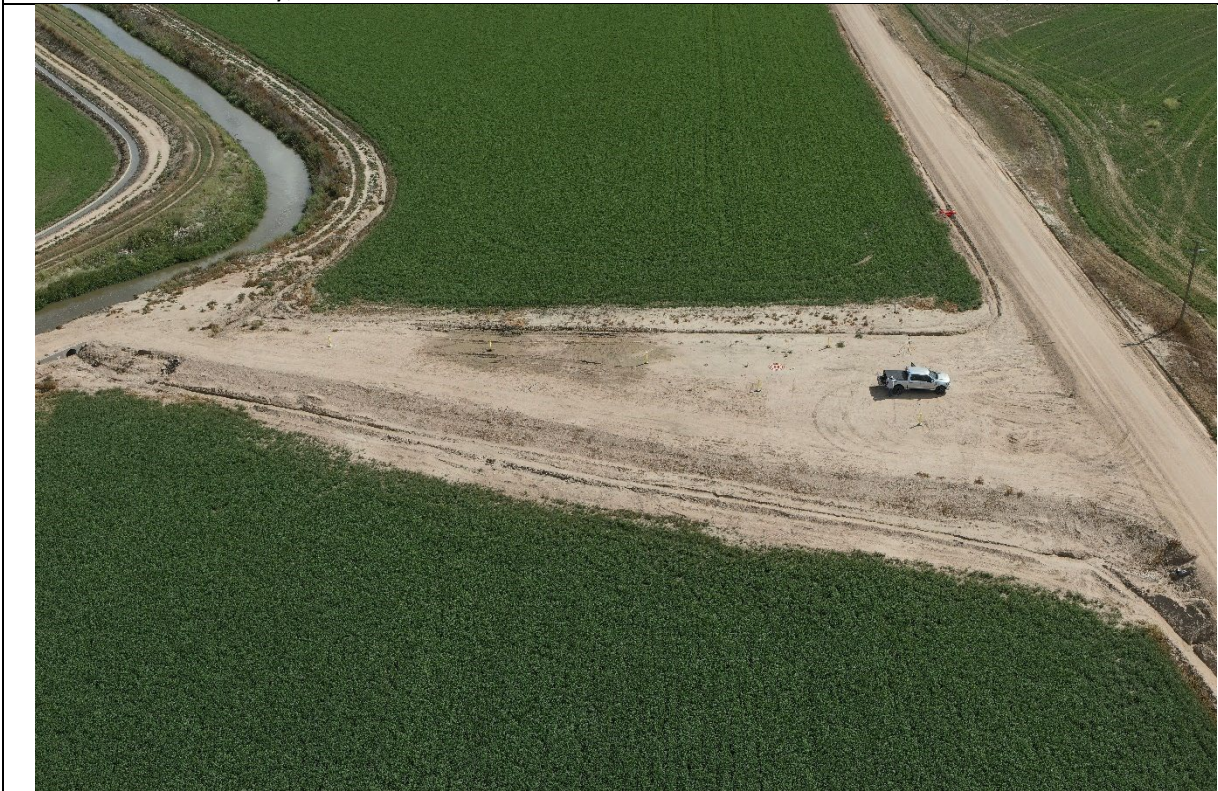
SOUTH – 40.373320 / -104.812388

In View – Tank Battery, Flowline

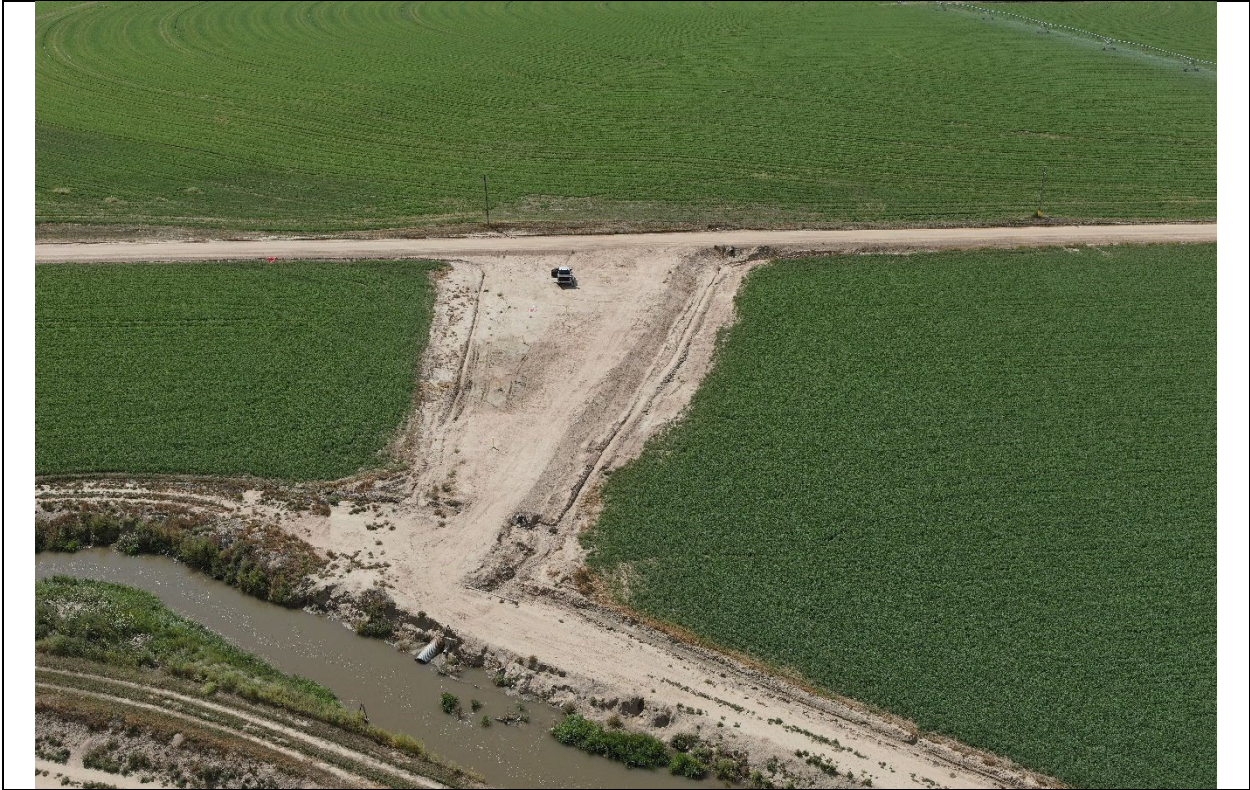
WEST – 40.372475 / -104.810709

In View – Tank Battery, Flowline

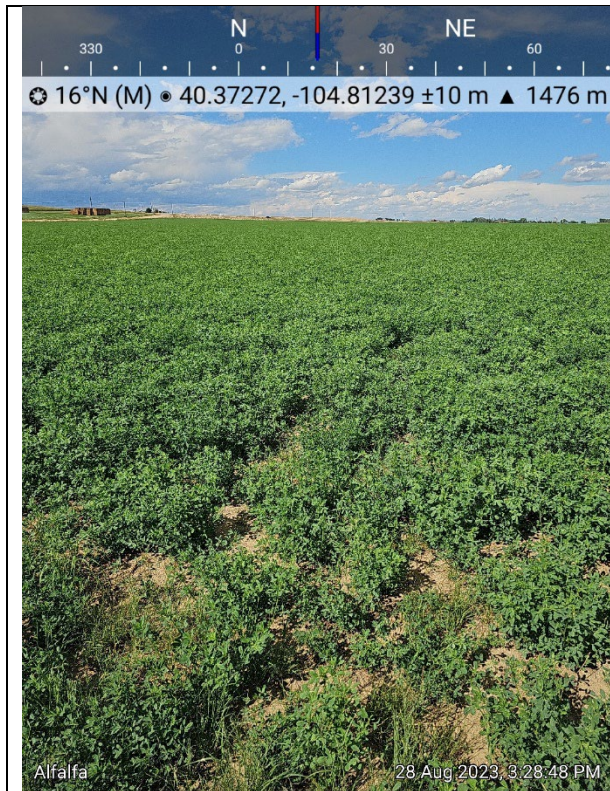
Looking North into alfalfa field –
40.372720 / -104.812390

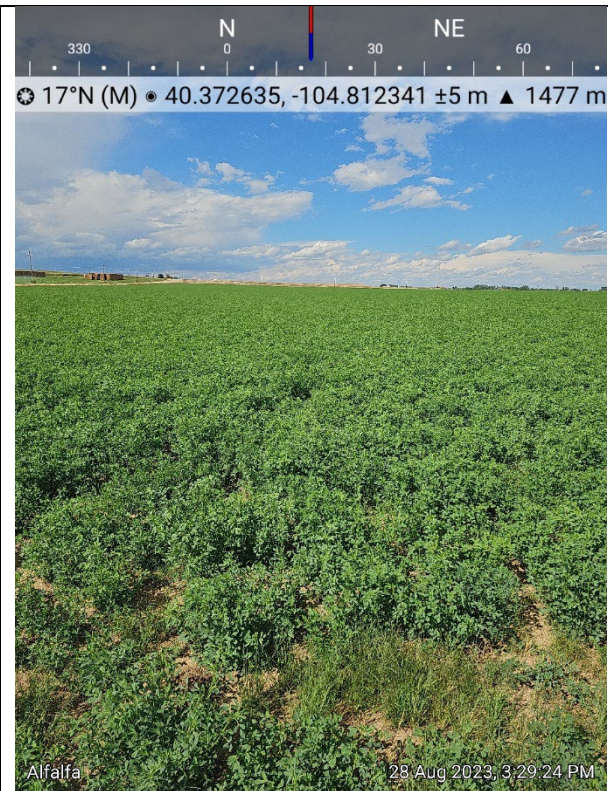
Looking North into alfalfa field –
40.372635 / -104.812341

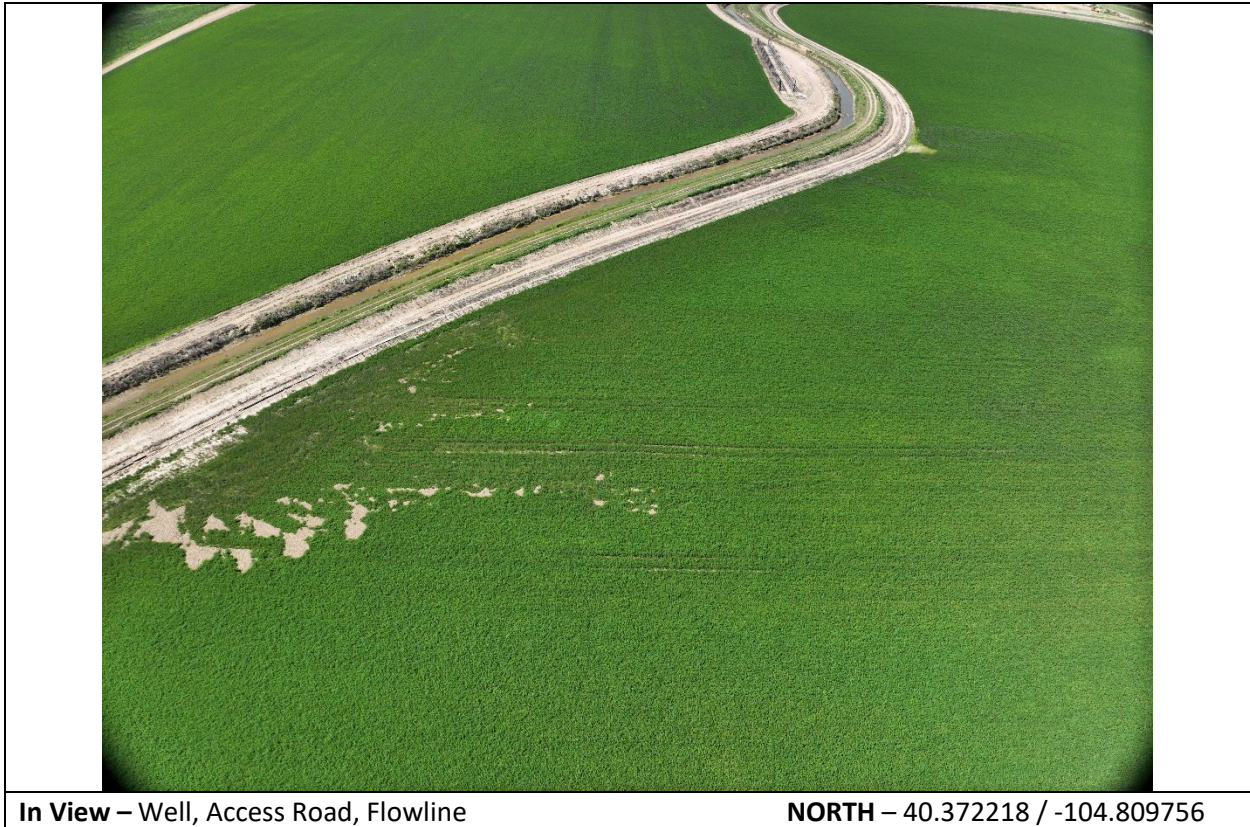
NORTH – 40.372218 / -104.809756

In View – Well, Access Road, Flowline

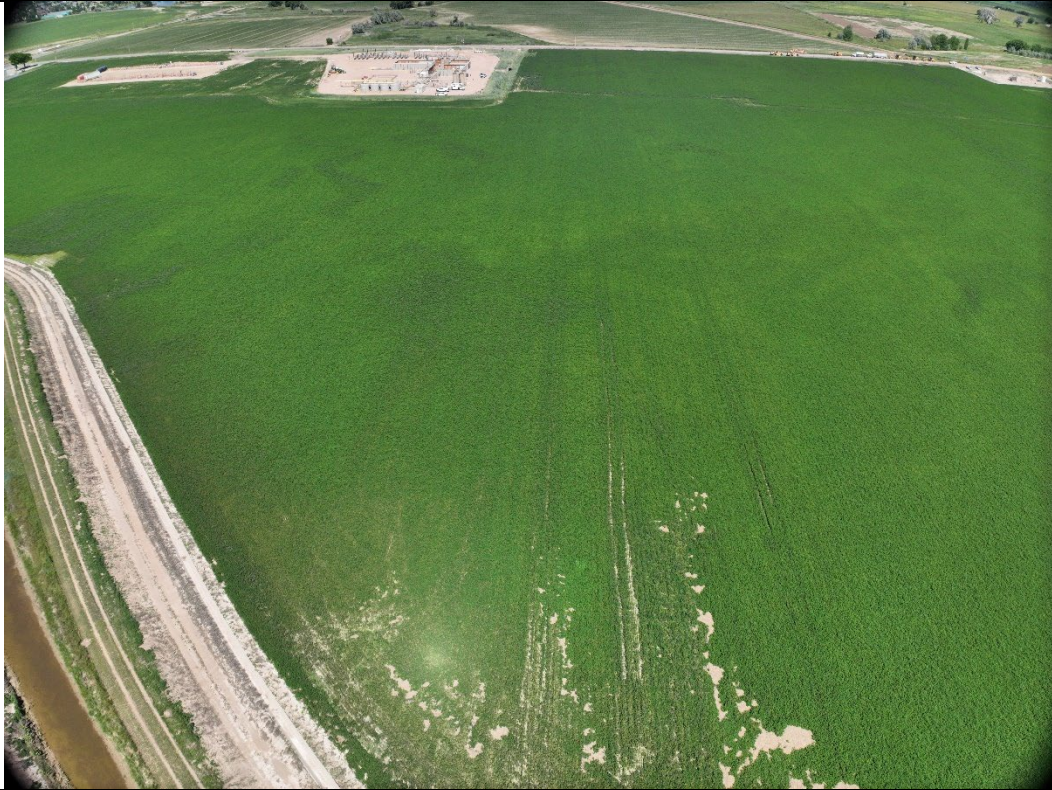
EAST – 40.373067 / -104.810751

In View – Well, Access Road, Flowline

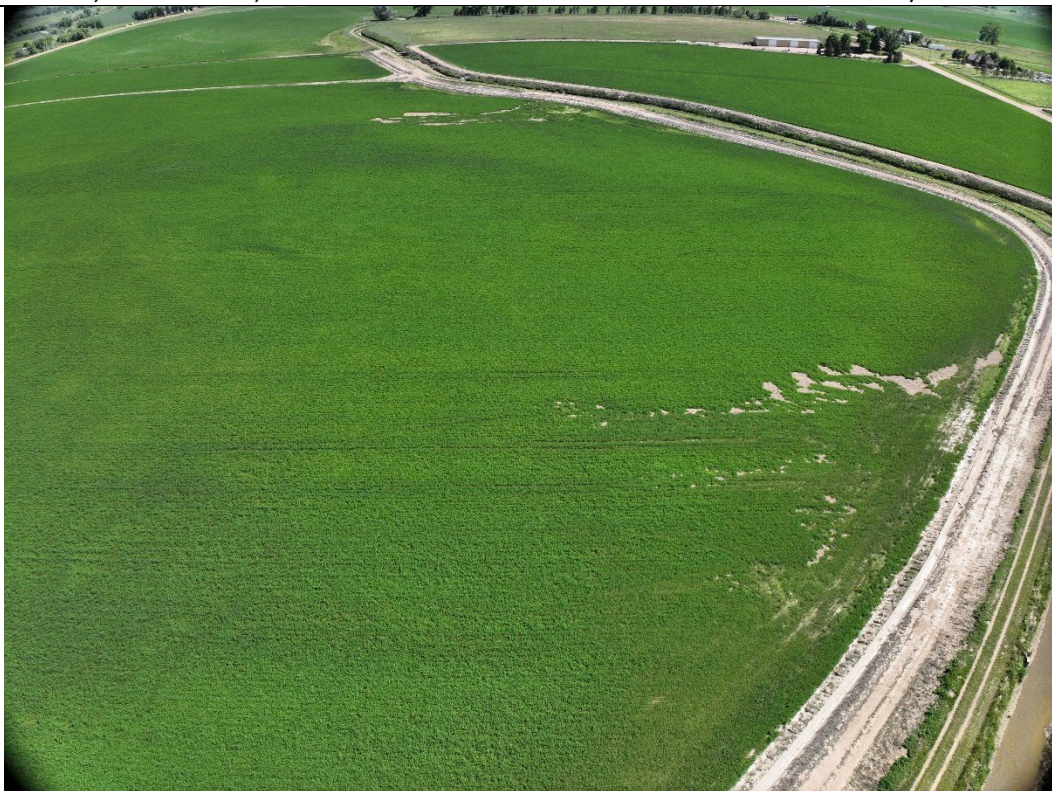
SOUTH – 40.373880 / -104.809669

In View – Well, Access Road, Flowline

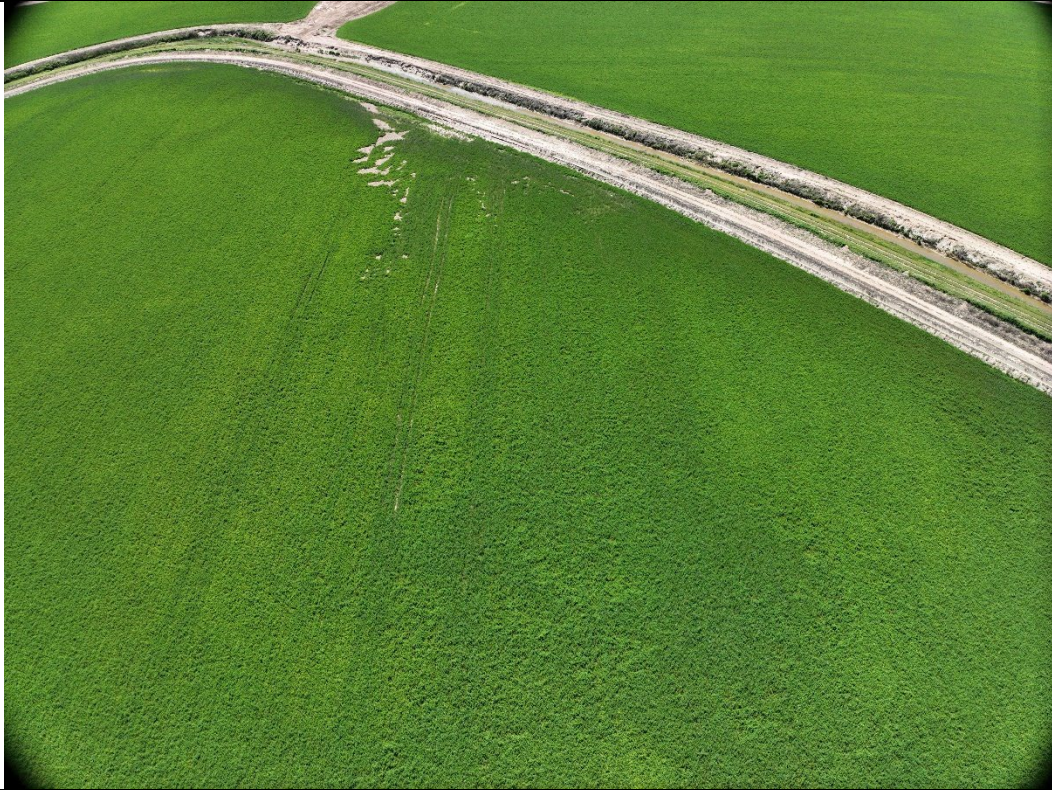
WEST – 40.373162 / -104.808343

In View – Well, Tank Battery, Access Road, Flowline

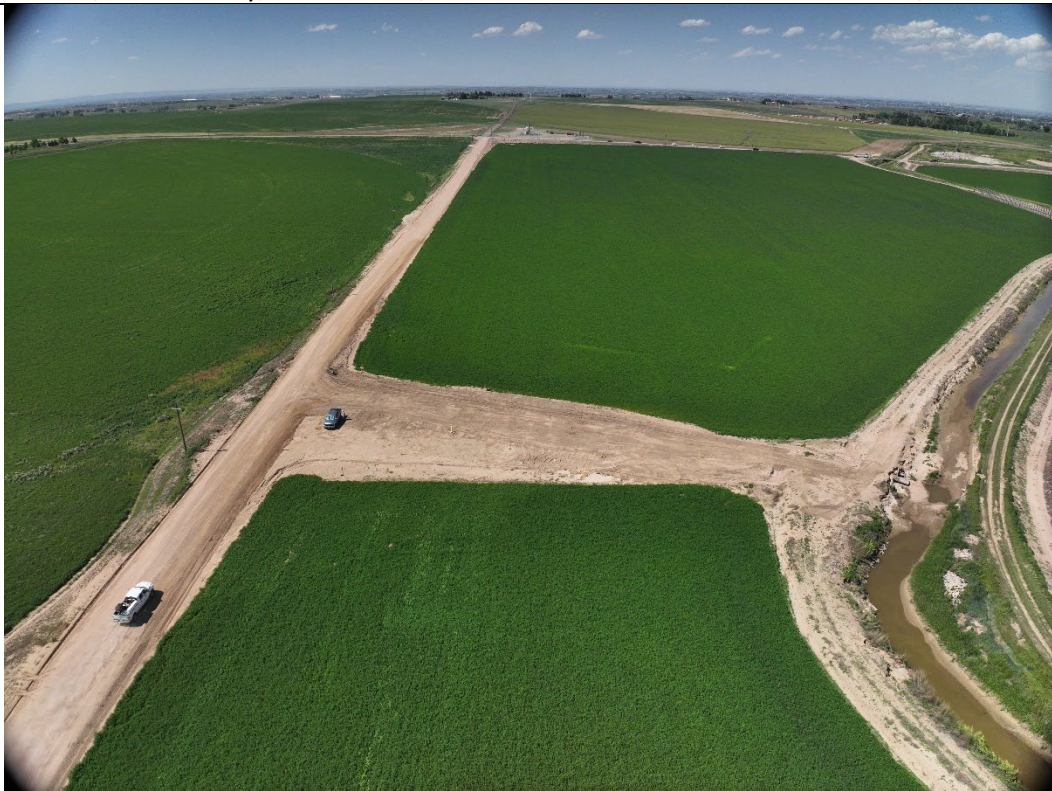
NORTH – 40.371467 / -104.812280

In View – Tank Battery, Flowline

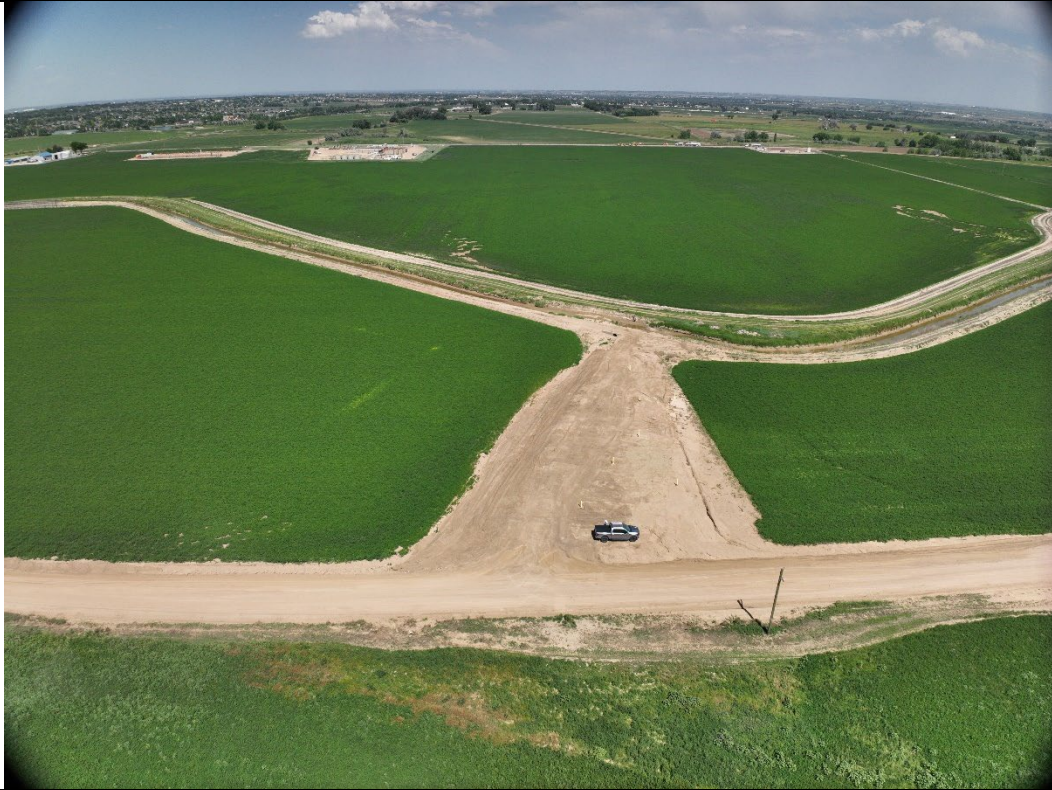
EAST – 40.372605 / -104.813673

In View – Well, Tank Battery, Access Road, Flowline
