**SITE-SPECIFIC QUALITY ASSURANCE
& QUALITY CONTROL AUDIT**

PERMIT CLOSURE REPORT – CROPLAND

Location ID 329854

Location Name KAMMERZELL-65N66W/29NWNW

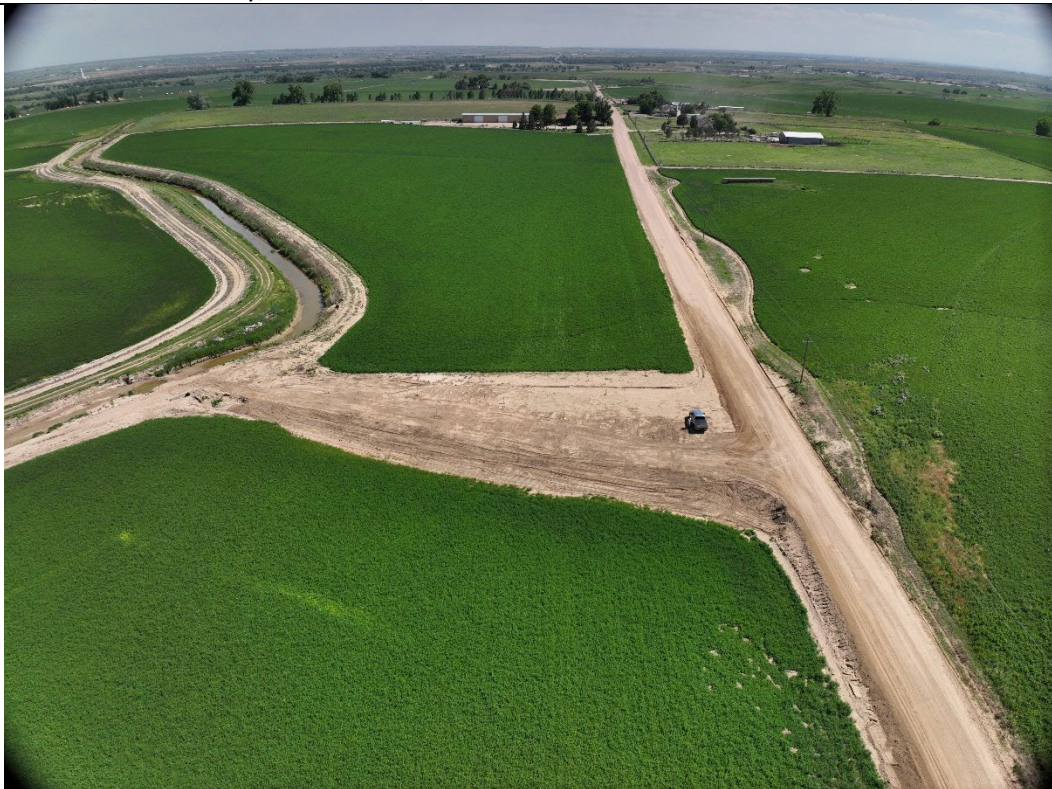
SOUTH – 40.373425 / -104.812476

In View – Tank Battery, Flowline

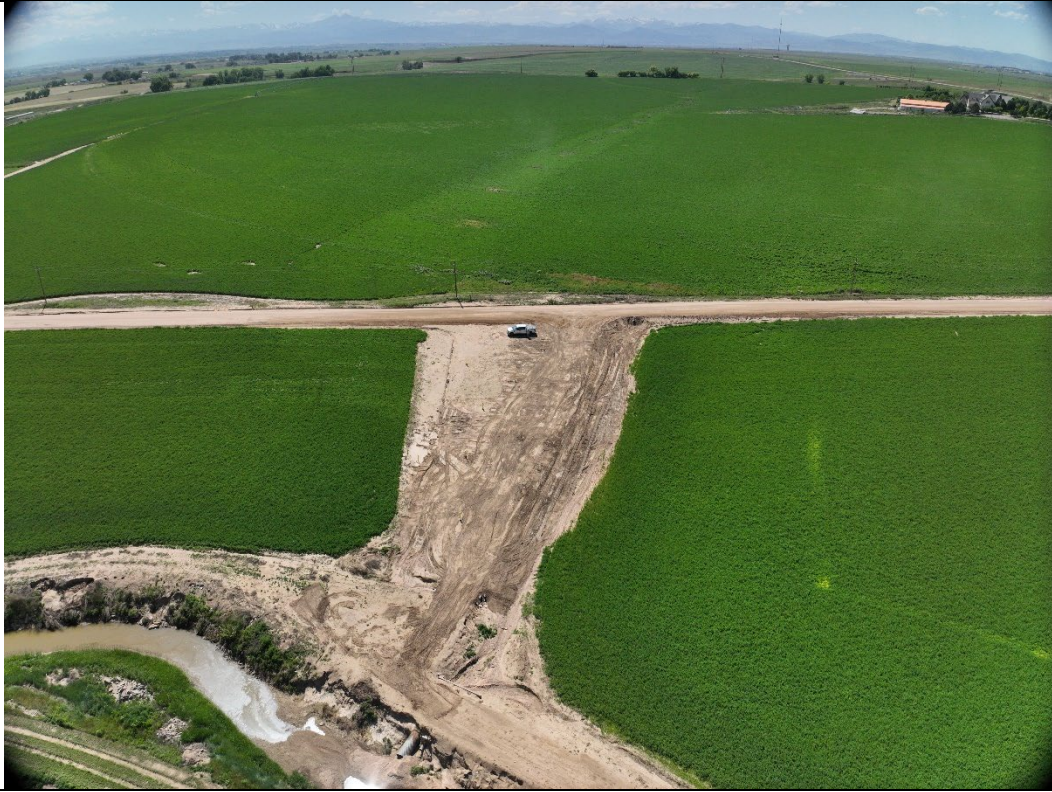
WEST – 40.372465 / -104.811086

In View – Tank Battery, Flowline

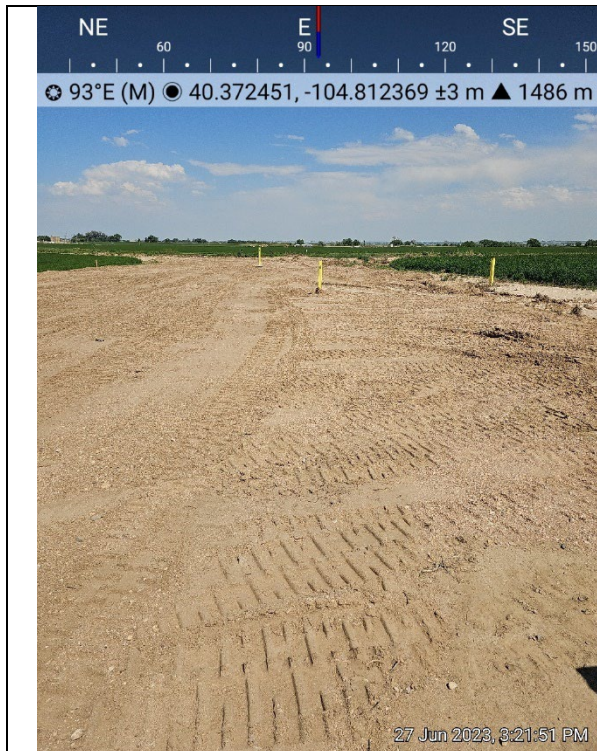
Looking East at tank battery and separator location – 40.372451 / -104.812369

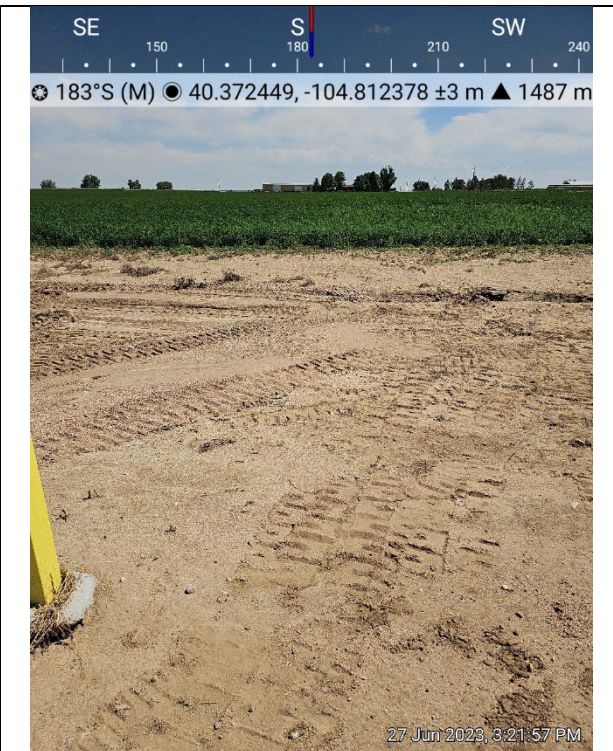
Looking South at tank battery and separator location – 40.372449 / -104.812378

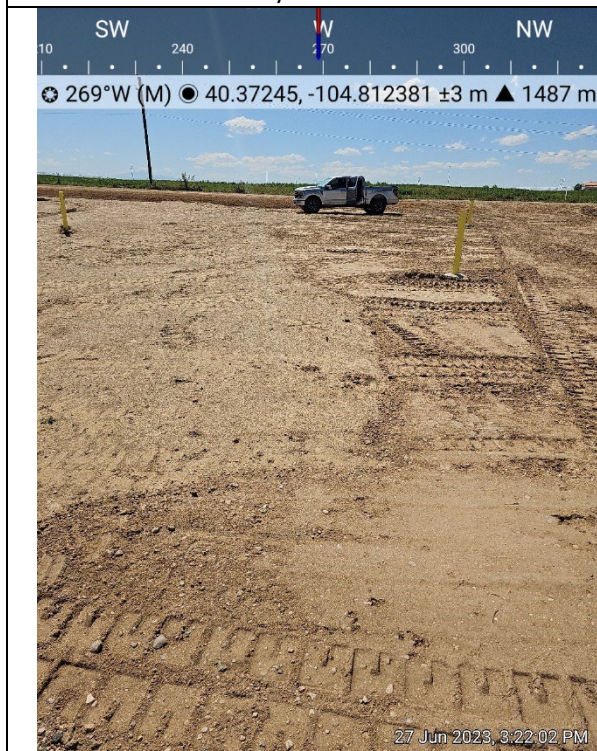
Looking West at tank battery and separator location – 40.372450 / -104.812381

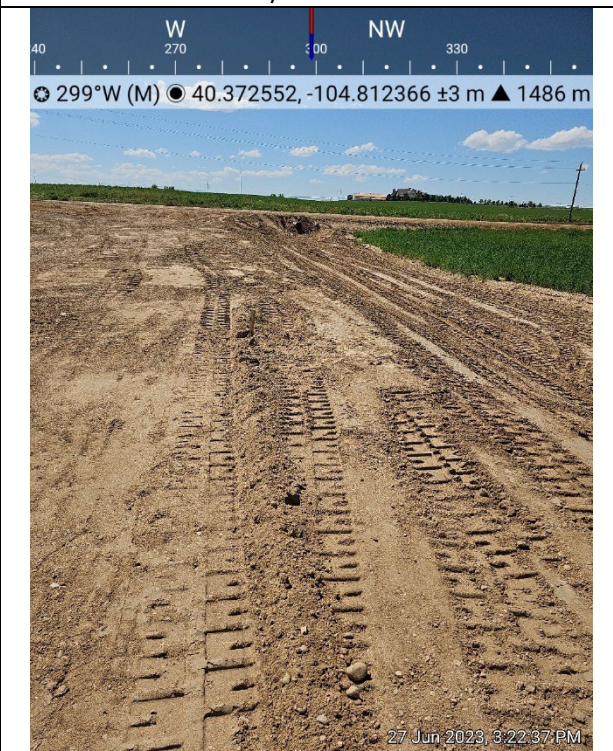
Looking Northwest at tank battery and separator location – 40.372552 / -104.812366

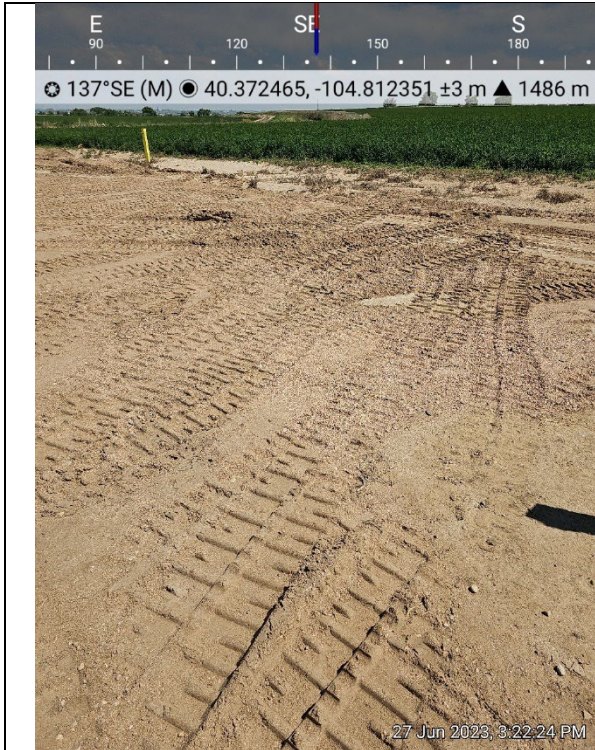
Looking Southeast at tank battery and separator location – 40.372465 / -104.812351

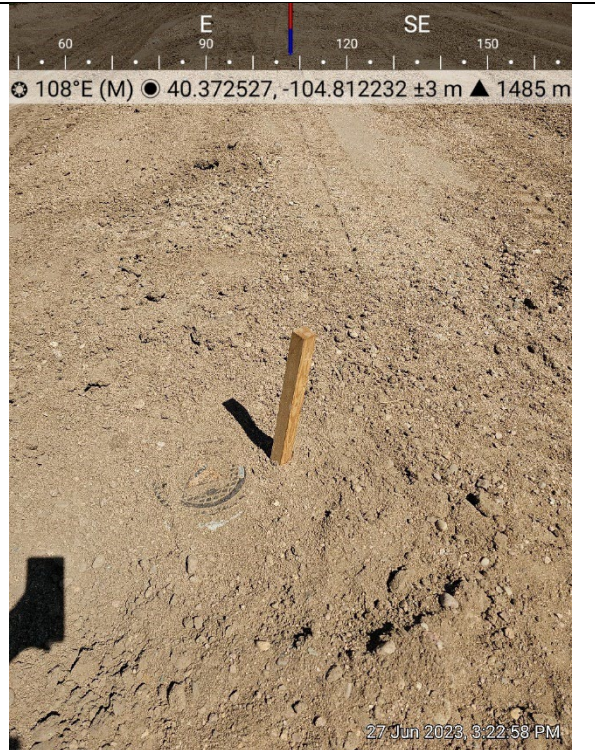
Monitoring well at tank battery and separator location – 40.372527 / -104.812232

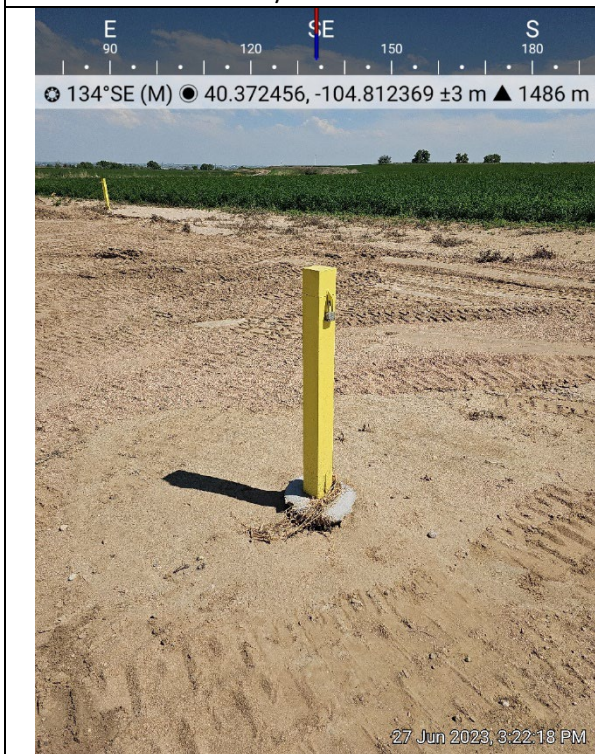
Monitoring well at tank battery and separator location – 40.372456 / -104.812369

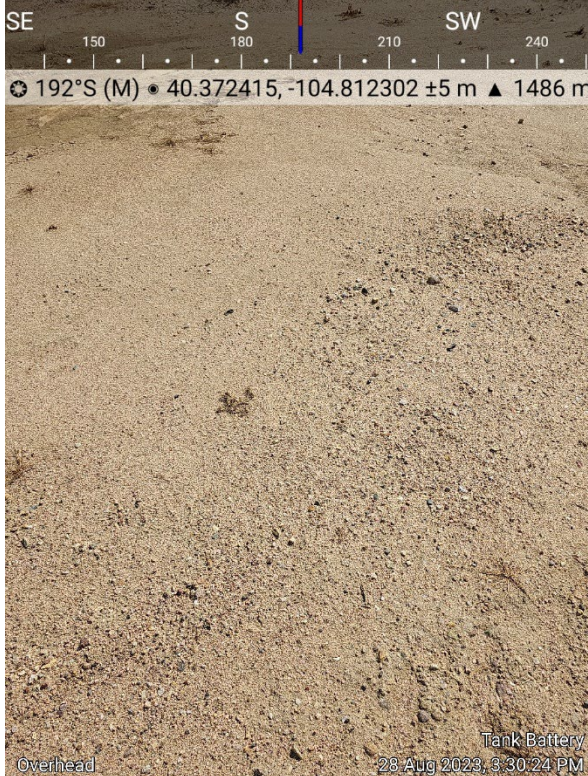
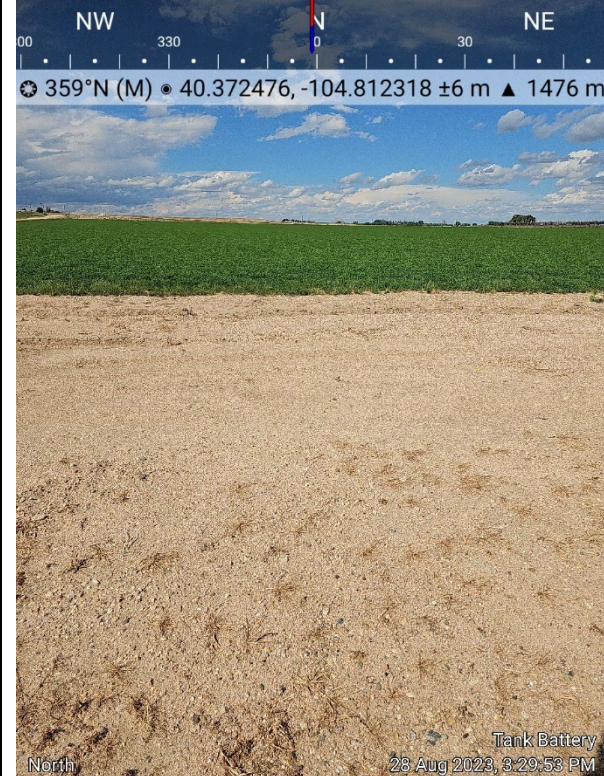
<p>NW 00 N 0 NE 30 359°N (M) • 40.372476, -104.812318 ±6 m ▲ 1476 m North Tank Battery 28 Aug 2023, 3:29:53 PM</p>
<p>Overhead photo at tank battery and separator location – 40.372415 / -104.812302</p>	<p>Looking North from tank battery and separator location – 40.372476 / -104.812318</p>

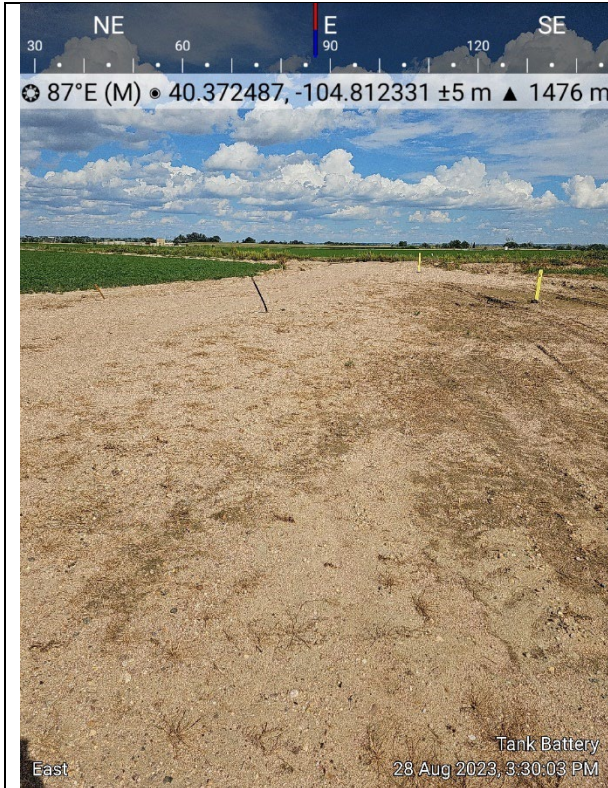
Looking East at tank battery and separator location – 40.372487 / -104.812331

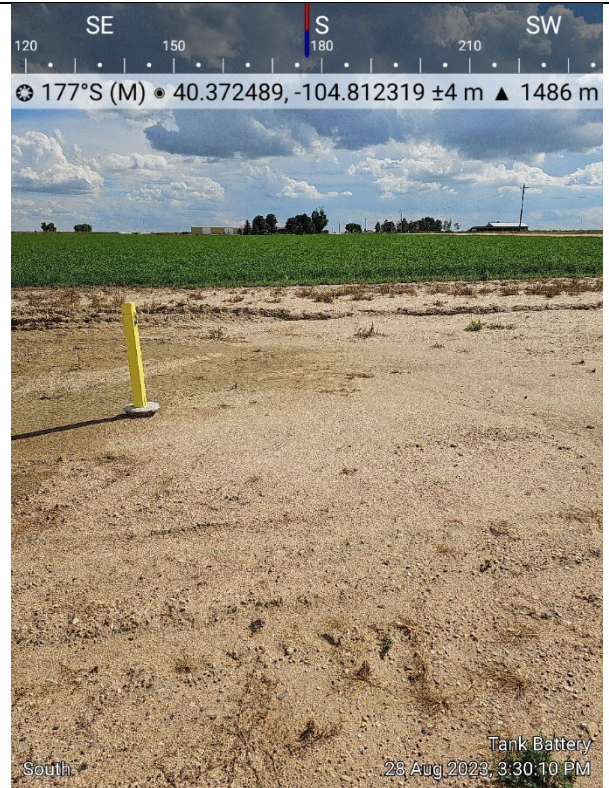
Looking South at tank battery and separator location – 40.372489 / -104.812319

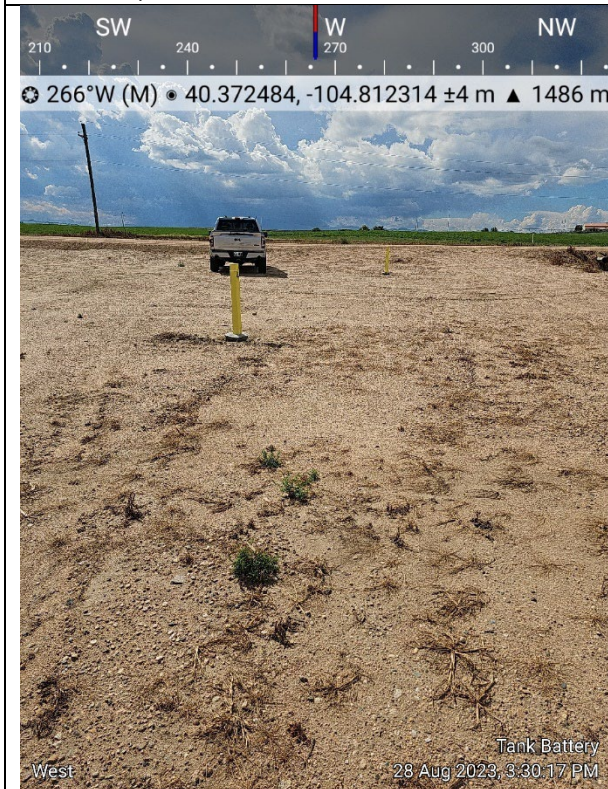
Looking West at tank battery and separator location – 40.372484 / -104.812314
