**SITE-SPECIFIC QUALITY ASSURANCE
& QUALITY CONTROL AUDIT**

PERMIT CLOSURE REPORT – CROPLAND

Location ID 332220

Location Name MANTLE-64N65W/28SWNE

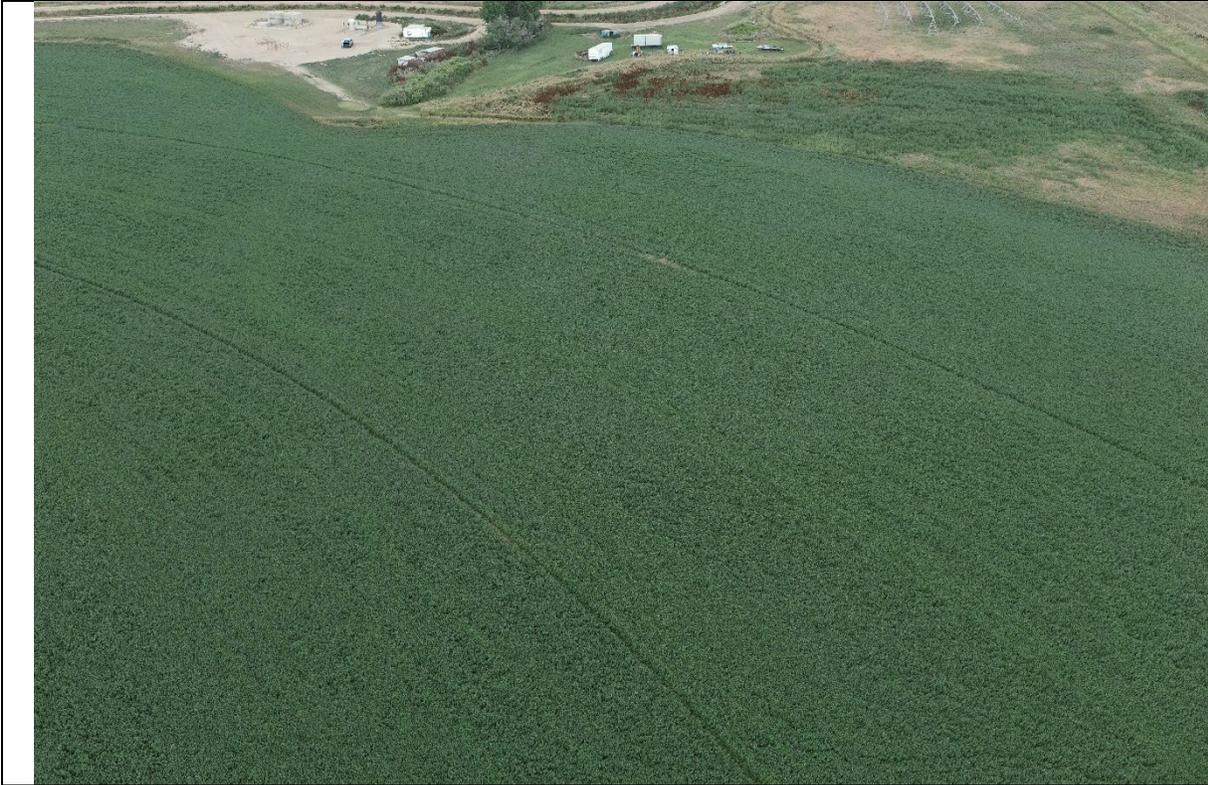
EAST – 40.284561 / -104.668177

In View – Well, Tank Battery, Access Road, Flowline

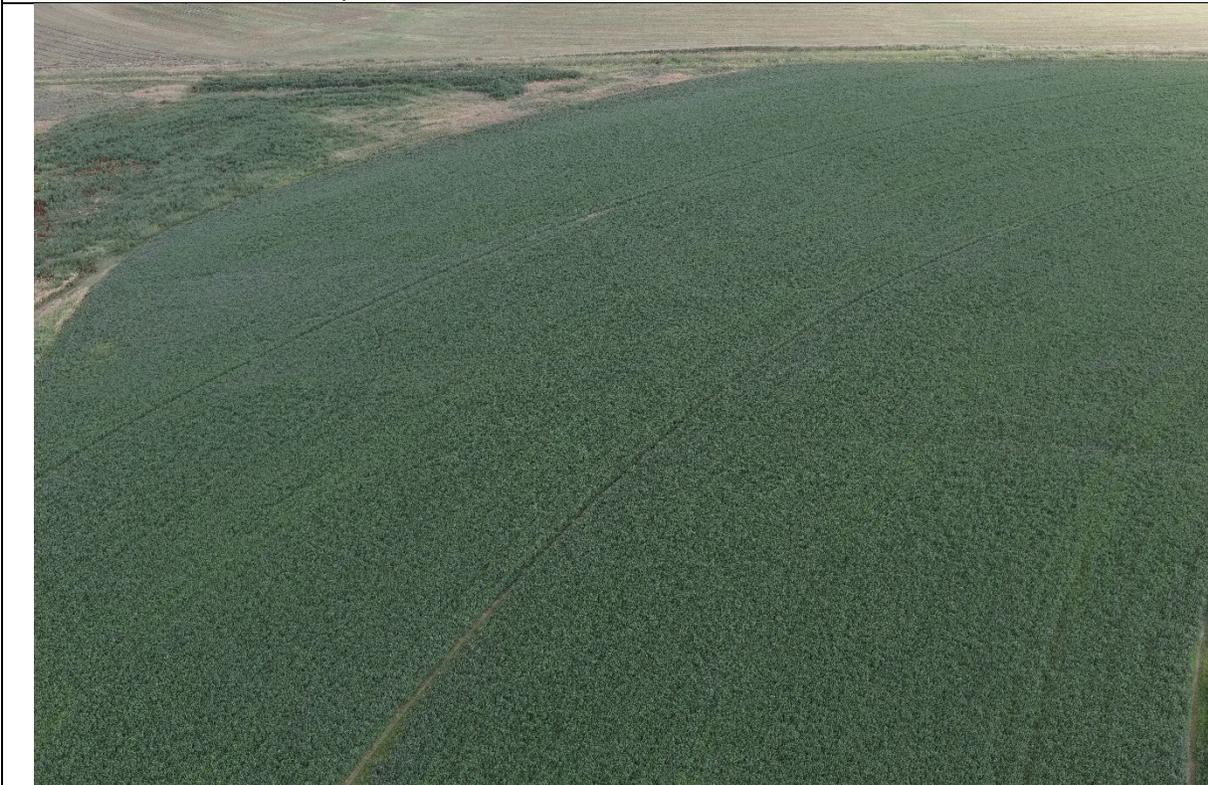
SOUTH – 40.286307 / -104.666443

In View – Well, Access Road, Flowline

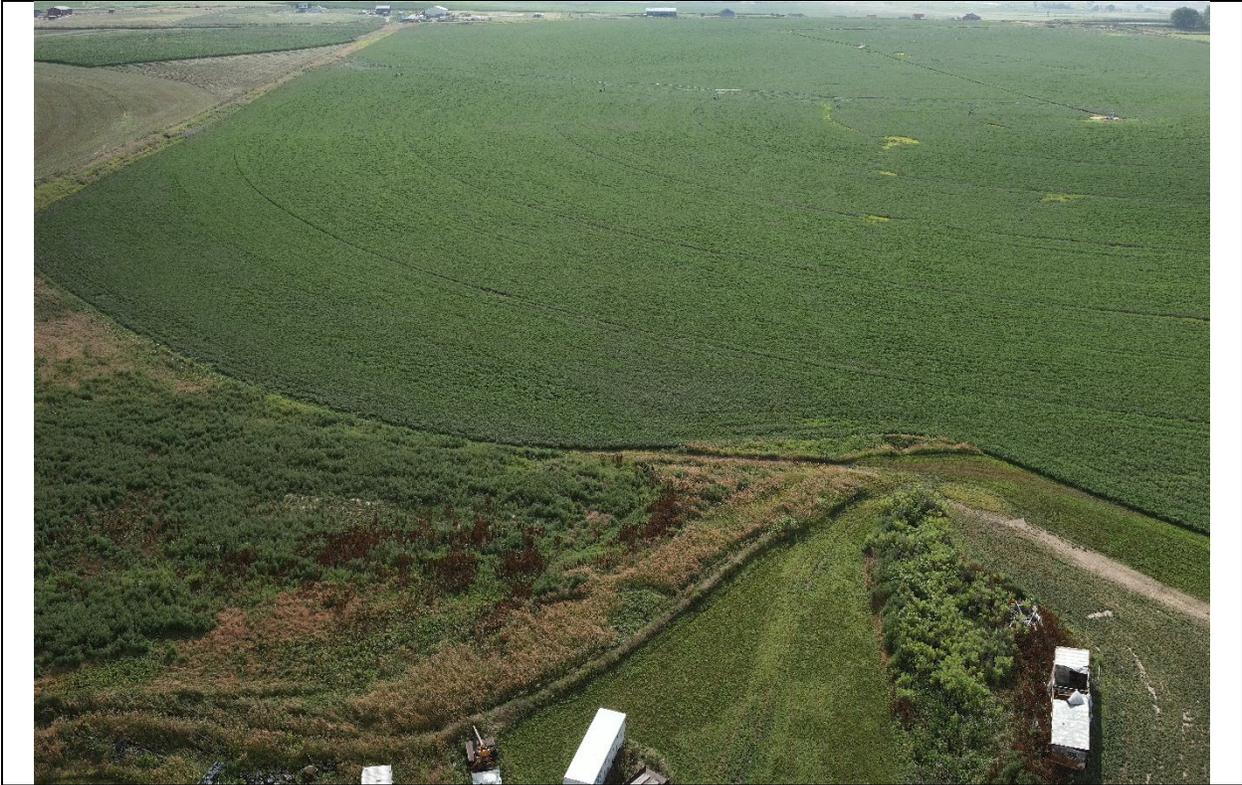
WEST – 40.284743 / -104.663828

In View – Well, Access Road, Flowline

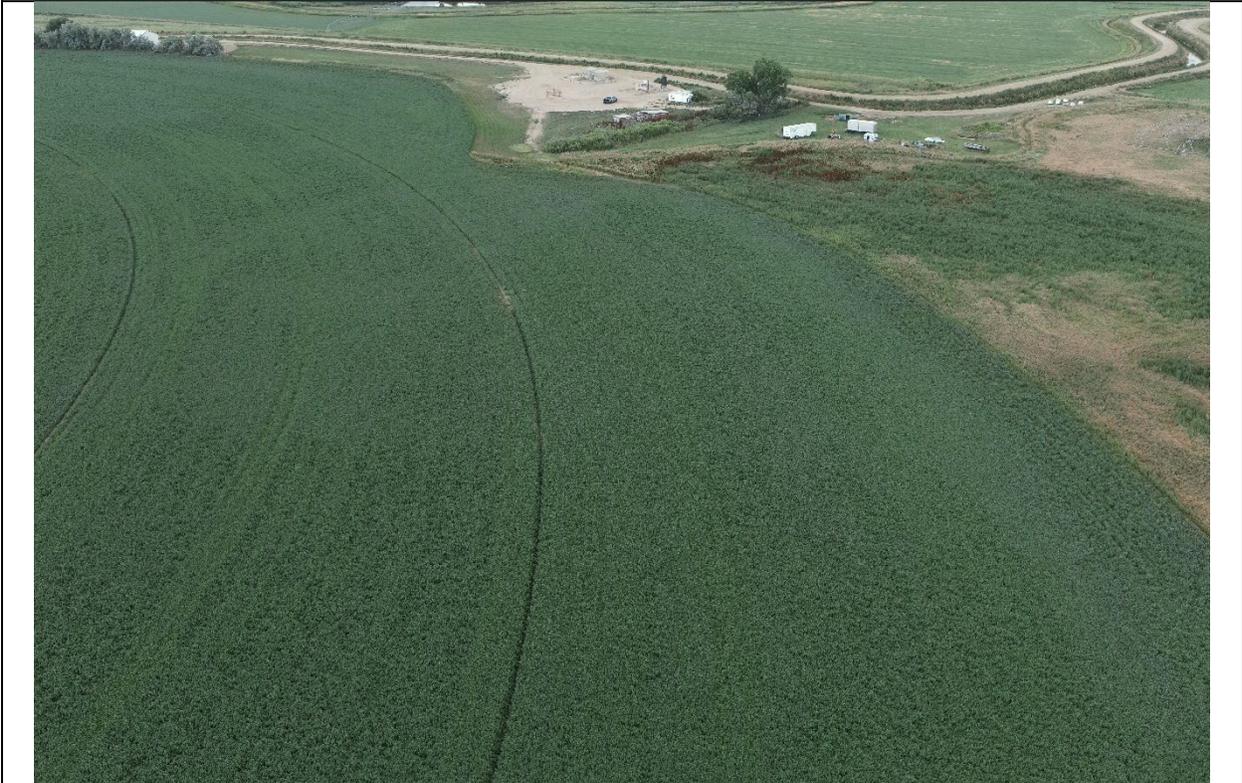
NORTHEAST – 40.283630 / -104.667945

In View – Well, Tank Battery, Access Road, Flowline

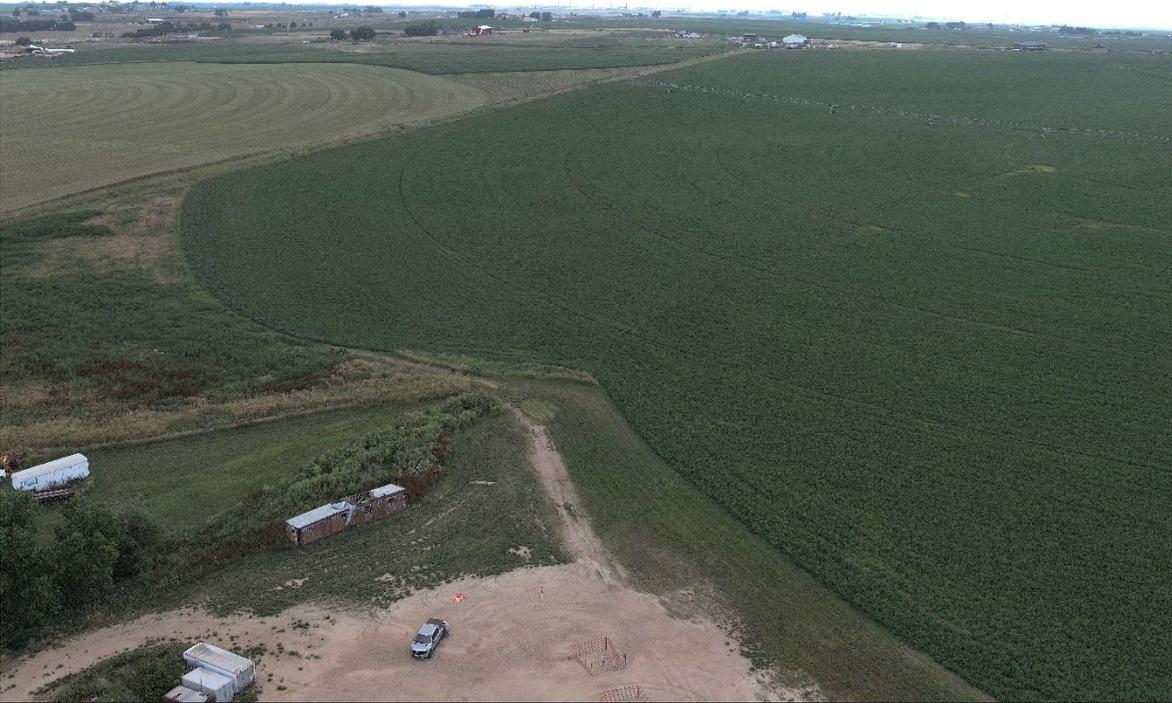
SOUTHWEST – 40.285842 / -104.663538

In View – Well, Access Road, Flowline

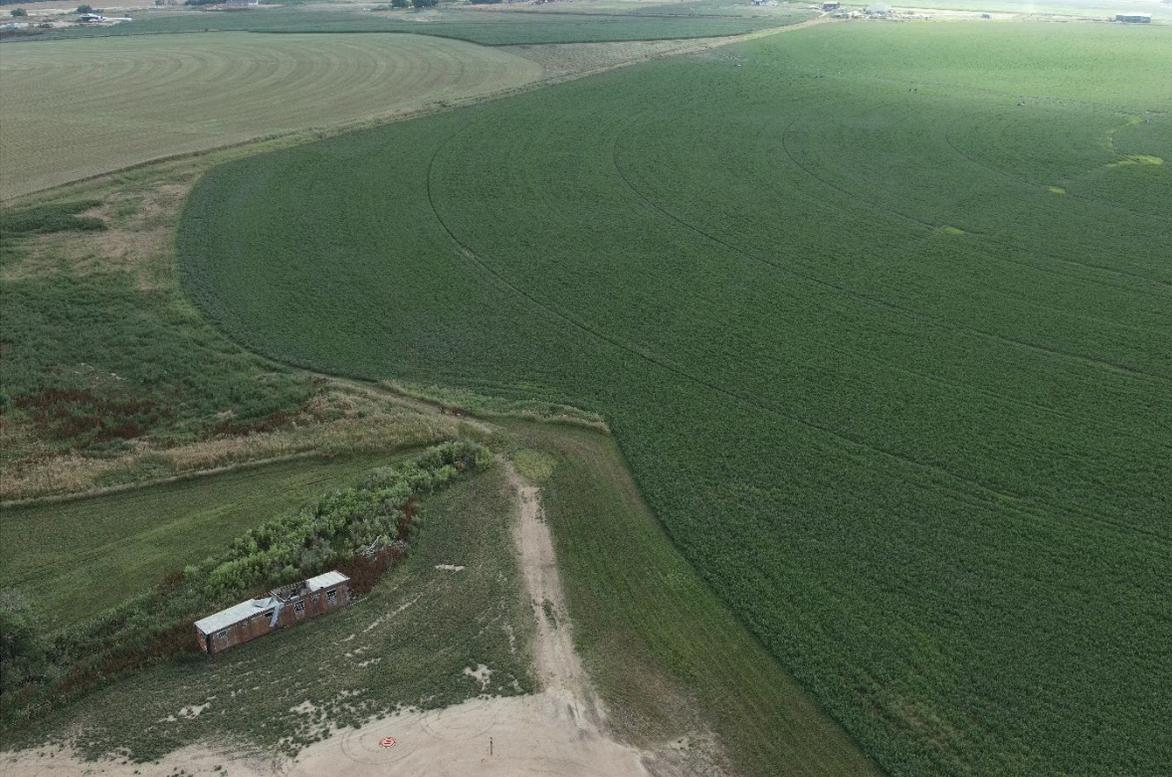
SOUTHWEST – 40.285801 / -104.663931

In View – Well, Access Road, Flowline

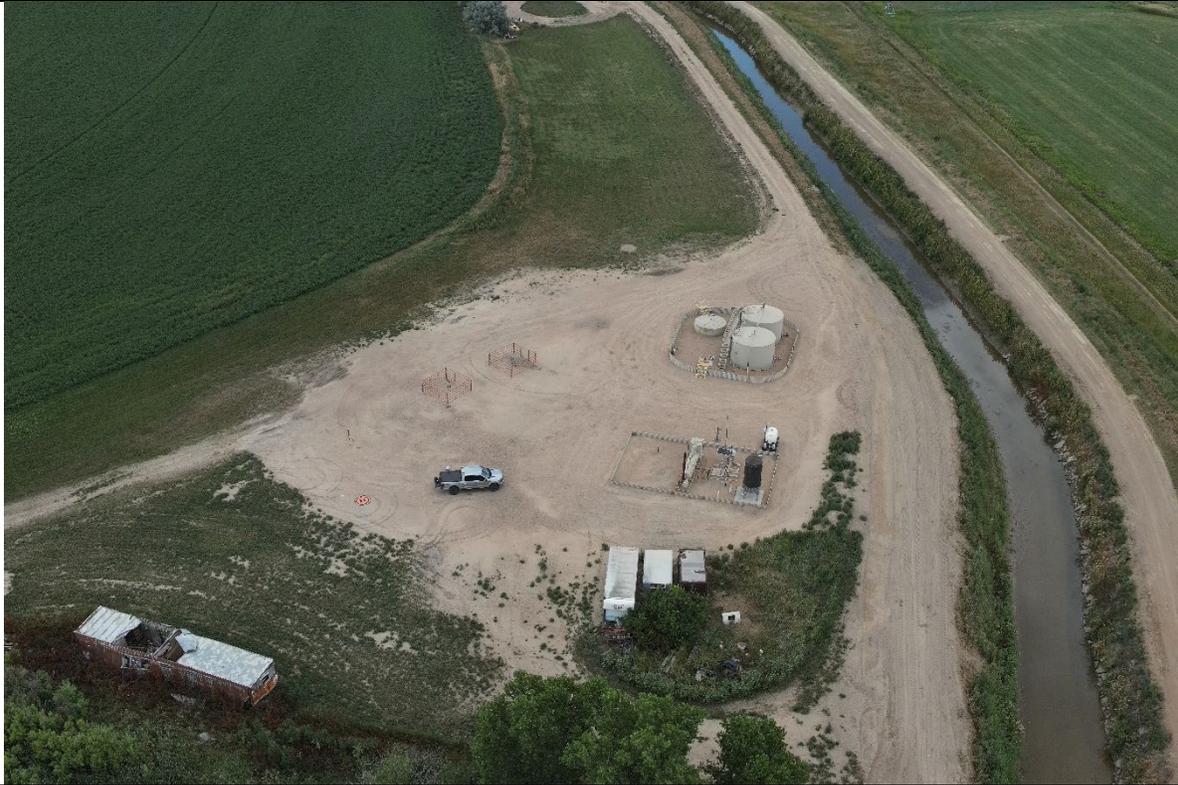
NORTH – 40.284533 / -104.664511

In View – Tank Battery, Access Road, Flowline

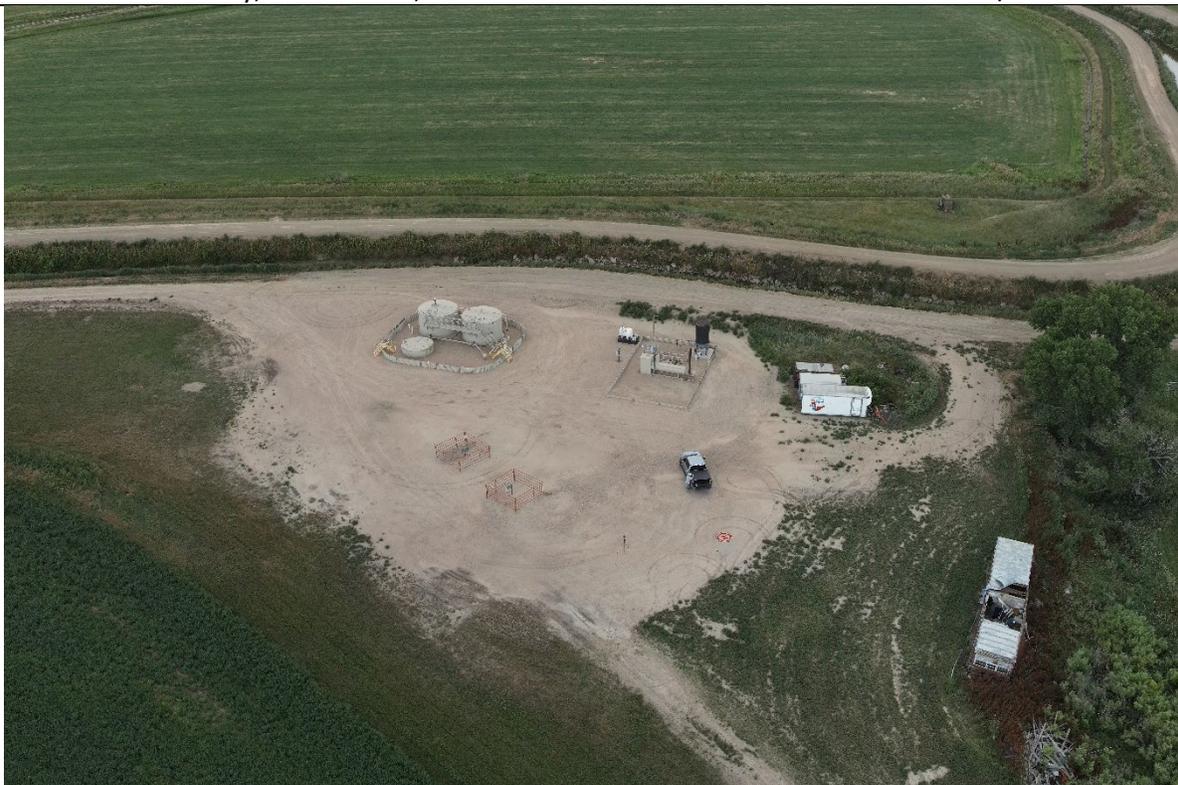
EAST – 40.285412 / -104.665724

In View – Tank Battery, Access Road, Flowline

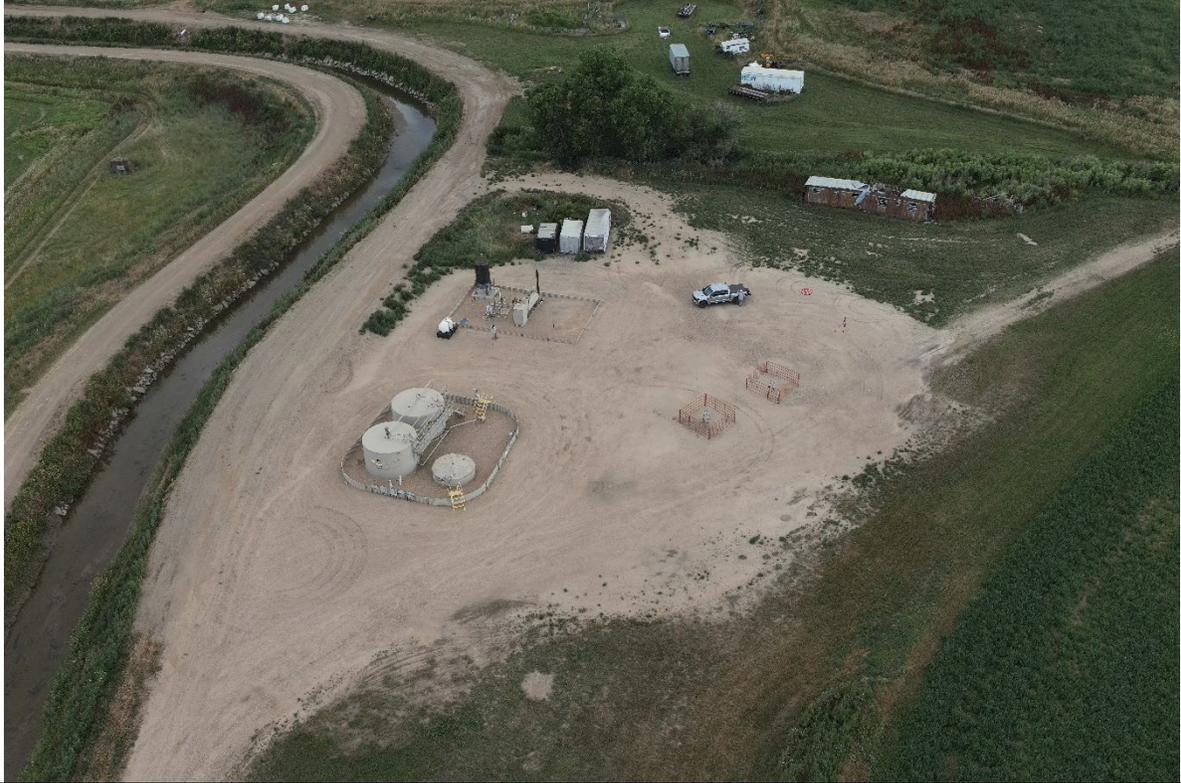
SOUTH – 40.286342 / -104.664457

In View – Tank Battery, Access Road, Flowline

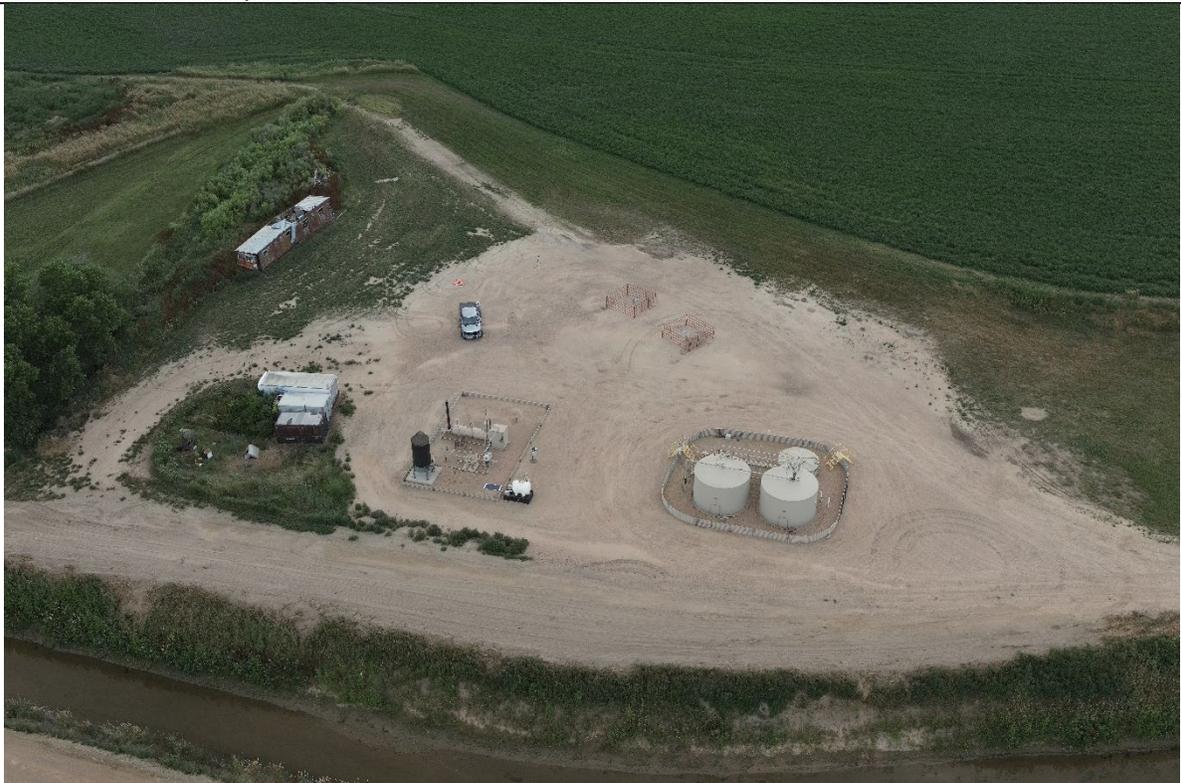
WEST – 40.285448 / -104.663346

In View – Tank Battery, Access Road, Flowline

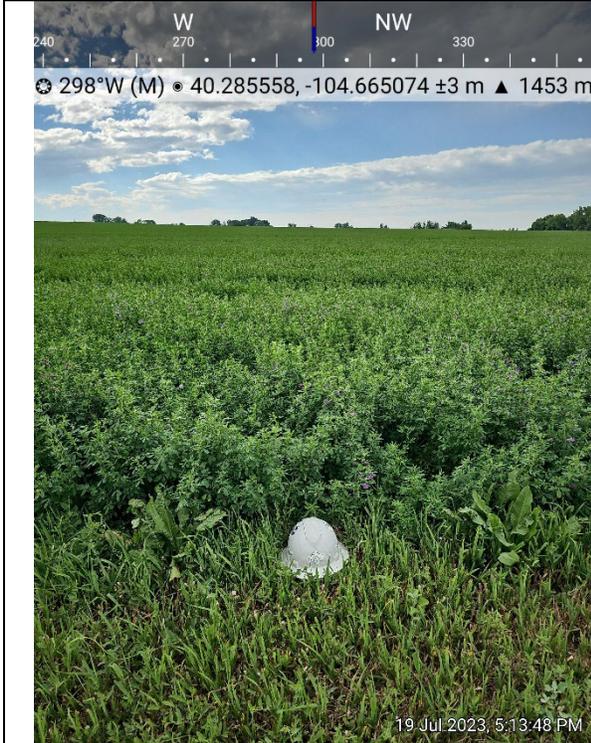
Handheld photos taken from Tank Battery location [332706](#) looking West into the Alfalfa field where the Mantle 32-28 wellhead was. No handheld photos taken from Mantle 32-28 wellhead location due to crop height.

Looking Northwest into field –
40.285558 / -104.665074

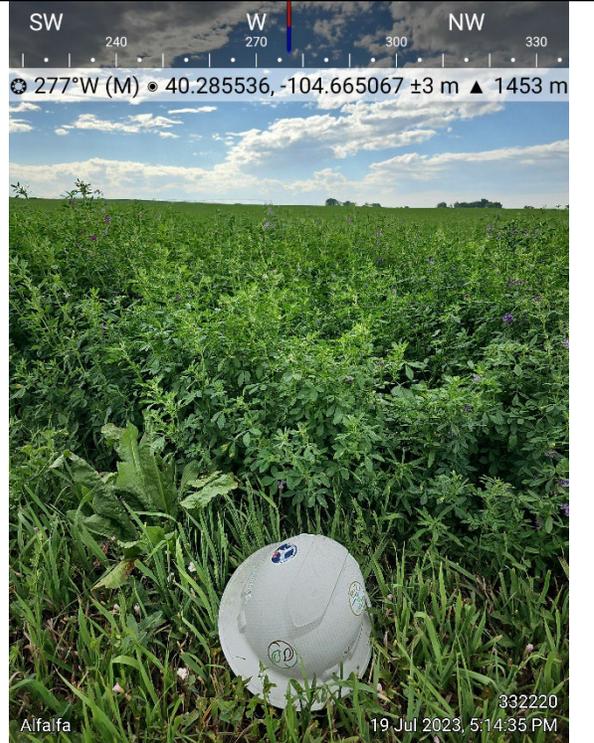
Looking West into field –
40.285536 / -104.665067

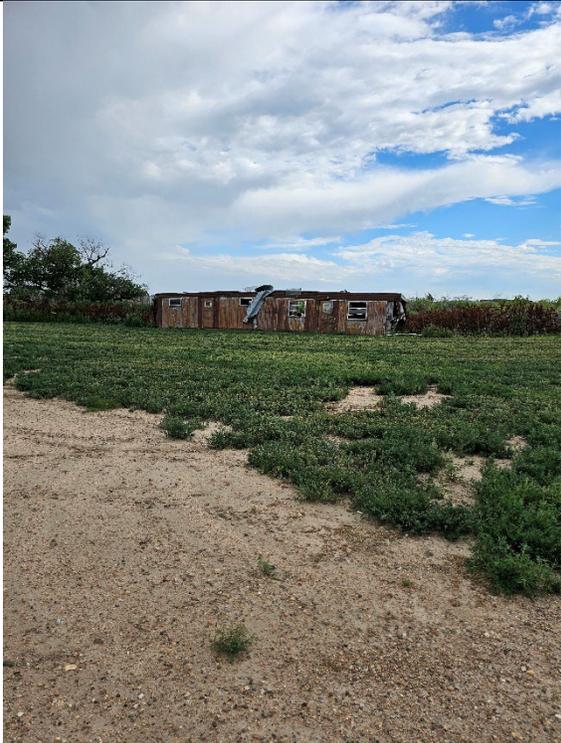
South end of Tank Battery location – 40.285410 / -104.664822

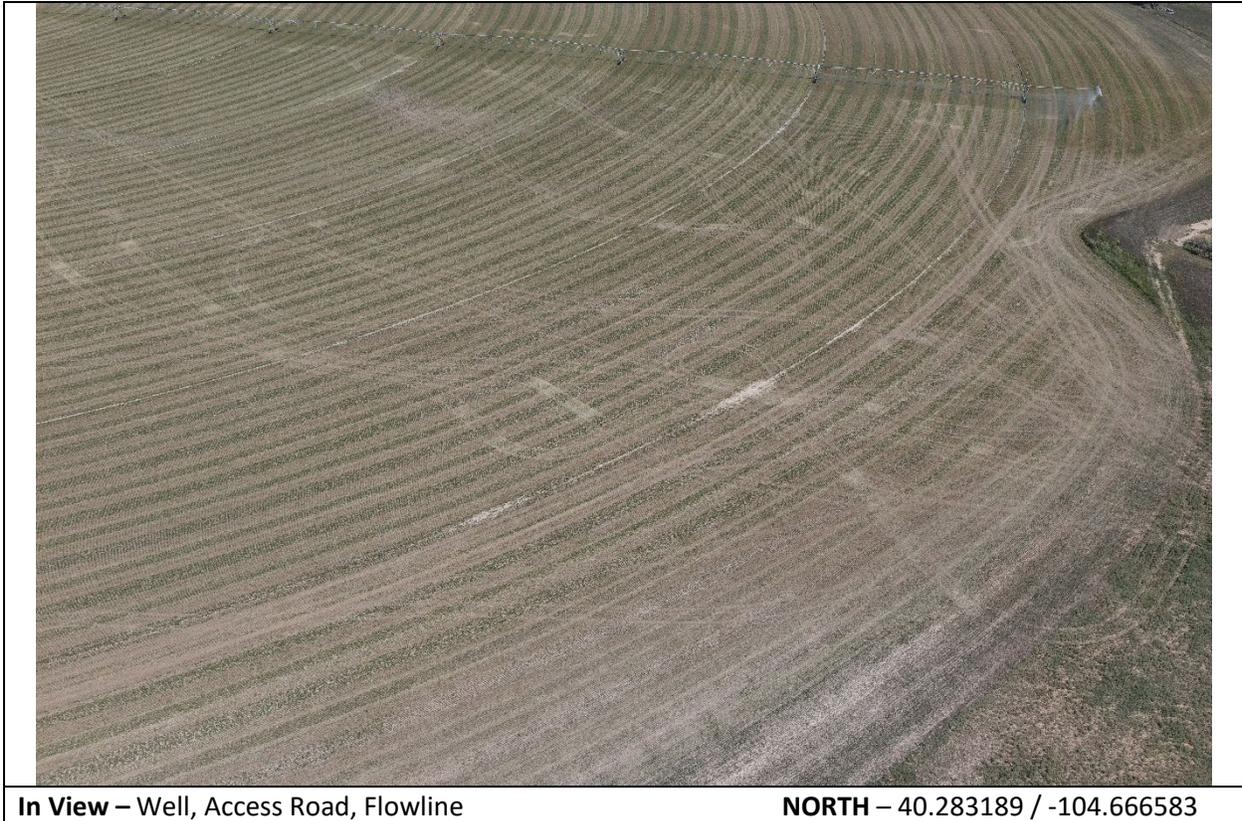
NORTH – 40.283189 / -104.666583

Cardinal Directional Drone Photos Showing No Equipment Remaining

In View – Well, Access Road, Flowline

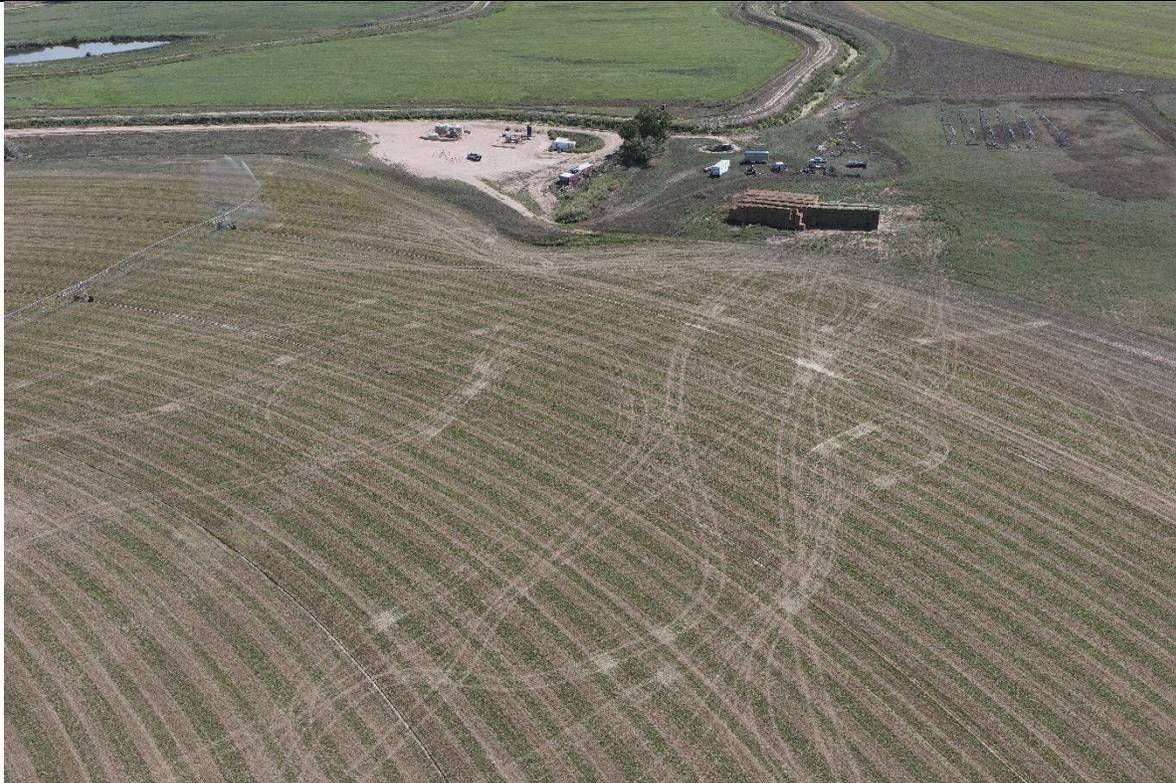
EAST – 40.284763 / -104.668857

In View – Well, Tank Battery, Access Road, Flowline

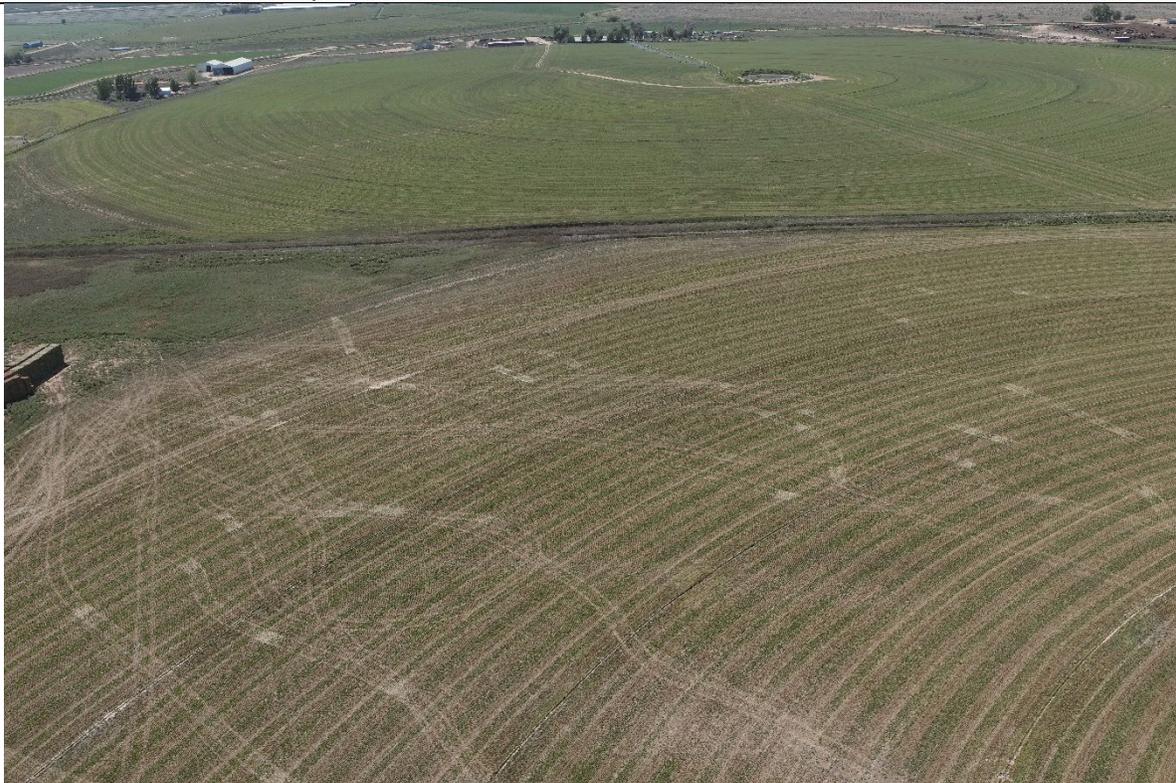
SOUTH – 40.286846 / -104.667135

In View – Well, Access Road, Flowline

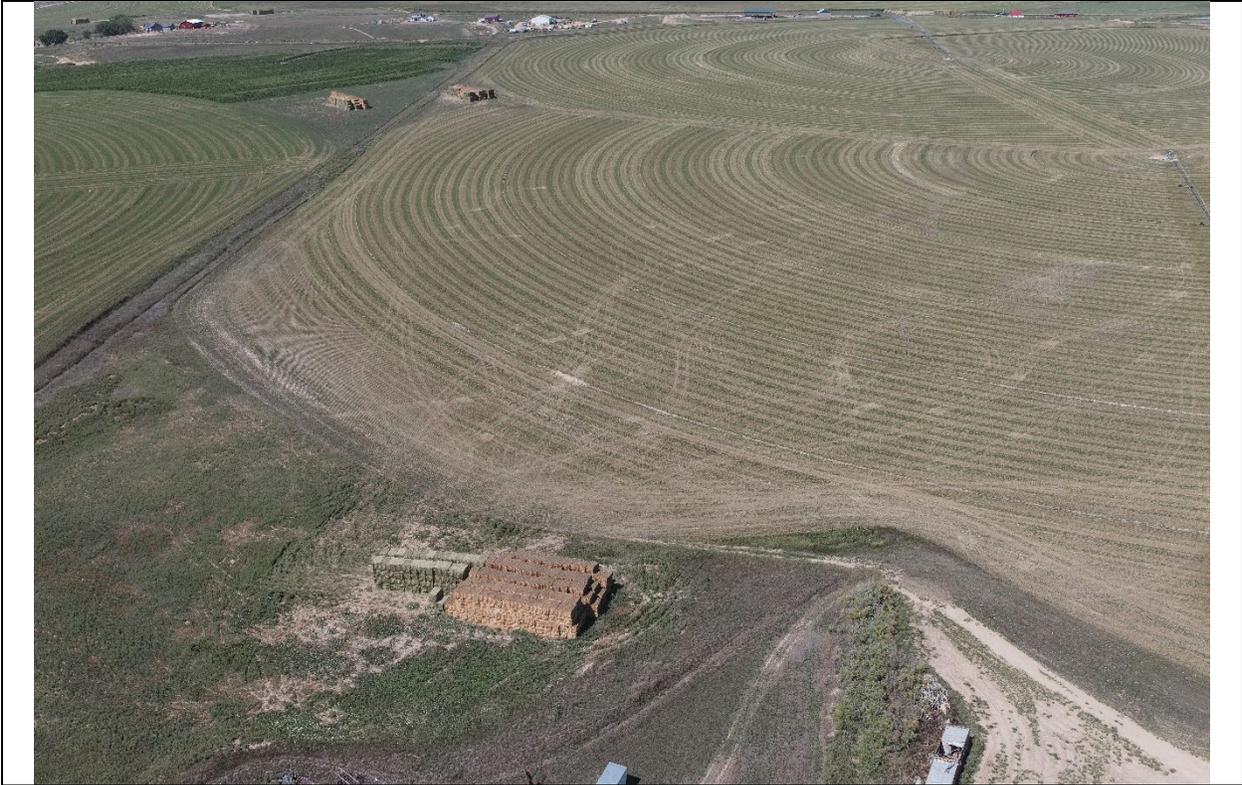
WEST – 40.284858 / -104.663450

In View – Well, Access Road, Flowline
