# Location Checklist

**Final Reclamation Complete Notice – Cropland Drone Imagery**

**PERMIT CLOSURE REPORT – CROPLAND**

**Location Name** BOULDER BANK -61N66W/7NESE

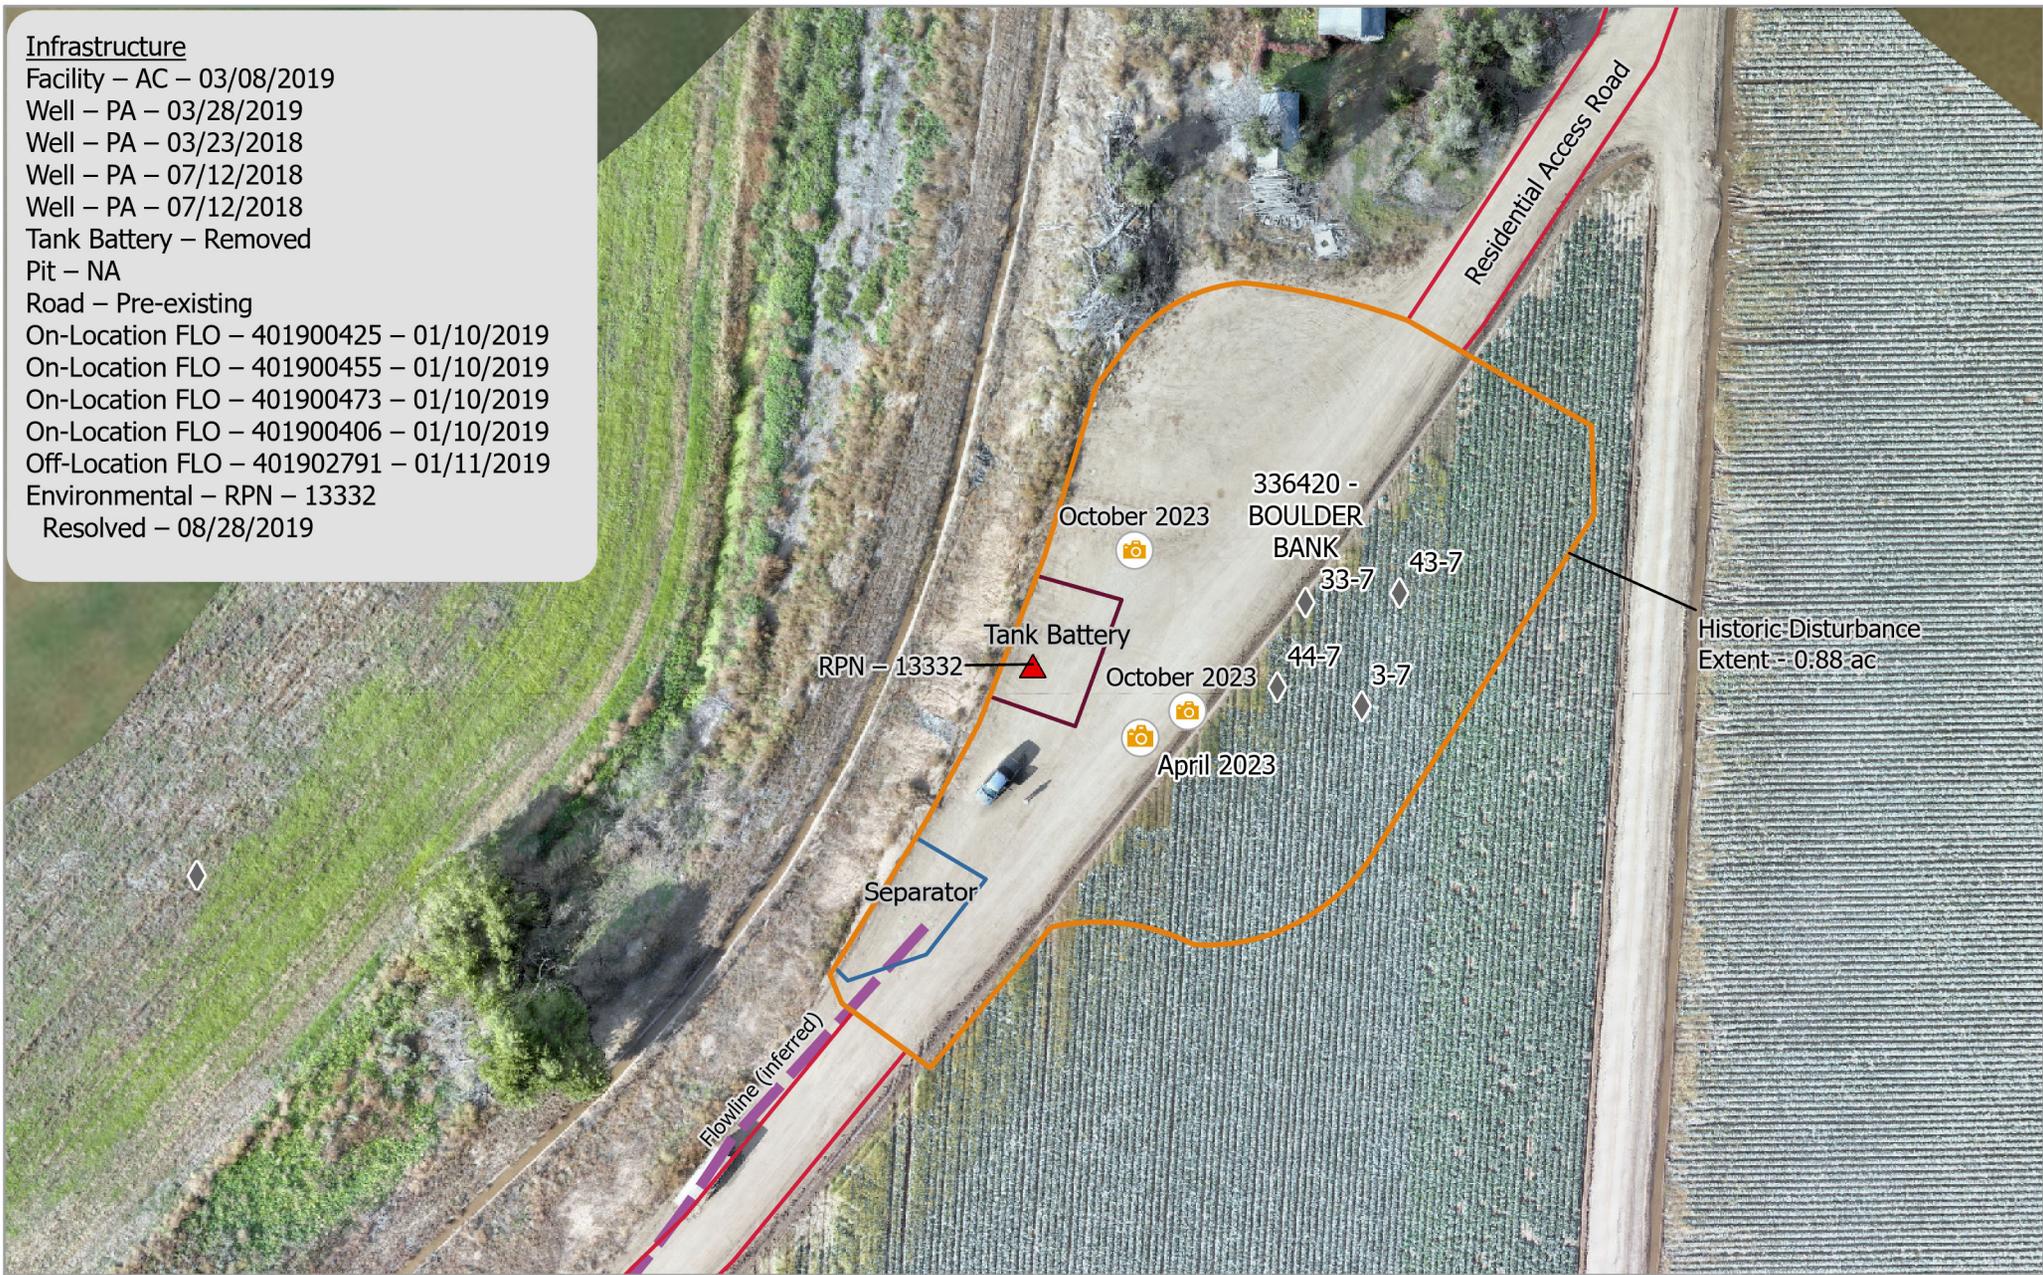
**CIV - 336420- BOULDER BANK  
Map Extent - Post-Plugging Overview**

Historic Disturbance  
Extent - 0.88 ac

Updated Historic  
Disturbance Extent  
Total Disturbance: 0.88 Ac  
Scale: 1:800

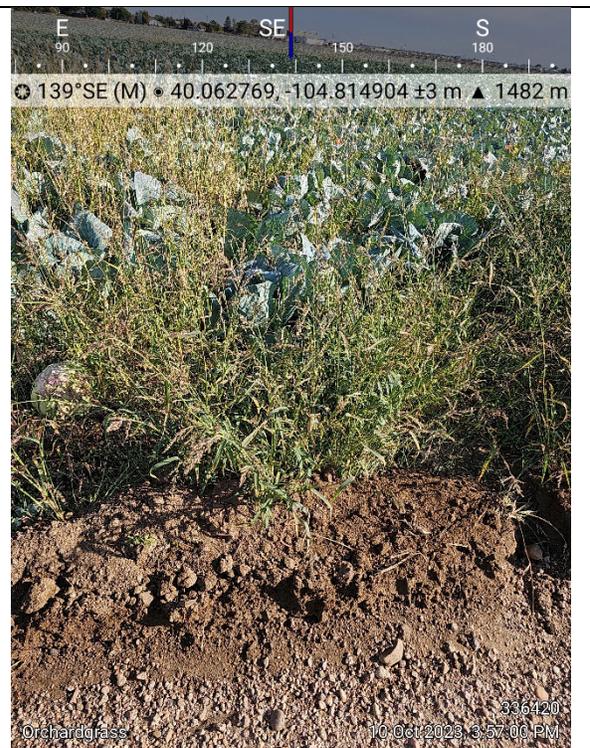
Orchardgrass – *Dactylis glomerata* found in cabbage field near wellhead and production facilities – 40.062769 / -104.814904

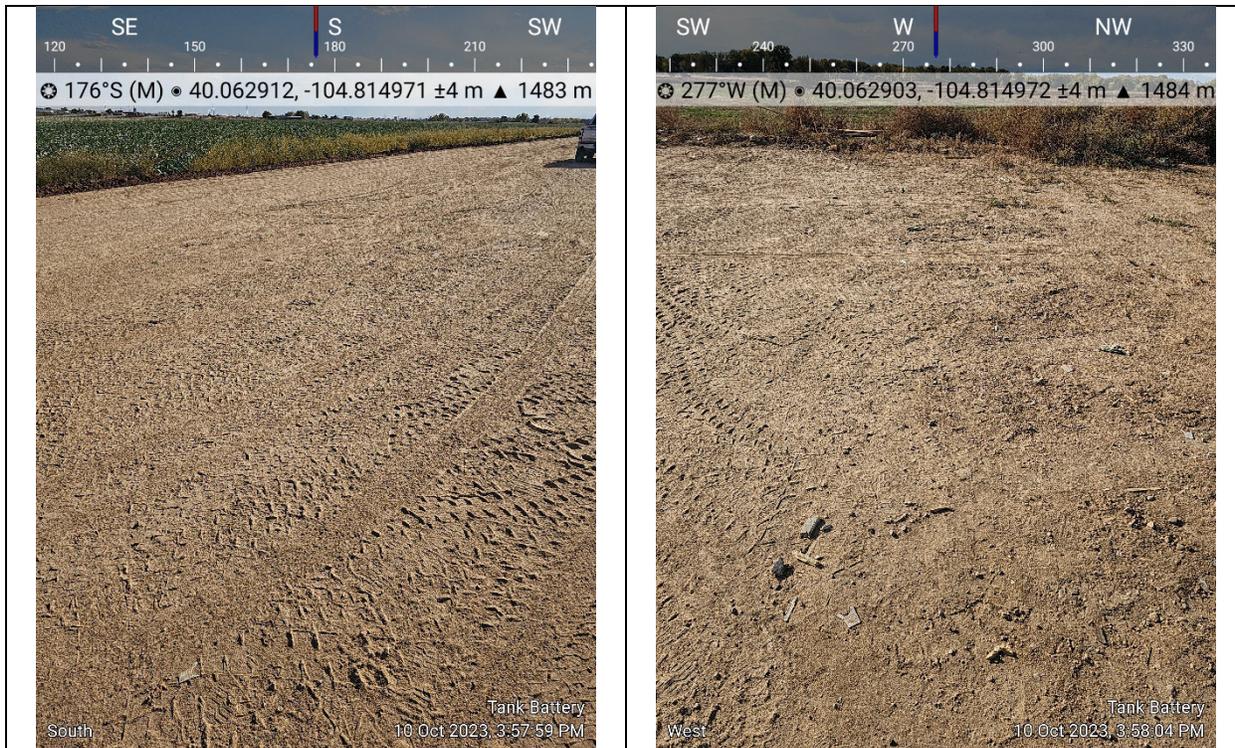
The Off-Location Flowline for this location followed the farm road, that existed prior to oil and gas activity as a farm access road. The tank battery and separator fall outside the crop area along the west side of farm road. No vegetation is present, and the area is being used as road/parking.
