Inspection Photos

Operator: CAERUS PICEANCE LLC #10456

Location ID: 335780

Inspection Doc: 696205626

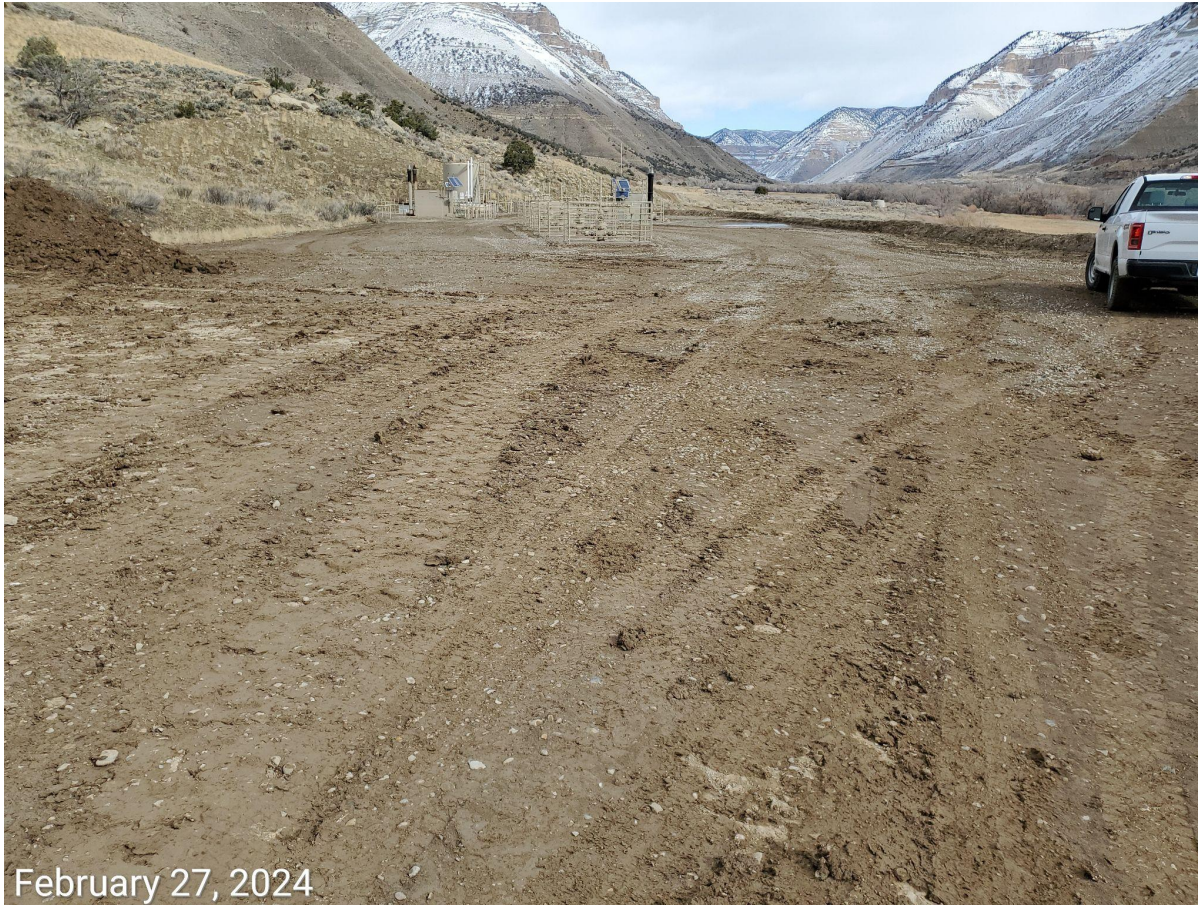
Photo 1: Photo taken from the south end of the Location, facing north. Photo provides an overview of the Location.

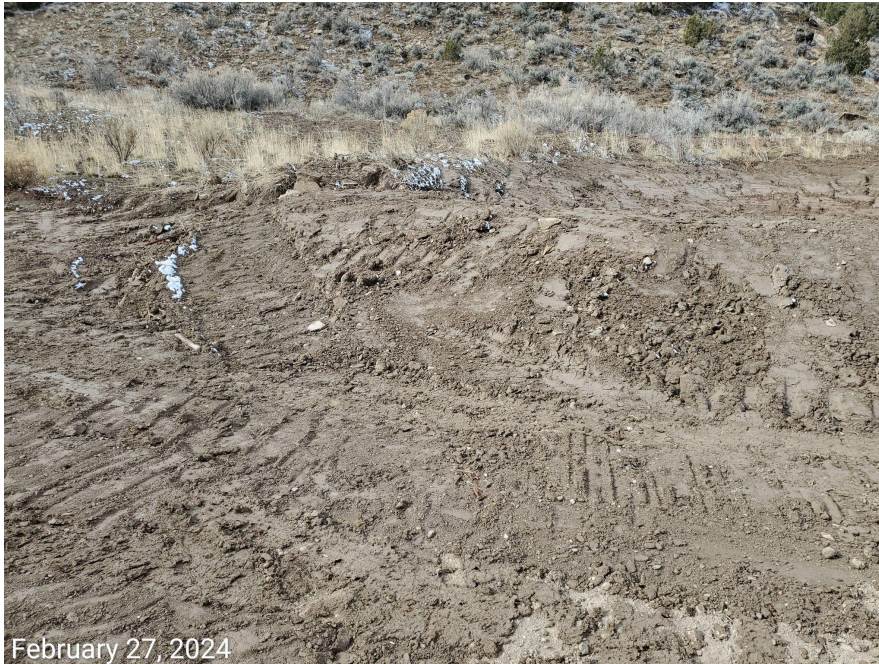
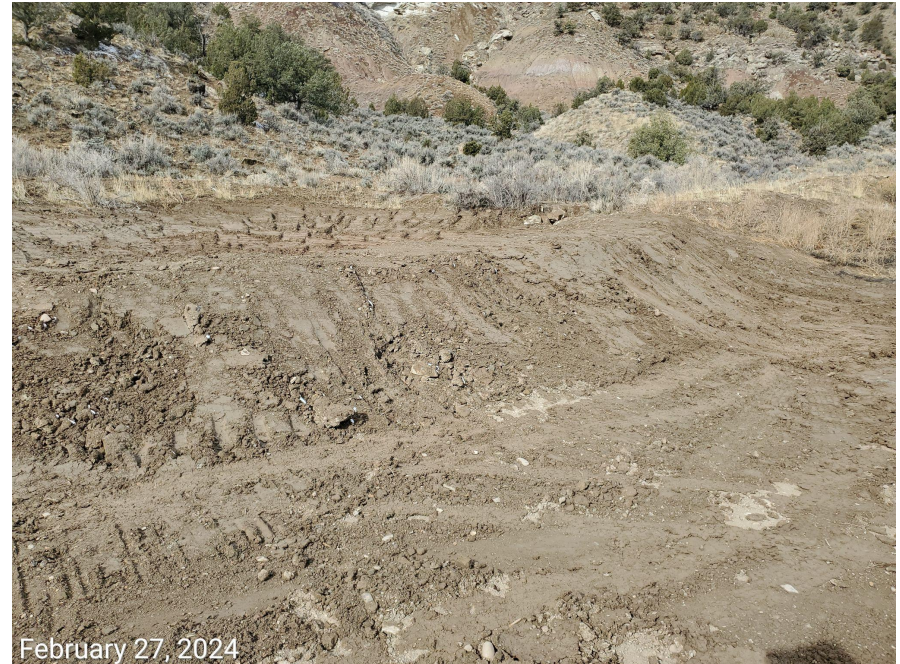
Photo 2: Photos taken from the sediment trap on the west end of the Location. Sediment material has been removed from the BMP and berms have been maintained.

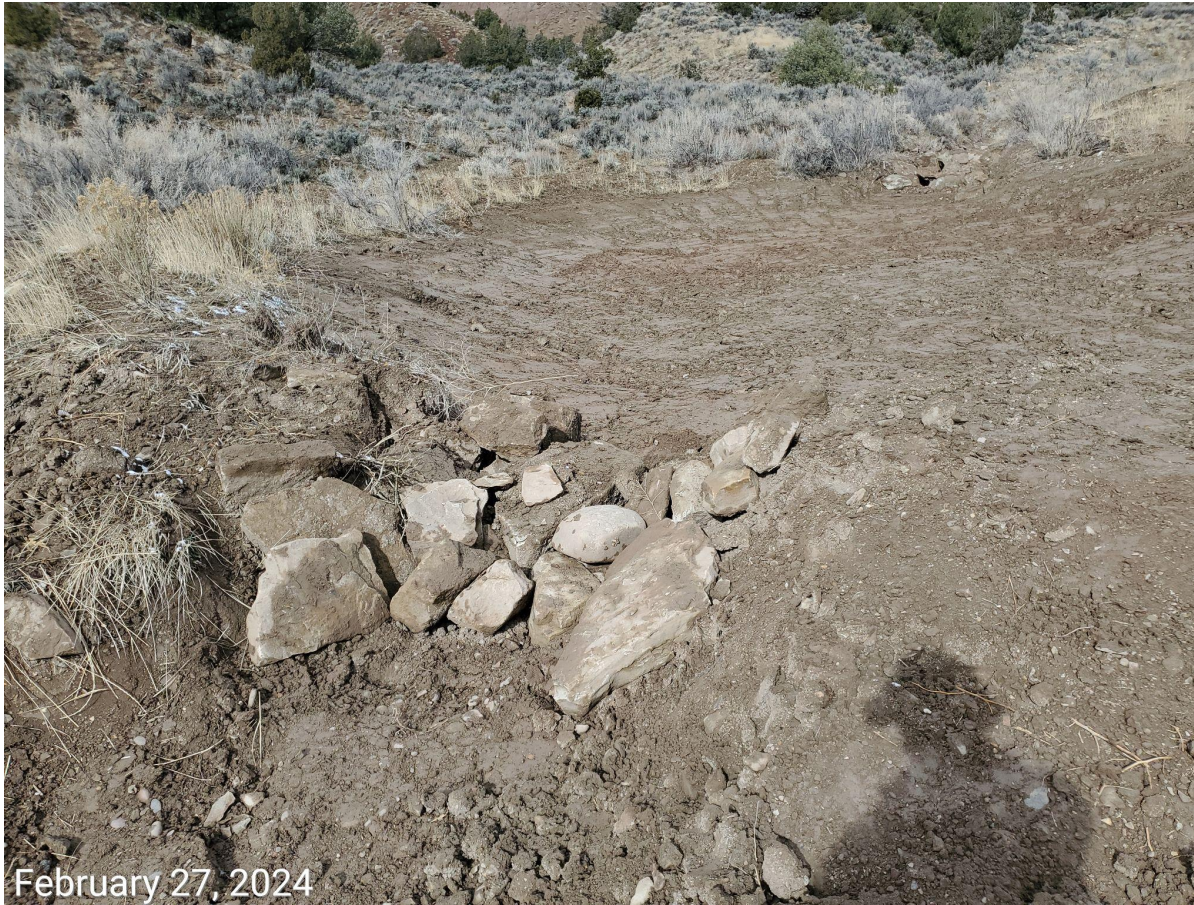
Photo 3: Continued from photo 2. Photo shows outlet of the sediment trap. Outlet has not yet been fully installed in accordance with good engineering practices, as geotextile lining in conjunction with combination coarse aggregate and riprap material was not observed; currently only large diameter rock material appears to have been placed at the outlet.

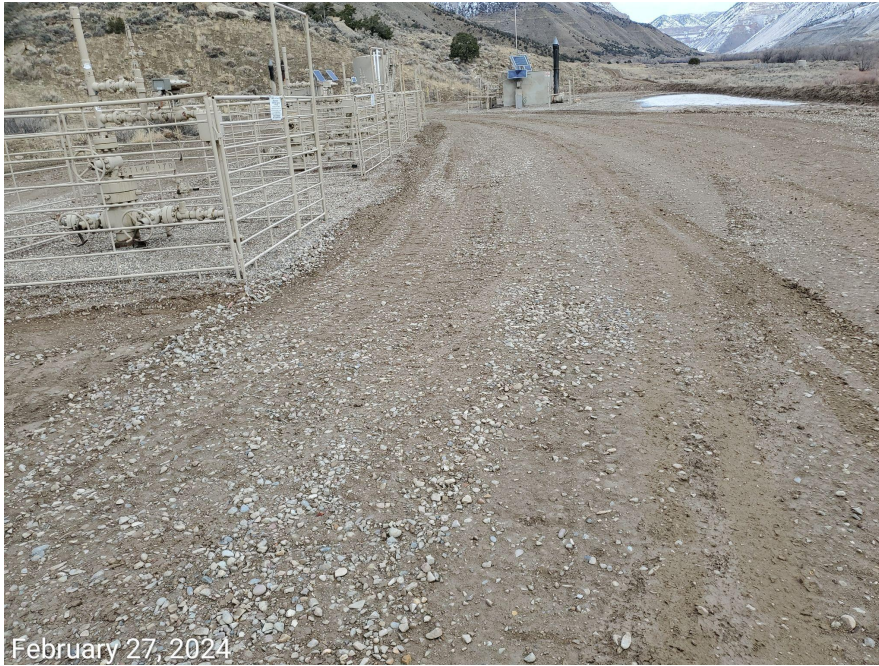
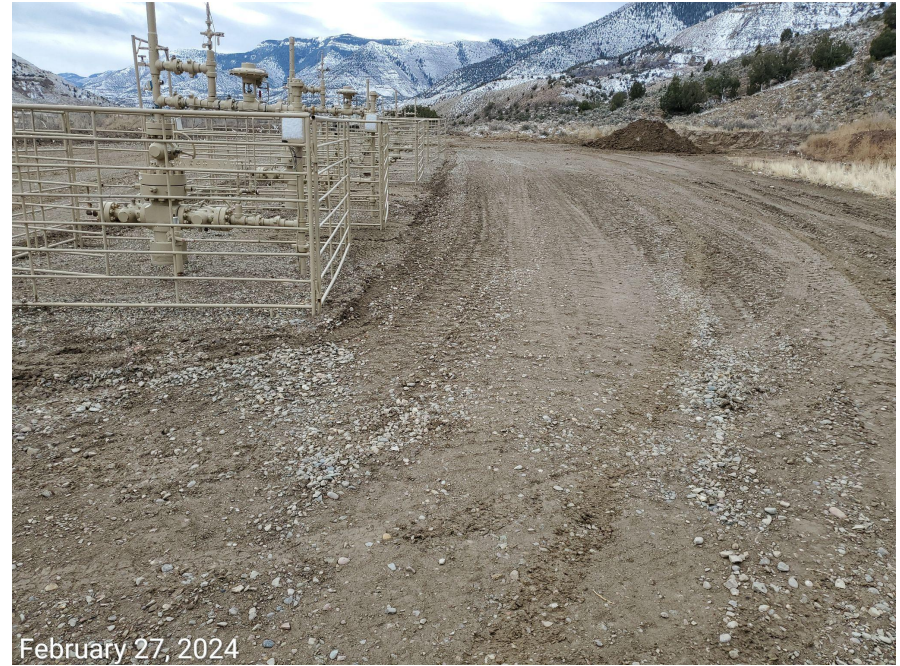
Photo 4: Photos taken from the working pad surface. BMPs to stabilize the working pad surface appears to have been maintained; additional compaction is apparent, and potentially addition of road base material. Continue to monitor and maintain BMPs to ensure location remains stabilized.

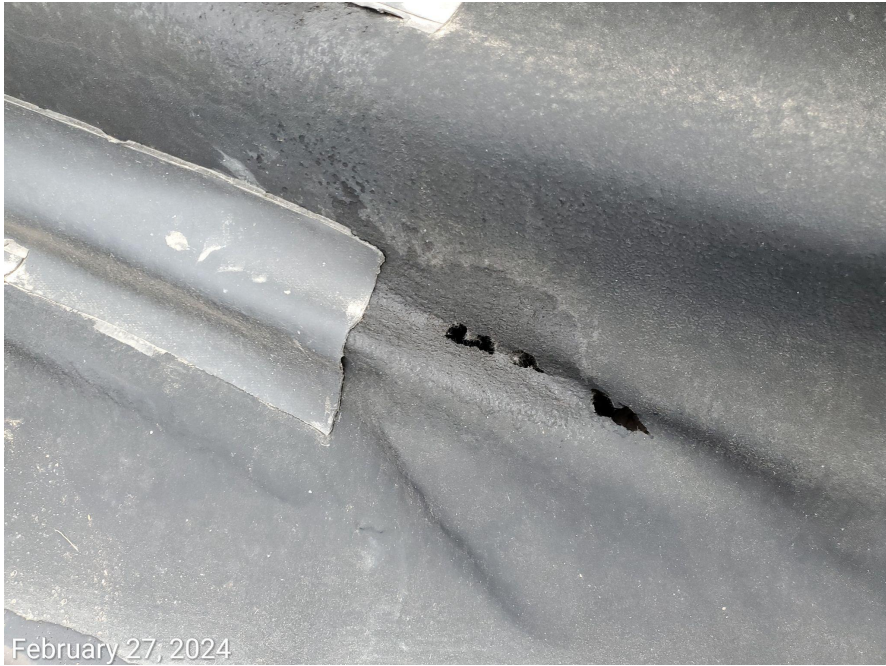
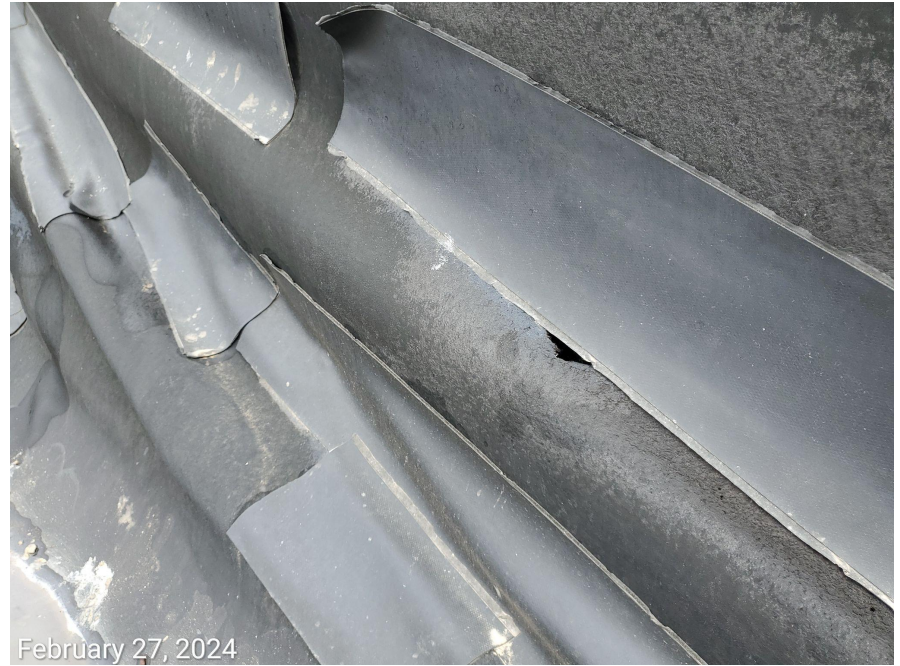
Photo 5: Photos 5-6 taken from the tank battery facility. Photos examples showing holes and tears remain apparent within the liner of the secondary containment measure.

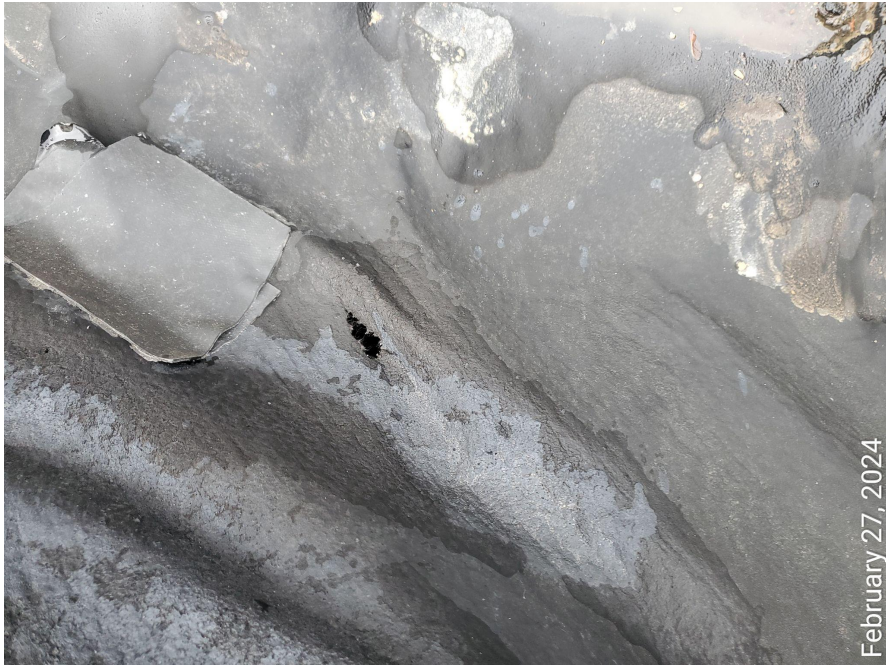
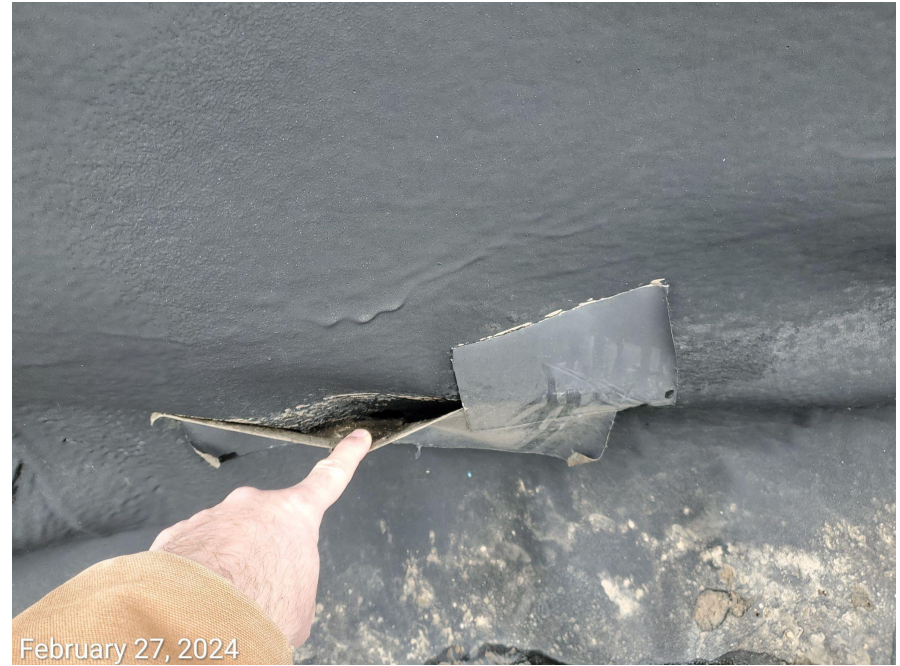
Photo 6: See comments under photo 5. Photo right example showing patches from previous repair work have not been maintained.

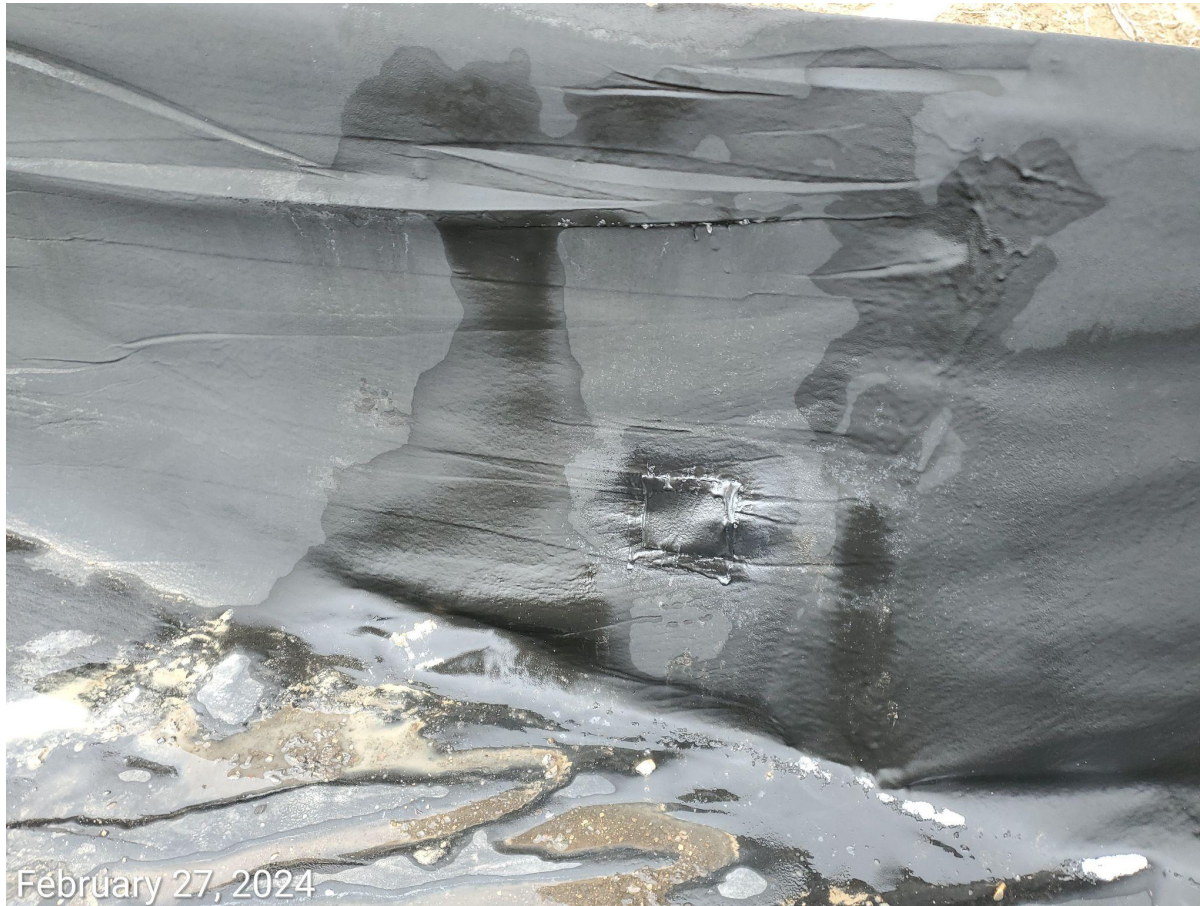
Photo 7: Photo example showing Operator appears to have conducted some maintenance work at the containment measure. Work is insufficient as holes/tears remain.

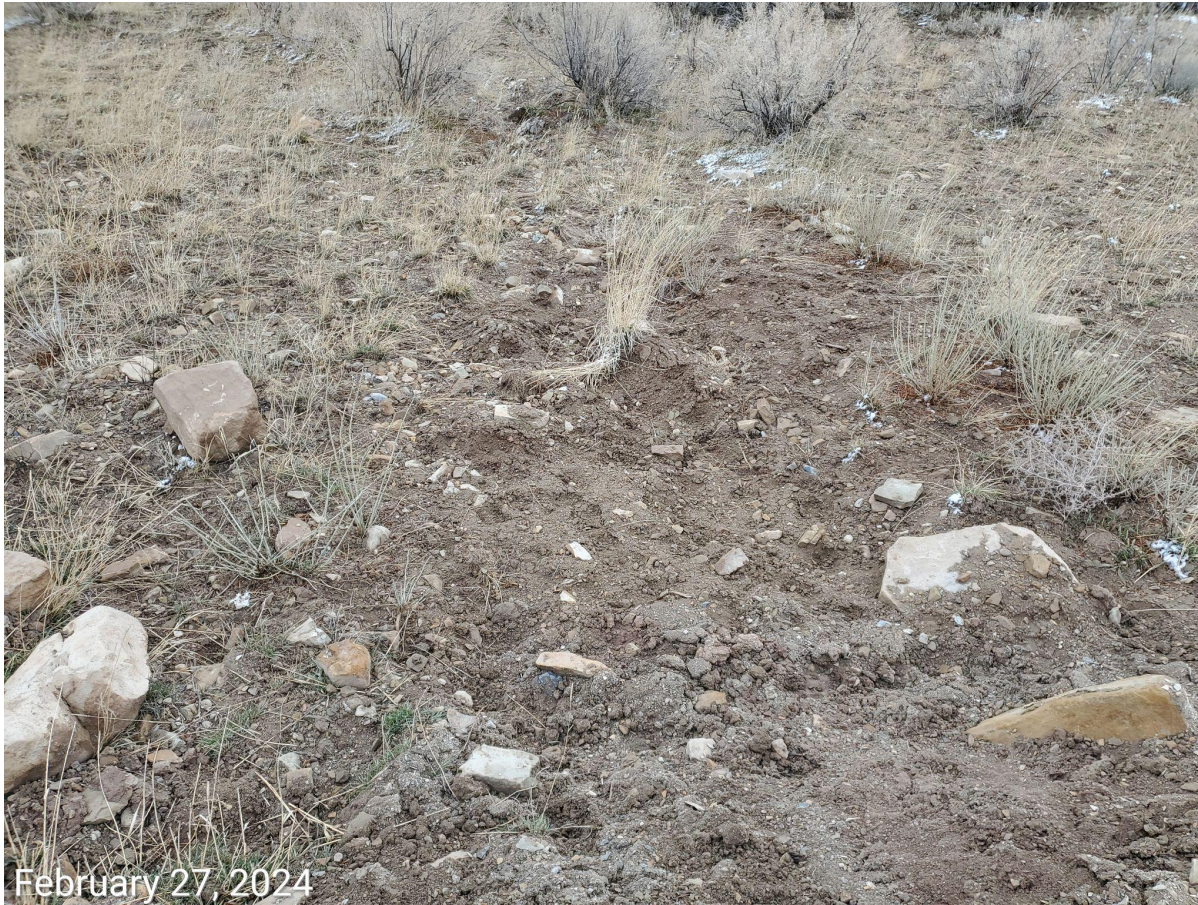
Photo 8: Photo taken from the slopes on the east end of the Location. Operator appears to have placed additional soil to repair the erosion degradation observed on the slopes on the east end of the Location. BMPs to stabilize the soils not observed per the CA. Unclear if additional reclamation work, such as seeding, has been performed.

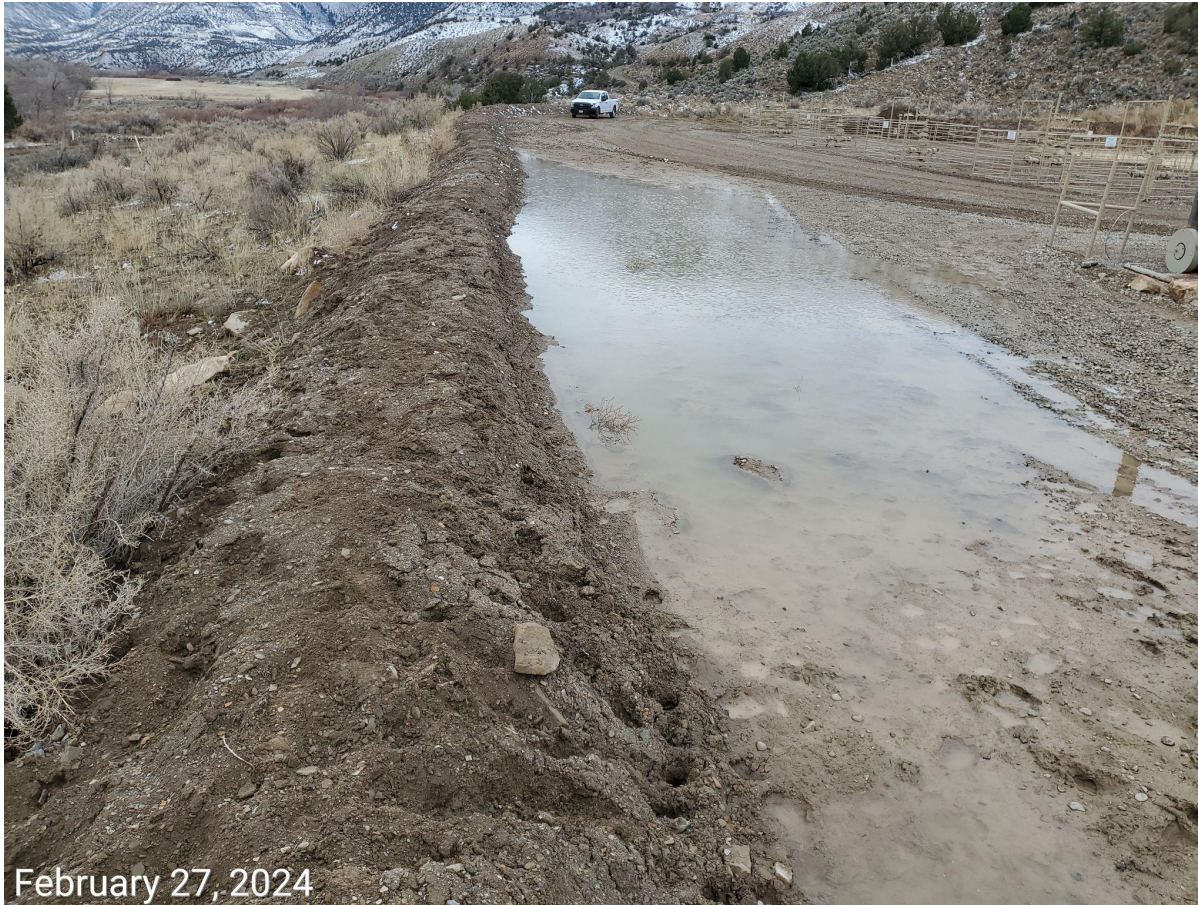
Photo 9: Photo taken from the east end of the working pad surface, facing south. Photo shows stormwater ponding has persisted on the east end of the Pad.
