**SITE-SPECIFIC QUALITY ASSURANCE
& QUALITY CONTROL AUDIT**

Final Reclamation Complete Notice – Cropland Drone Imagery

PERMIT CLOSURE REPORT – CROPLAND

Location Name BOULDER BANK-61N66W/7SWSE

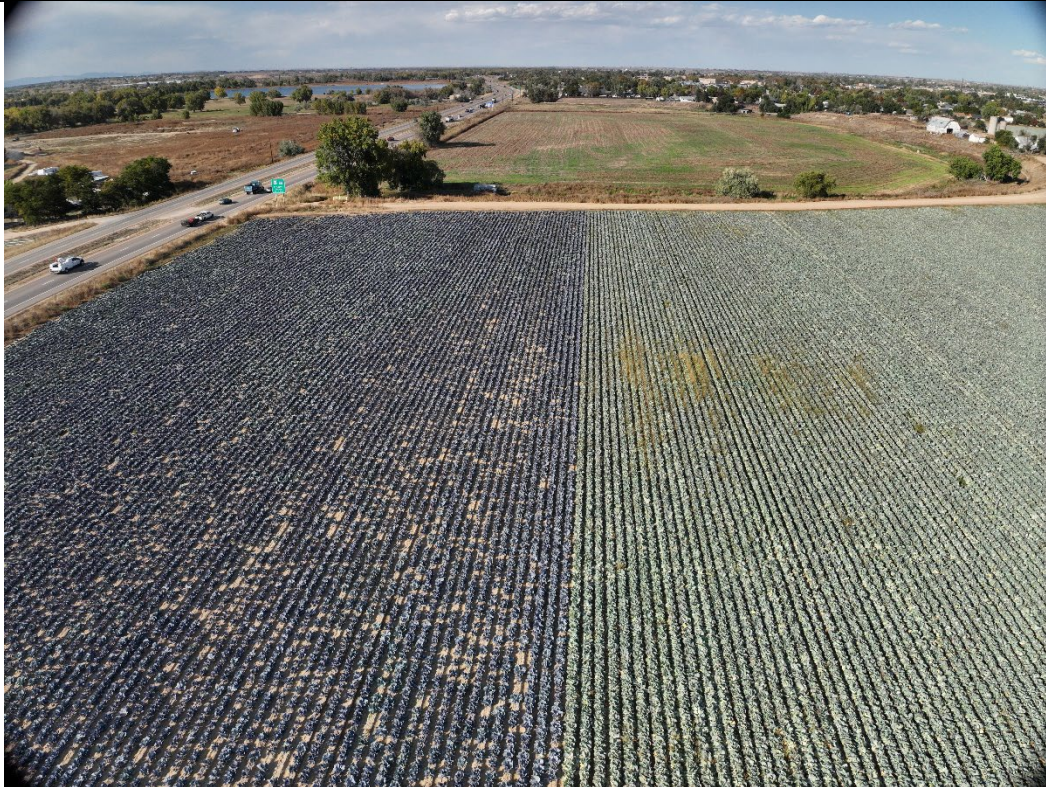
NORTH – 40.059979 / -104.817758

In View – Well, Access Road, Flowline

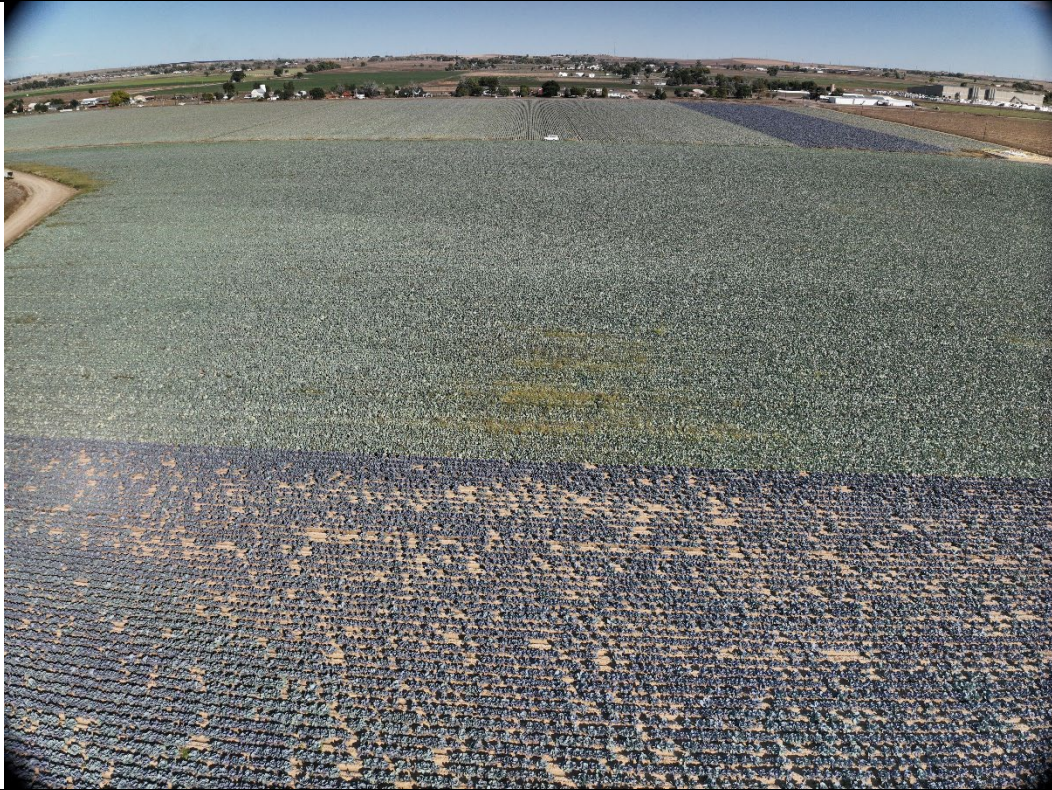
EAST – 40.060673 / -104.818644

In View – Well, Access Road, Flowline

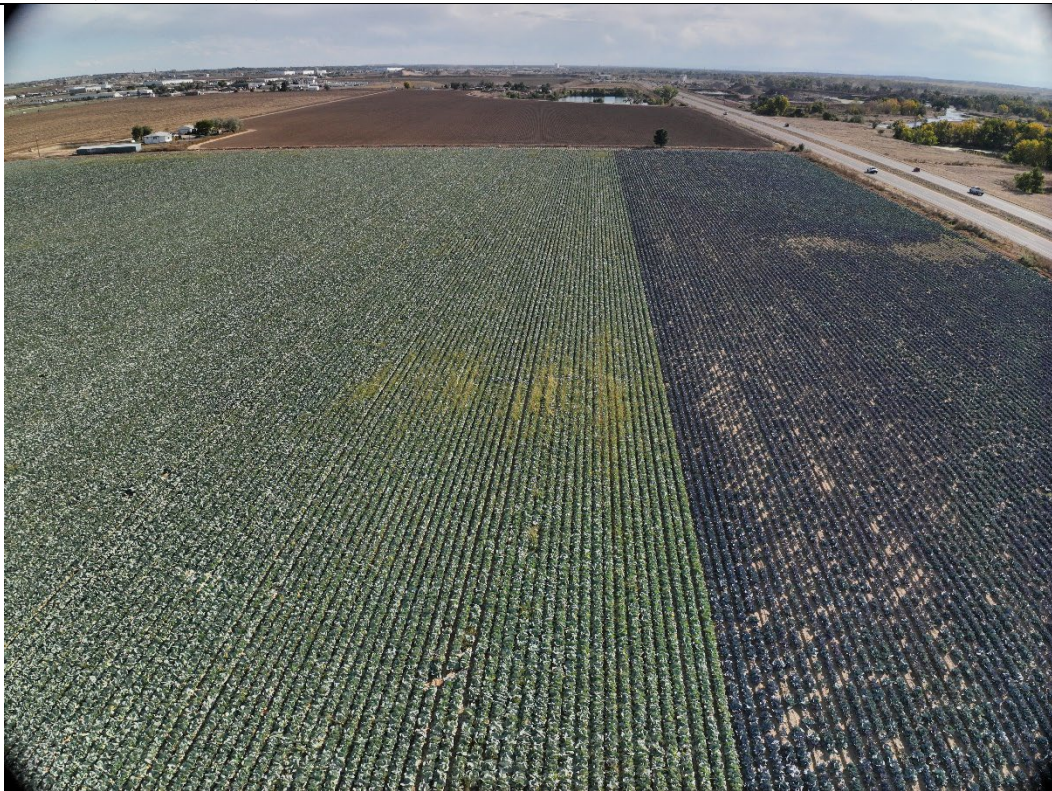
SOUTH – 40.061288 / -104.817546

In View – Well, Access Road, Flowline

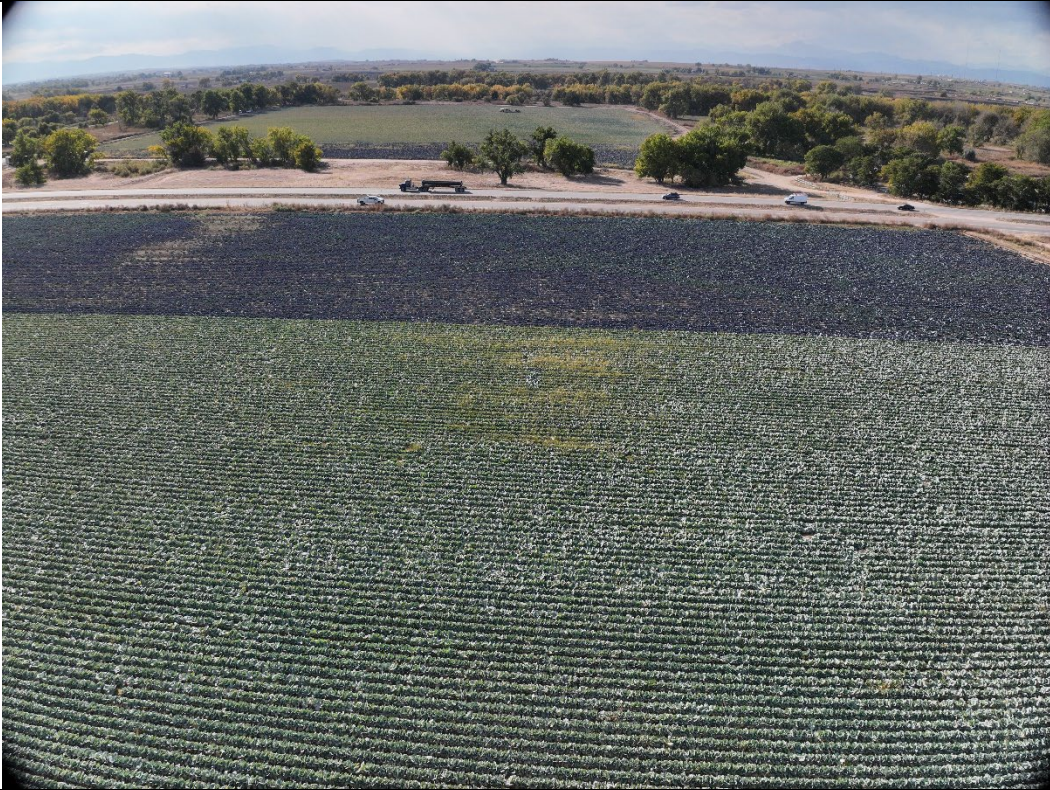
WEST – 40.060640 / -104.816652

In View – Well, Access Road, Flowline

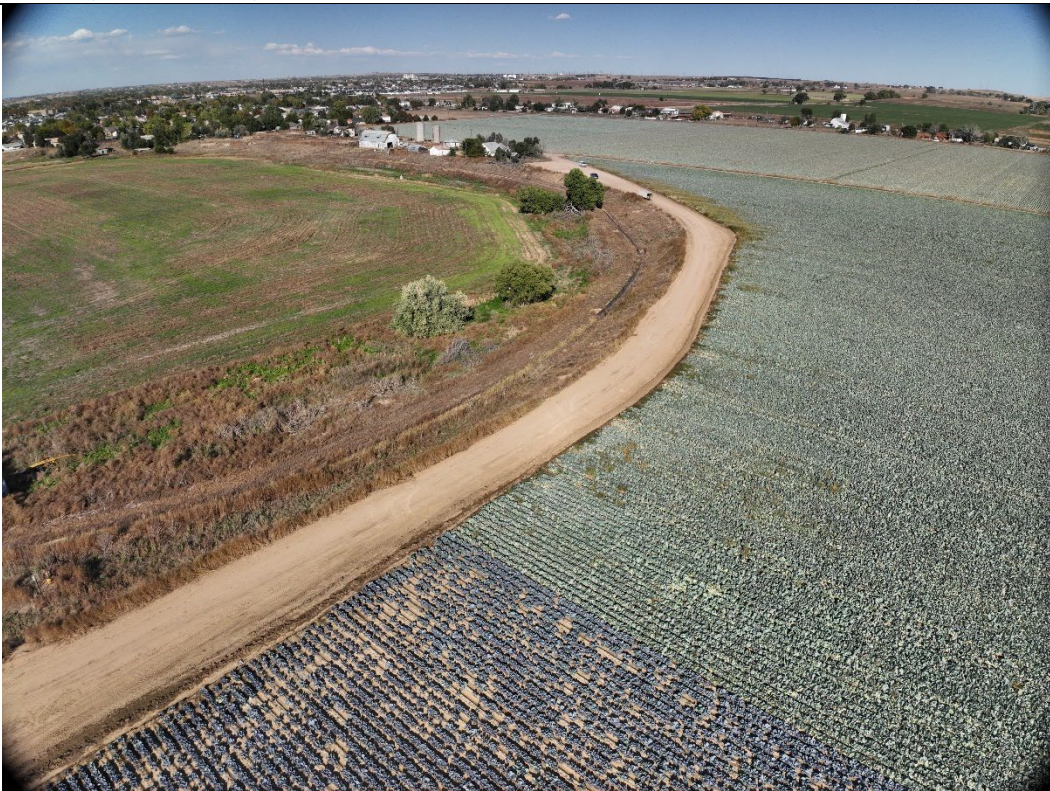
NORTHEAST – 40.061171 / -104.818081

In View – Tank Battery, Flowline

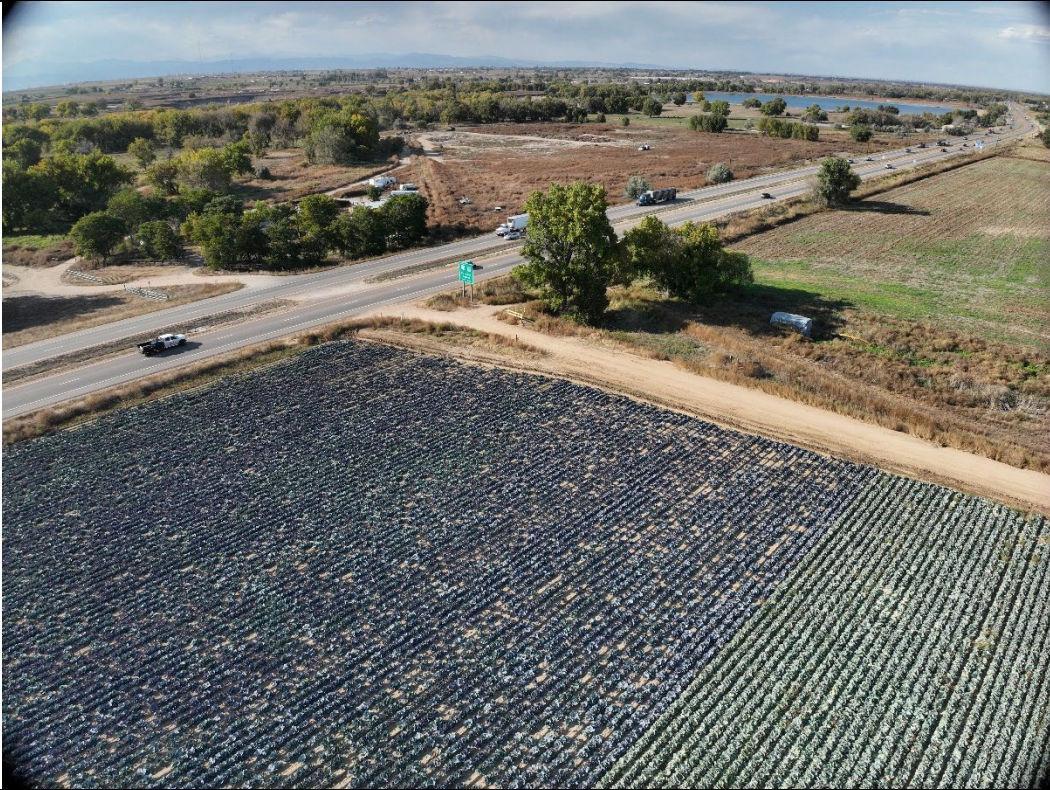
NORTHWEST – 40.060867 / -104.817491

In View – Access Road, Flowline

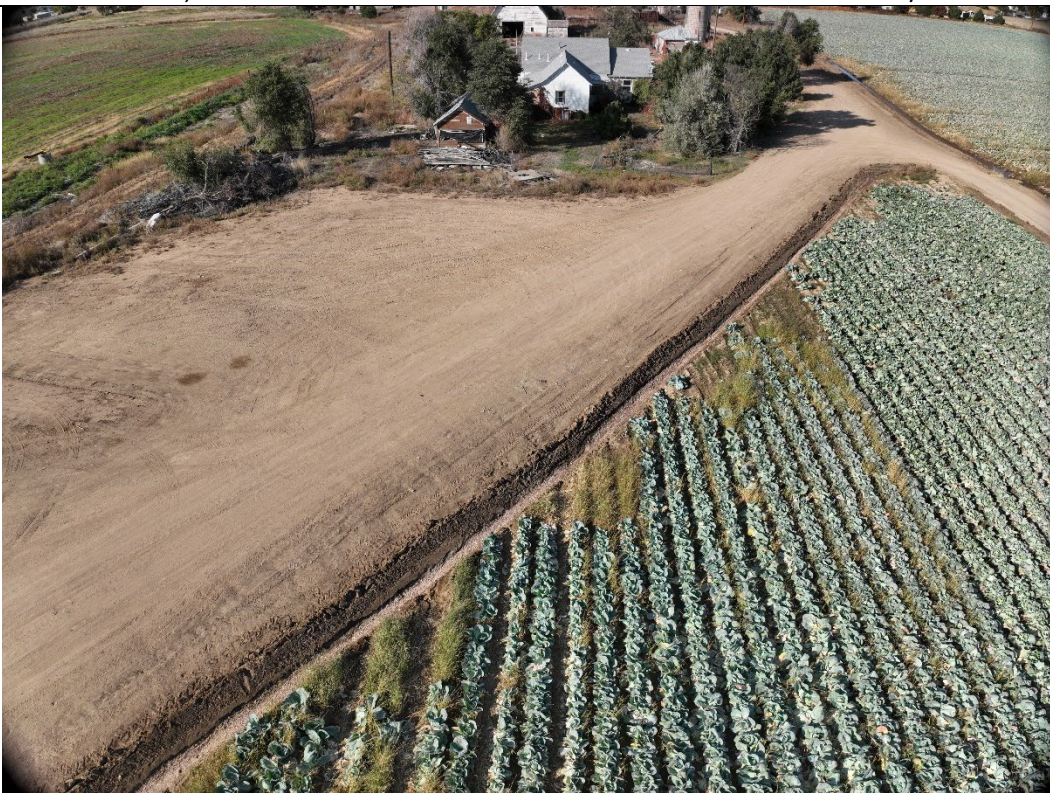
NORTH – 40.062732 / -104.814750

In View – Tank Battery, Flowline

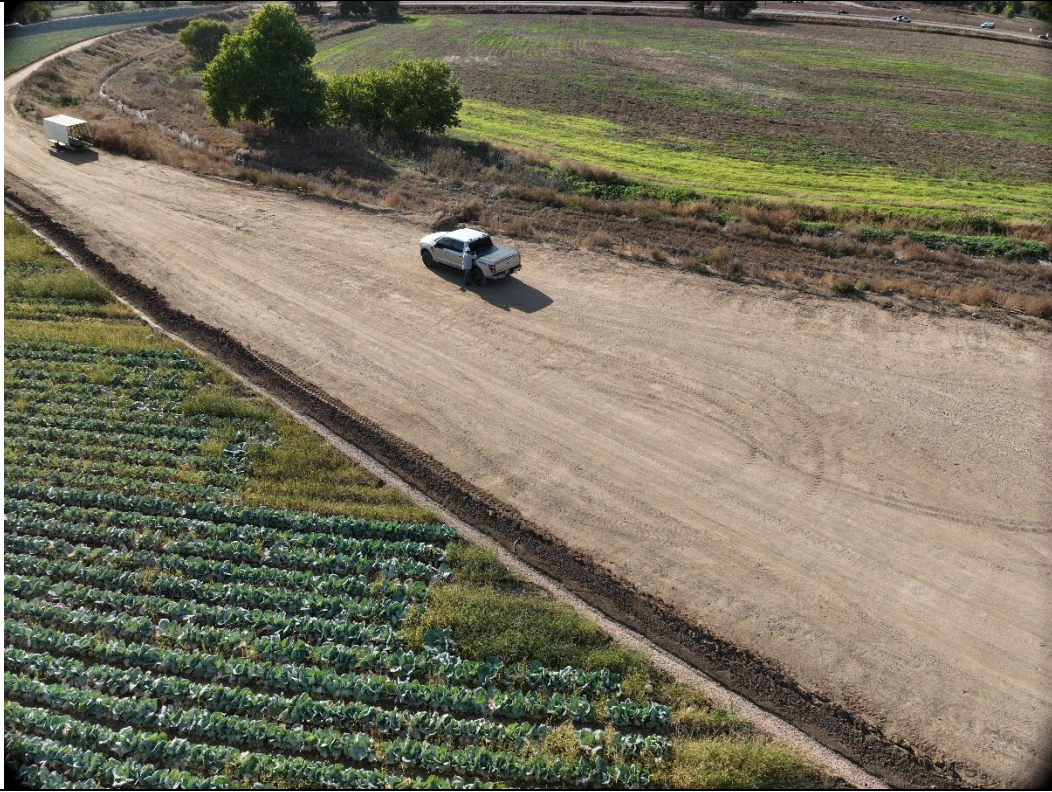
WEST – 40.062733 / -104.814752

In View – Tank Battery, Flowline

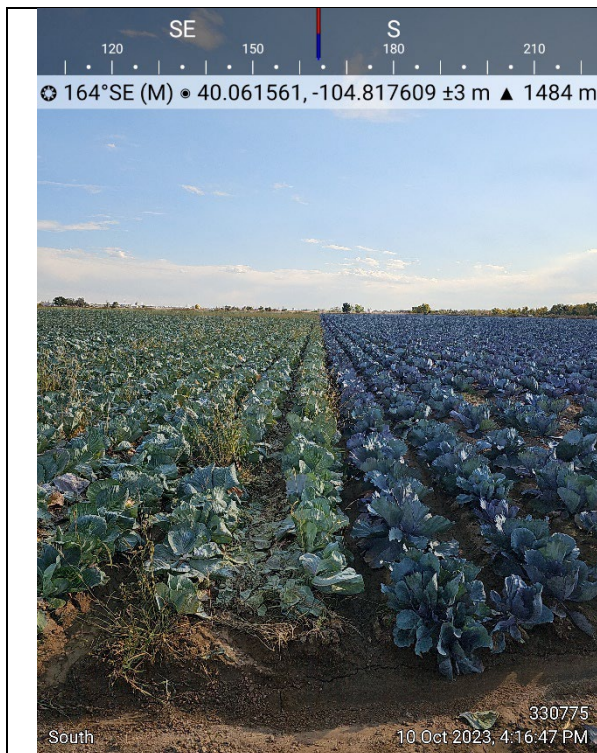
Looking south from farm access road towards wellhead, access road and flowline – 40.061561 / -104.817609

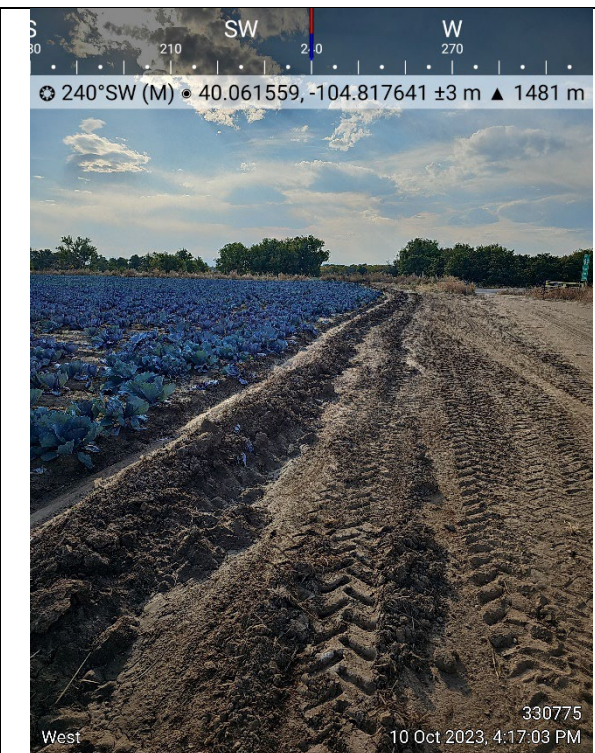
Looking west from farm access road north of wellhead – 40.061559 / -104.817641

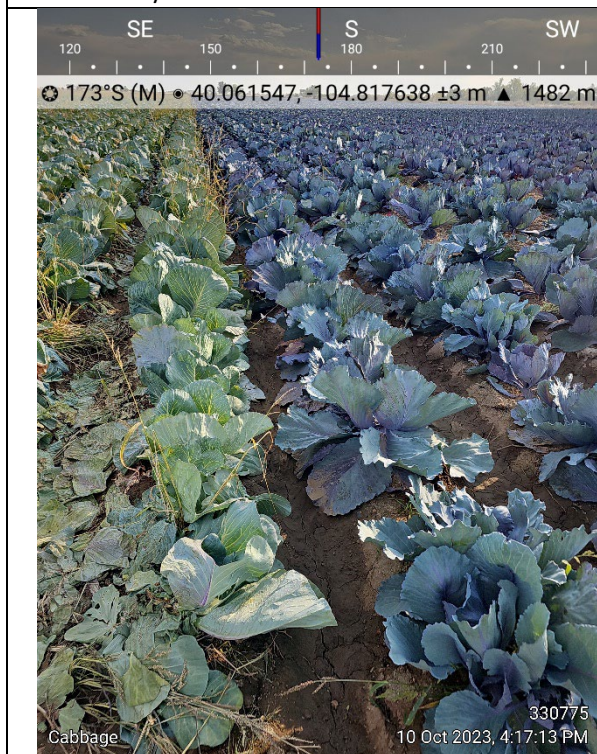
Looking South into cabbage field towards wellhead from farm access road – 40.061547 / -104.817638

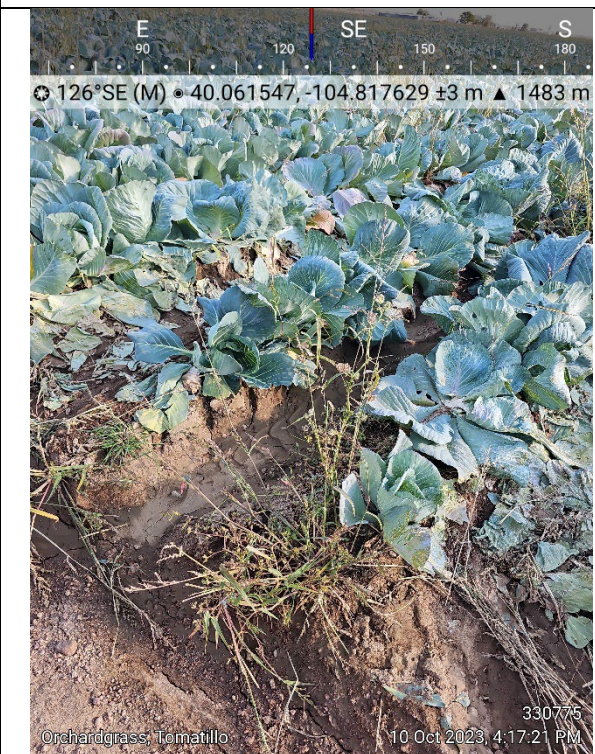
Orchardgrass – *Dactylis glomerata* and Tomatillo – *Physalis philadelphica* growing in cabbage field near wellhead – 40.061547 / -107817629

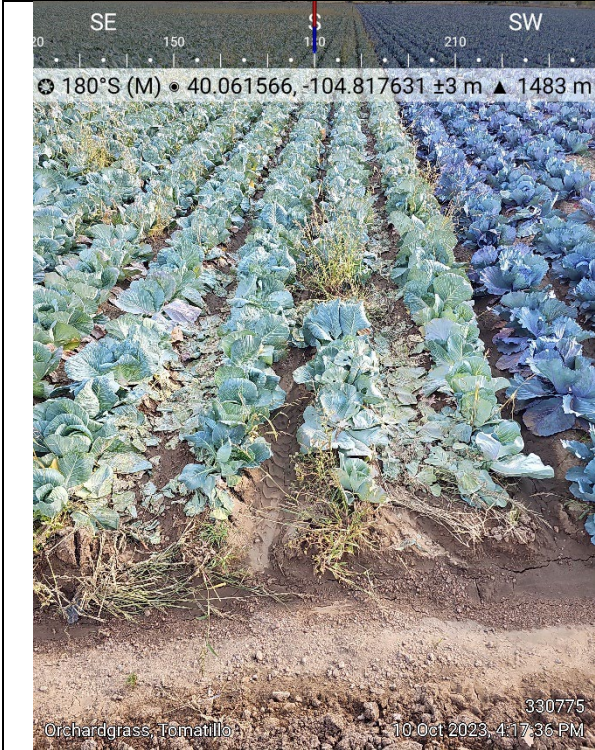
Orchardgrass – *Dactylis glomerata* and Tomatillo – *Physalis philadelphica* growing in cabbage field near wellhead – 40.061566 / -104.817631

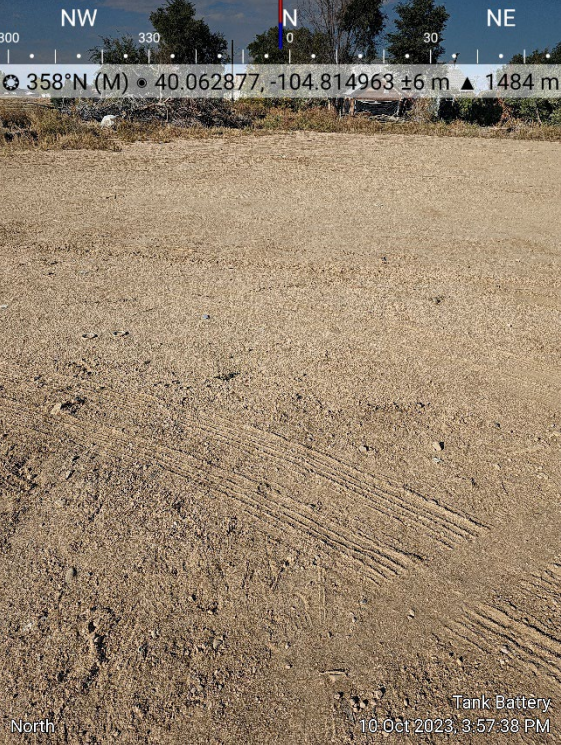
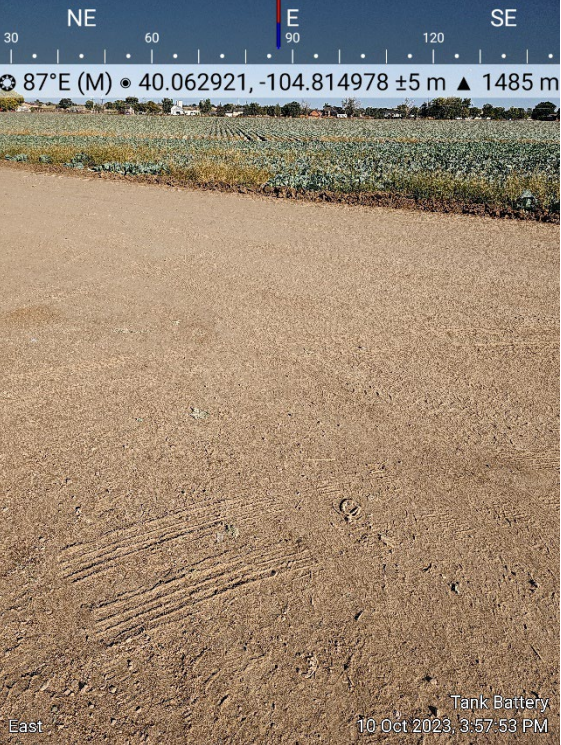
The Off-Location Flowline for this location followed the farm road, that existed prior to oil and gas activity as a farm access road. The tank battery and separator fall outside the crop area along the west side of farm/ditch road. Vegetation in this area has recovered to similar or better than surrounding non-crop farm areas. Within the recovery there are native grasses and low weed concentrations.

<p>Looking North towards tank battery and separator location from farm access road – 40.062877 / -104.814963</p>	<p>Looking East at tank battery and separator location – 40.062921 / -104.814978</p>

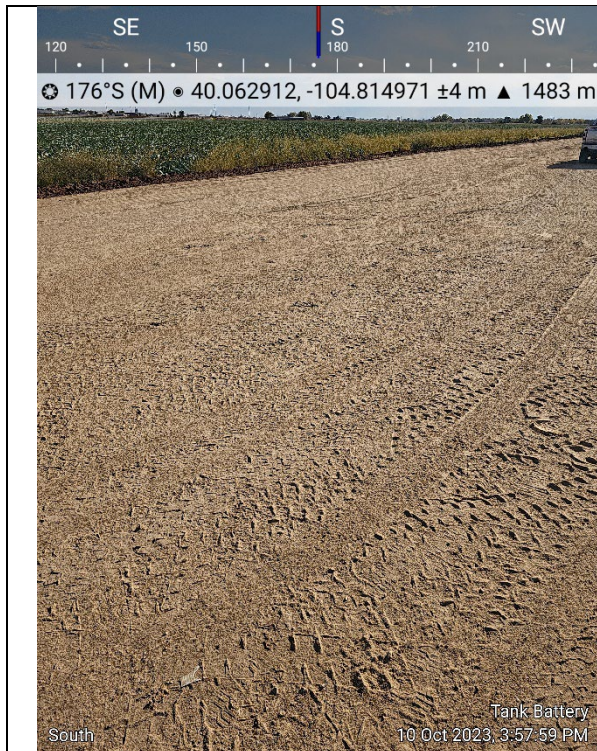
Looking South looking at tank battery and separator location – 40.062912 / -104.814971

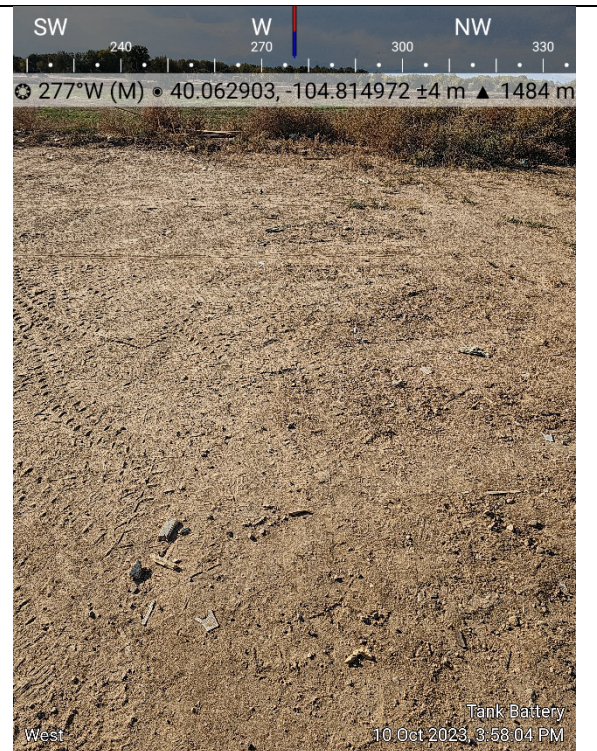
Looking West looking at tank battery and separator location – 40.062903 / -104.814972

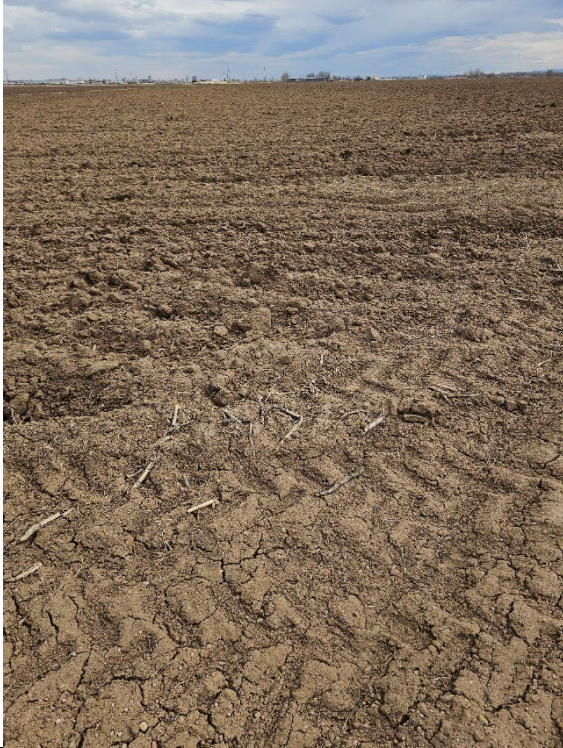
Looking South at well pads from tank battery and separator location – 40.062731 / -104.814968

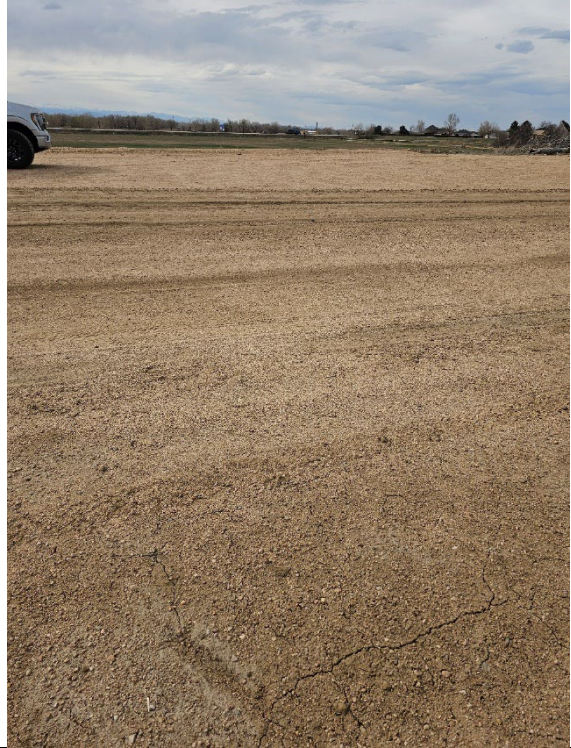
Looking West from well pad towards tank battery and separator location – 40.062729 / -104.814965

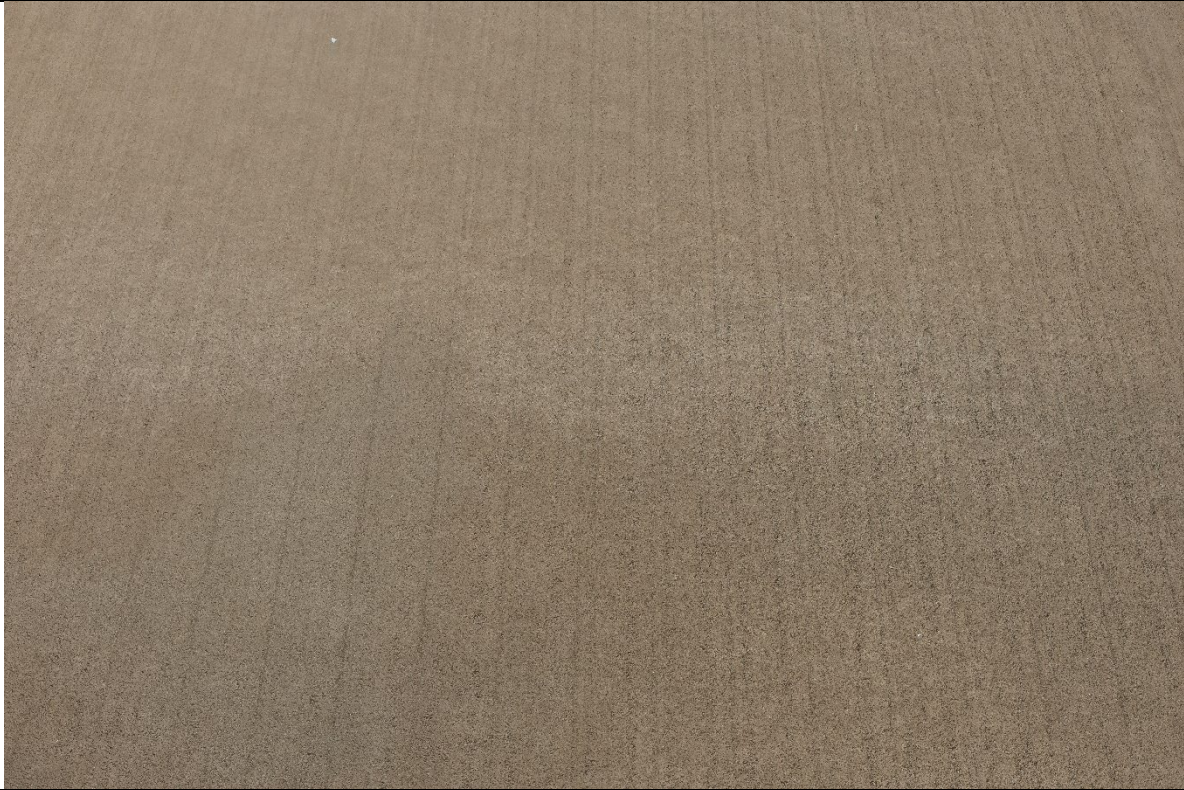
EAST – 40.060555 / -104.818037

Soil Sage drone imagery confirms that no equipment was left on site at this location after reclamation activities occurred.

In View – Well, Access Road, Flowline

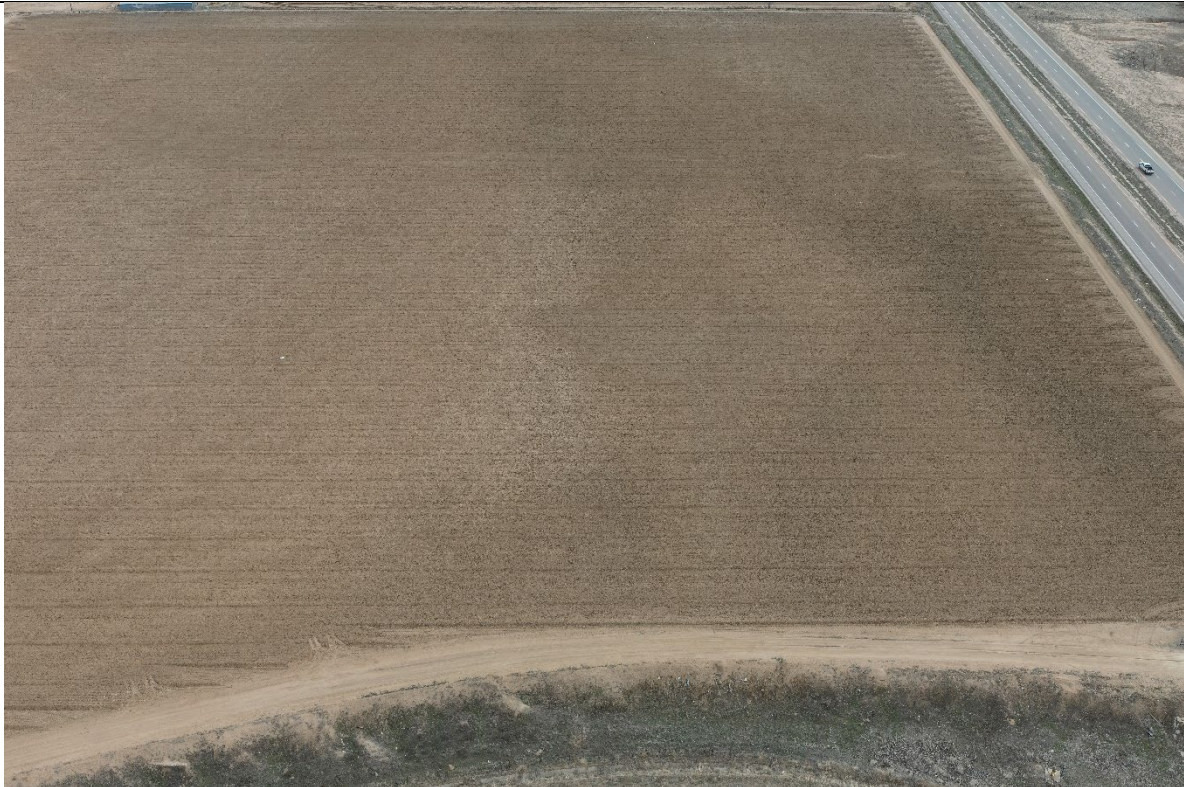
SOUTH – 40.062615 / -104.817281

In View – Well, Access Road, Flowline

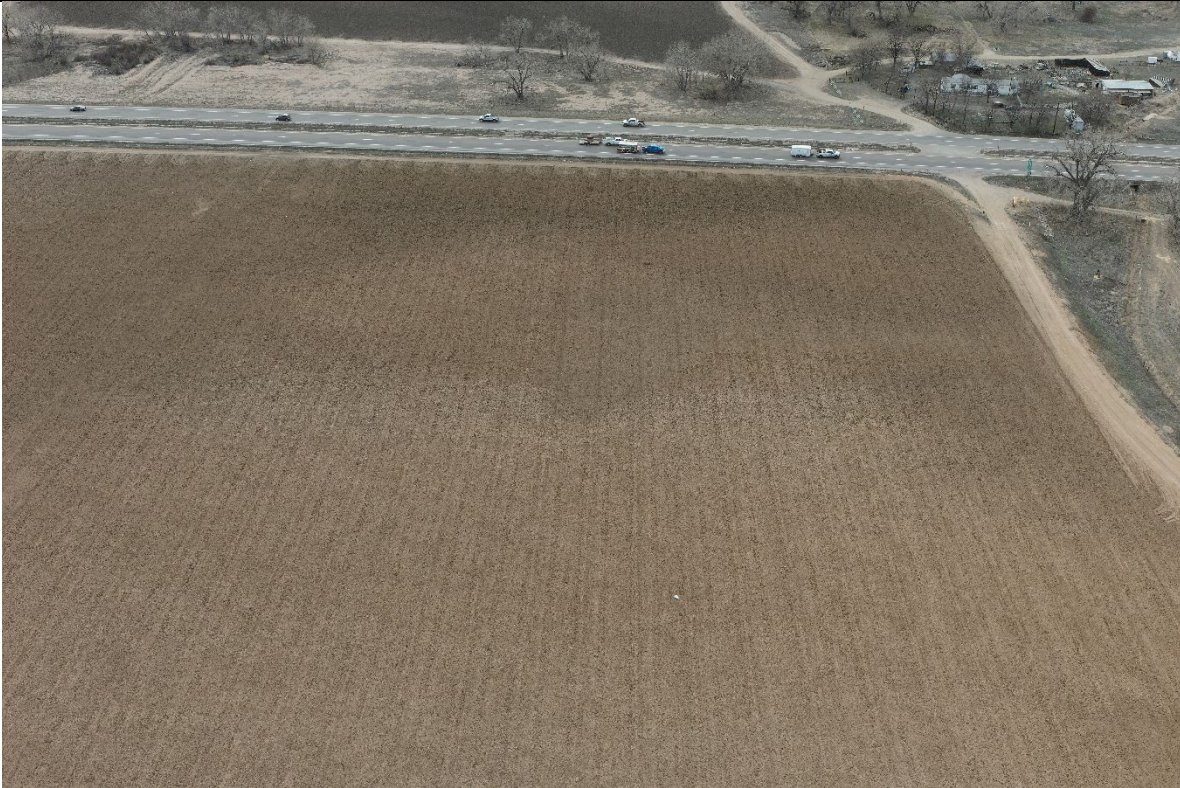
WEST – 40.060830 / -104.81518

In View – Well, Access Road, Flowline

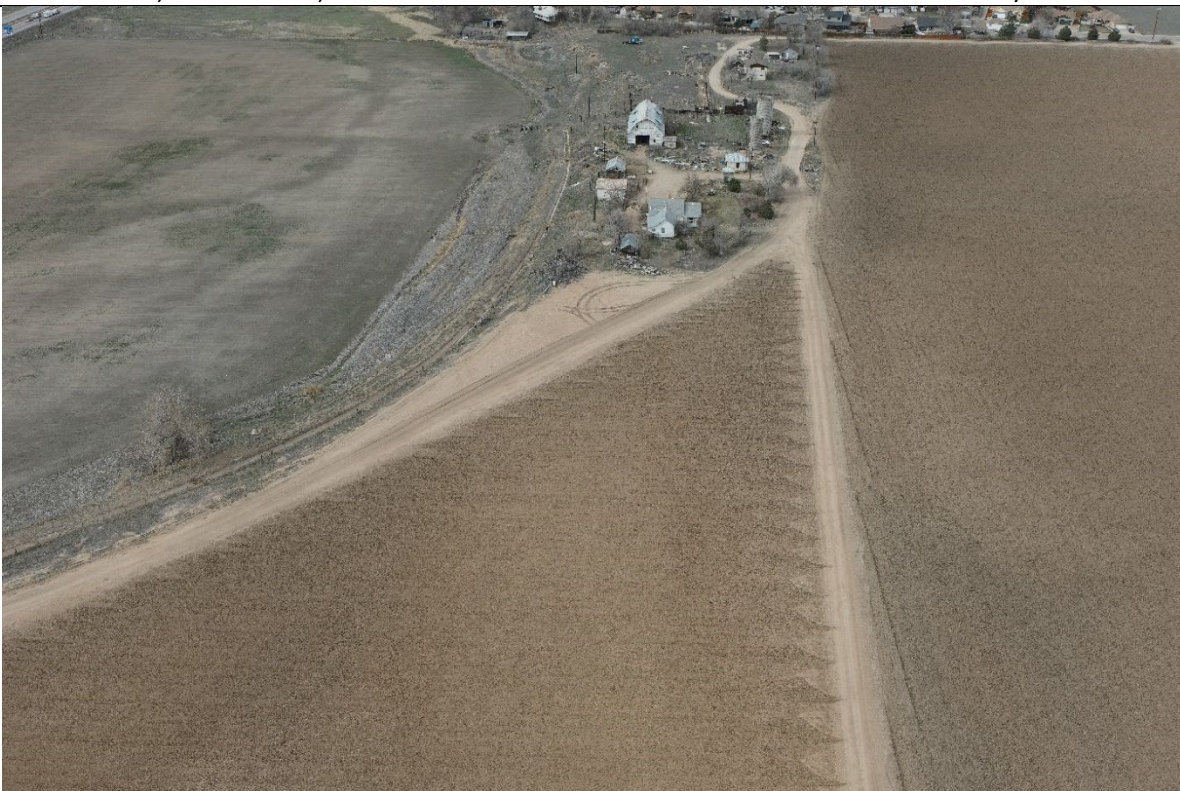
NORTH – 40.060827 / -104.814781

In View – Tank Battery, Flowline

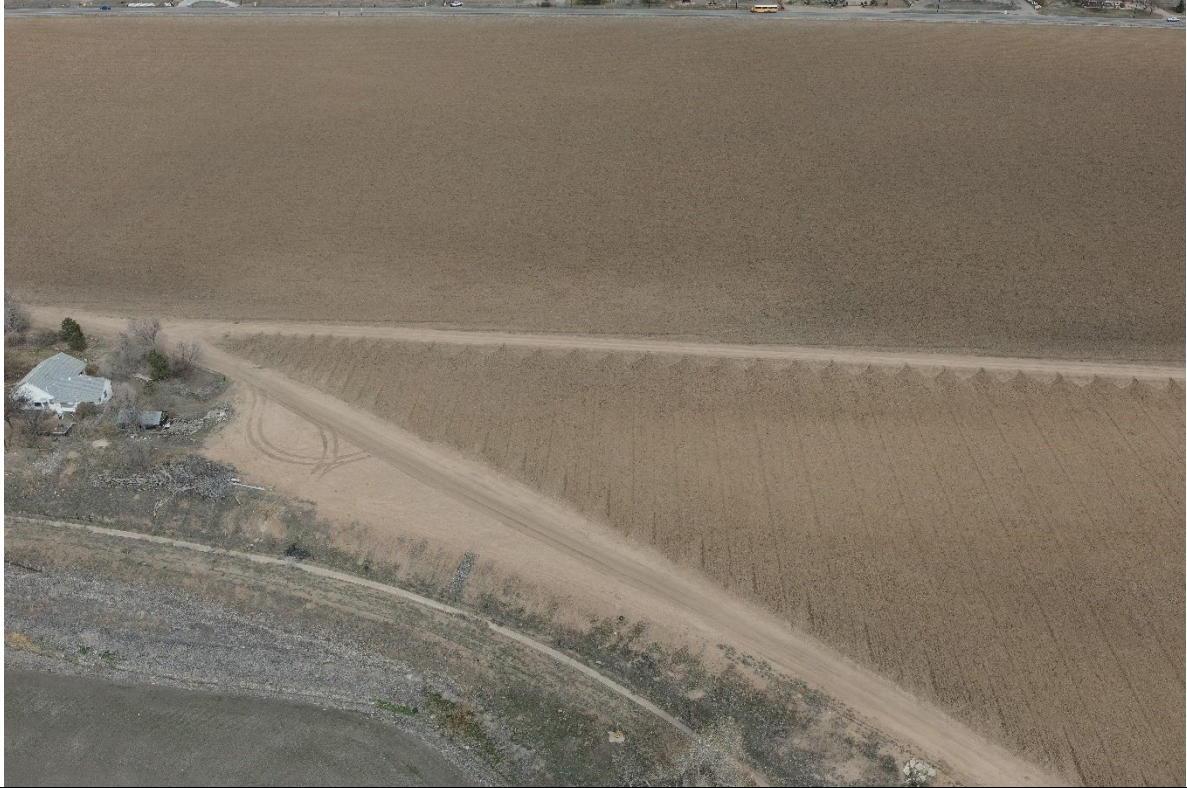
EAST – 40.06251 / -104.816906

In View – Tank Battery, Flowline

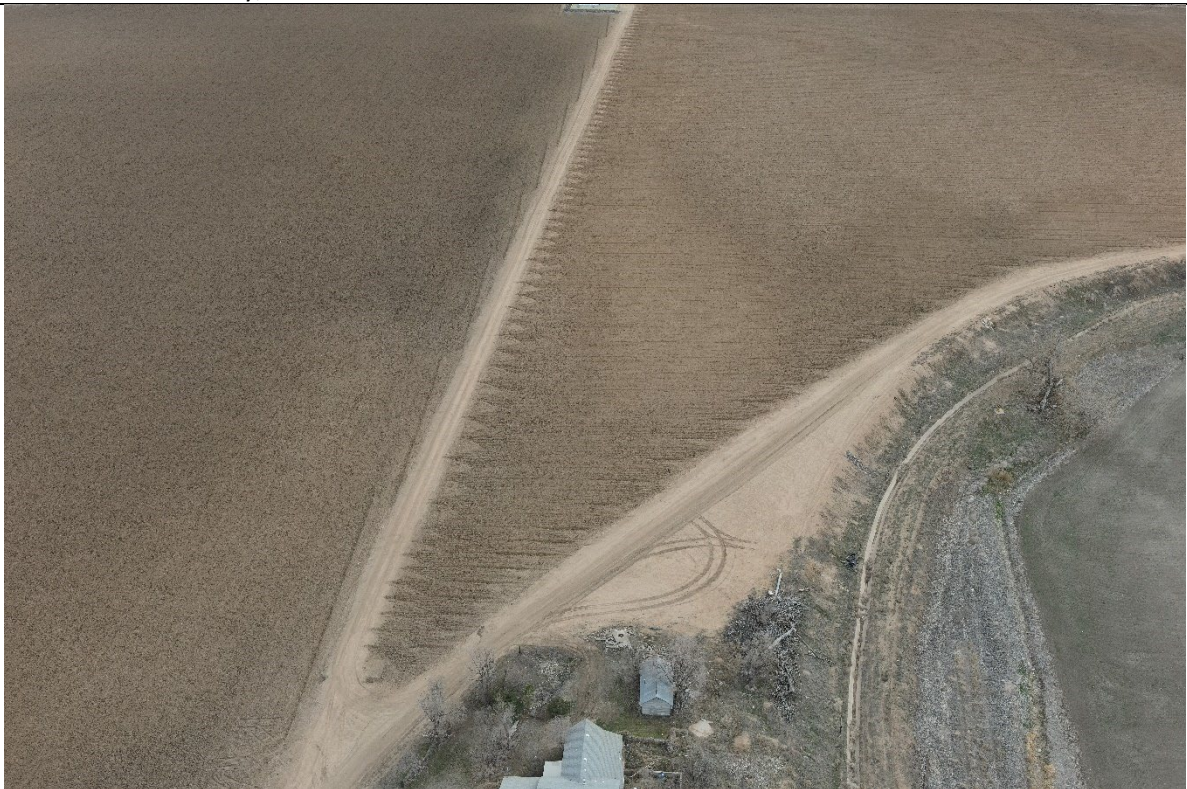
SOUTH – 40.064362 / -104.814775

In View – Tank Battery, Flowline

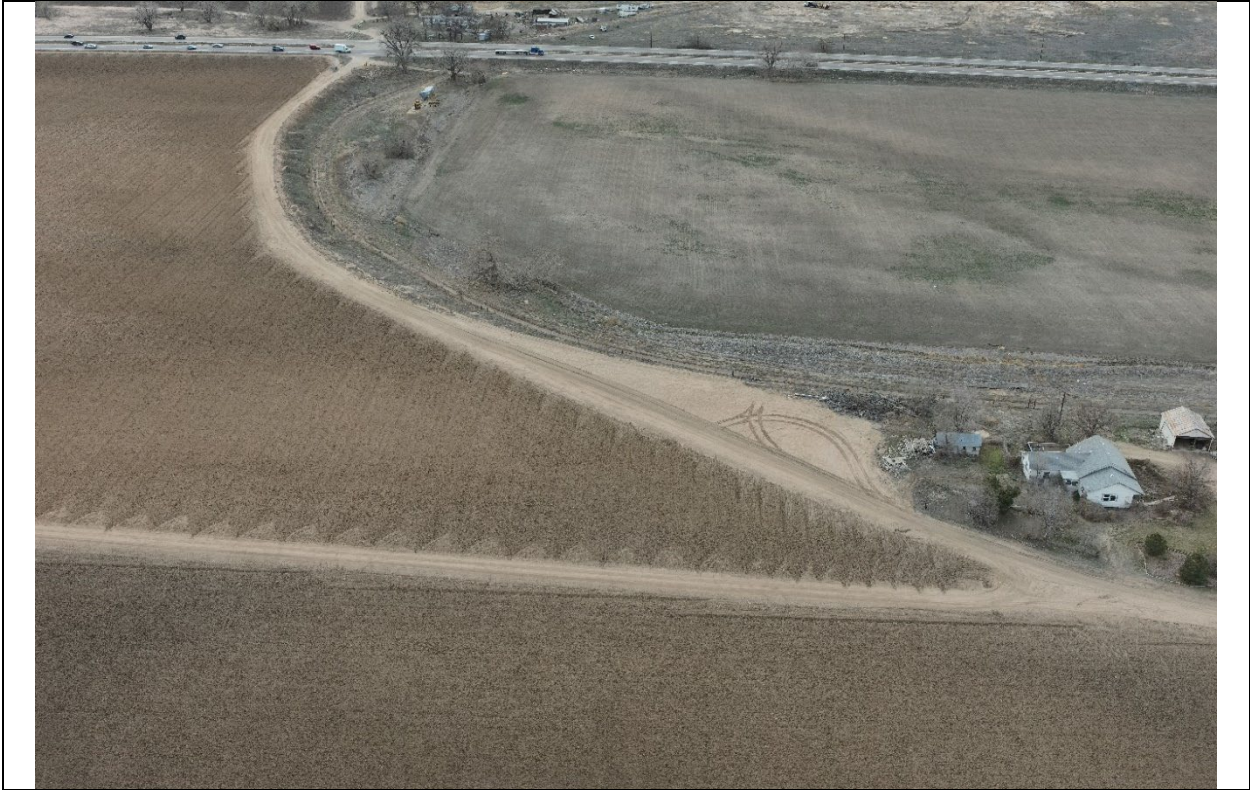
WEST – 40.062838 / -104.812665

In View – Tank Battery, Flowline
