Interim Reclamation and Stormwater Inspection

Date: 2/22/24

Operator: Highpoint Operating Corporation - 10071

Location Name: Anschutz Equus Farms

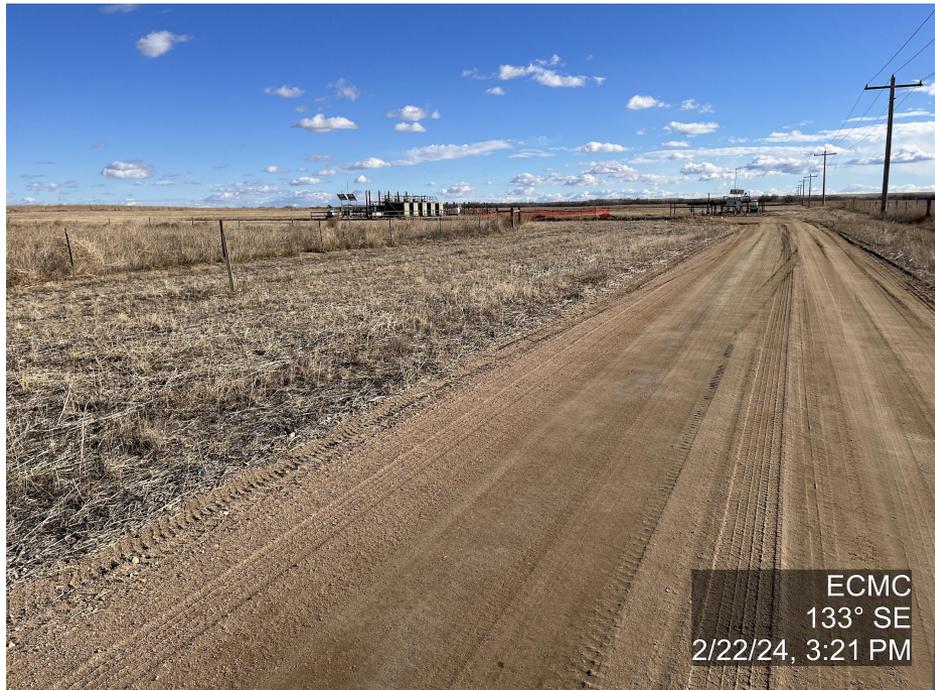
Photo 1. The photo was taken at the well location entrance facing Southeast. The photo illustrates the access road and an overview of the facility.

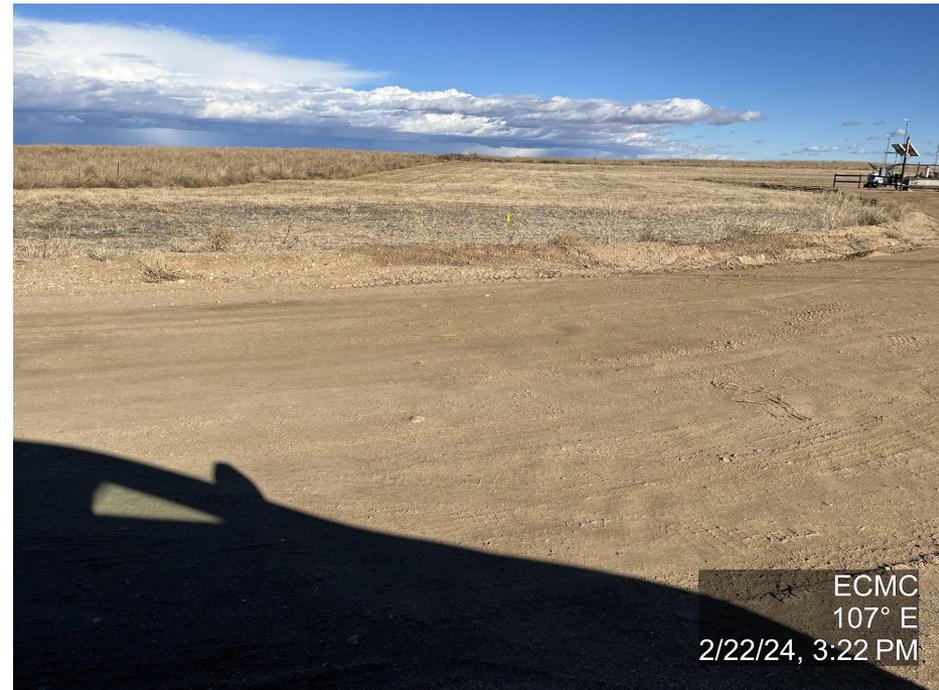
Photo 2. The photo was taken at the well location entrance facing East. The photo illustrates the interim area has been mowed on the North side of the facility.

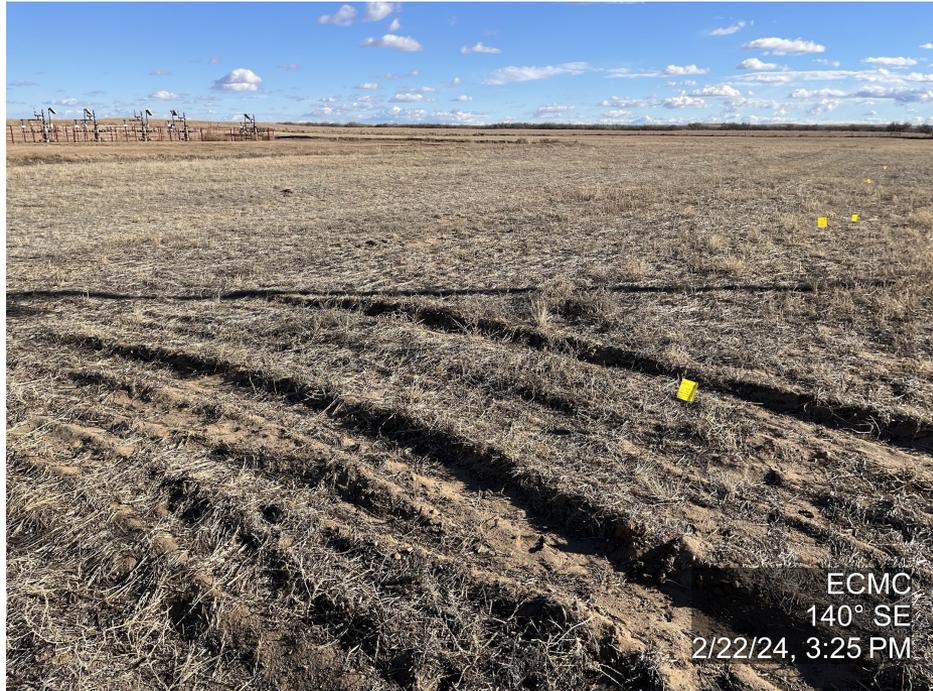
Photo 3. The photo was taken at the well location entrance facing Southeast. The photo illustrates the interim area has been mowed on the West side of the facility.

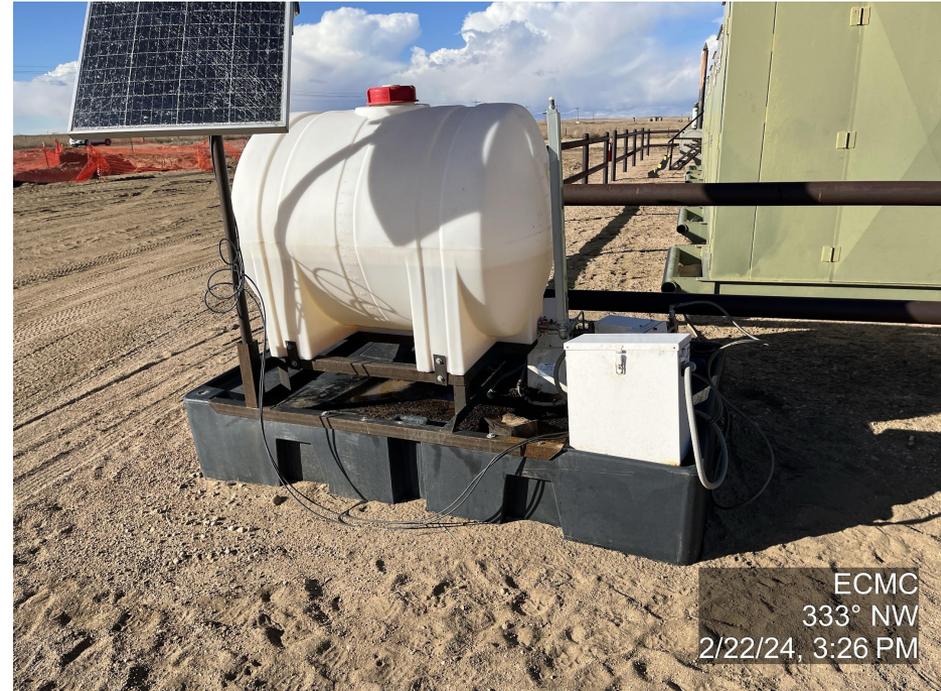
Photo 4. The photo was taken at the well location facing Northwest. The photo illustrates the tank is missing a tank placard.

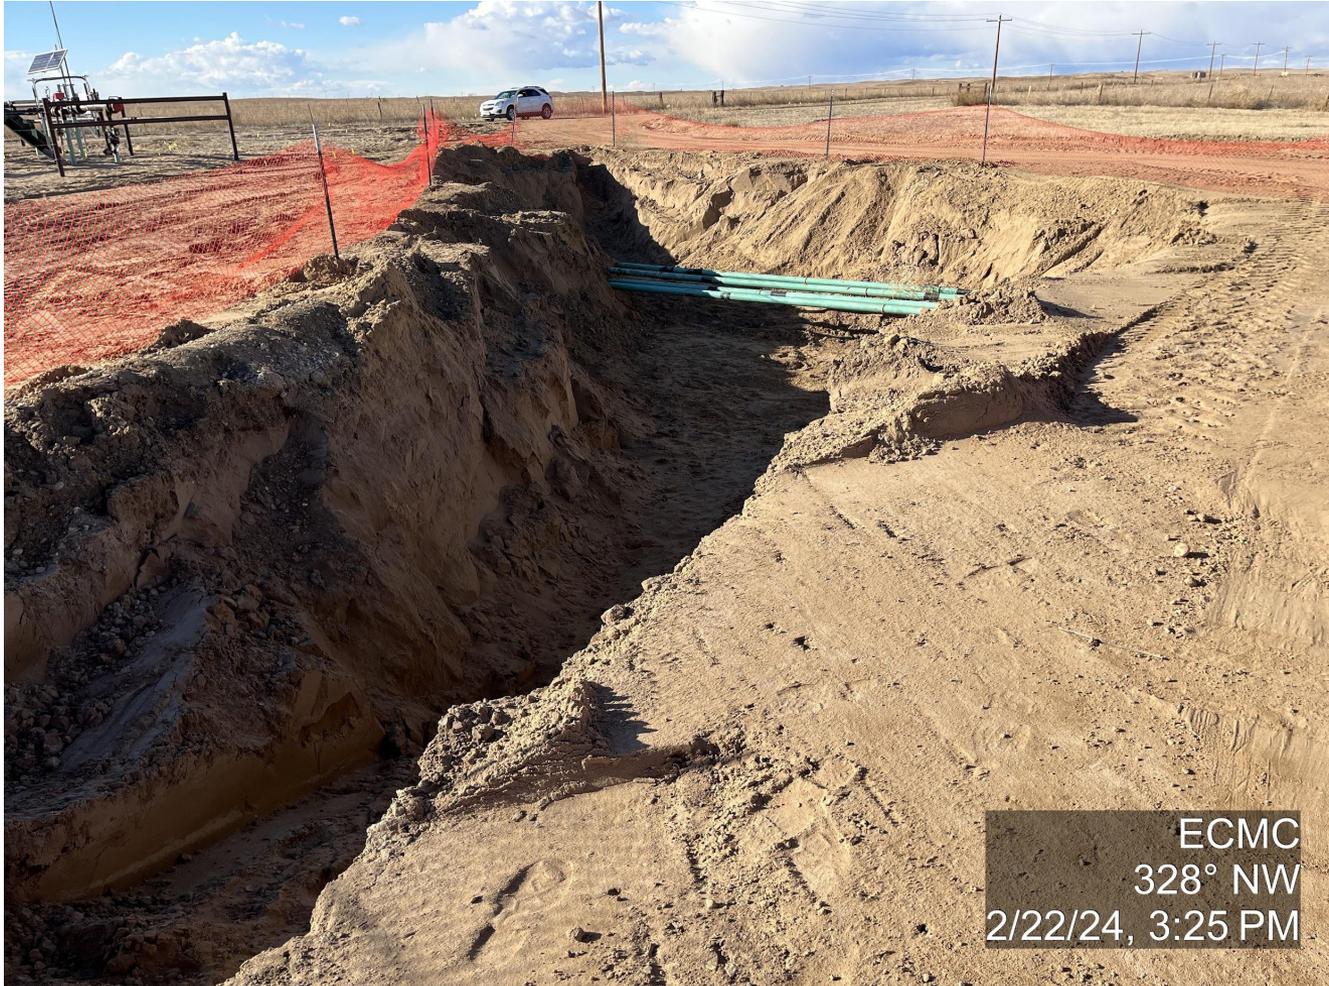
Photo 5. The photo was taken at the well location facing Northwest. The photo illustrates the active excavation of a reported spill on the facility production pad.

Note - The excavation was fenced in and not being worked on during the inspection.

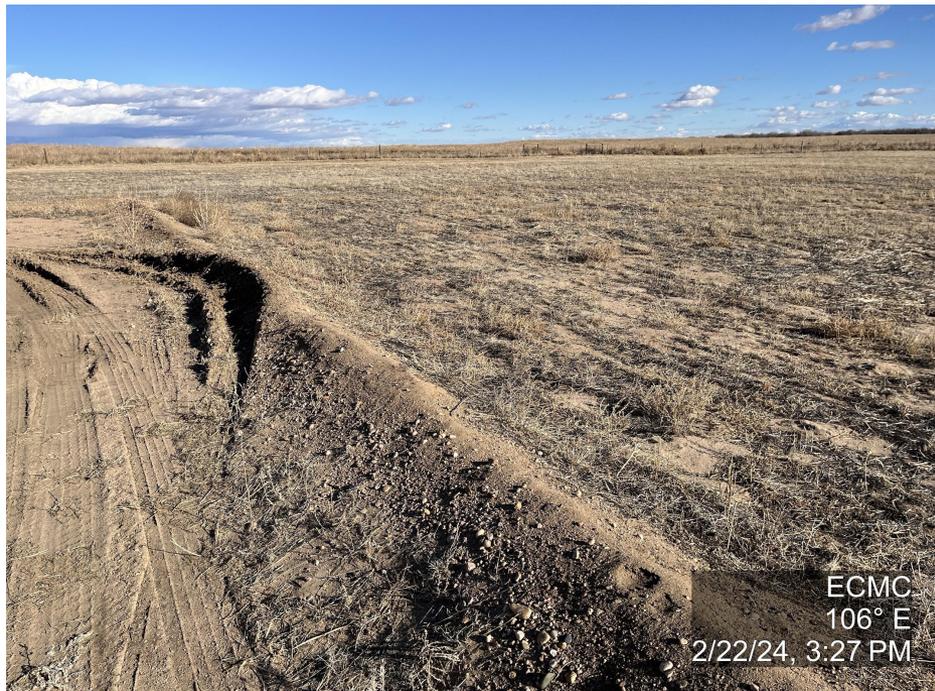
Photo 6. The photo was taken at the well location facing East. The photo illustrates the interim area has been mowed on the Southeast side of the facility.

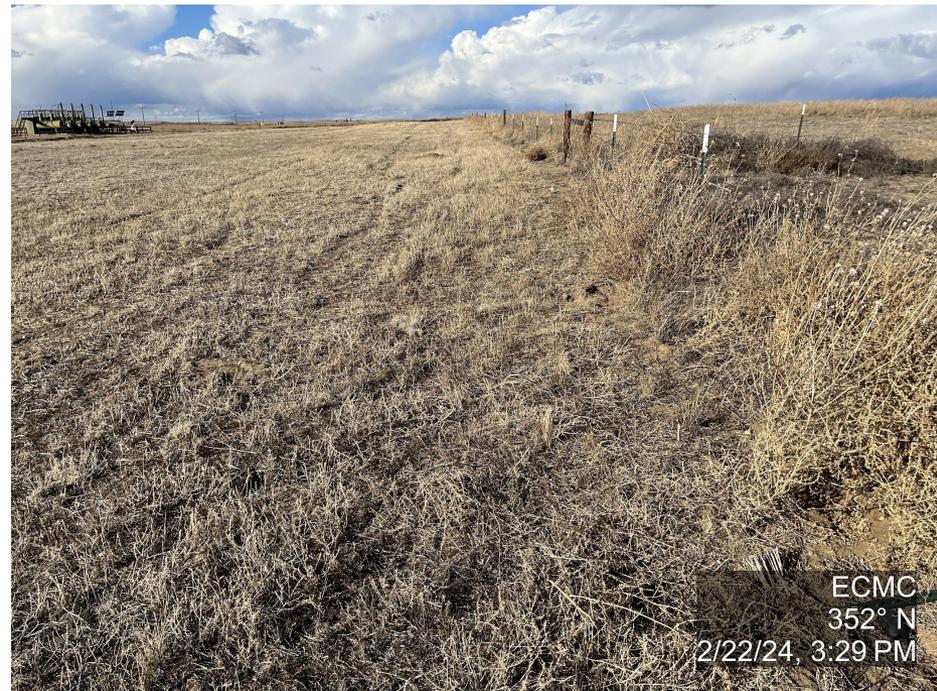
Photo 7. The photo was taken at the well location facing North. The photo illustrates the interim area has been mowed on the East side of the facility.

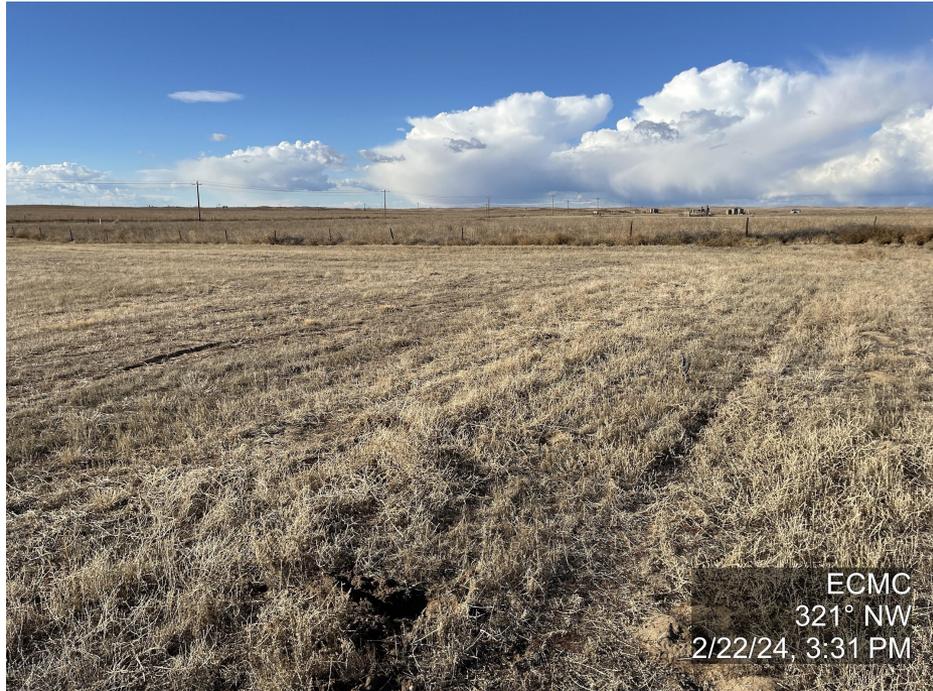
Photo 8. The photo was taken at the well location facing Northwest. The photo illustrates the interim area has been mowed on the Northeast side of the facility.

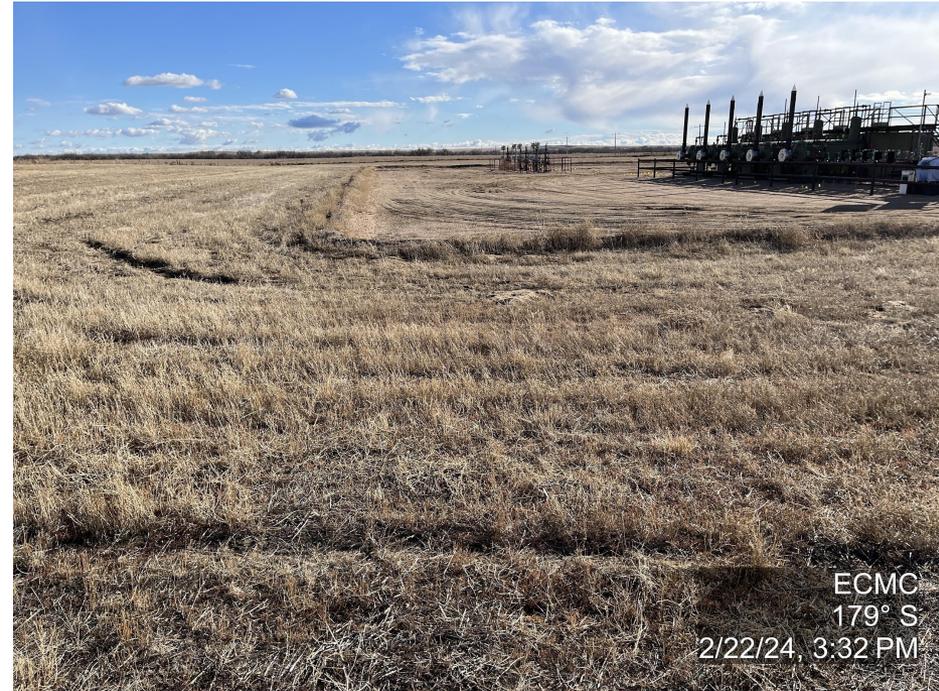
Photo 9. The photo was taken at the well location facing South. The photo illustrates the the berm around the production pad.
