Inspection Photos

Operator: CAERUS PICEANCE LLC #10456

Location ID: 335781

Inspection Doc: 696205628

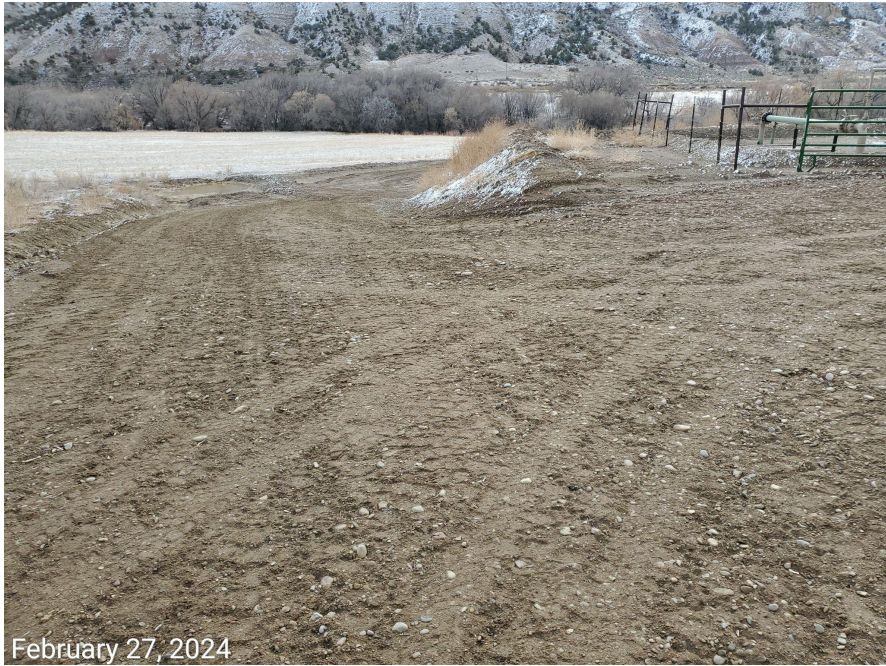
Photo 1: Photos 1-2 taken from the north end of the Location. Photos provide an overview of the Location from east, southeast, southwest to west. Photos also examples showing additional work to stabilize the upper areas of the Location appear to have been performed.

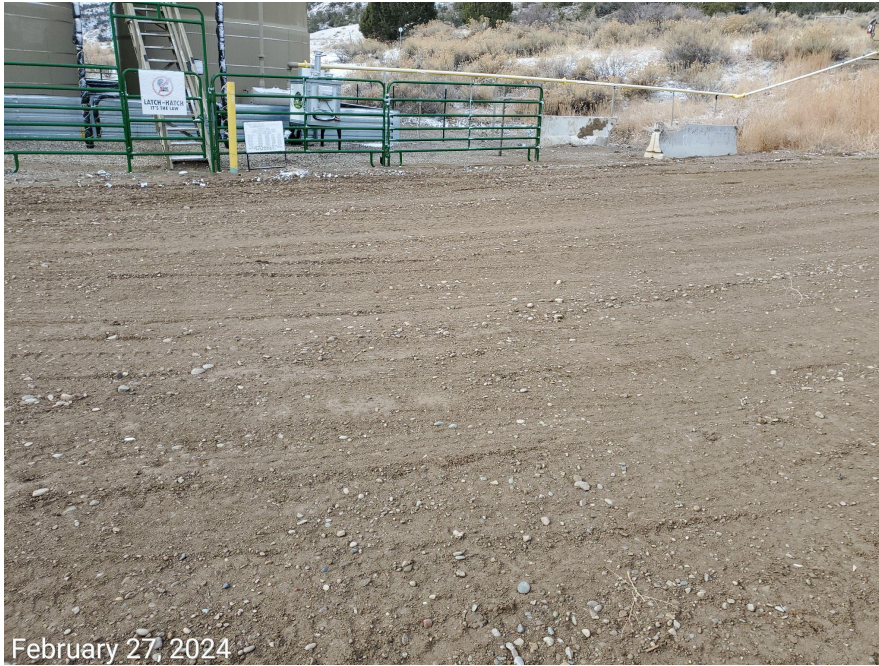
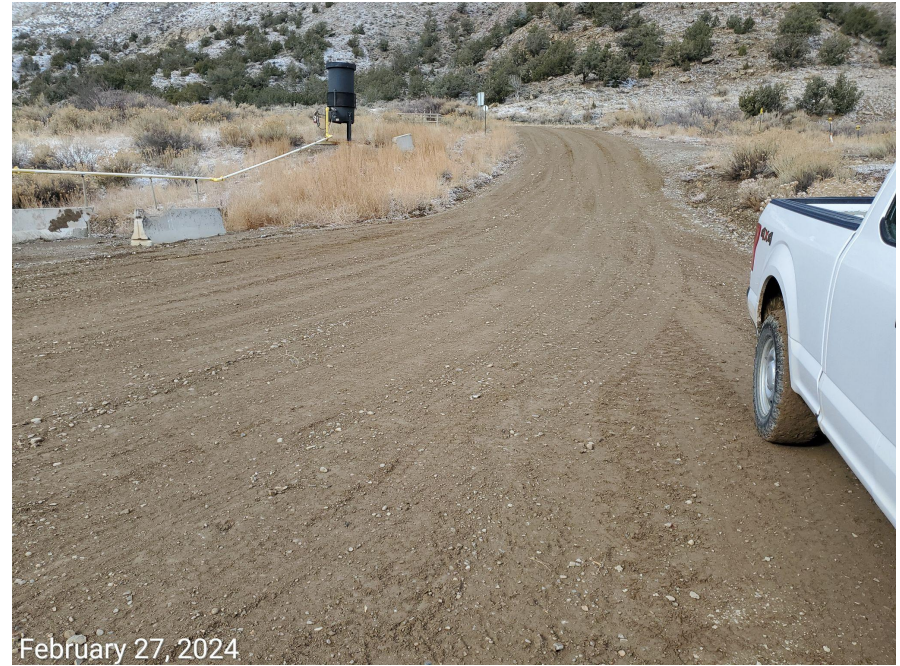
Photo 2: See comments under photo 1.

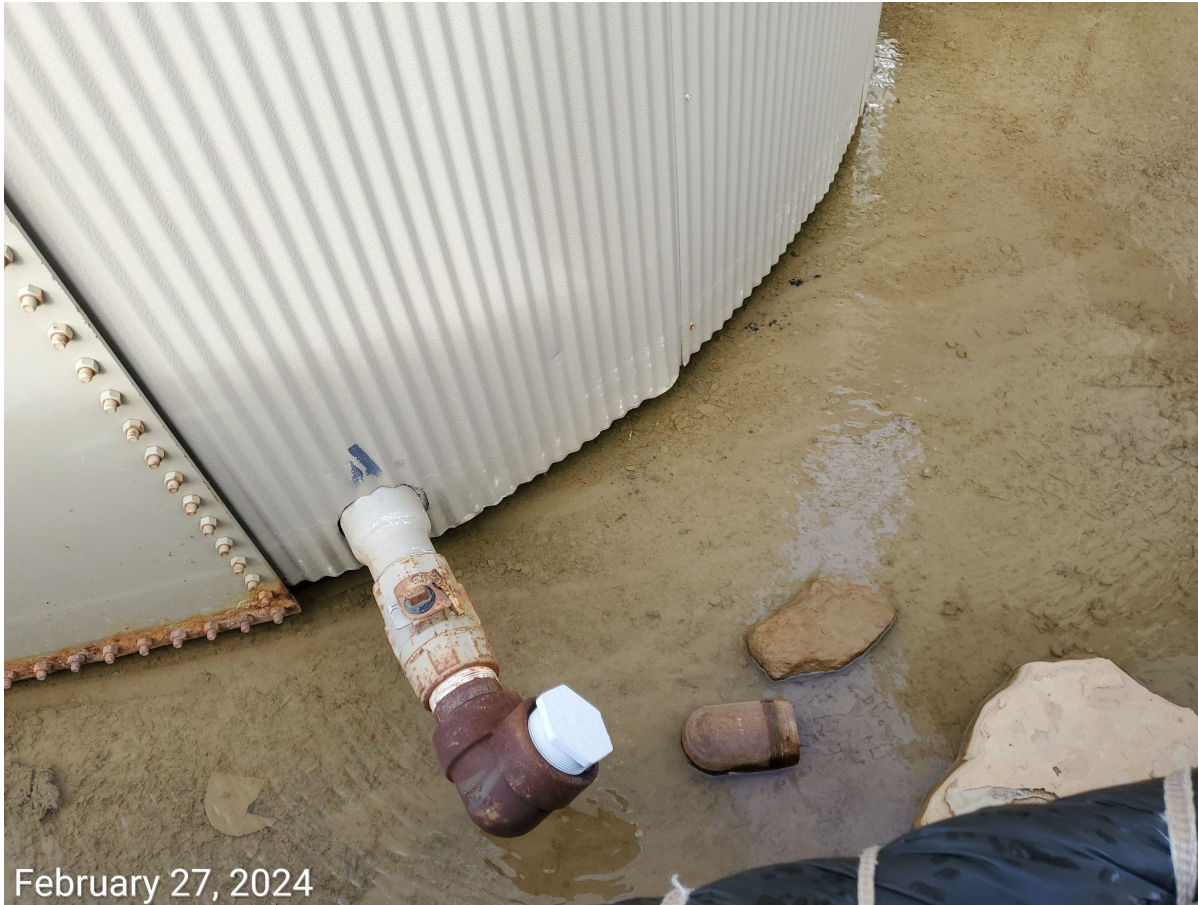
Photo 3: Photo examples showing caps/plugs have been installed at the lines at tanks.

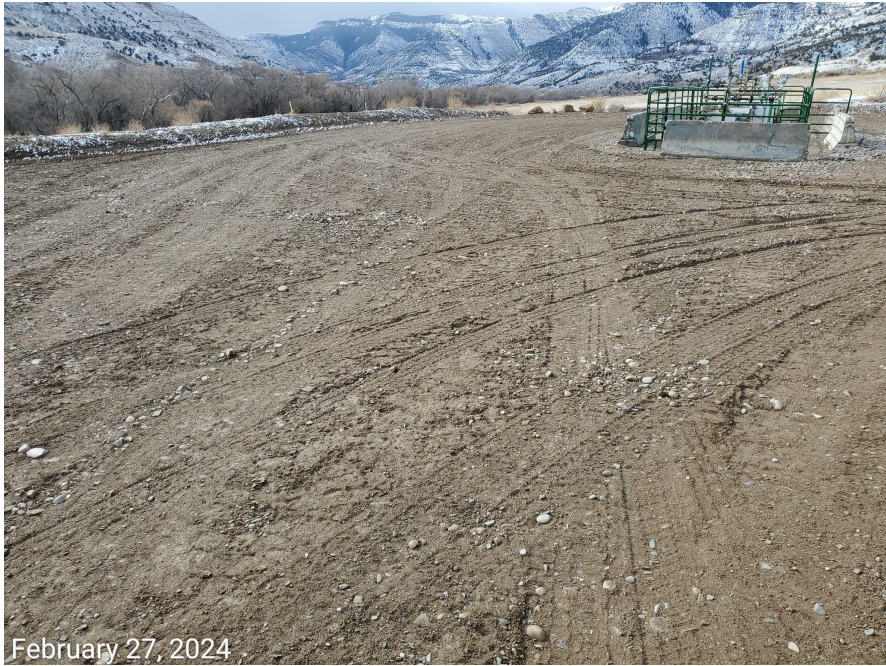
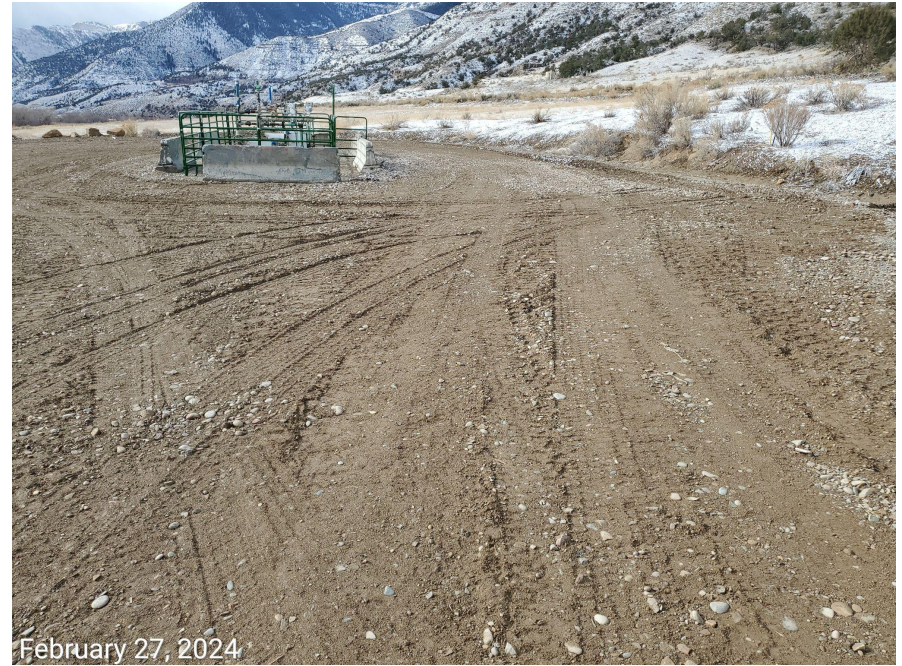
Photo 4: Photos taken from the western working pad surface. BMPs to stabilize the working pad surface appears to have been maintained; additional compaction is apparent, and potentially addition of road base material. Continue to monitor and maintain BMPs to ensure location remains stabilized.

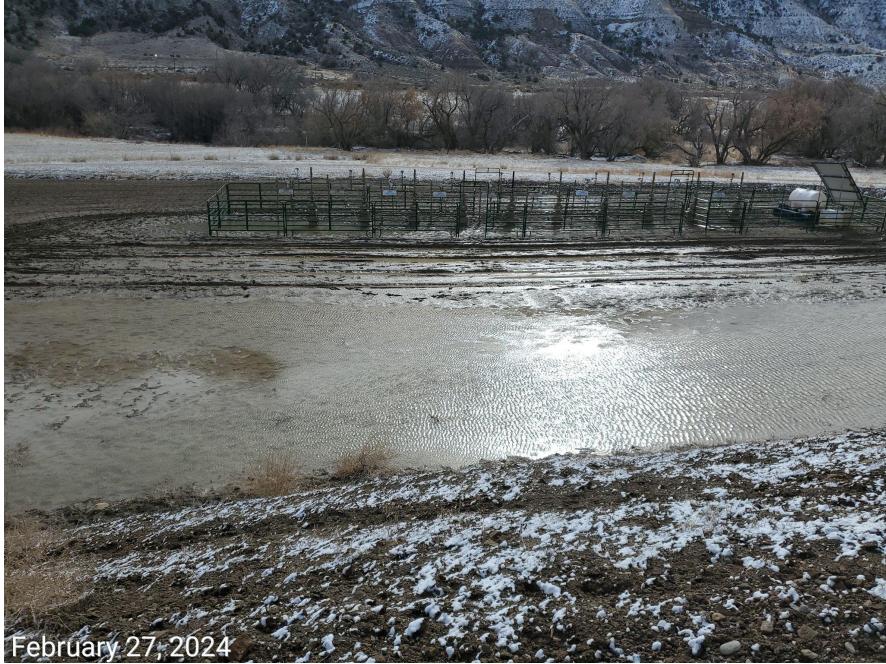
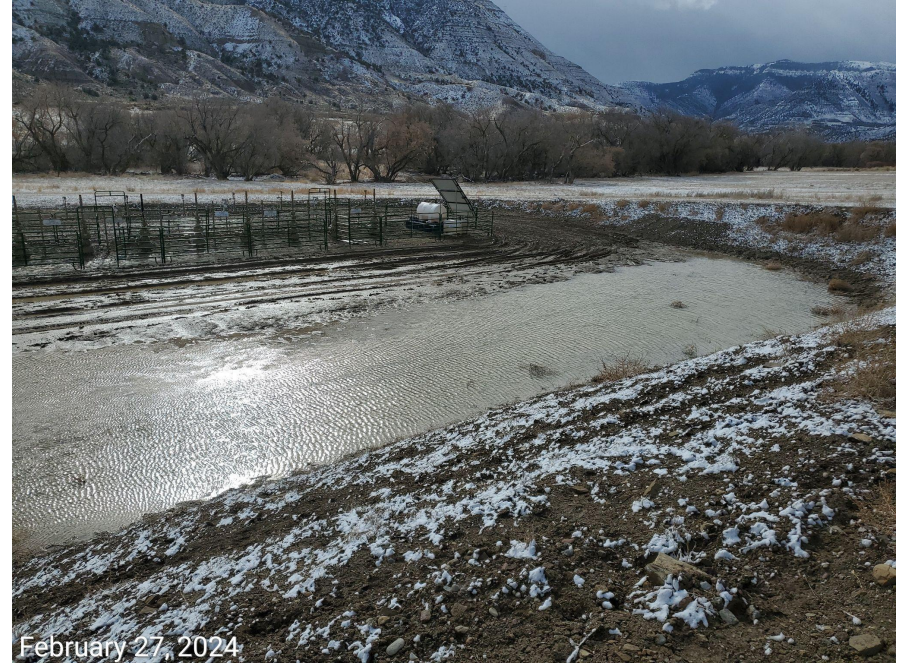
Photo 5: Photos taken from the east end of the upper working pad surface, facing east and southeast. Photo shows stormwater remains ponding on the lower working pad surface has persisted. This has resulted in stormwater contact with production equipment (wells). Ponding has also contributed to the stabilizing and tracking issues observed on the lower working pad surface.

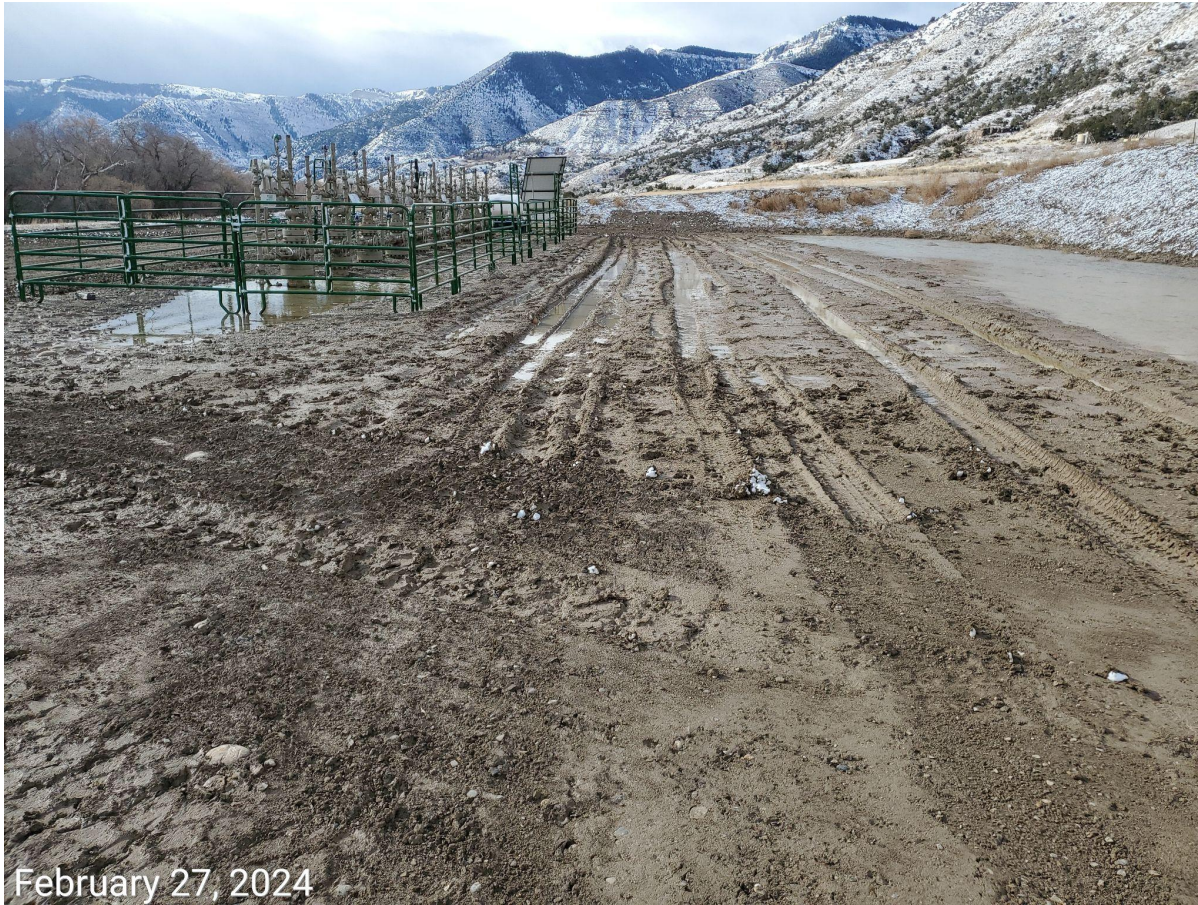
Photo 6: Photo taken from the lower working pad surface on the east end of the Location. Photos show BMPs to stabilize the working pad, as well as to minimize tracking, degradation and sediment transport remain missing or insufficient.

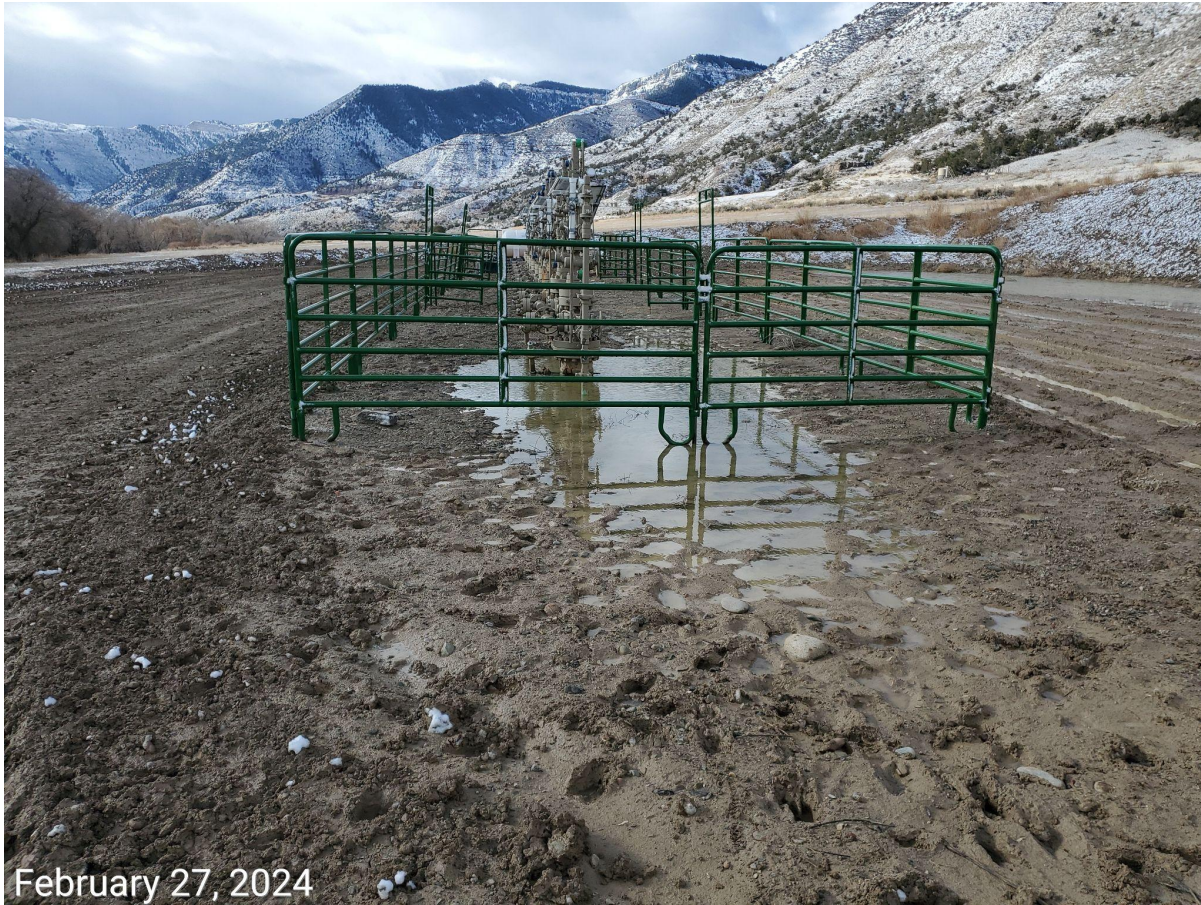
Photo 7: Photo taken from the wells on the east end of the Location. Photo shows stormwater ponding around the well equipment.

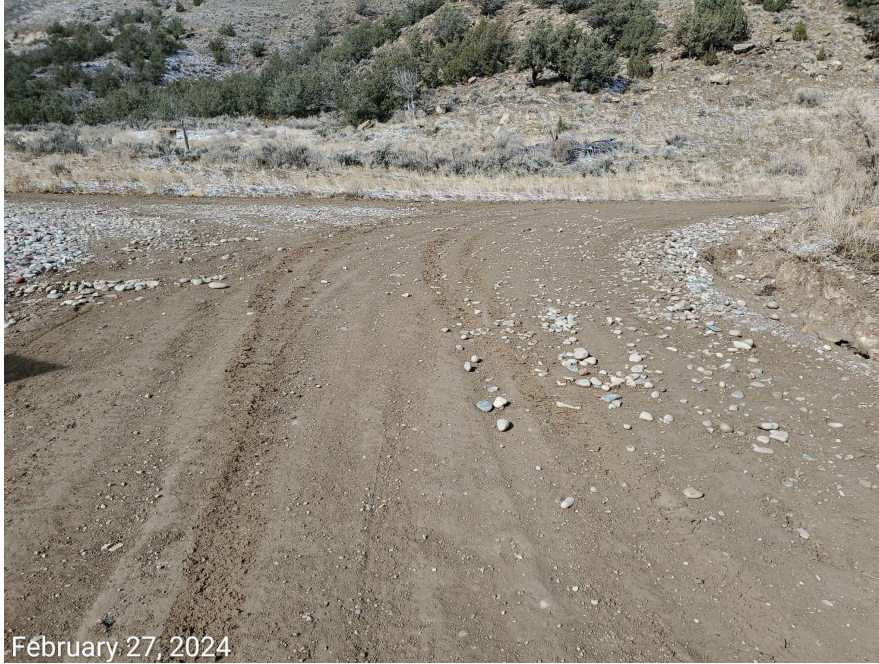
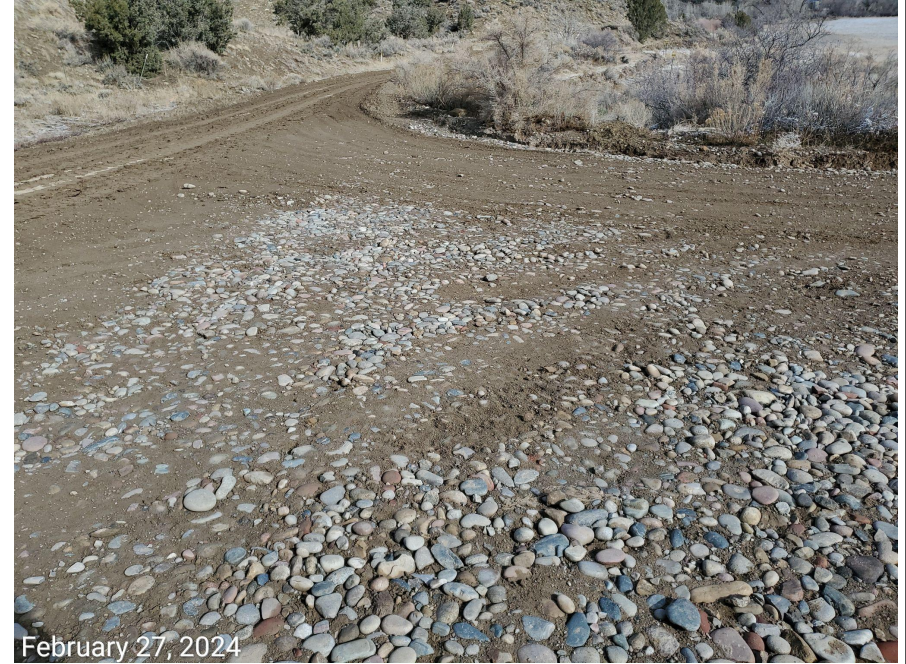
Photo 8: Photo taken from the Location entrance. Photo shows the vehicle tracking pad has not been maintained, and remains filled with sediment.
