Inspection Photos

Location Name: CAERUS PICEANCE LLC Warren 15-9 (PI15) Pad

Location #: 334751

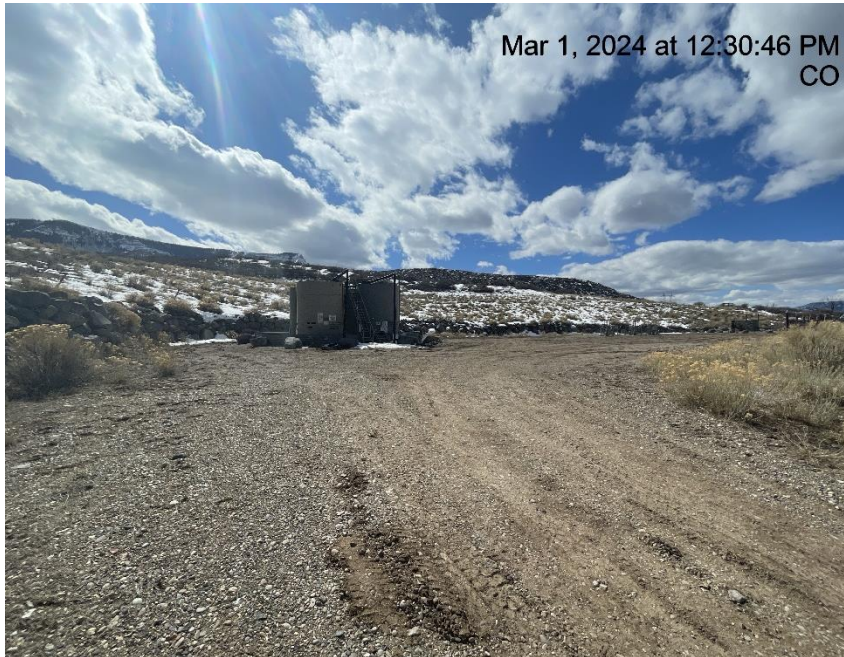
Photo # 8072 From entrance to location

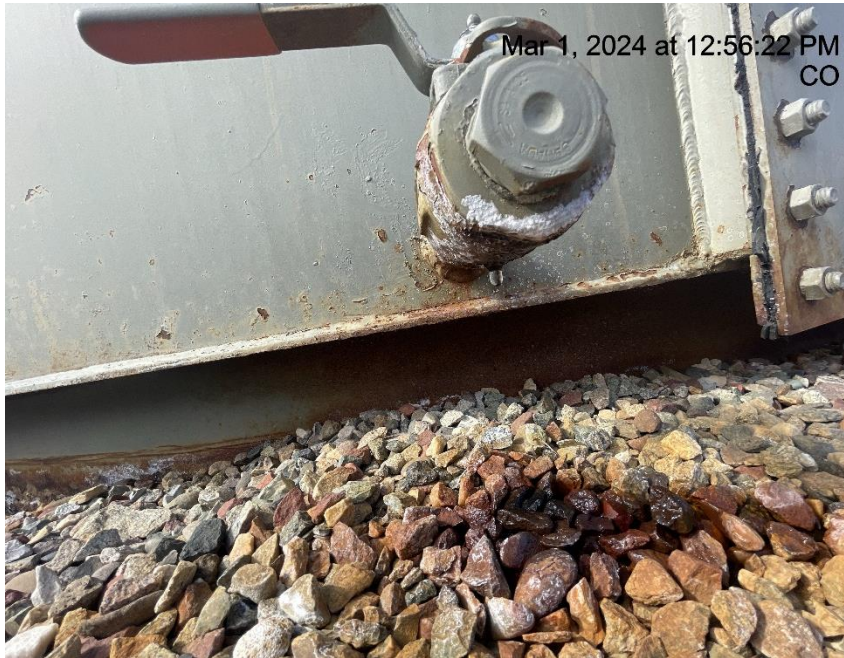
Photo # 8080 Valve on production tank leaking fluid

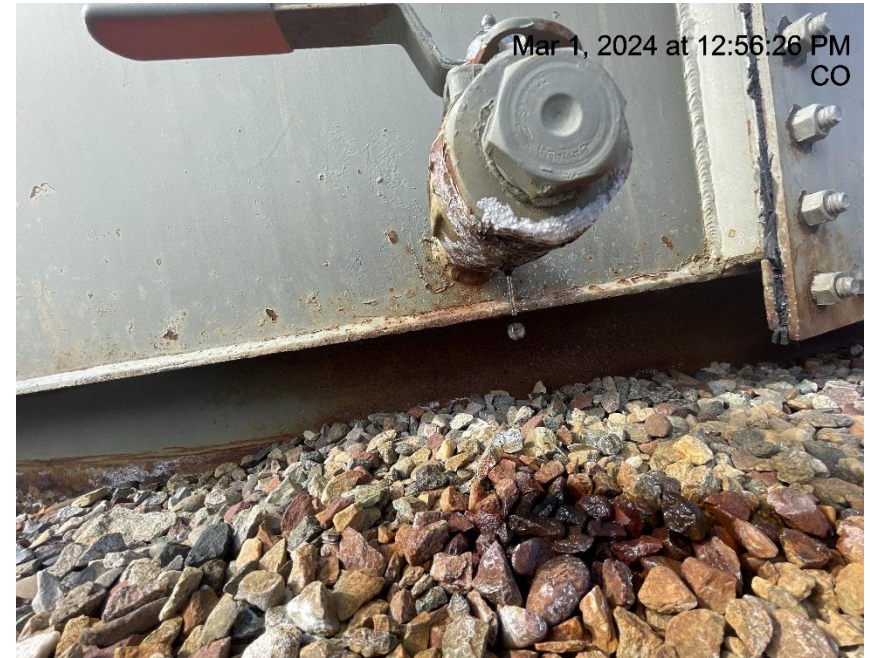
Photo # 8081 Valve on production tank leaking fluid

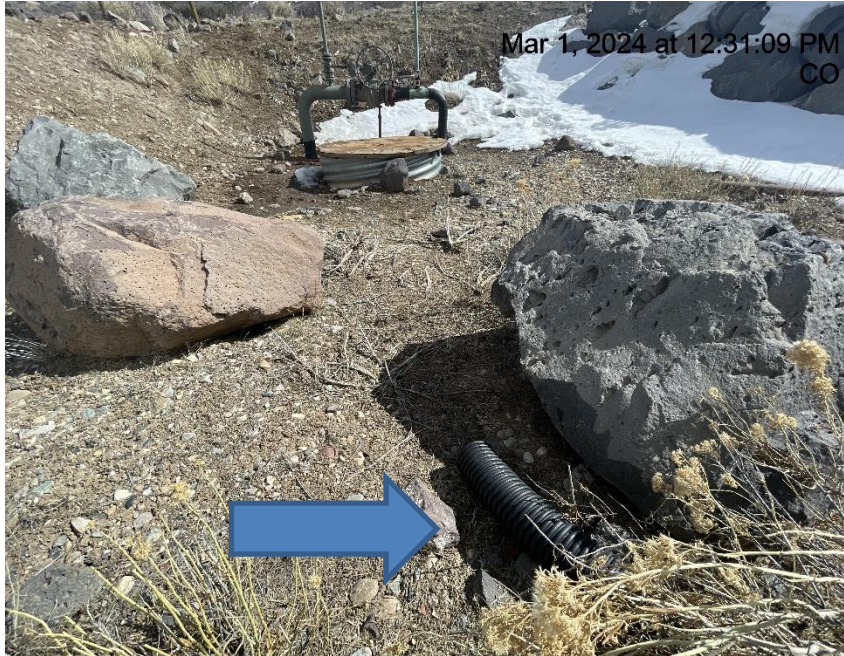
Photo # 8082 Debris

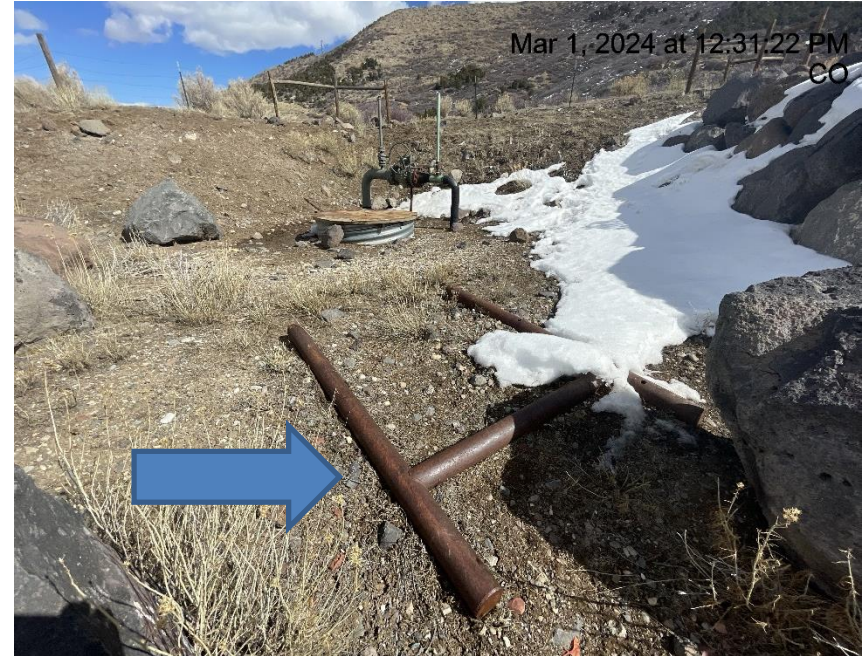
Photo # 8083 Debris

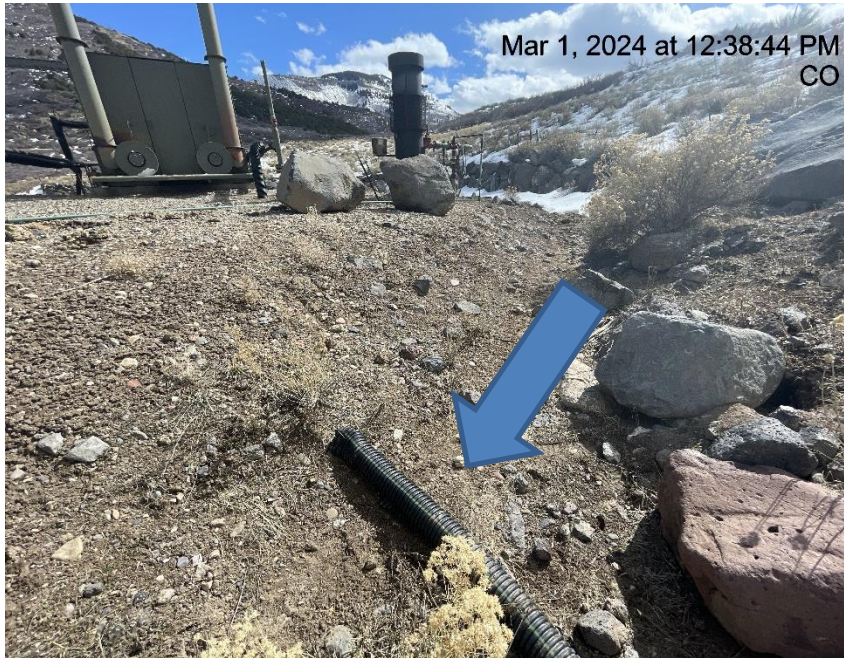
Photo # 8084 Debris
