Inspection Photos

Location Name: TEP Rocky Mountain LLC WATSON RANCH A Pad

Location # 413055

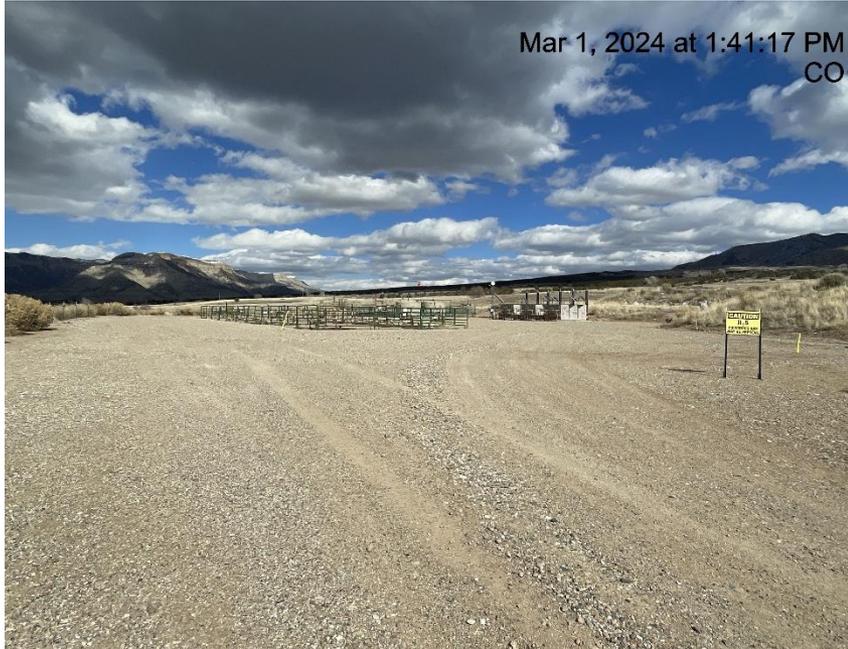
Photo # 8148 From entrance to location

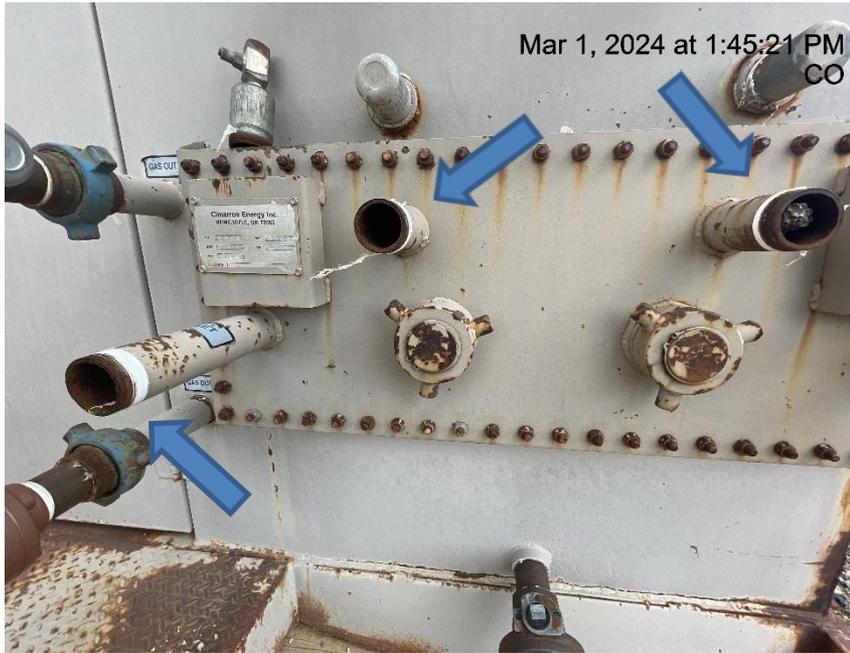
Photo # 8154 Open ended pipes on production separators/wildlife hazards

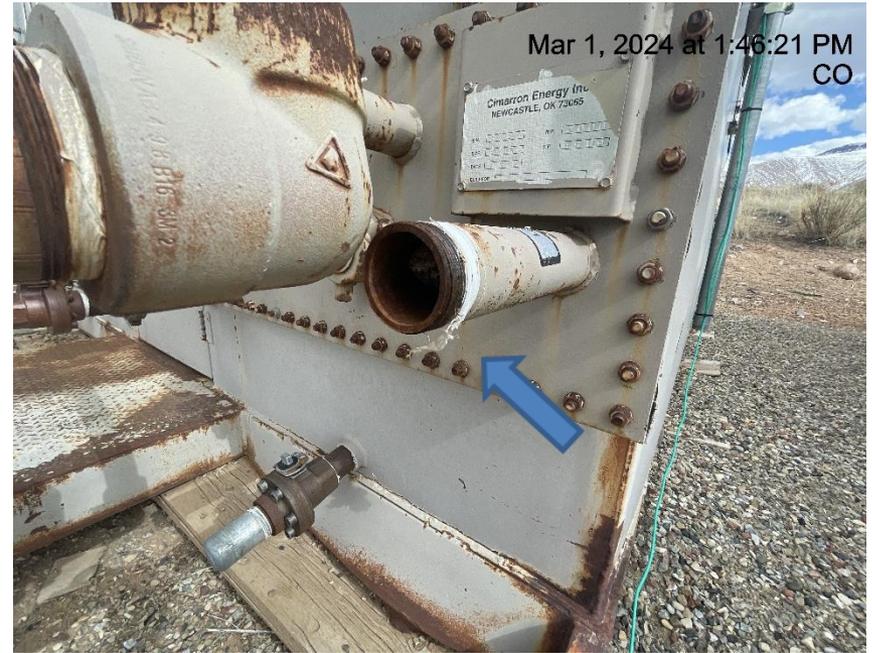
Photo # 8155 Open ended pipe on production separator/wildlife hazard

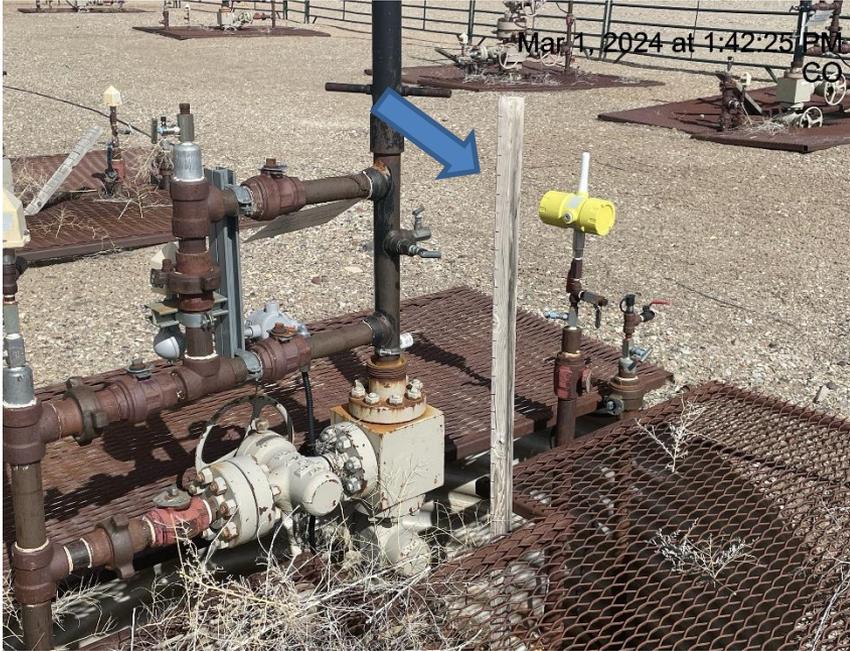
Photo # 8156 Wildlife egress on BAT 14B-17-07-95 well cellar not installed properly

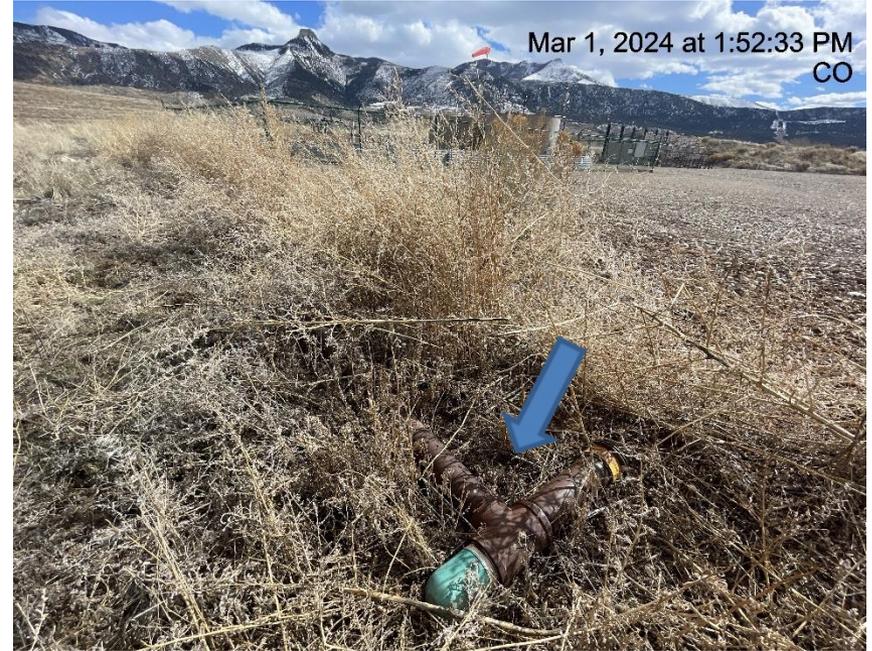
Photo # 8157 Debris

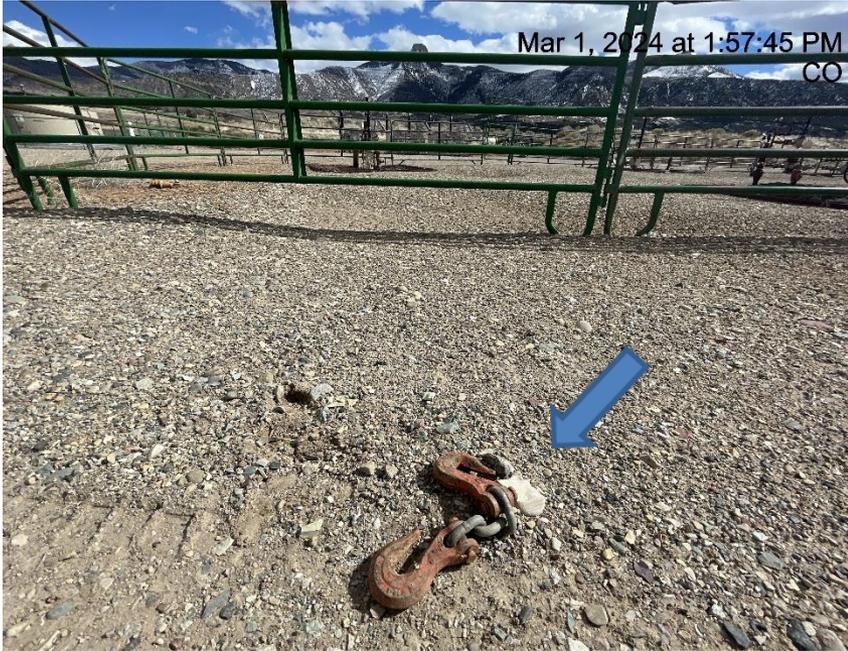
Photo # 8158 Debris

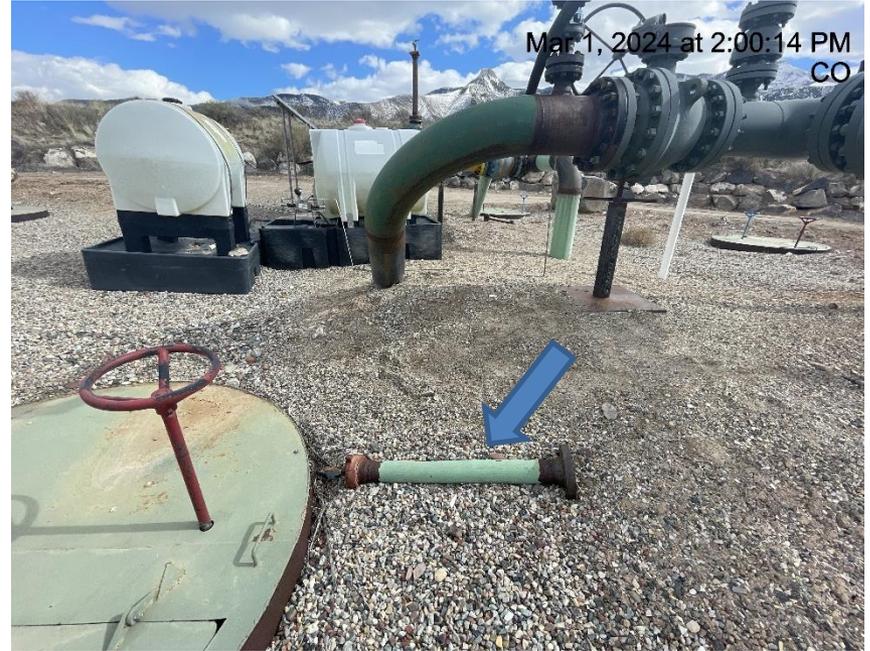
Photo # 8159 Debris

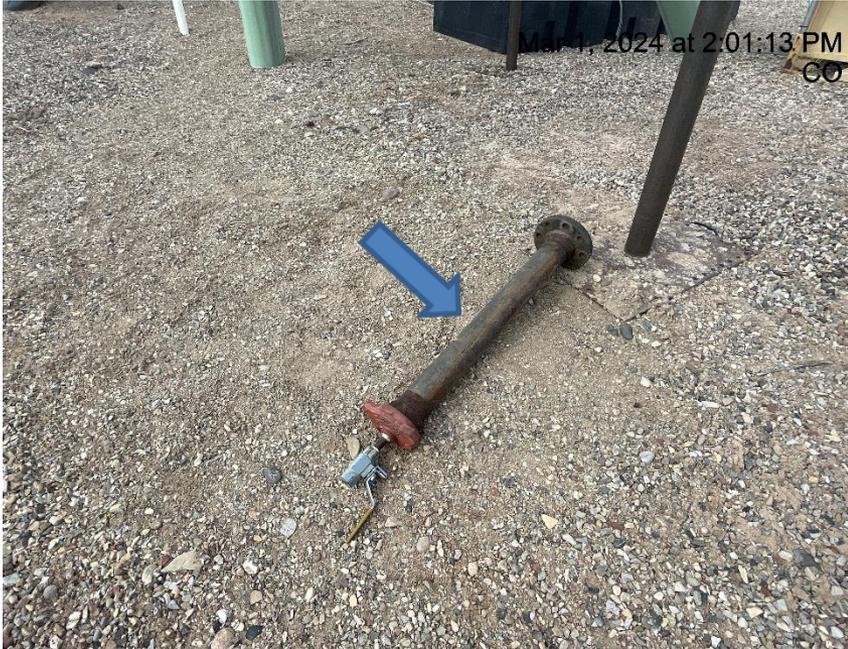
Photo # 8160 Debris
