## Inspection Photos

Location Name: Railsback Water Facility & Spill/Release

Facility ID: #486170 & Spill/Release ID: #486172

Inspection Date: March 1, 2024

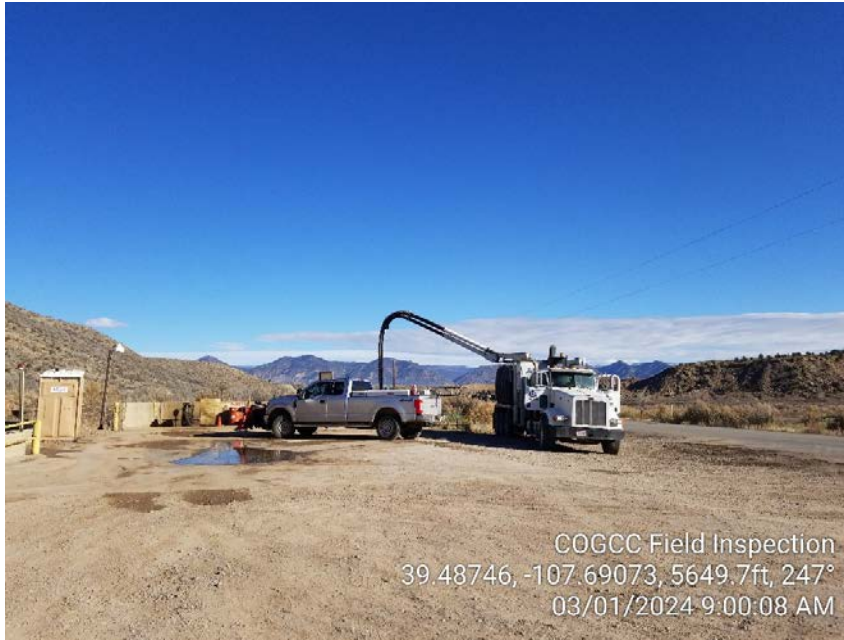
**Photo #1 – Recovery Operations were underway upon arrival of ECMC environmental protection specialist. View from center of pad, looking north.**

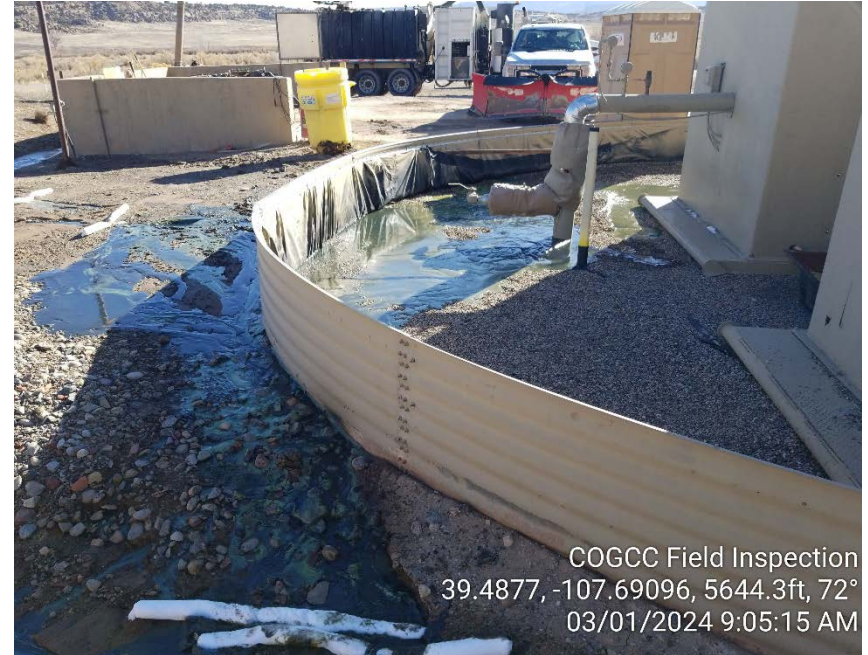
**Photo #2 – Fluid release at north end of tank battery, looking east. Note presence of fluids inside of tank battery secondary containment area and just outside of containment to the north/northwest.**

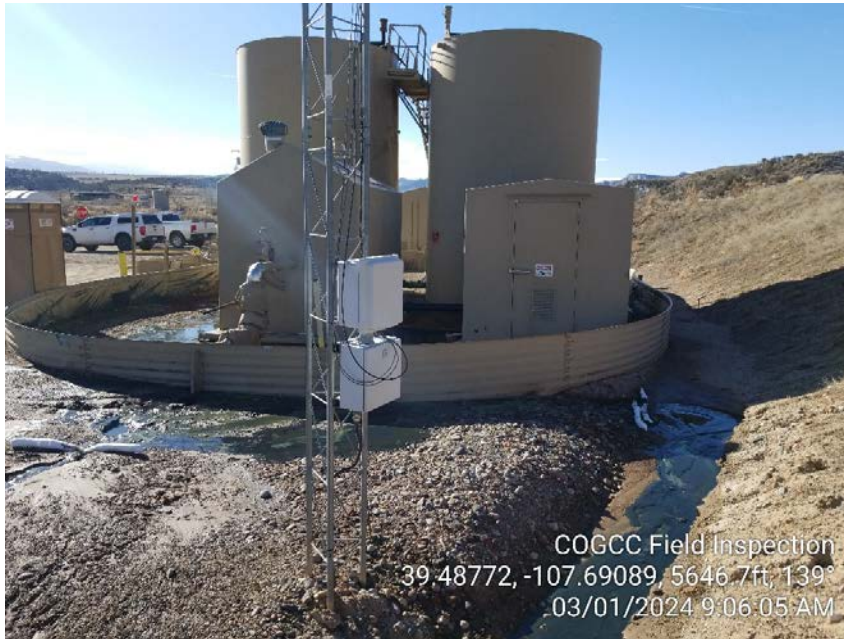
**Photo #3 – View of released fluids entering perimeter ditch on north/northwest end of pad, looking South. Note absorbent booms had been installed by Operator prior to inspection.**

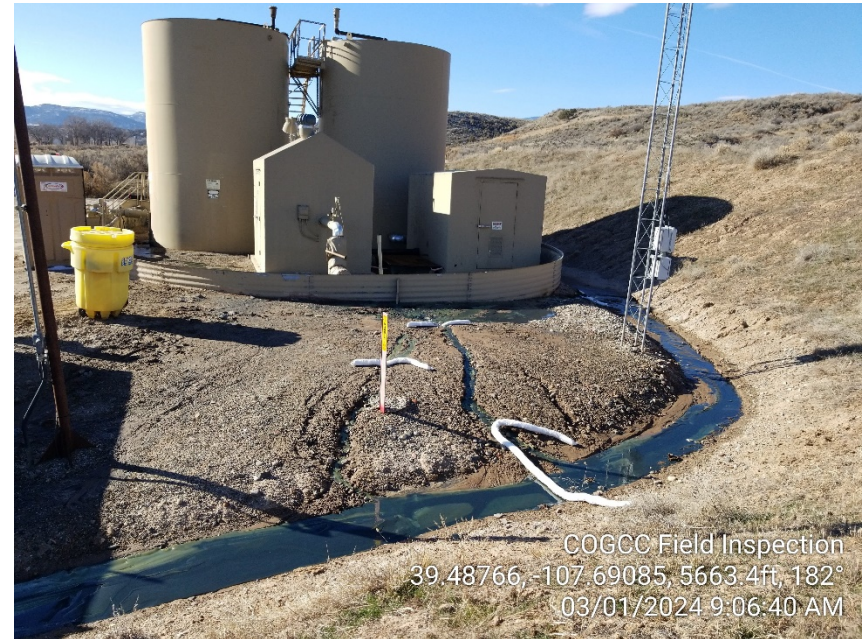
**Photo #4 – Released fluids inside of perimeter ditch on north end of facility.**

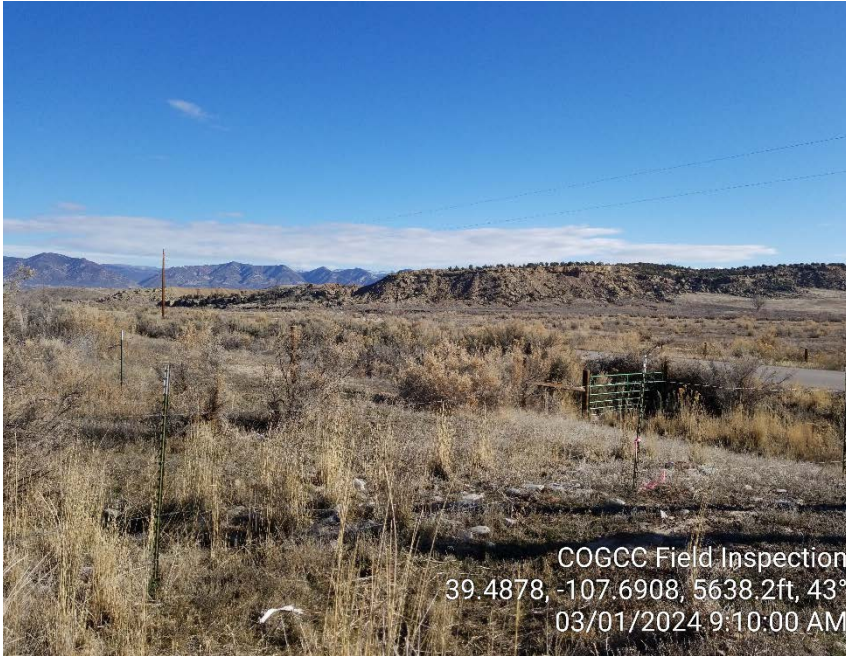
**Photo #5 – View of impacted ditch located north of facility, looking Northeast. Impacted ditch runs along the west side of C.R. 315.**

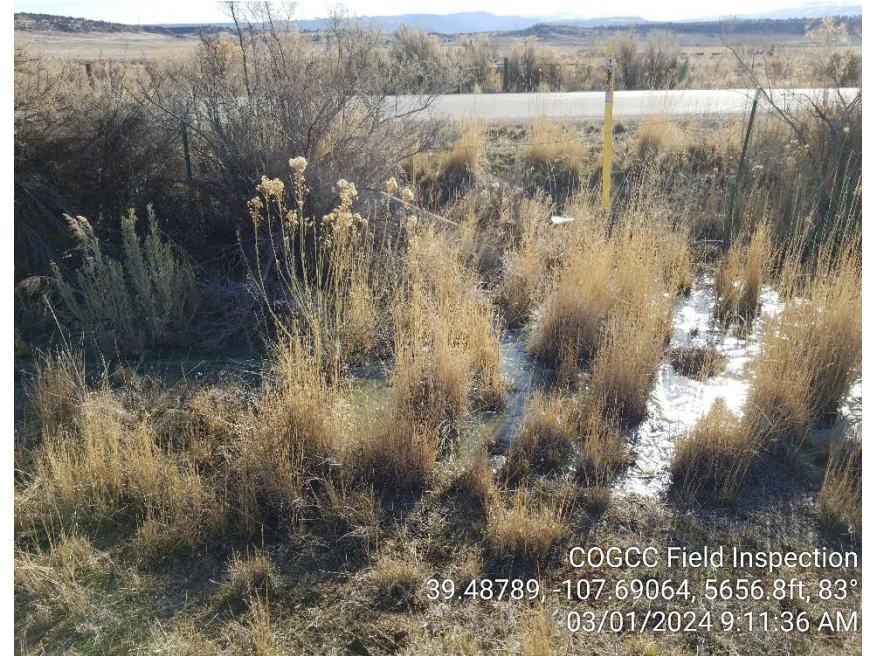
**Photo #6 – Impacted fluids inside of ditch located offsite to the north.**

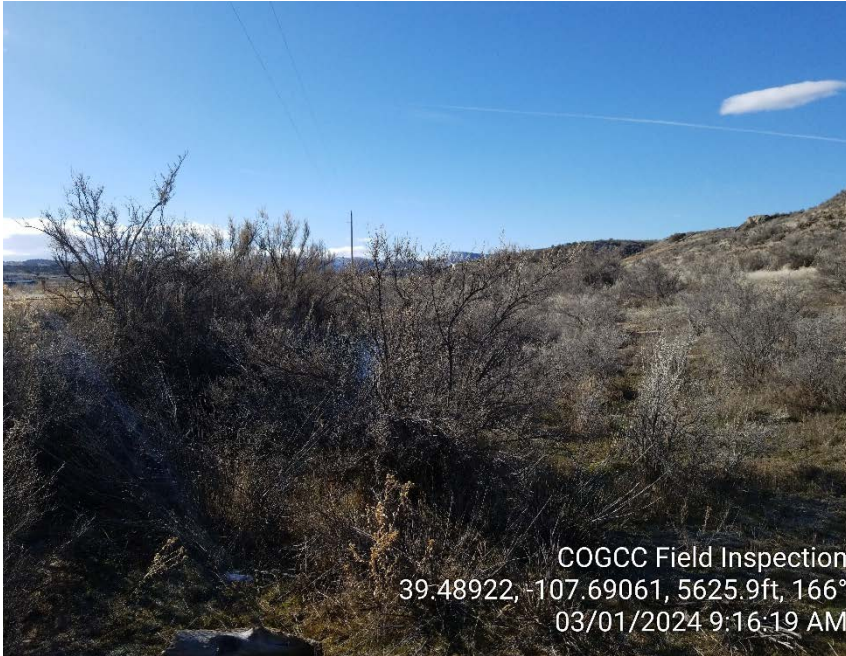
**Photo #7 – View of the terminus of flowpath, looking South.** During inspection, ECMC inspector walked with Operator to the terminus of the flowpath, located approximately 660 feet from the point of release at the tank battery.

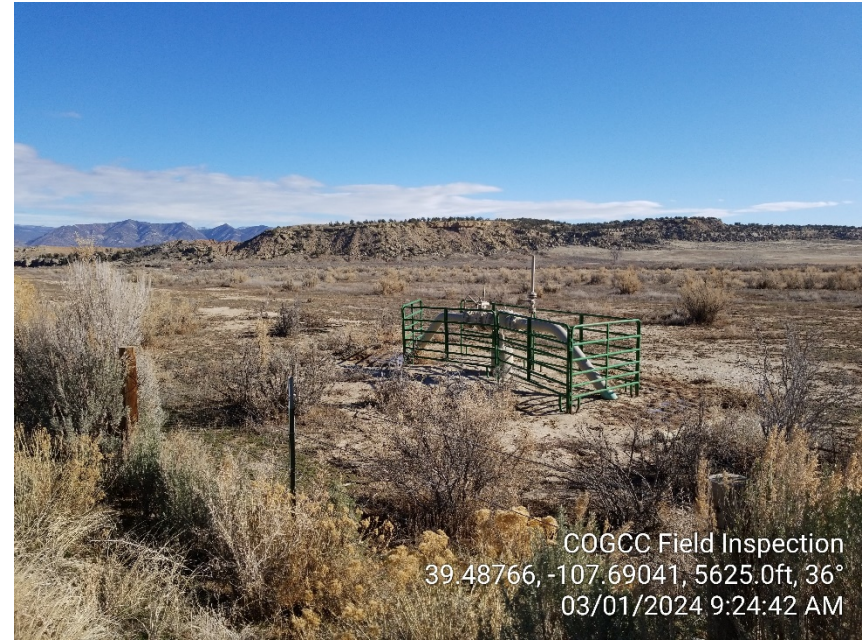
**Photo #8 – Pig launcher located approximately 170' Northeast of the observed point of release, across C.R. 315.** During inspection, ECMC inspector observed areas parallel to flow path on the opposite side of C.R. 315 with Operator. Unidentified fluids were observed at the pig launcher, but no hydrocarbon stains, sheens, or odors were observed in area.
