Little Beaver Unit TB Photo Log

Location ID: 451505

February 15, 2024

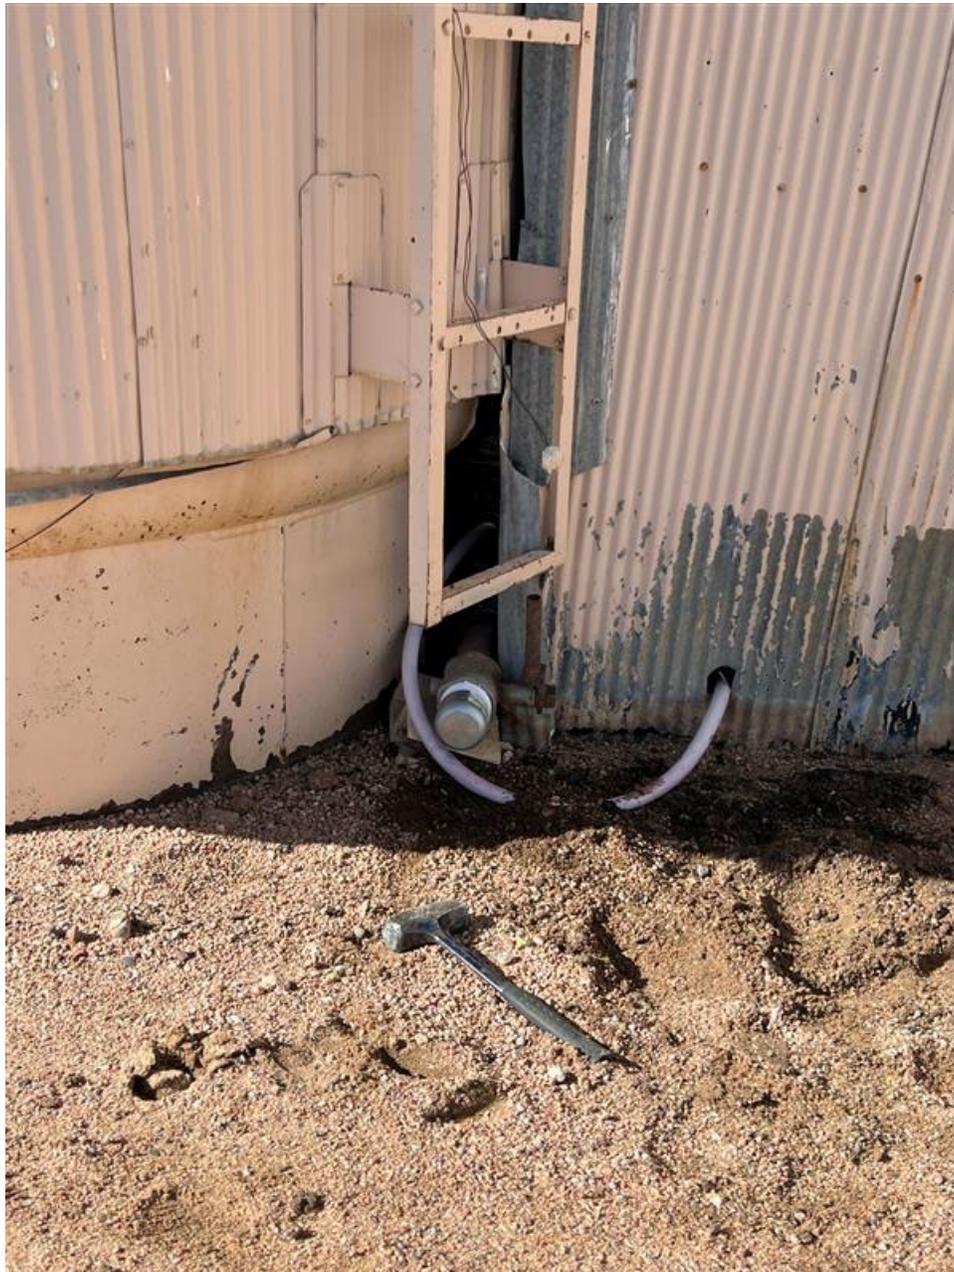
Figure No.:
1

Title:
Stained Soils removed [ref photo 33 from inspection photos]

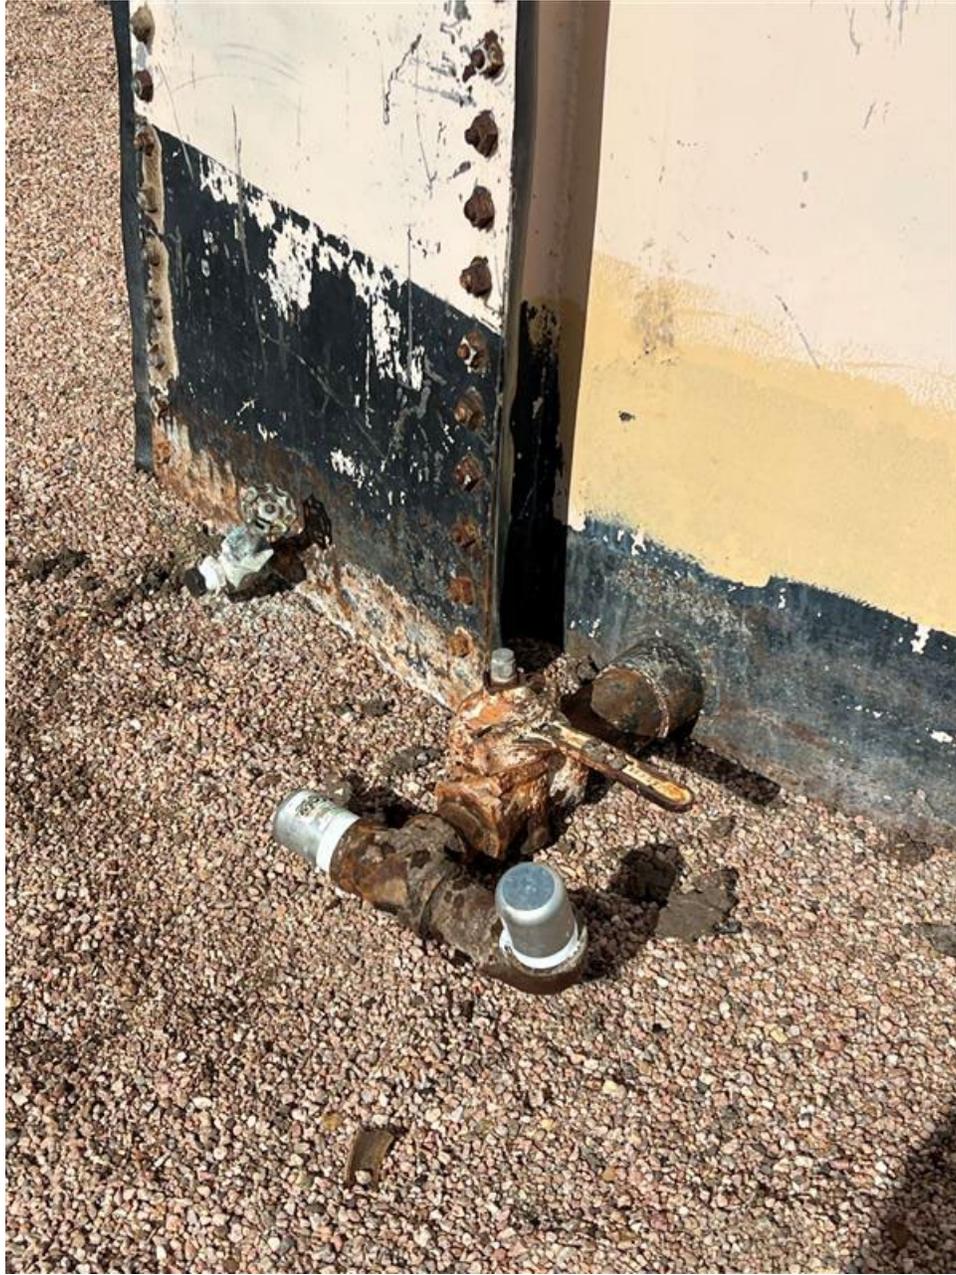
Figure No.:
2

Title:
Capped piping [ref photo 6 from inspection photos]

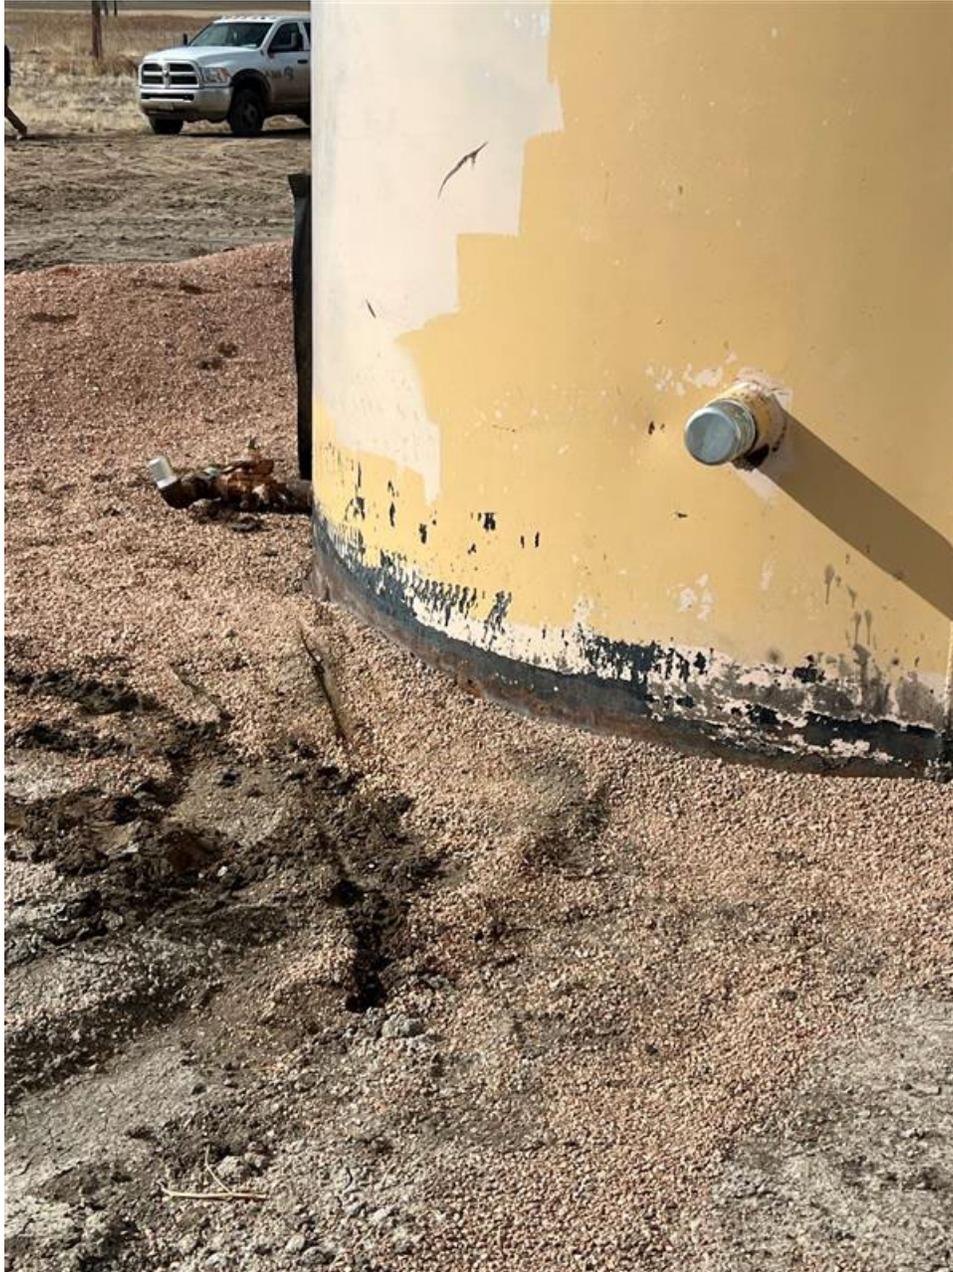
Figure No.:
3

Title:
Capped piping (2) [ref photo 7 from inspection photos]

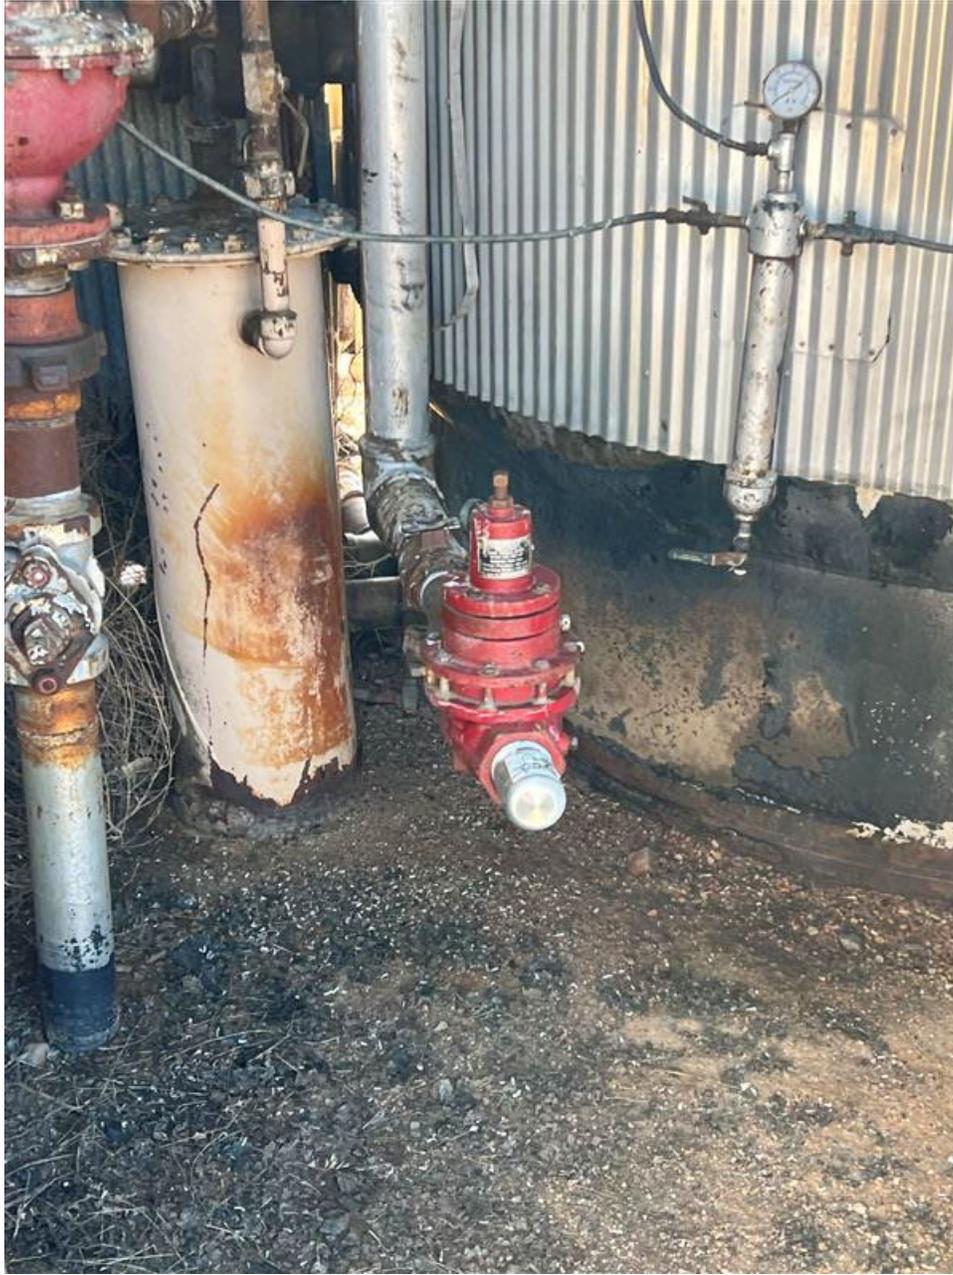
Figure No.:
4

Title:
Capped pipe [ref photo 29 from inspection photos]

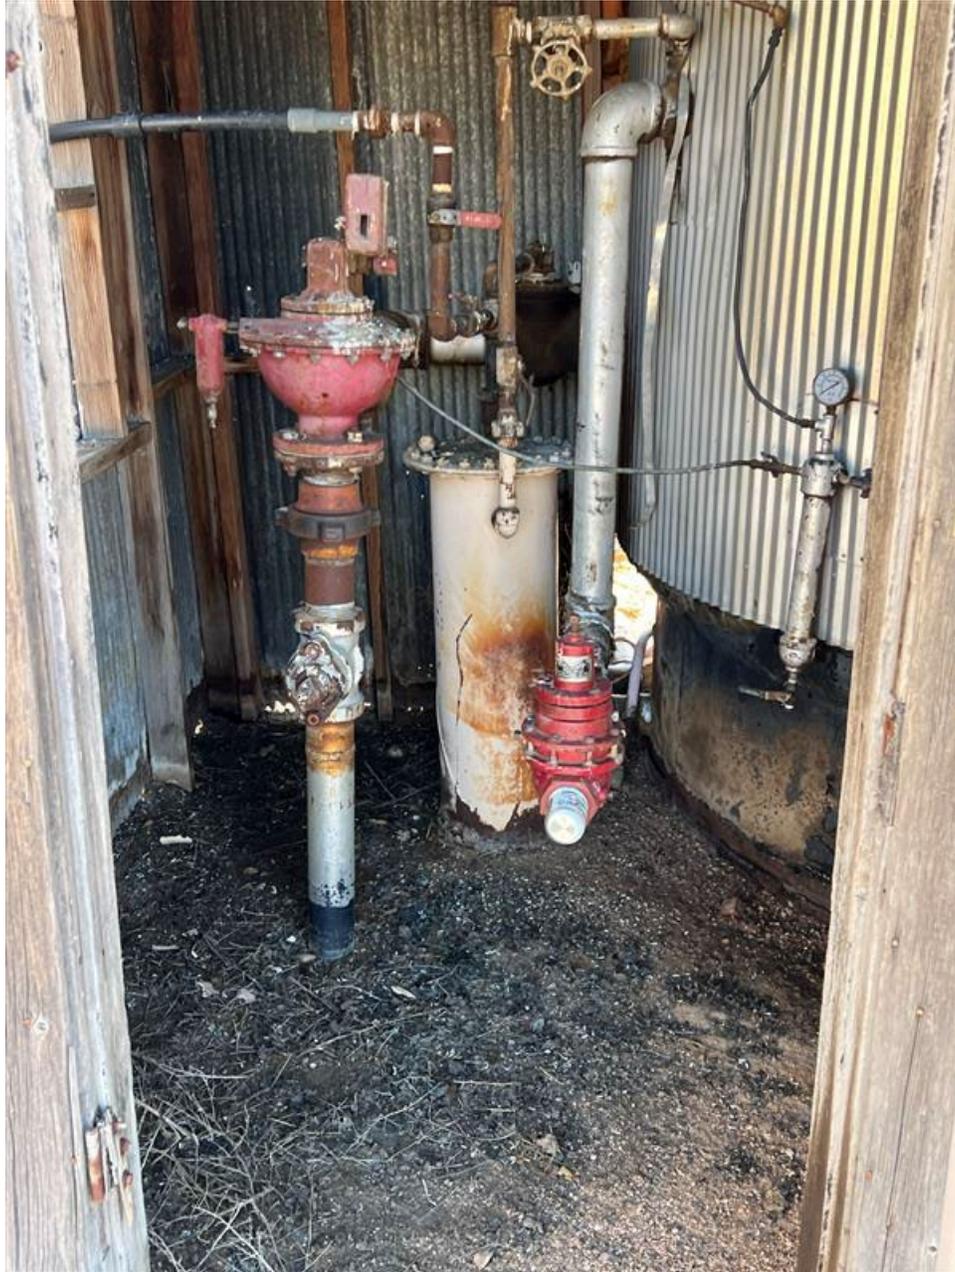
Figure No.:
5

Title:
Capped pipe [ref photo 29 from inspection photos]

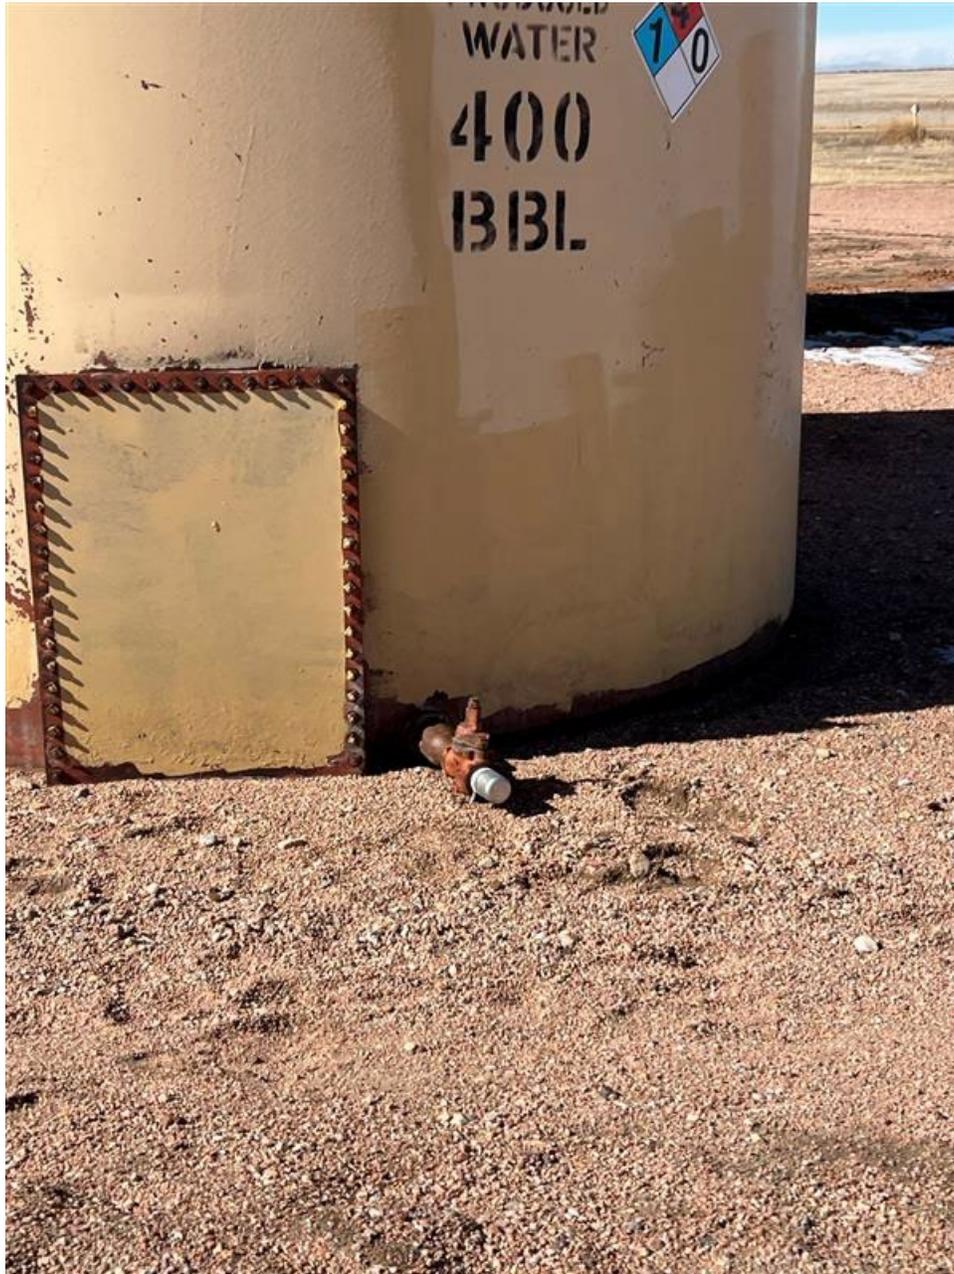
Figure No.:
6

Title:
Capped pipe [ref photo 40 from inspection photos]

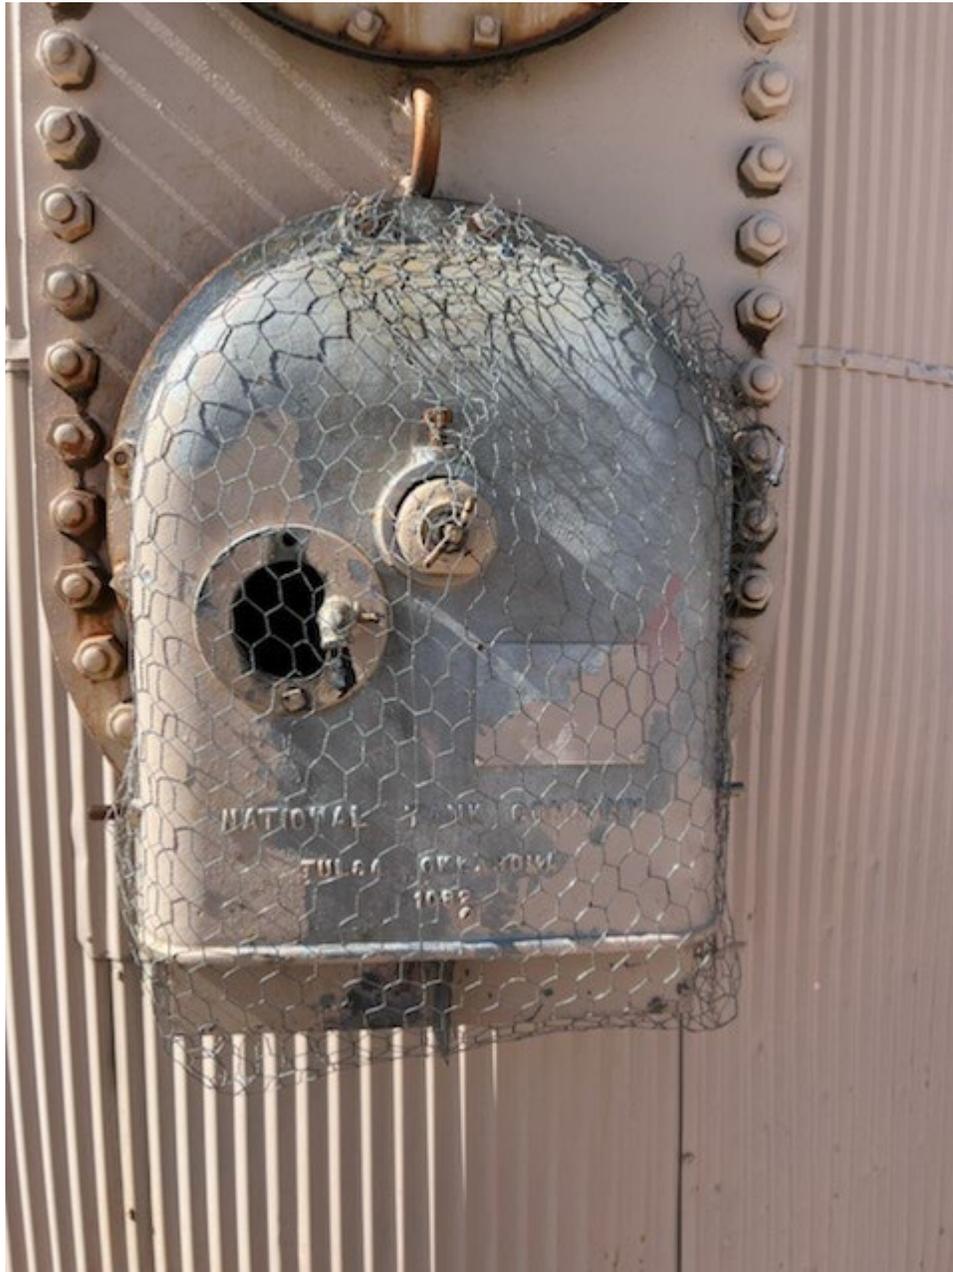
Figure No.:
7

Title:
Bird nesting removed. Ref inspection photo 44

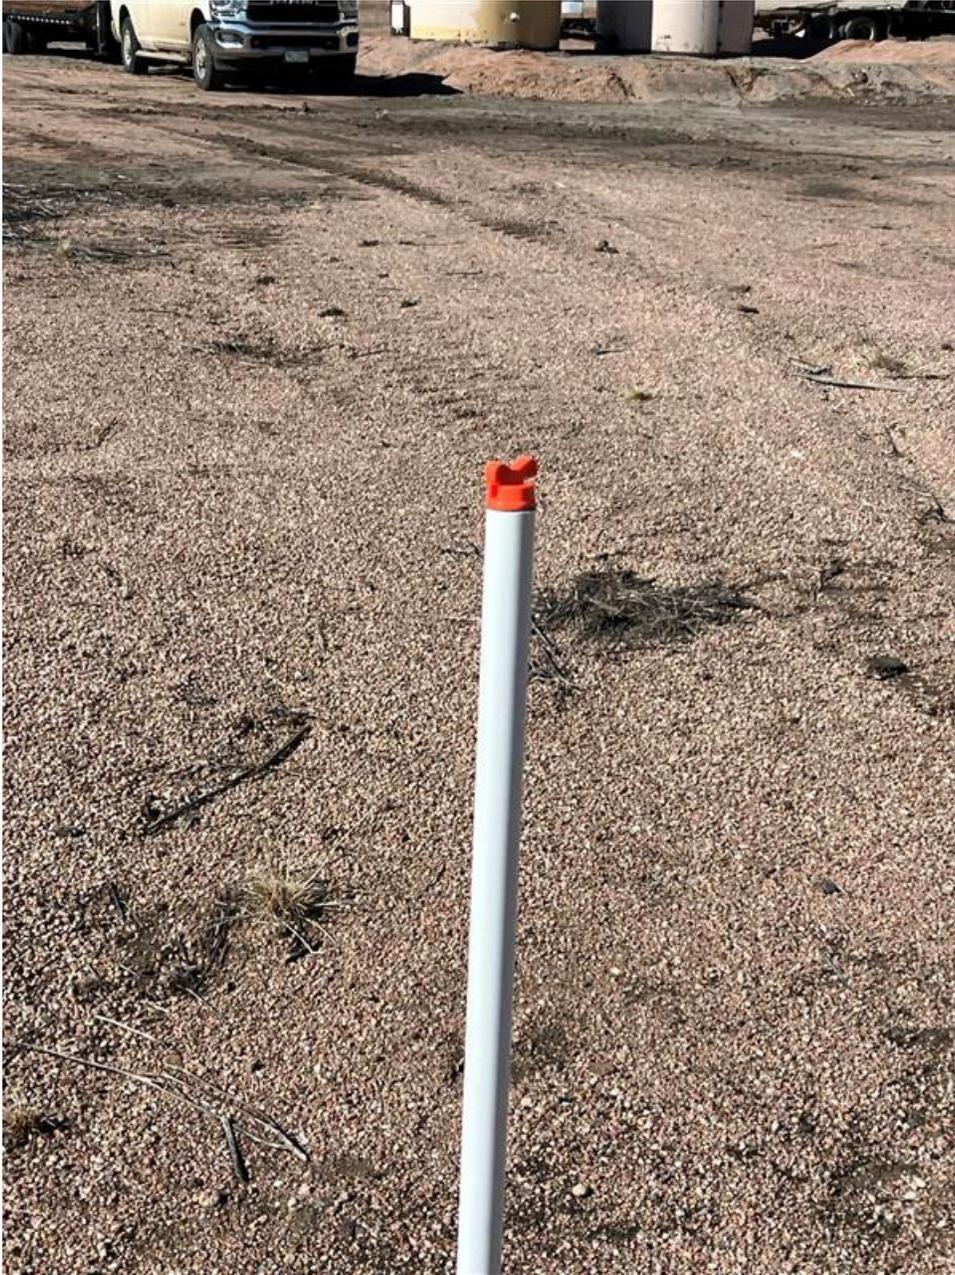
Figure No.:
14

Title:
Monitoring well cap installed

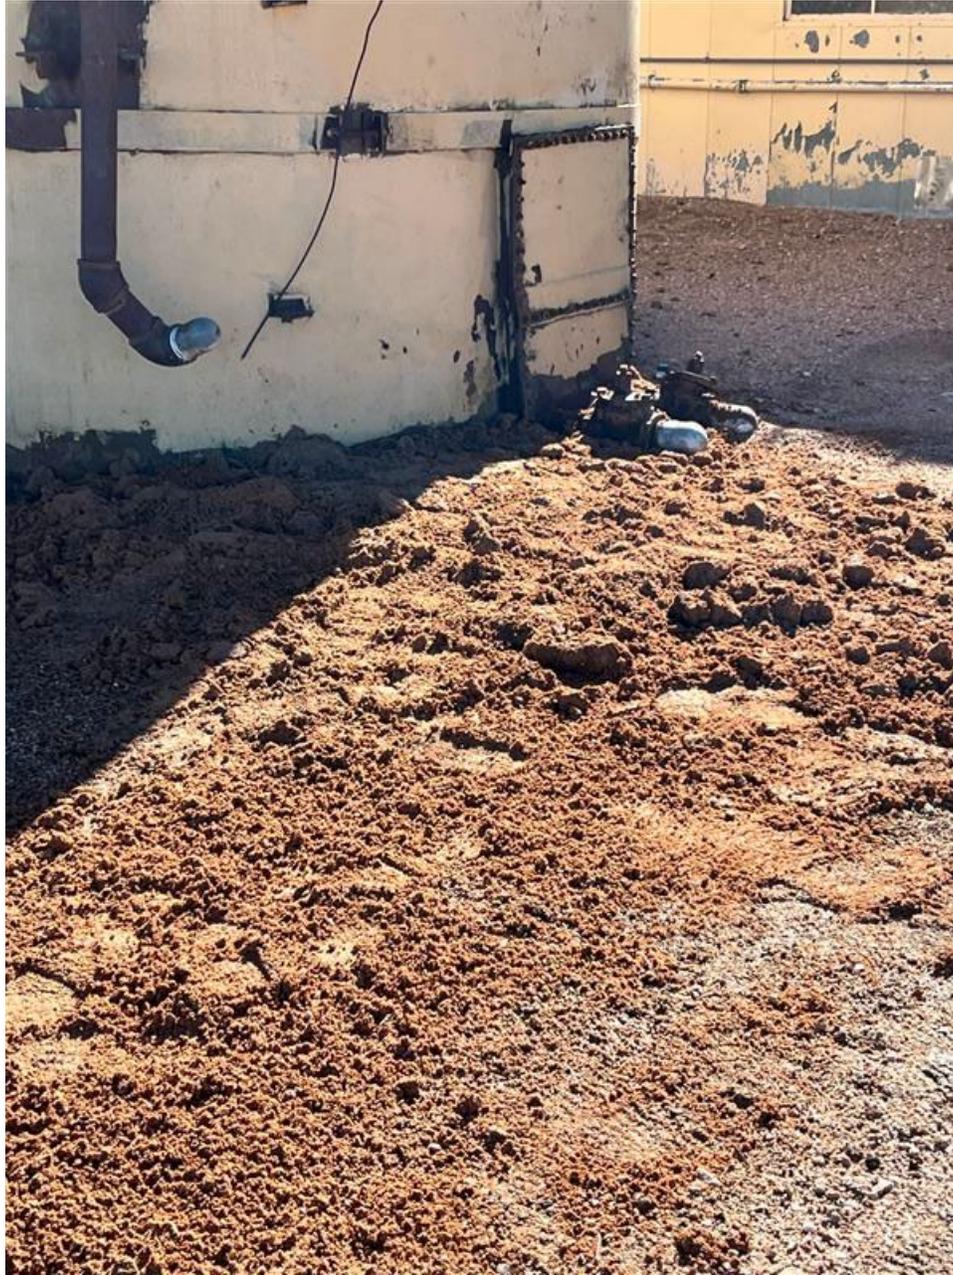
Figure No.:
17

Title:
Pipes secured, oily waste removed. (see inspection photo 46)

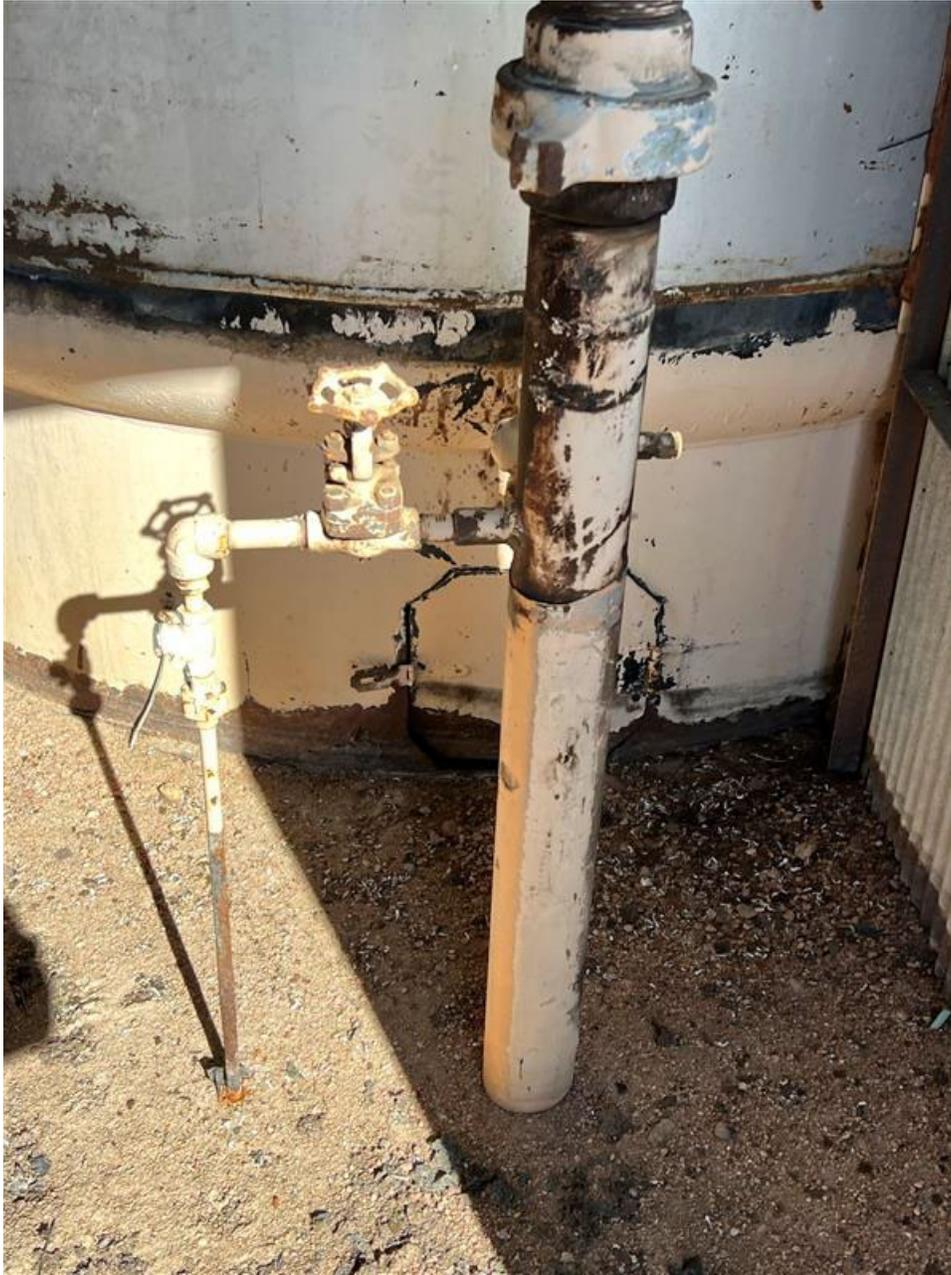
Figure No.:
18

Title:
Oily waste removed

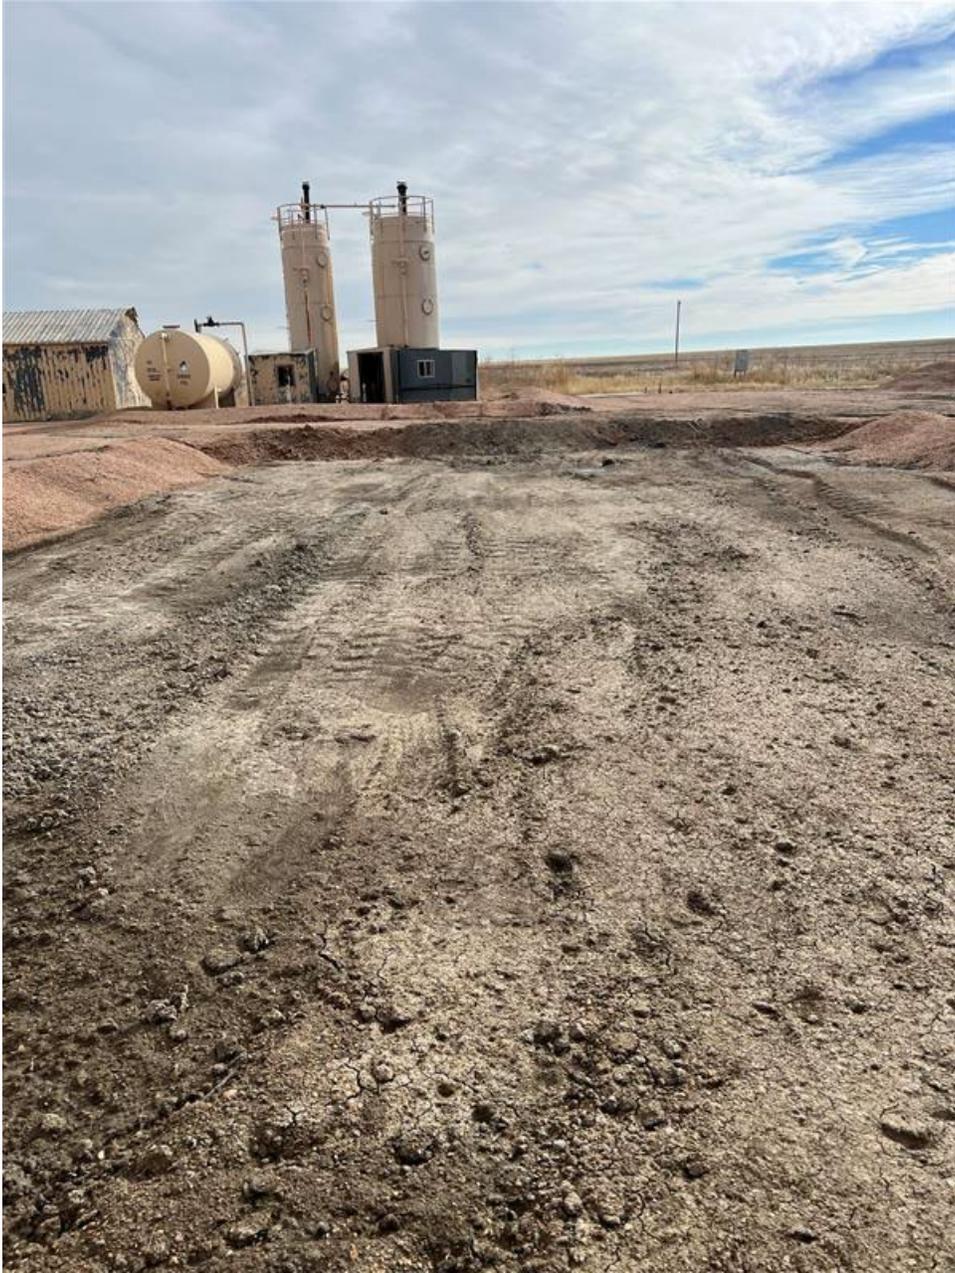
Figure No.:
20

Title:
Excavation area backfilled.
