Final Reclamation Inspection

February 29th, 2024

Operator: Simcoe LLC - 10749

Location ID: 333510

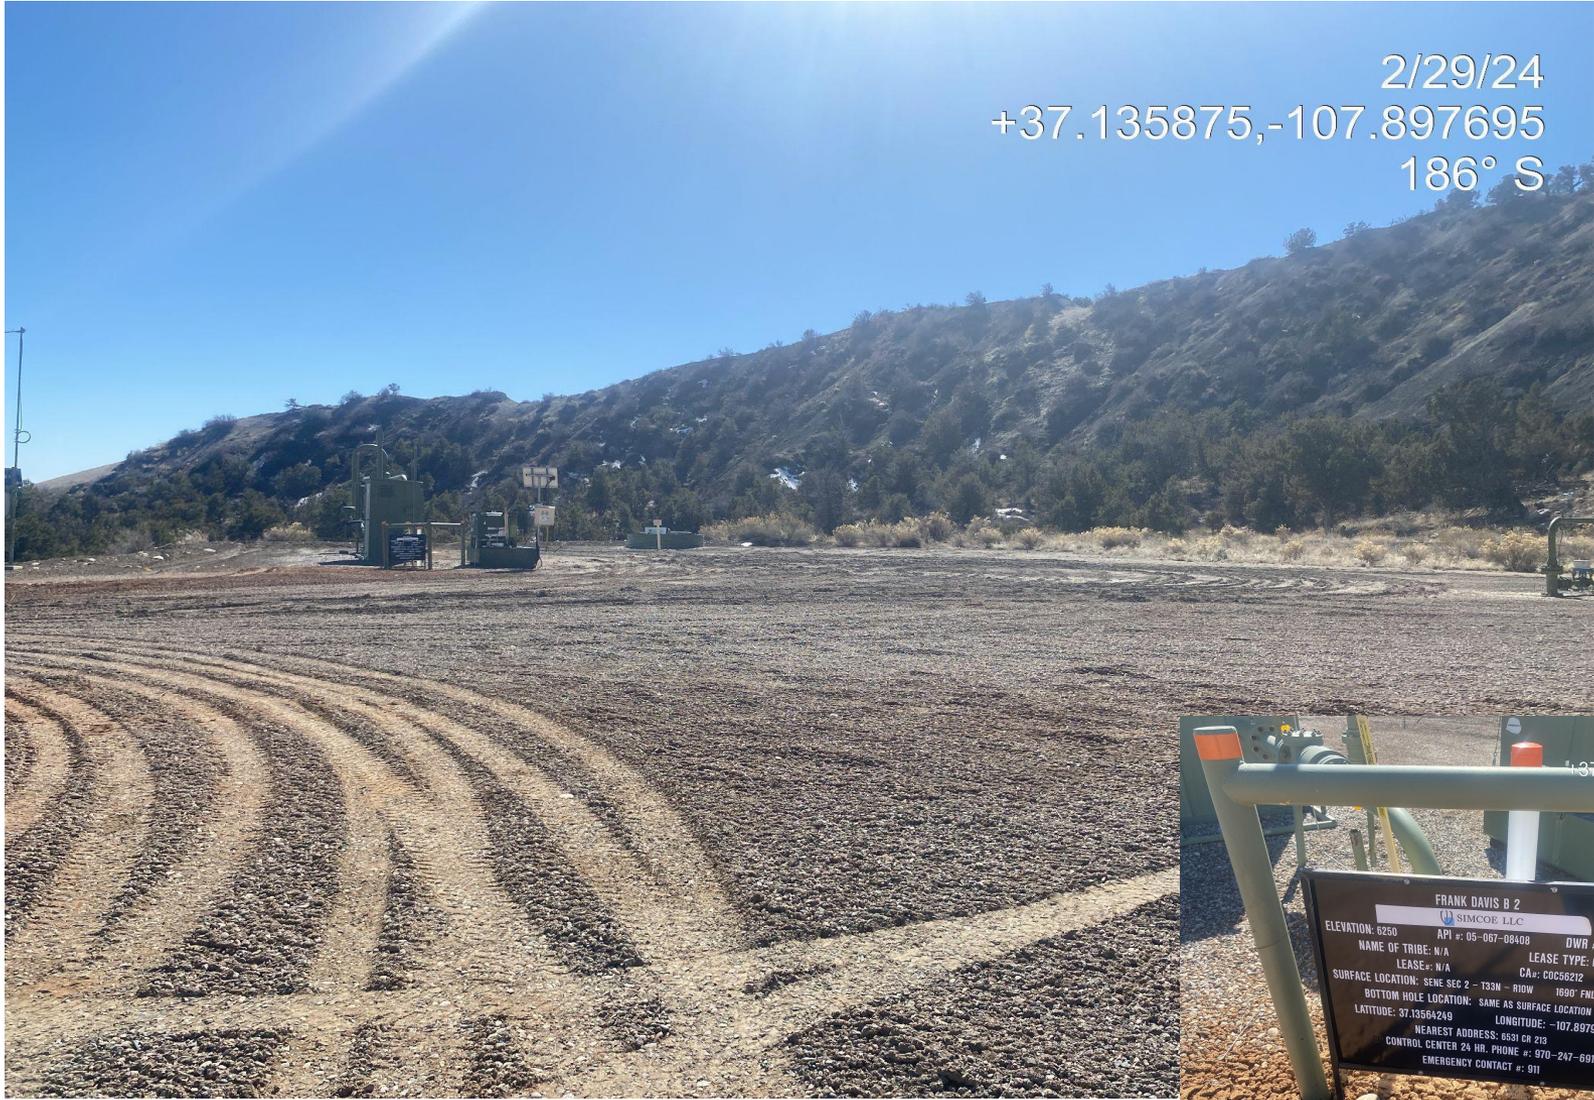
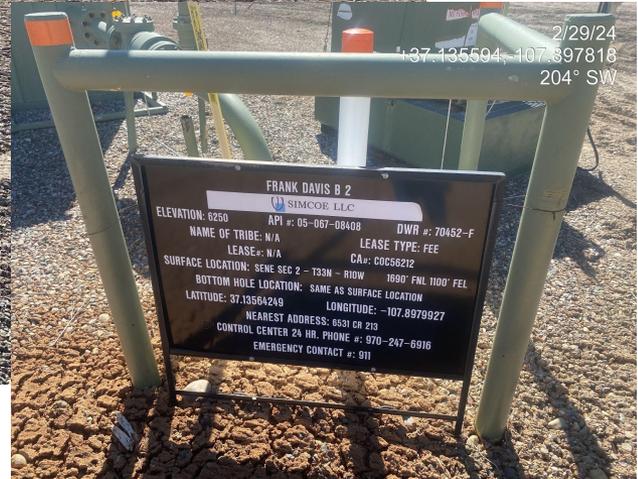
Photo 1. View of the disturbance facing center from the entrance.

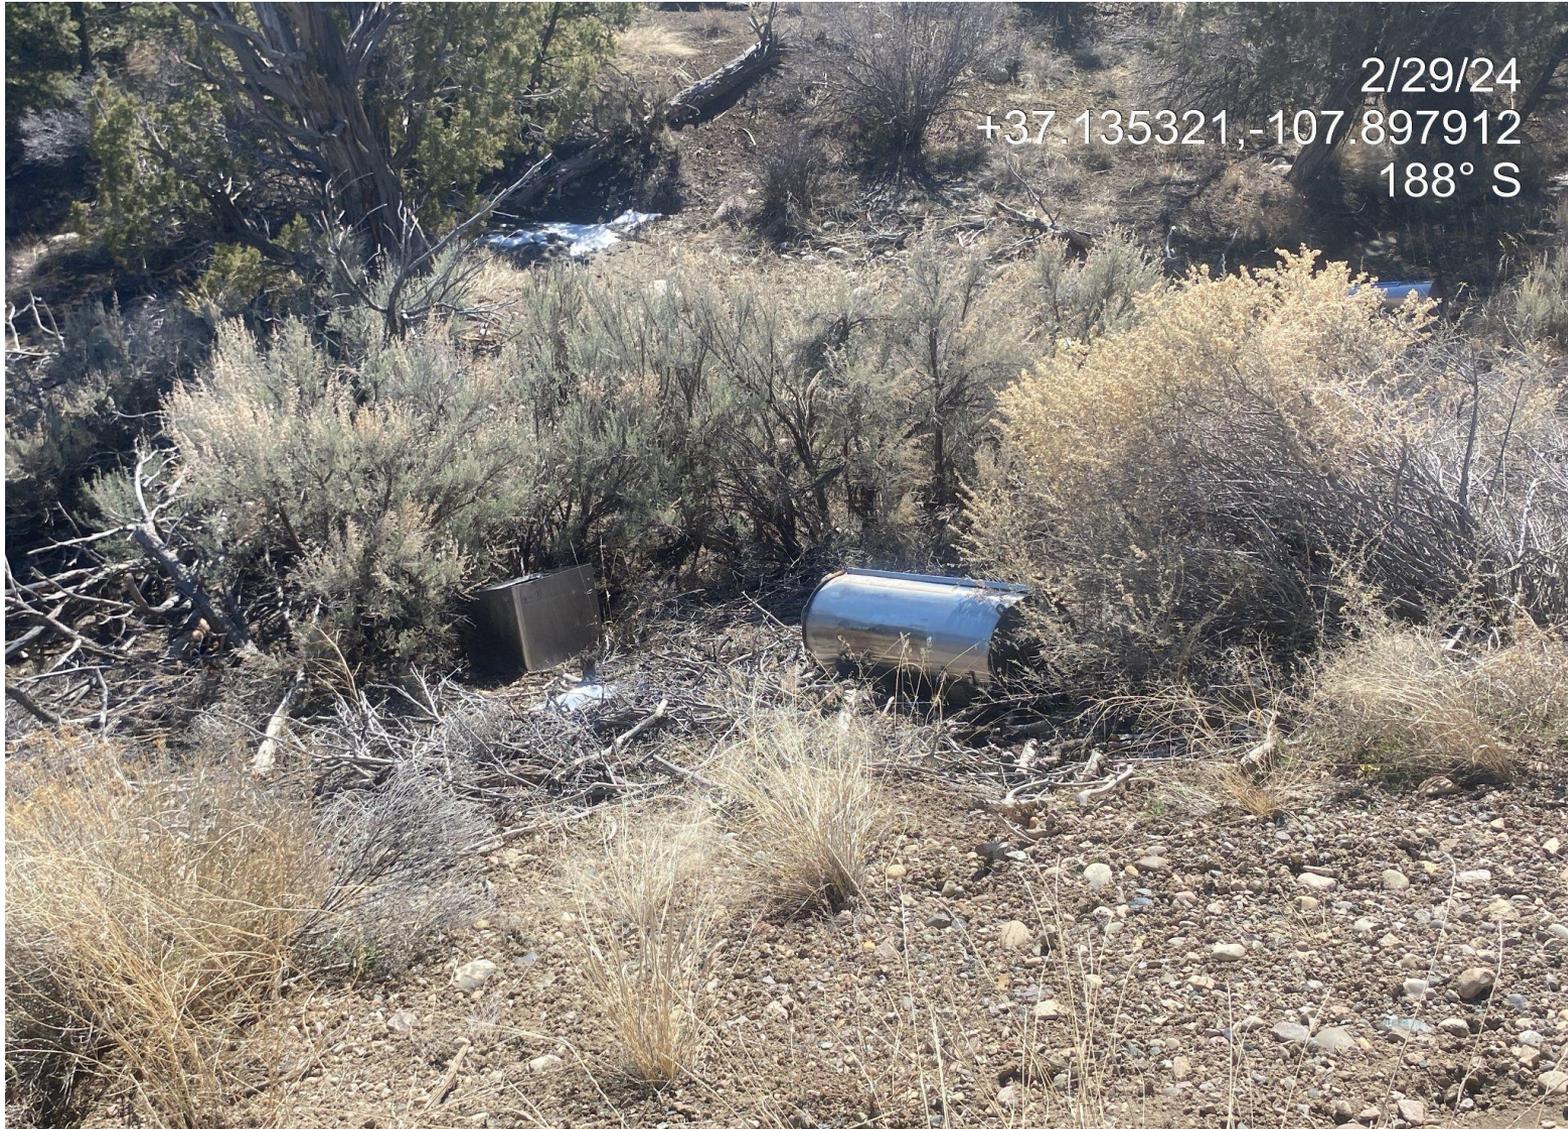
Photo 2. View of trash observed in the southern interim reclamation/fill slope area.

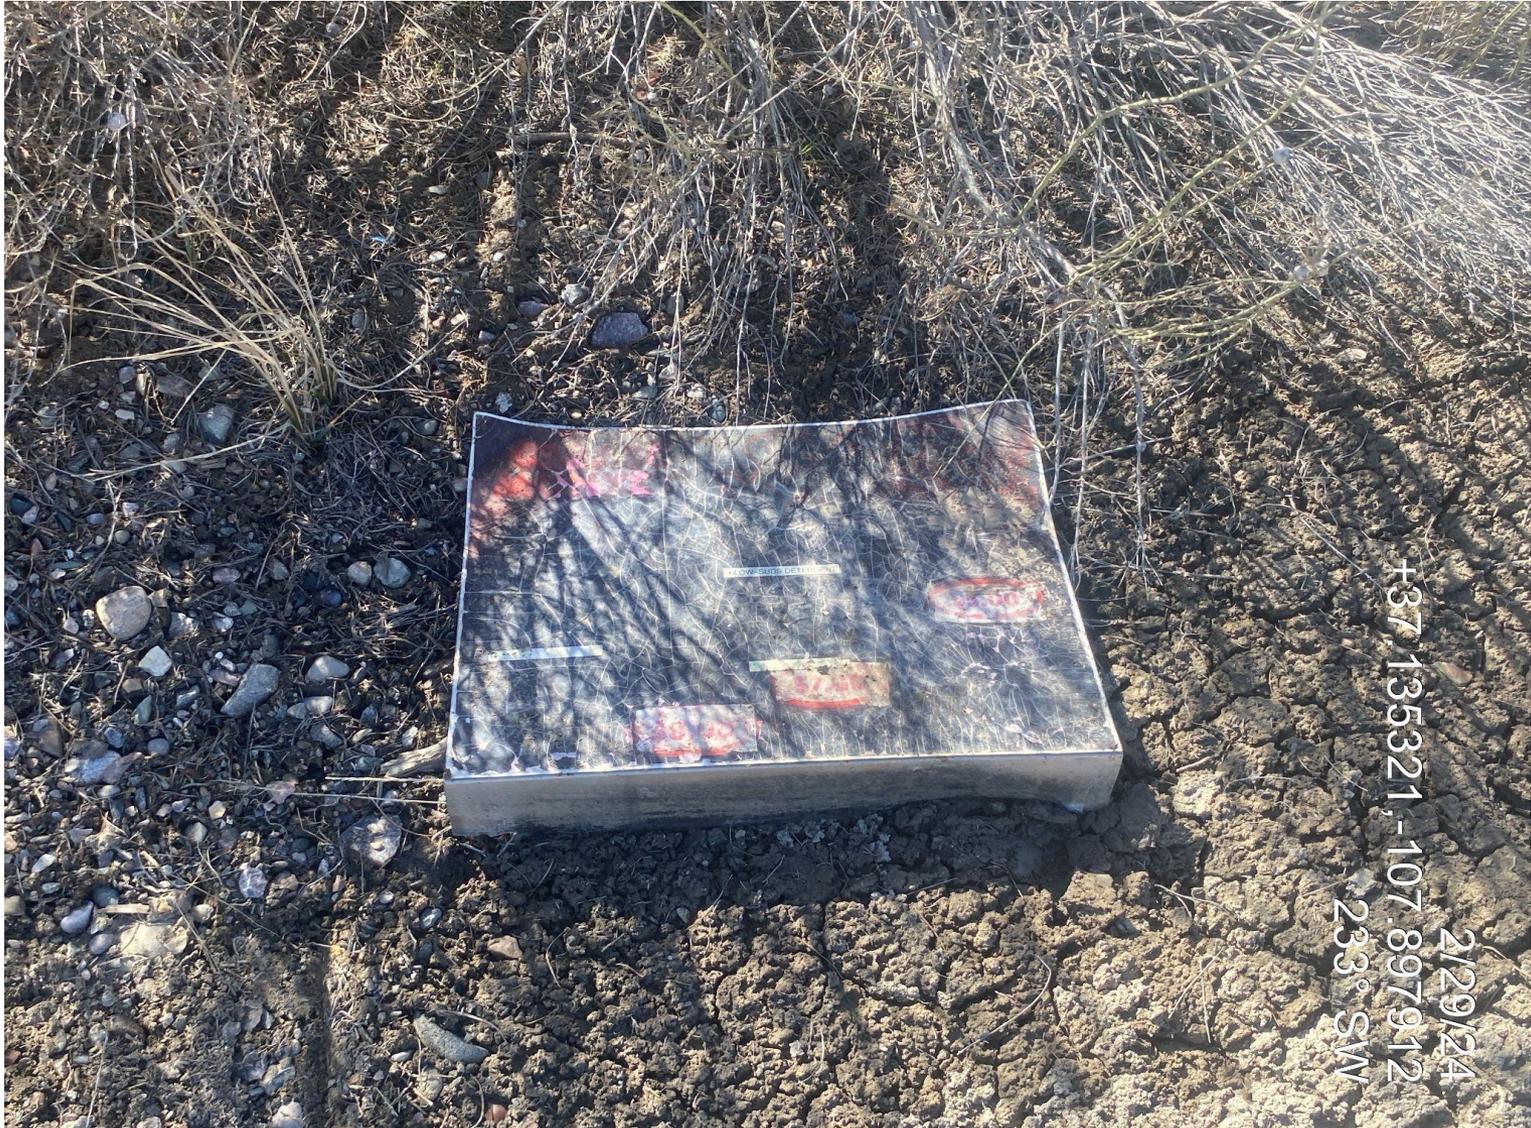
Photo 3. View of additional bits of trash observed in the southern edge of the disturbance.

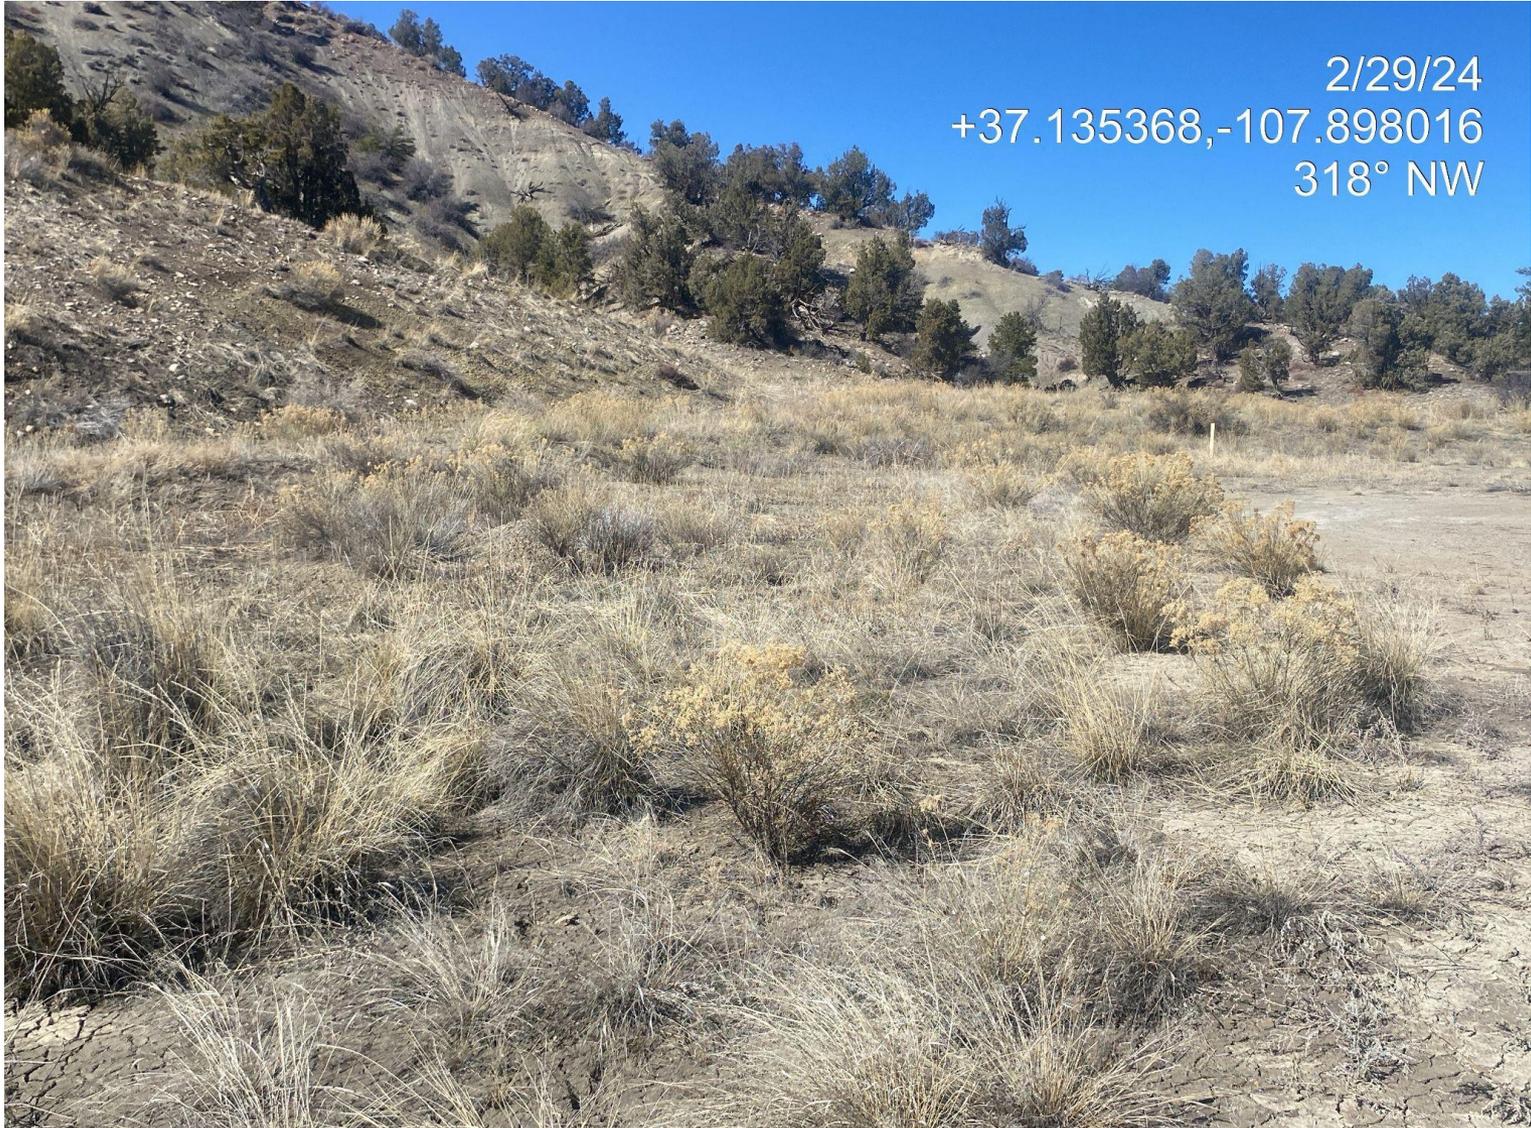
Photo 4. View of the western interim reclamation area facing northwest.

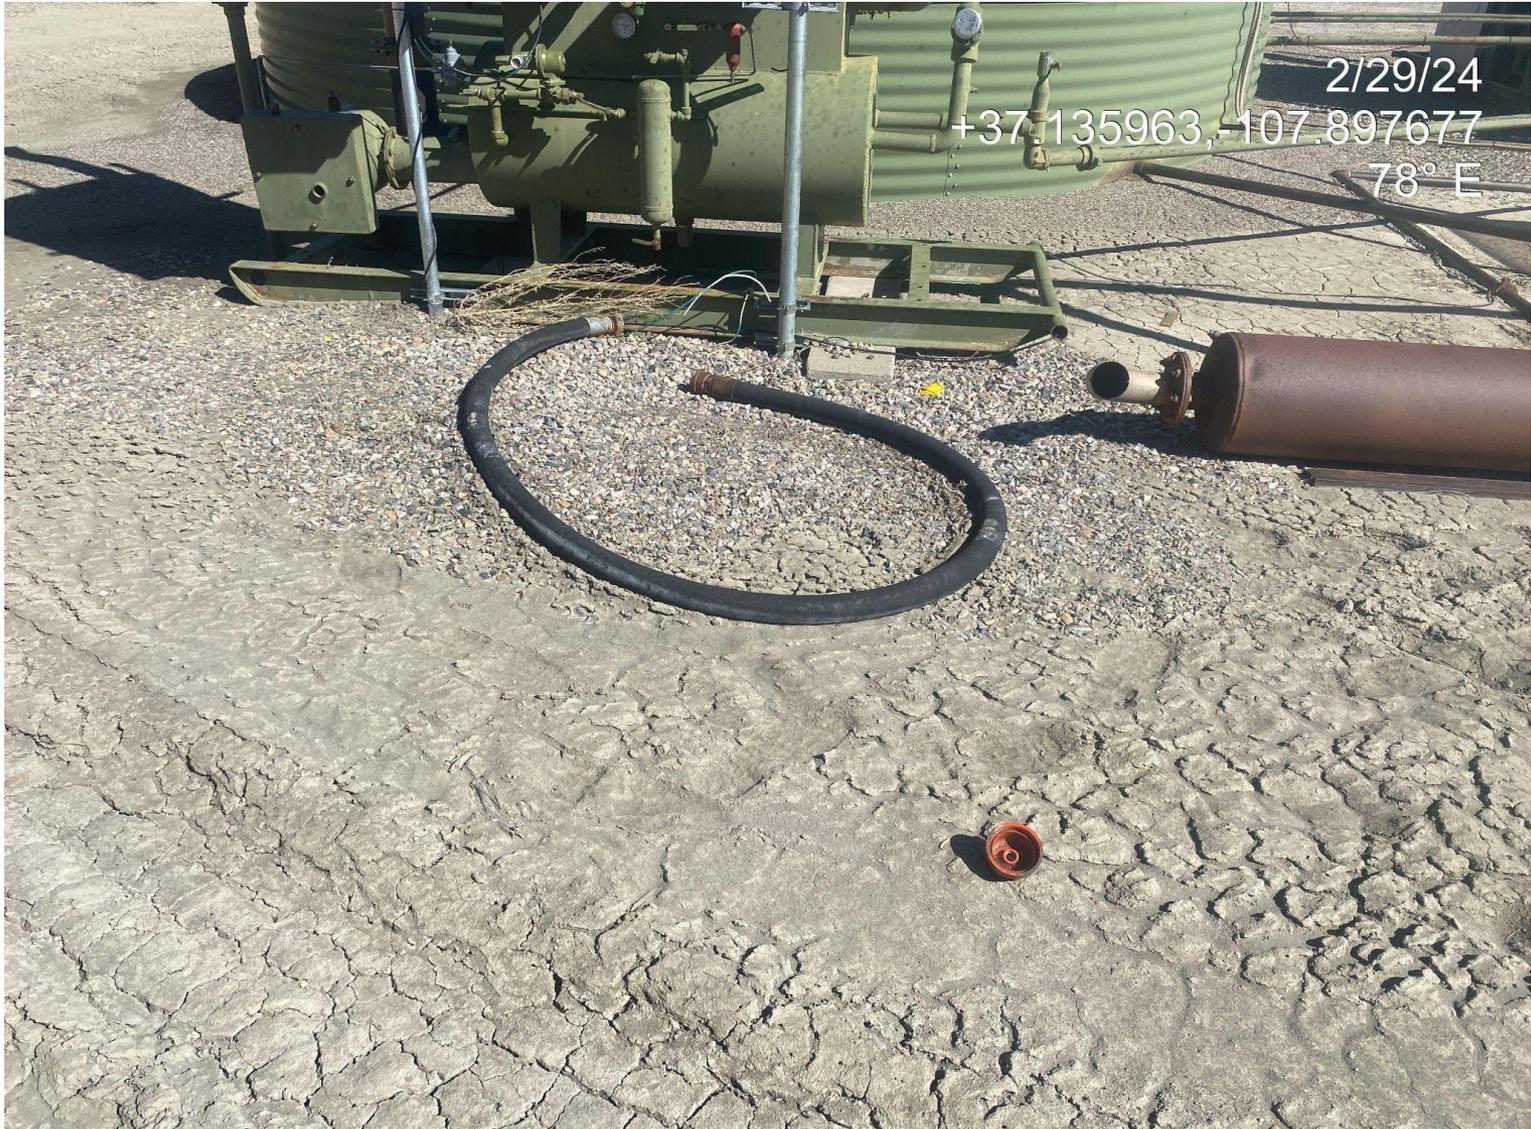
Photo 5. View of unused equipment observed on location.

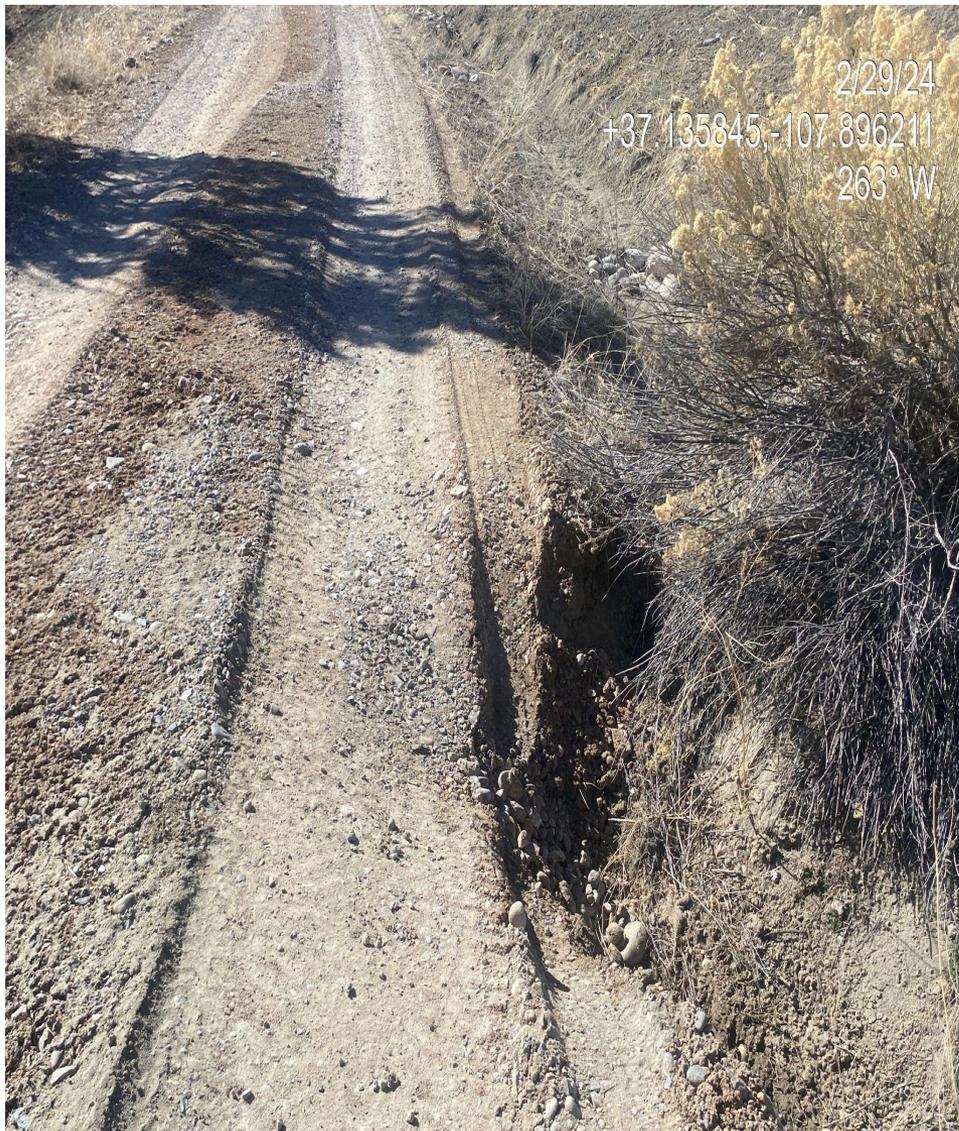
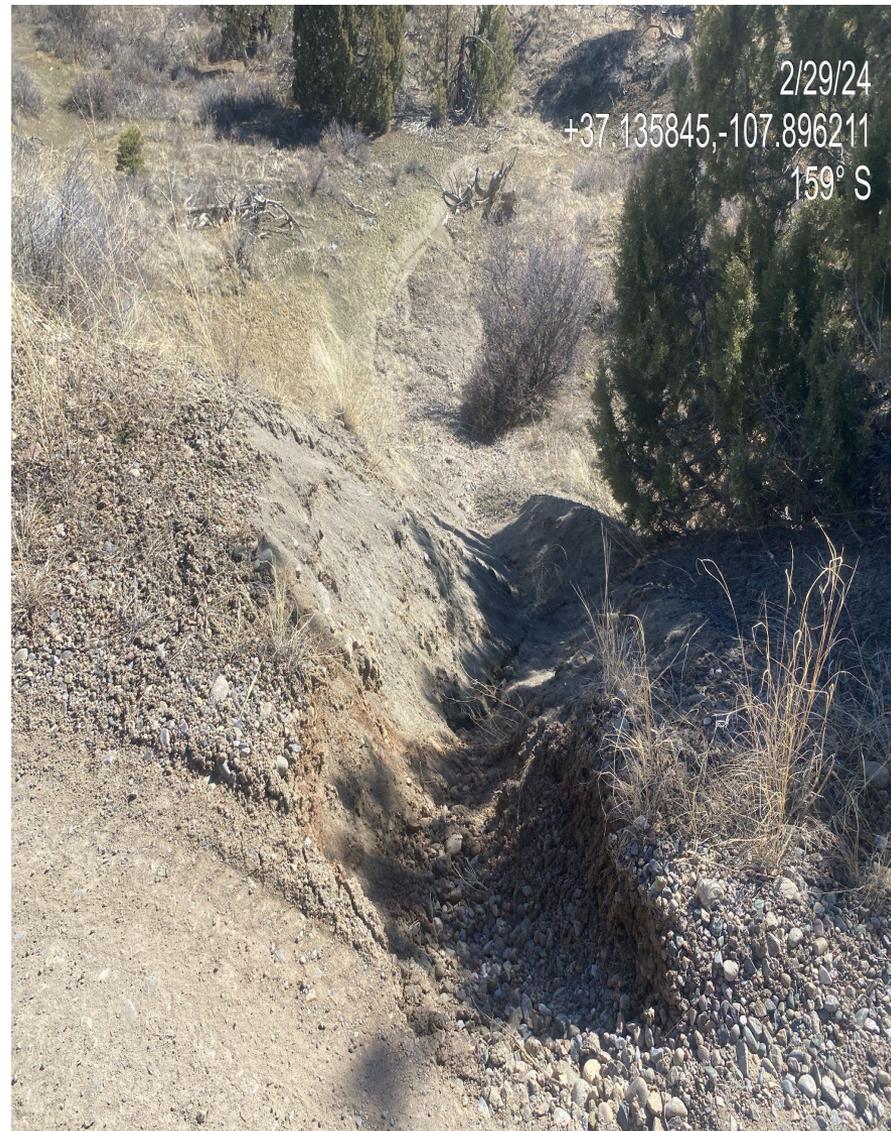
Photo 6. View of gully erosion forming along the access road.

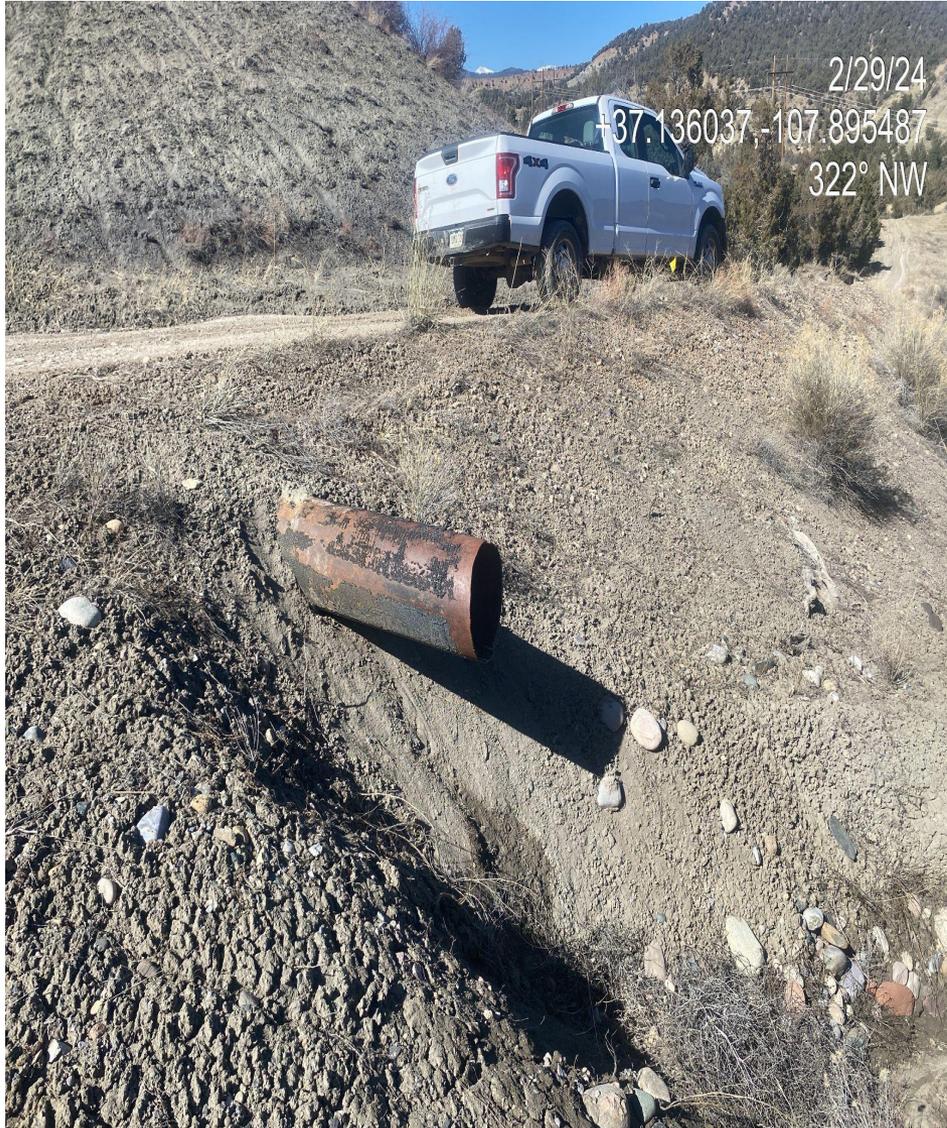
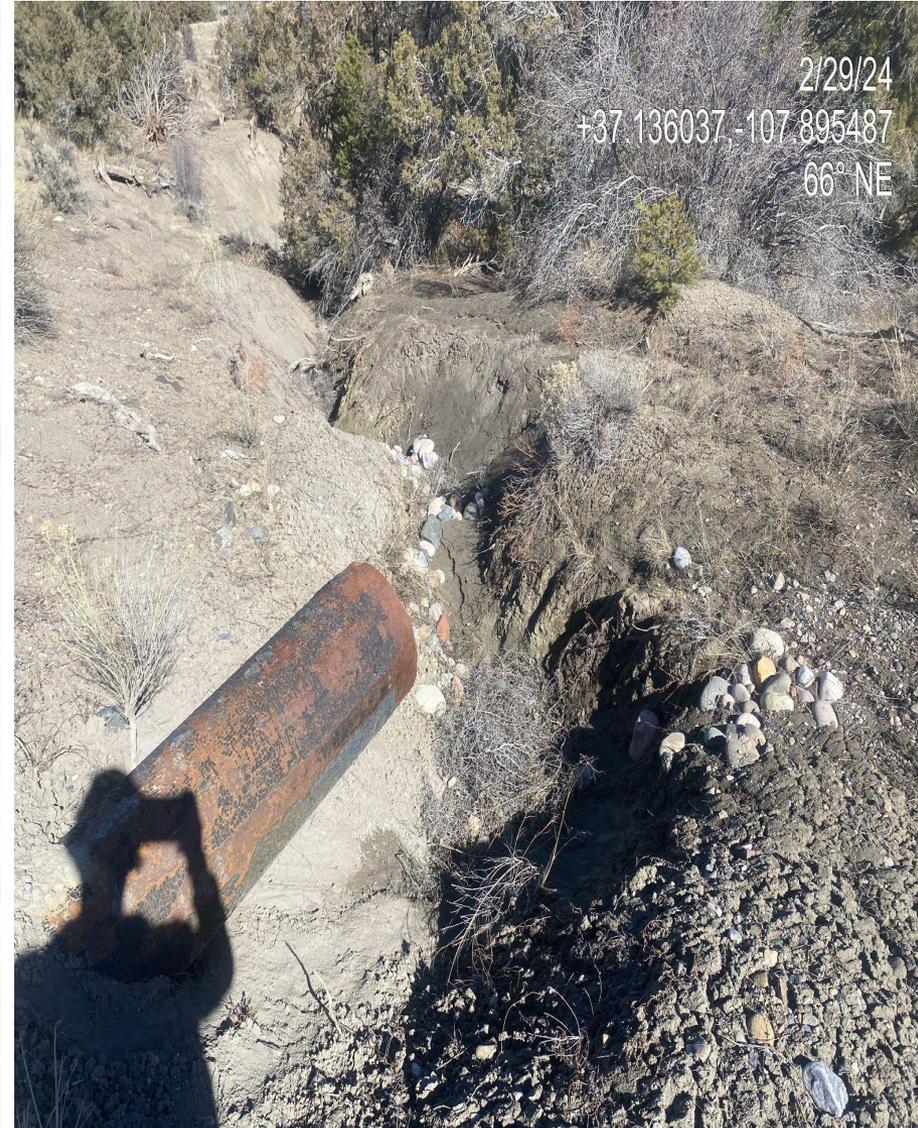
Photo 7. View of culvert that is not installed has not been installed or maintained in accordance with good engineering practices and causing severe gully erosion on the eastern edge of the access road.

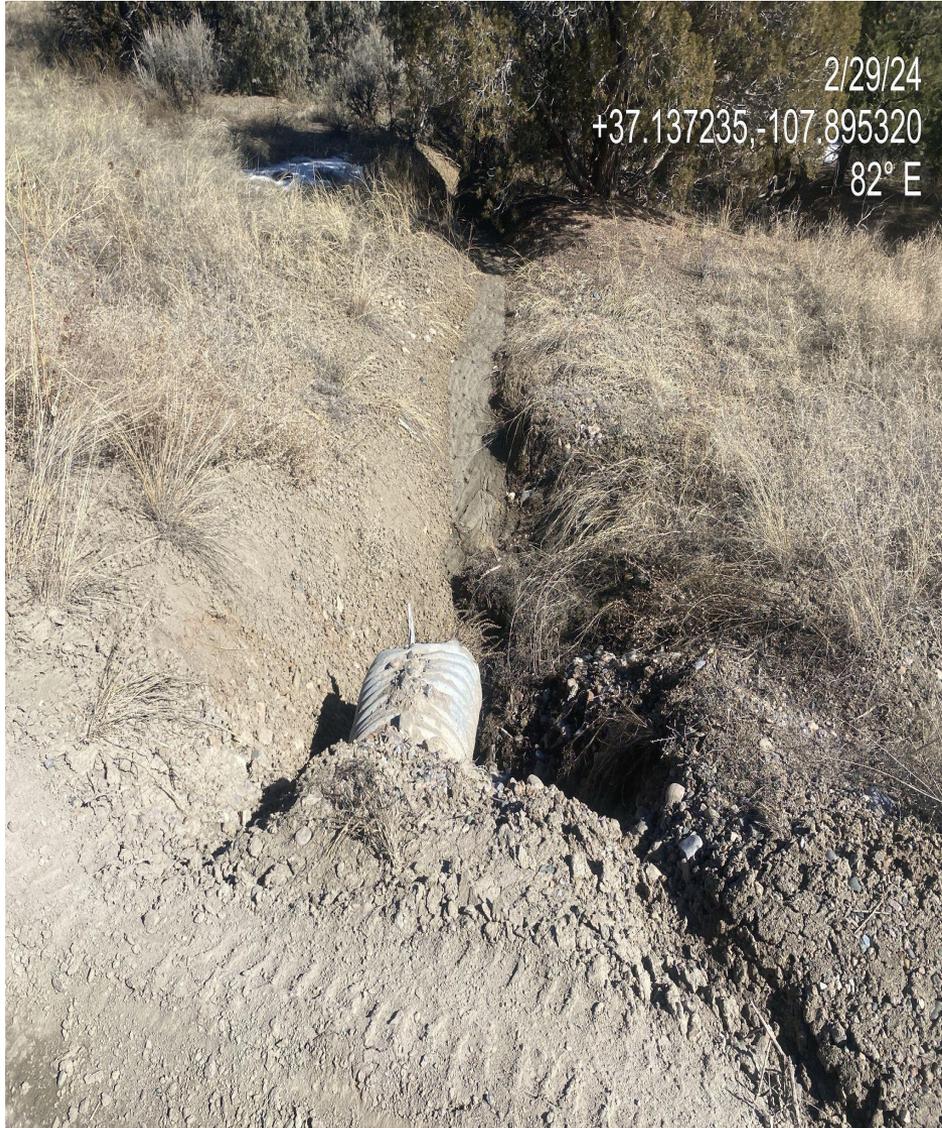
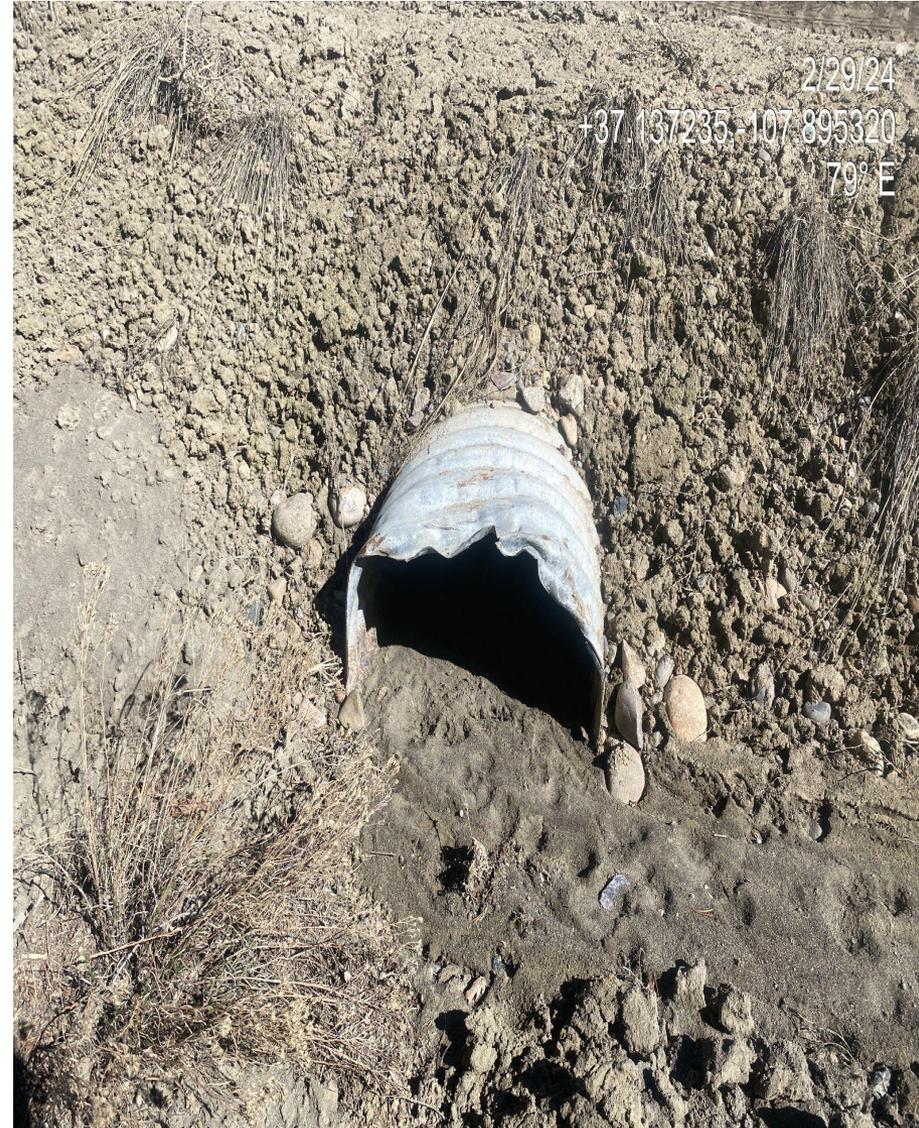
Photo 8. View of culvert that is full of sediment and has not been installed or maintained in accordance with good engineering practices and causing erosion moving east off of the access road.

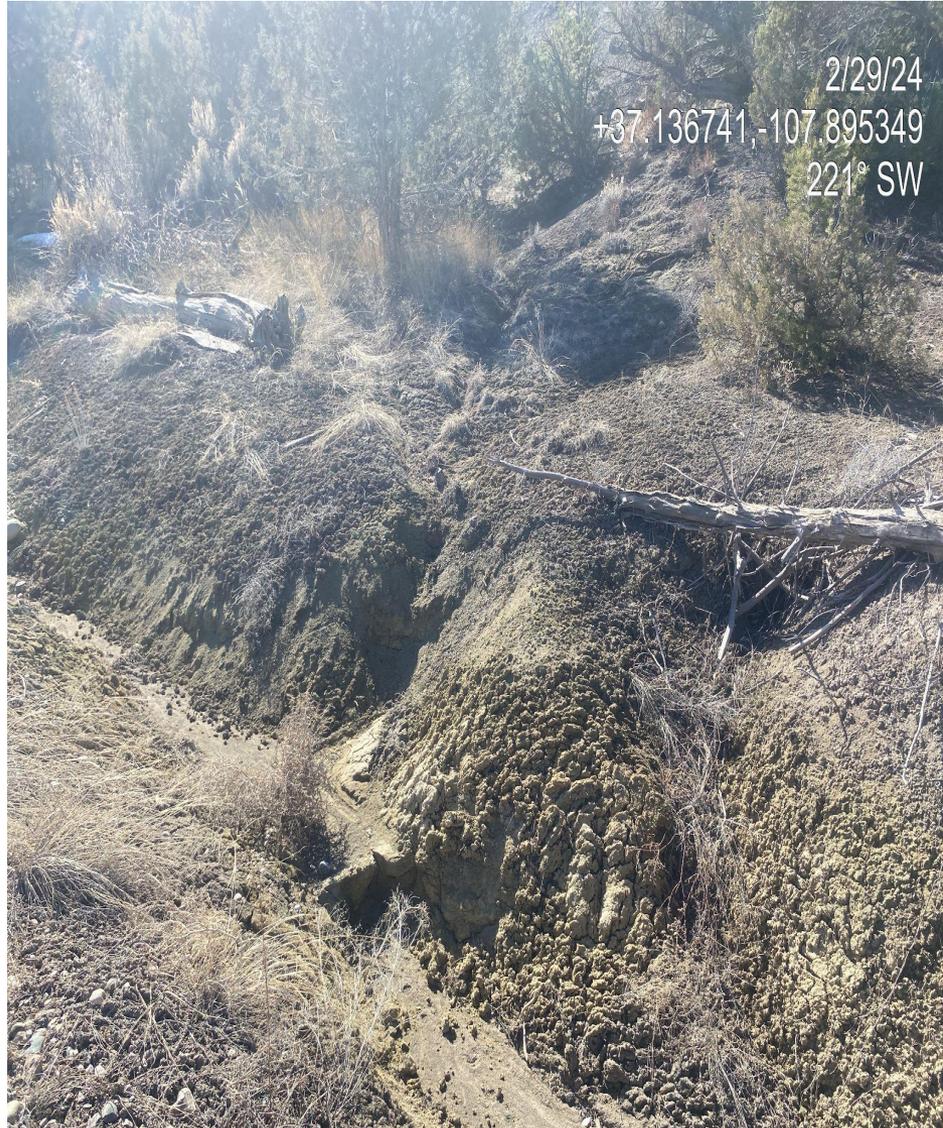
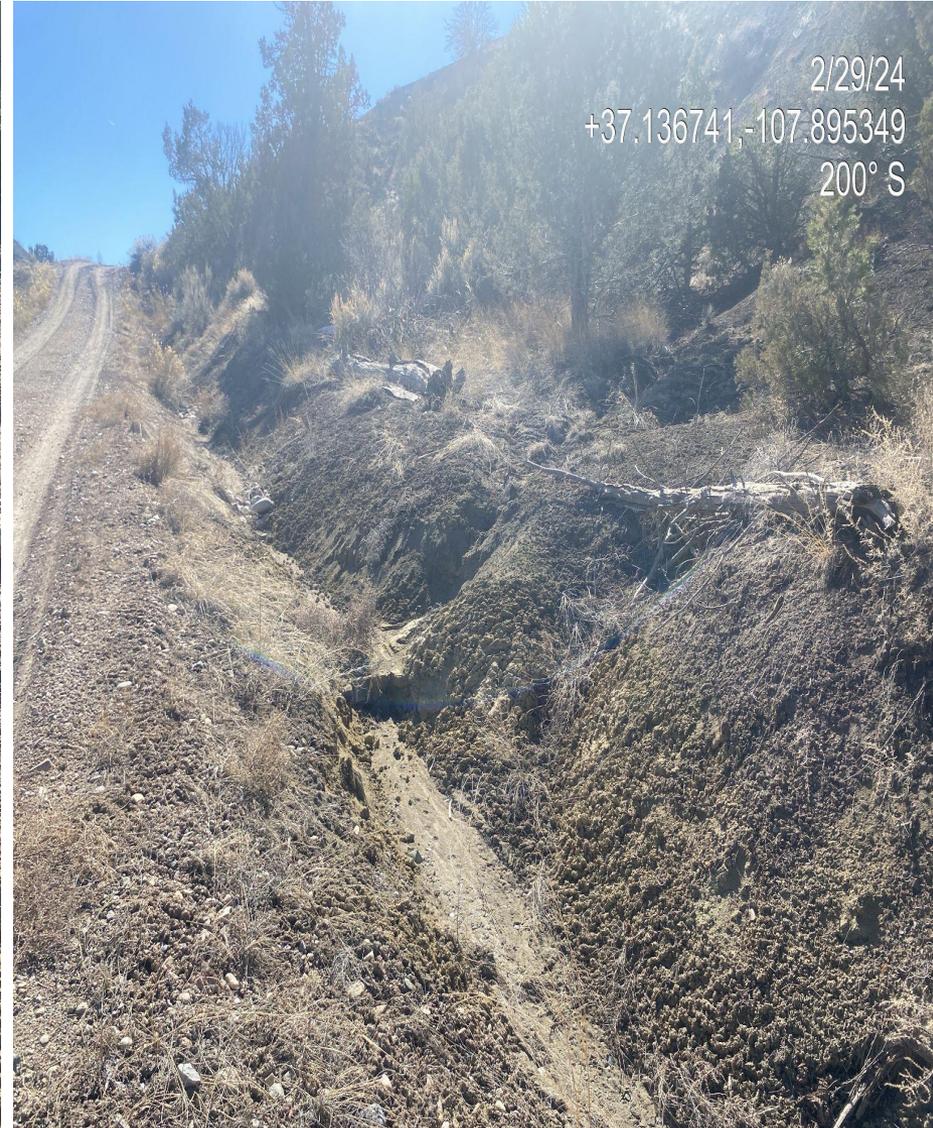
Photo 8. View of rill erosion observed on the western edge of the access road. No installed stormwater BMPs were observed in this location.

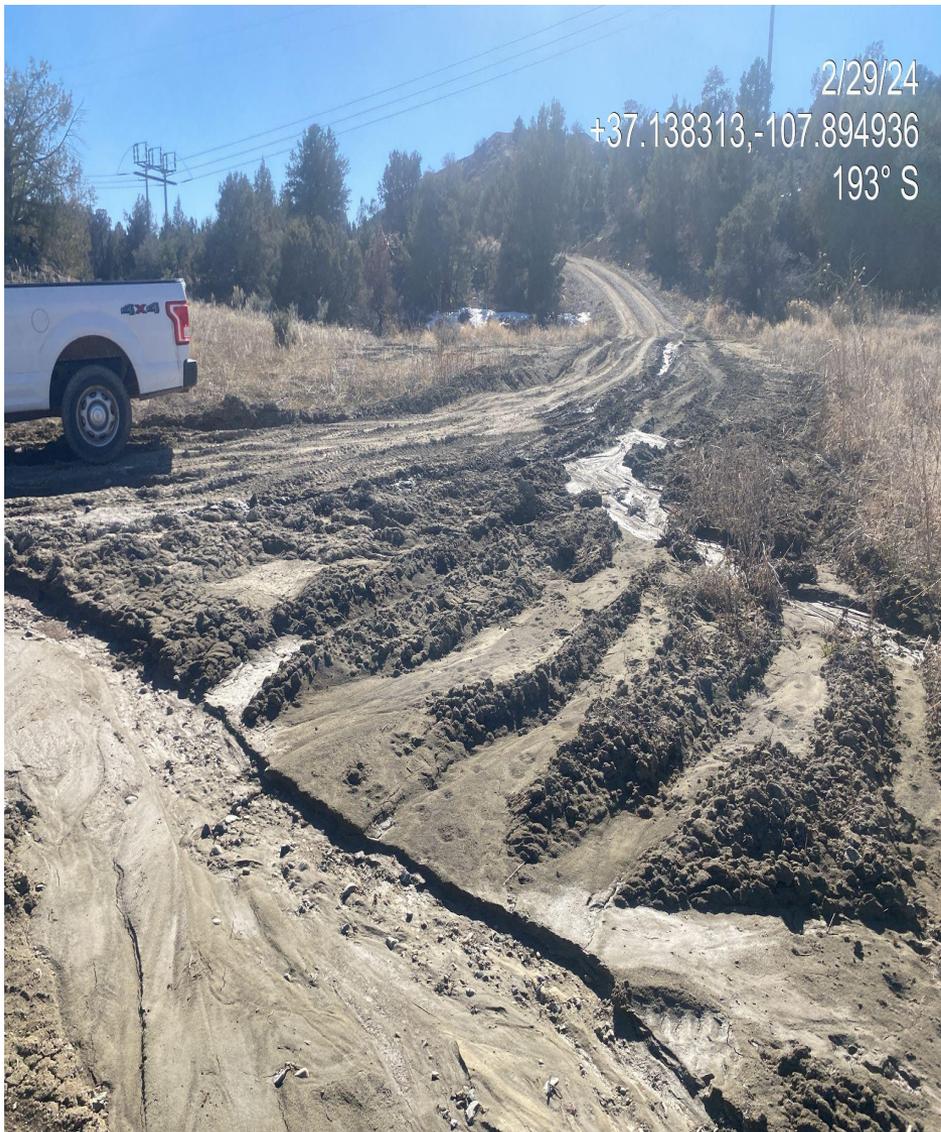
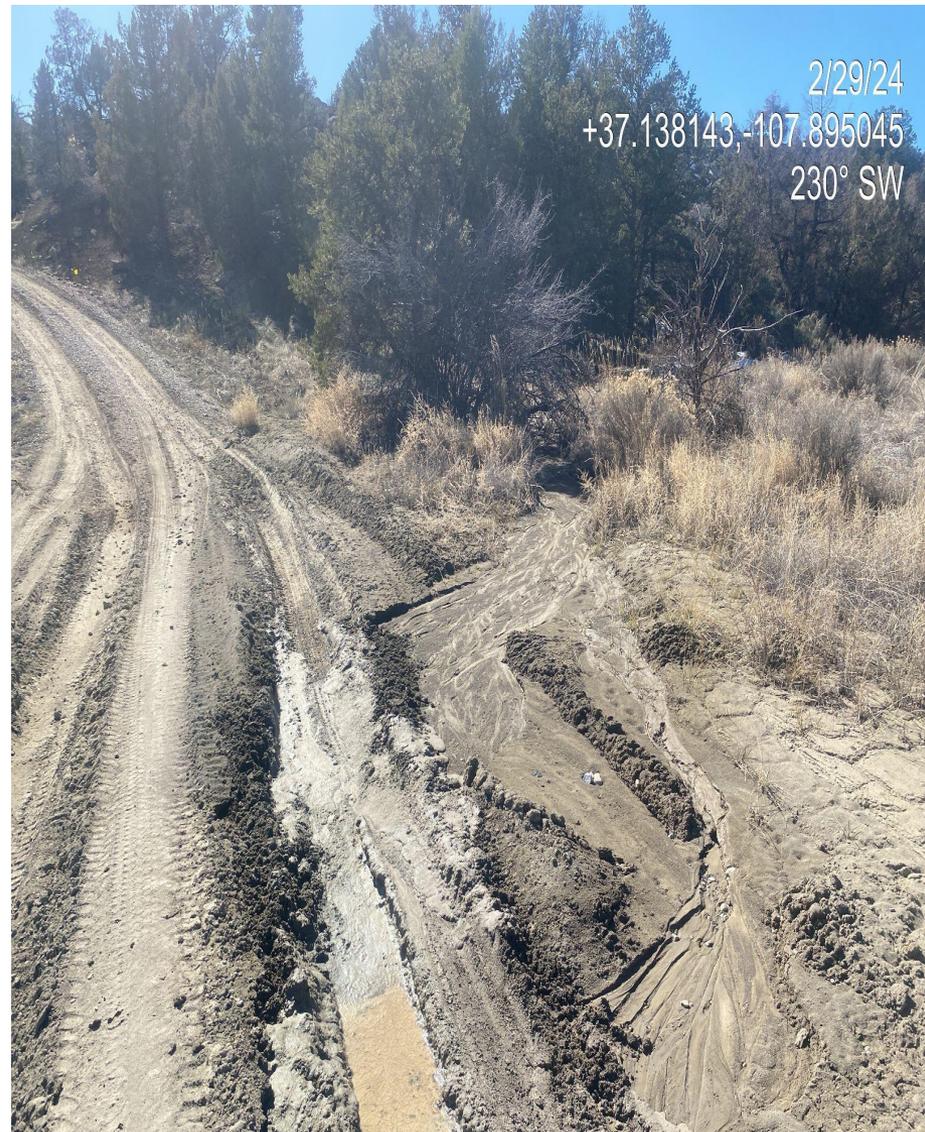
Photo 9. View of severe rutting and sediment transport observed at the access road entrance point. No installed stormwater BMPs were observed in this area.

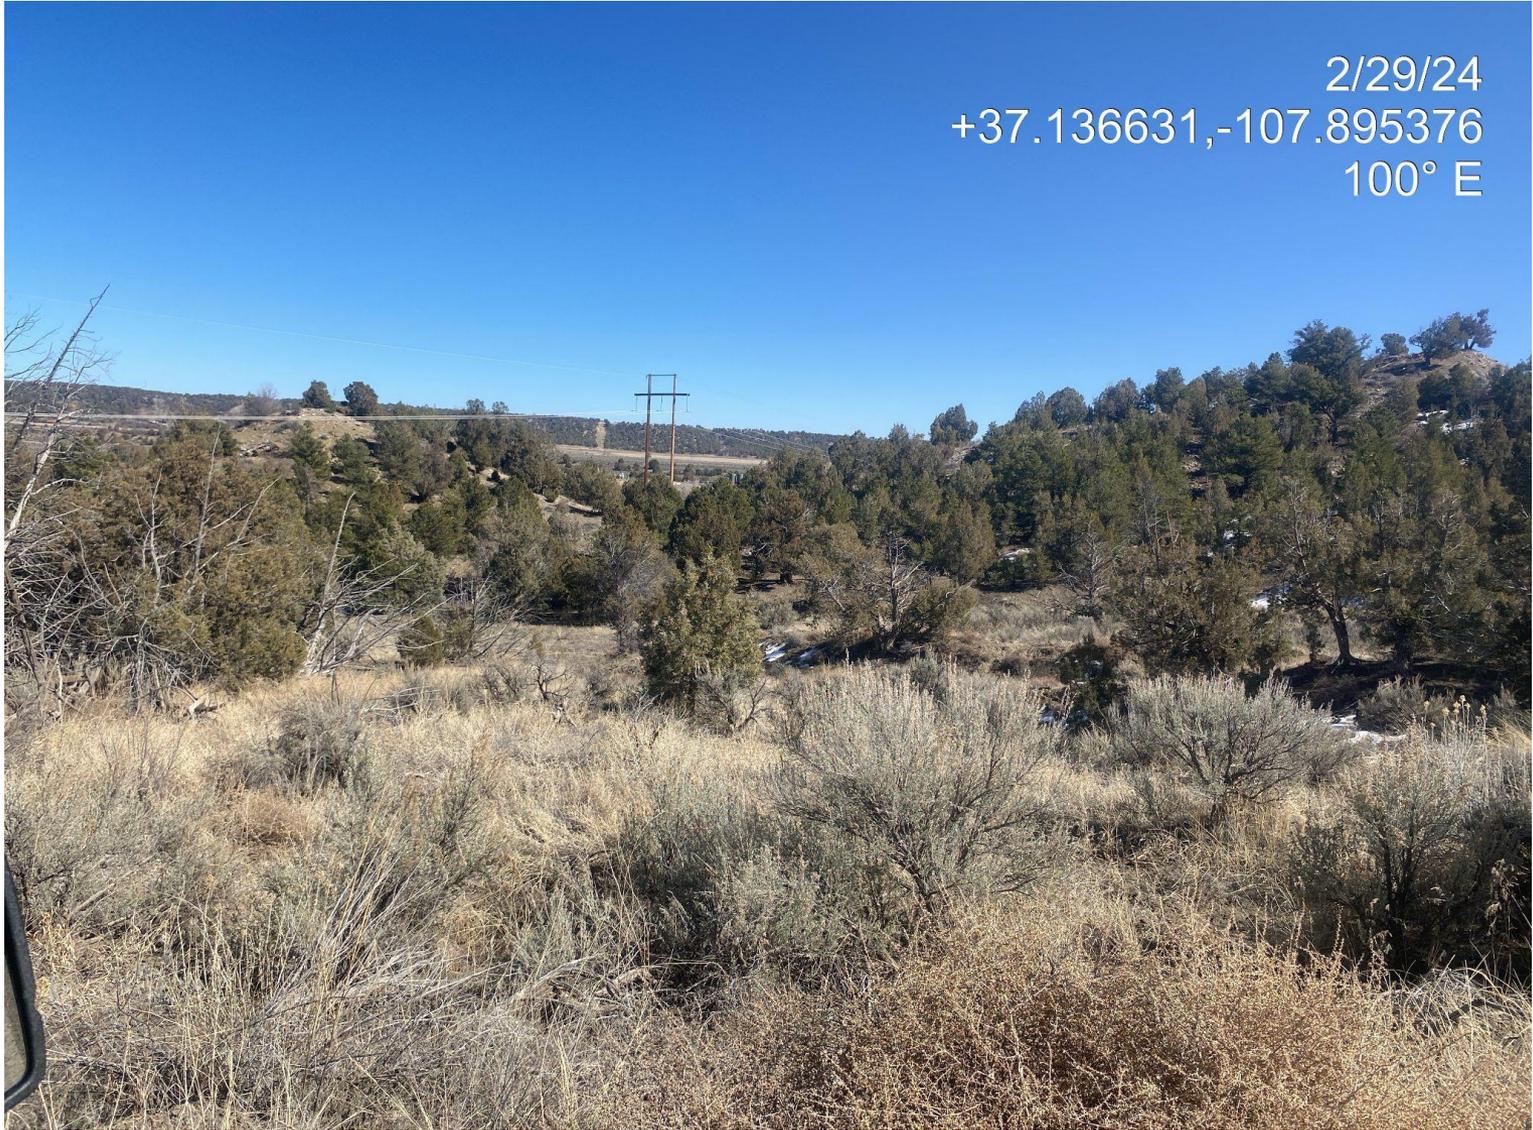
Photo 10. View of the reference comprised of kochia, sagebrush and juniper.
