# SITE-SPECIFIC QUALITY ASSURANCE & QUALITY CONTROL AUDIT

## PERMIT CLOSURE REPORT – DESIGNATION LAND USE CHANGE

Location ID: 320291

Location Name: BYDALEK-61S68W/11SESW

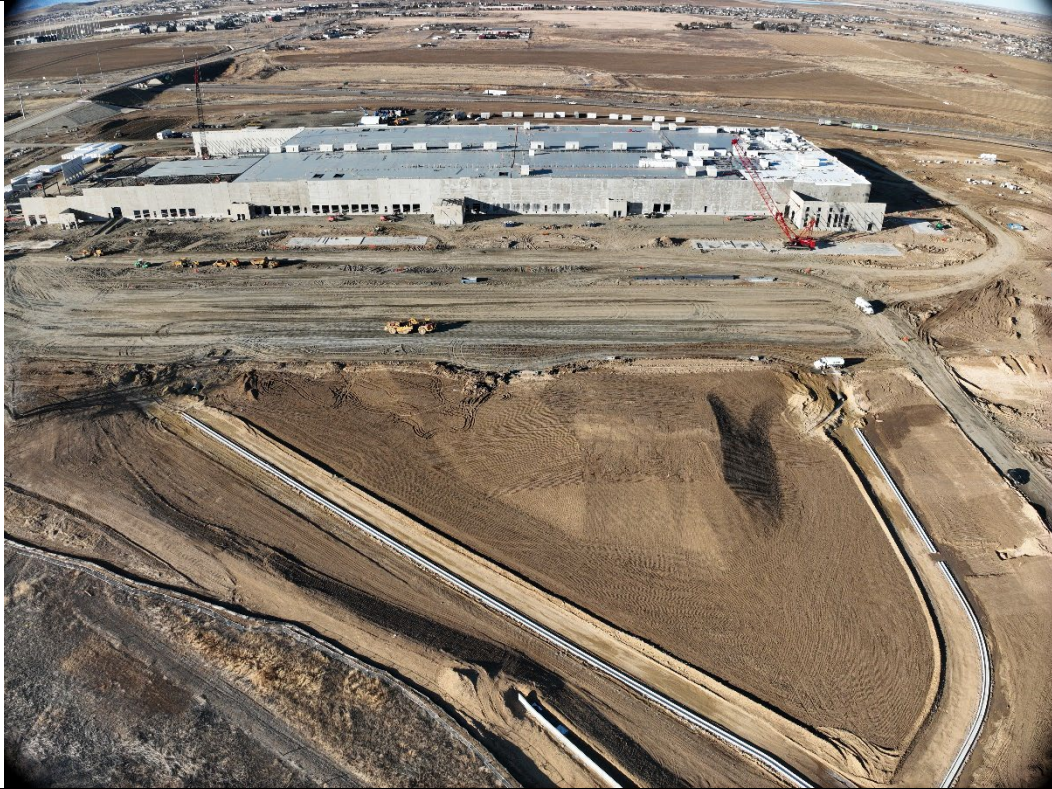
**NORTH** – 39.972908 / -104.973504

**In View** – Well, Tank Battery, Access Road, Flowline

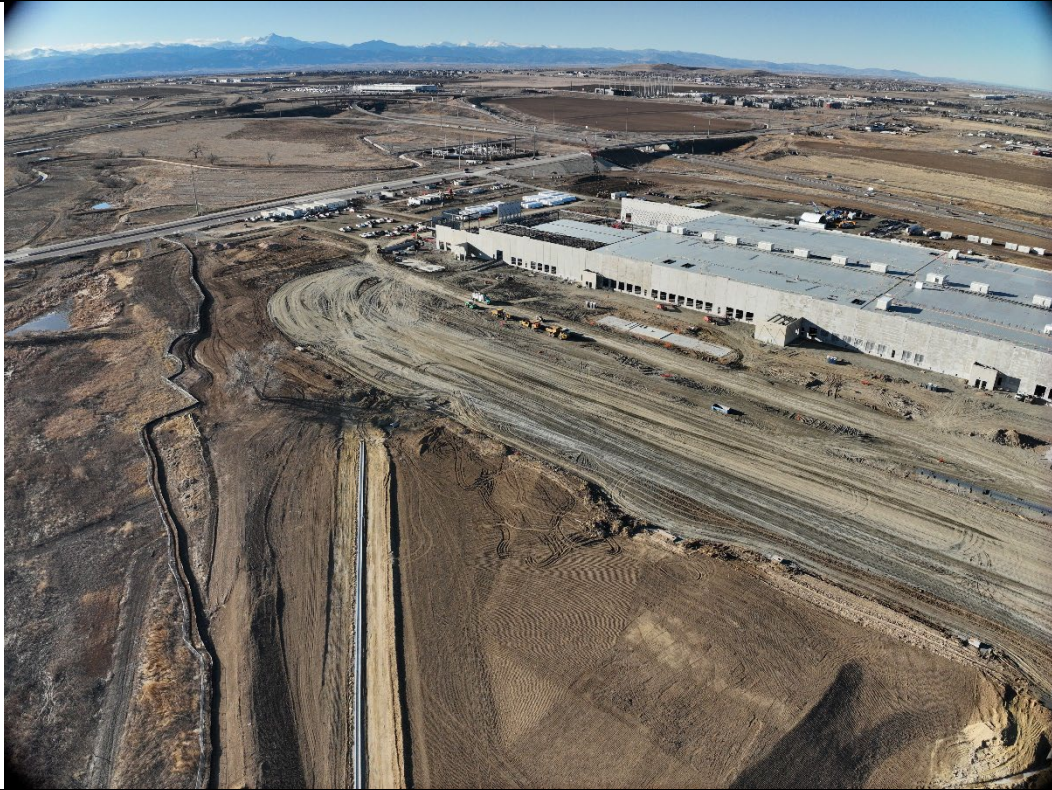
**NORTHWEST – 39.973398 / -104.972730**

**In View – Well, Tank Battery, Access Road, Flowline**

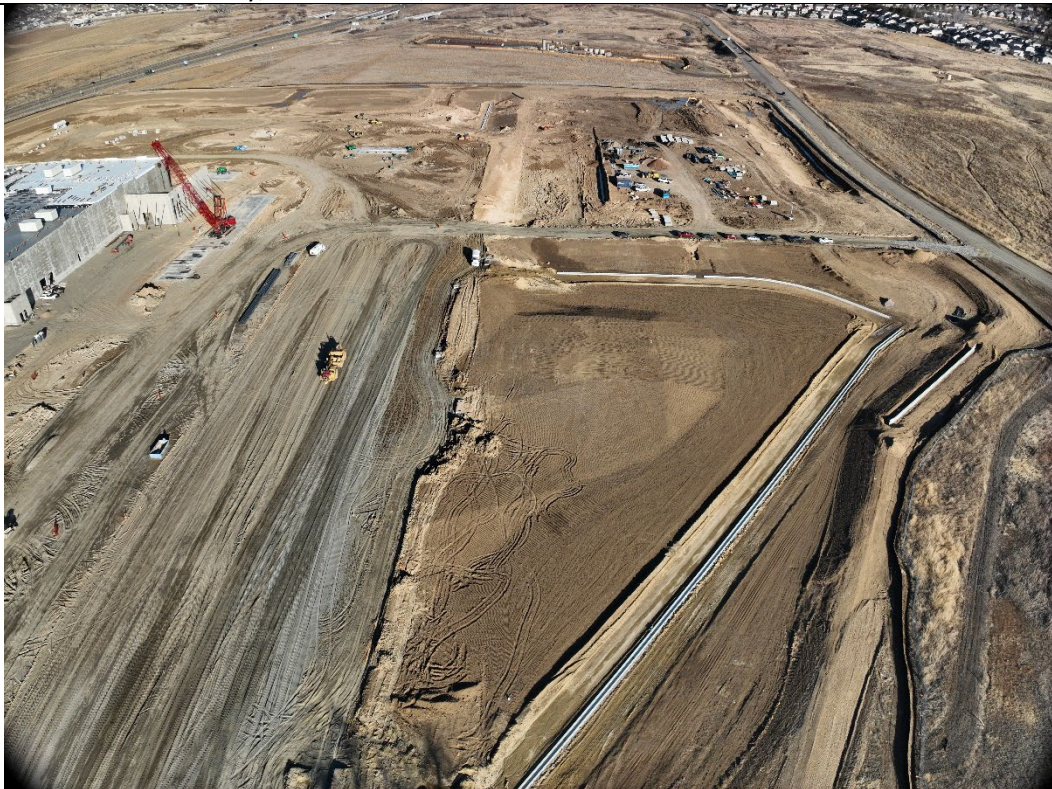
**EAST – 39.974298 / -104.975159**

**In View – Well, Tank Battery, Access Road, Flowline**

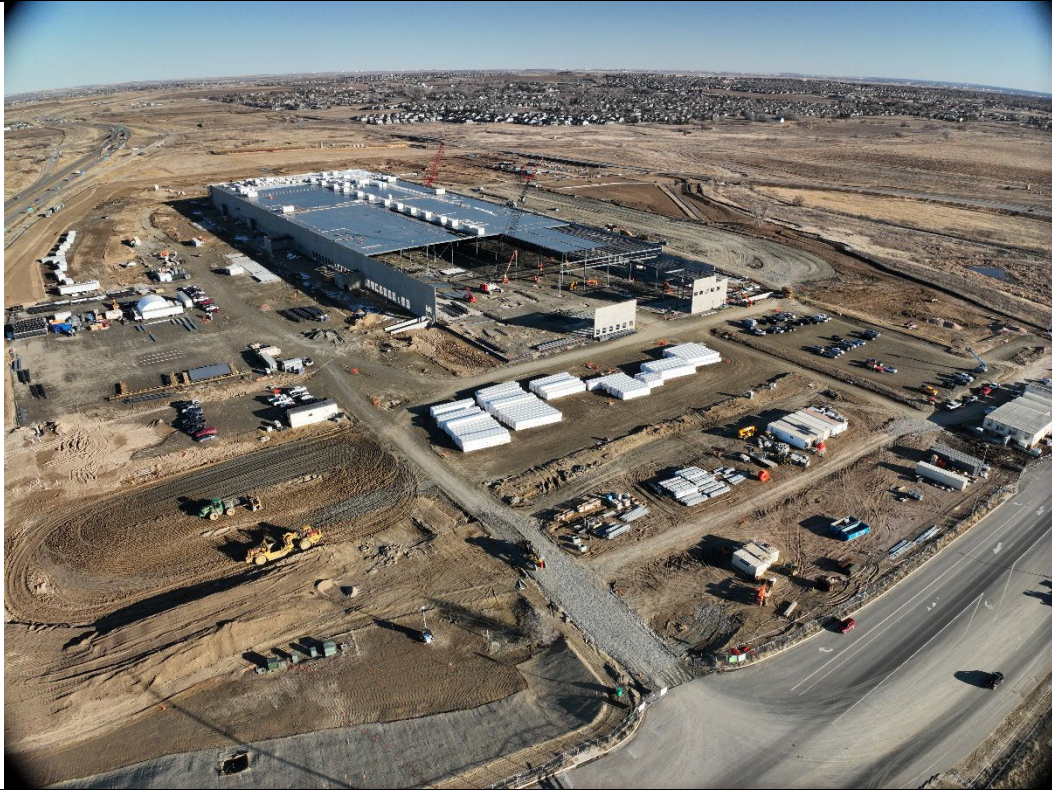
**SOUTHEAST – 39.977959 / -104.978643**

**In View – Well, Tank Battery, Access Road, Flowline**

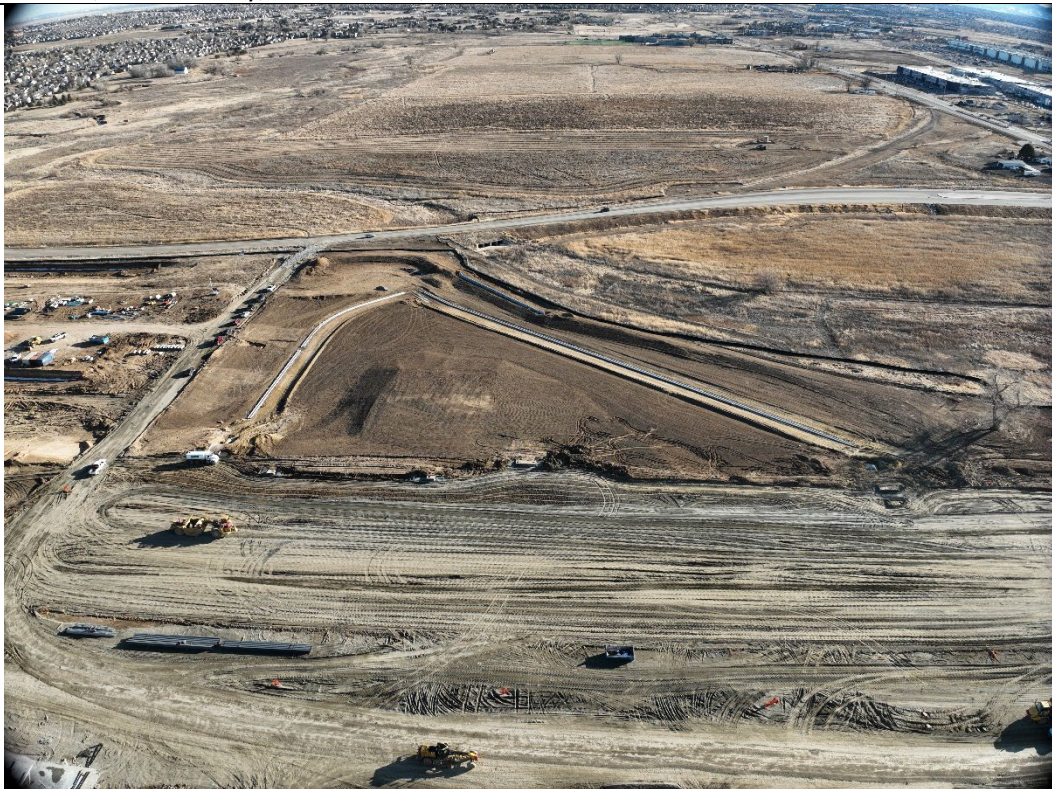
**SOUTH – 39.975867 / -104.973636**

**In View – Well, Tank Battery, Access Road, Flowline**

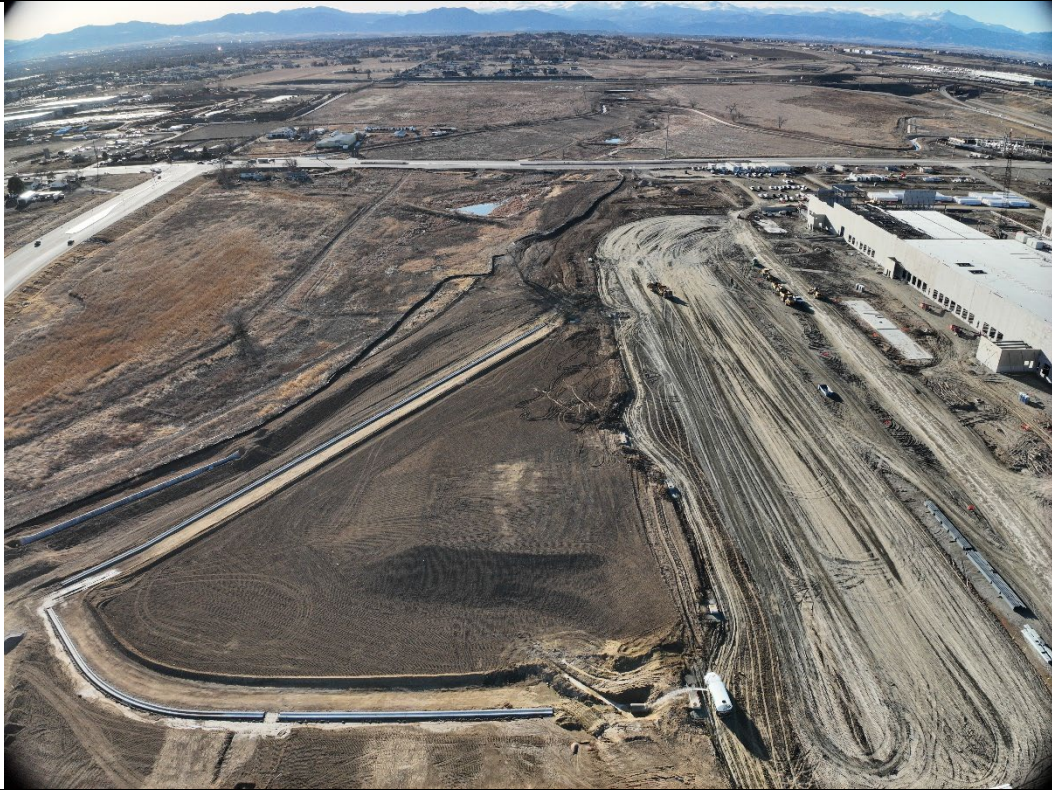
**WEST – 39.974235 / -104.971594**

**In View – Well, Tank Battery, Access Road, Flowline**

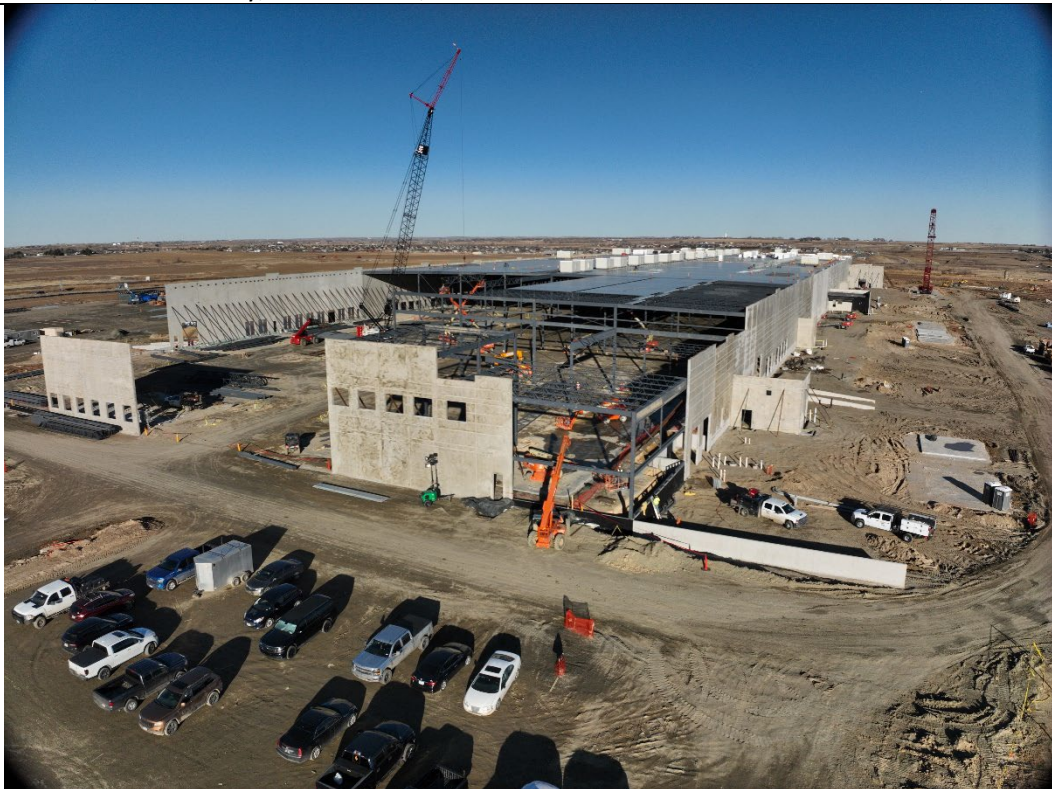
**EAST – 39.975532 / -104.977058**

**In View – Close-up of construction**

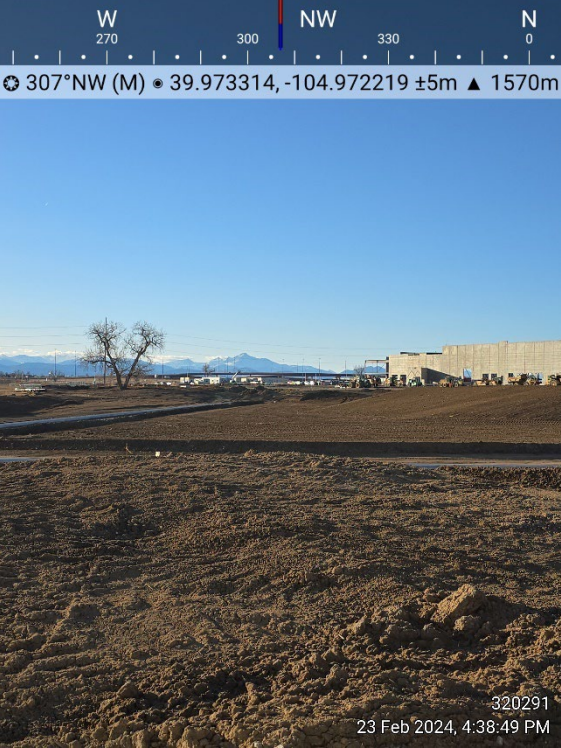
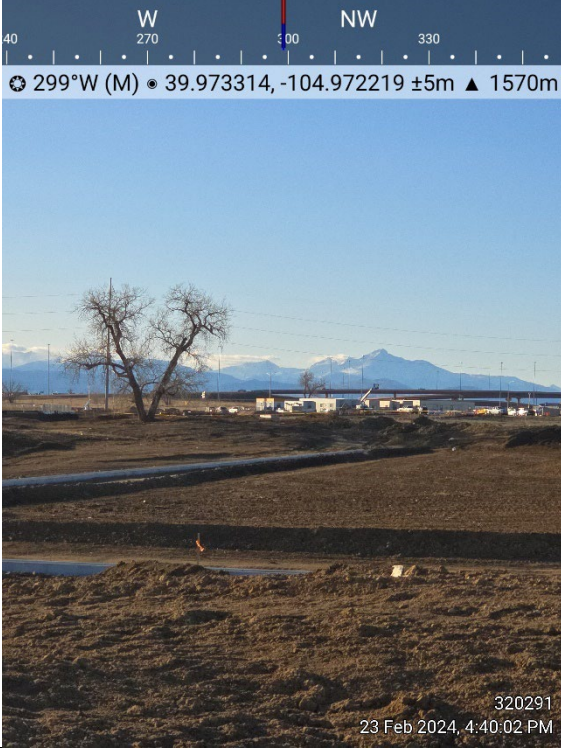
Facing Northwest looking at construction from south of wellhead – 39.973314 / -104.972219	Facing Northwest looking at construction from south of wellhead – 39.973314 / -104.972219
