Inspection Photos
Location Name: UPRR HABEL 1-35
Location ID: 319728

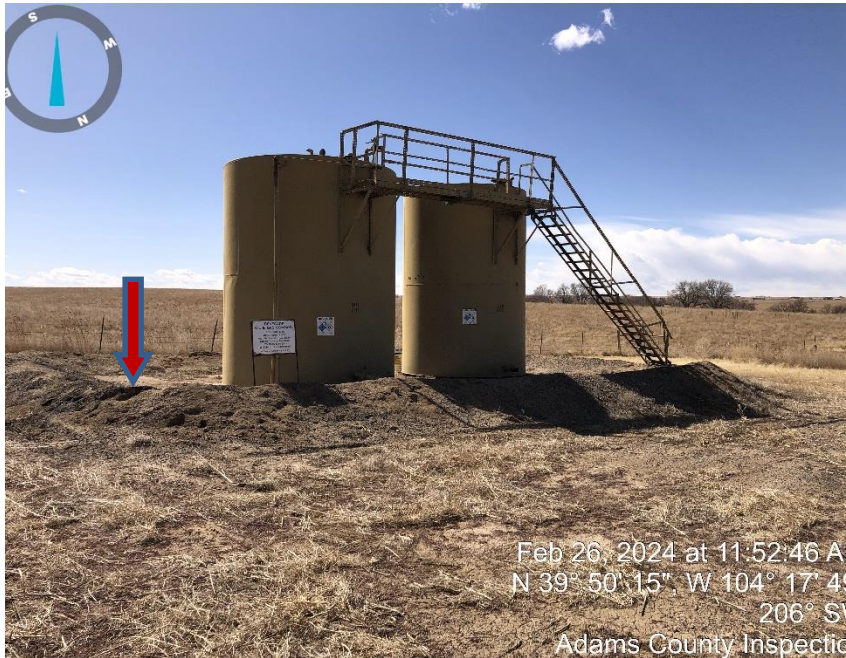
Photo #1 tanks and berm that needs maintained.

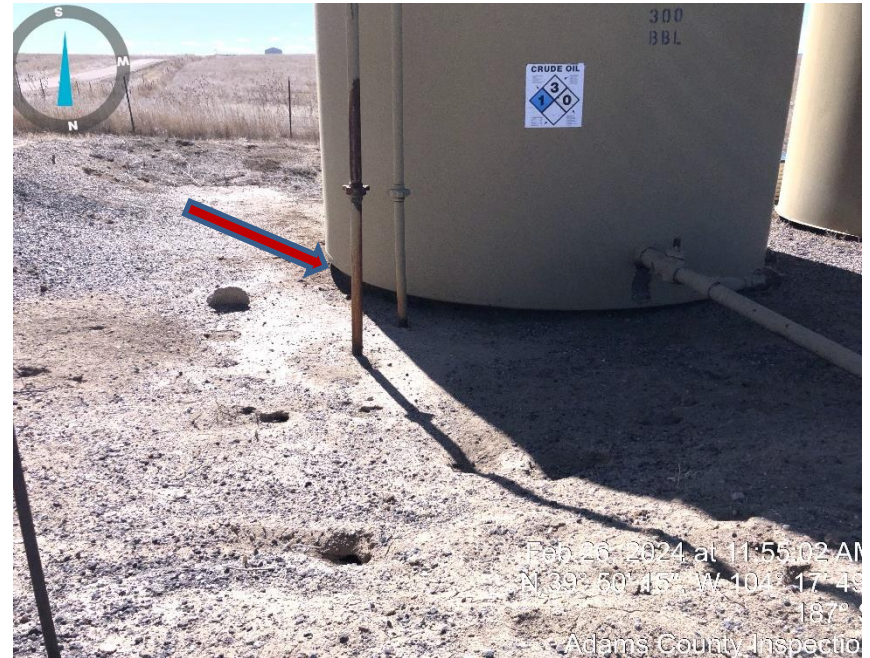
Photo #2 base of containment eroded under tanks.

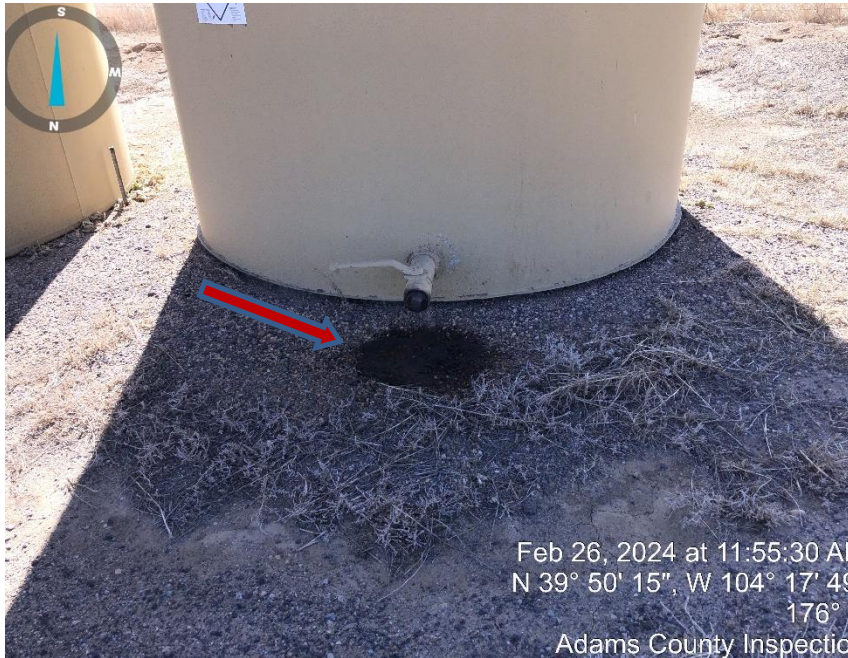
Photo #3 Stained soil under load-out line.
