Inspection Photos
Location Name: Fonte 33-21
API Number: 125-09192

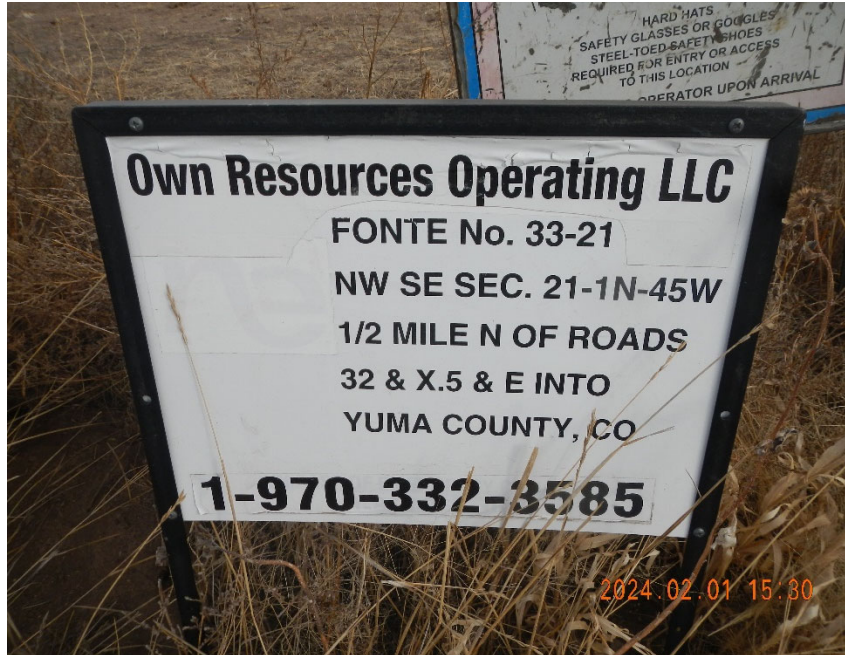
1. Well sign at CR and access two track.

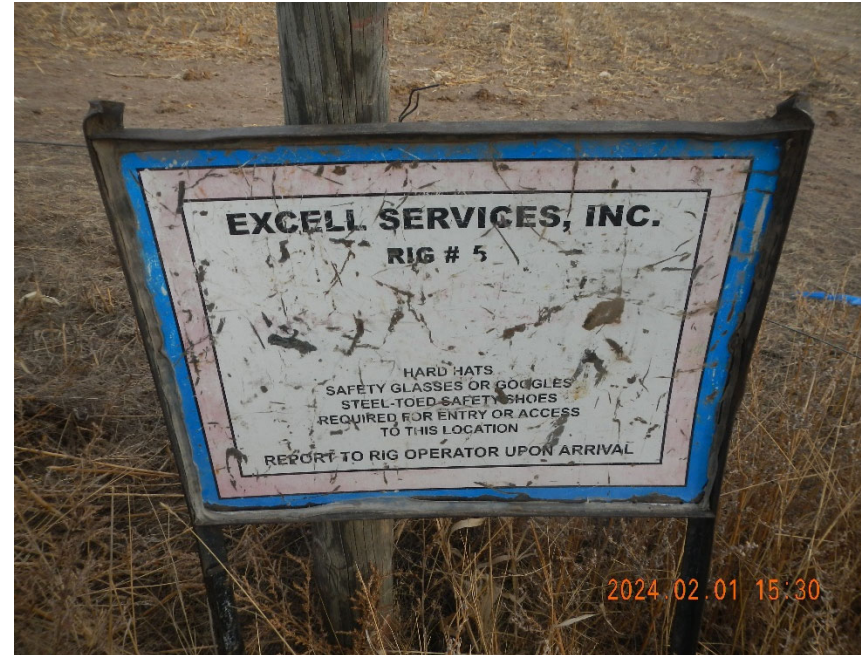
2. Rig sign at CR and access two track.

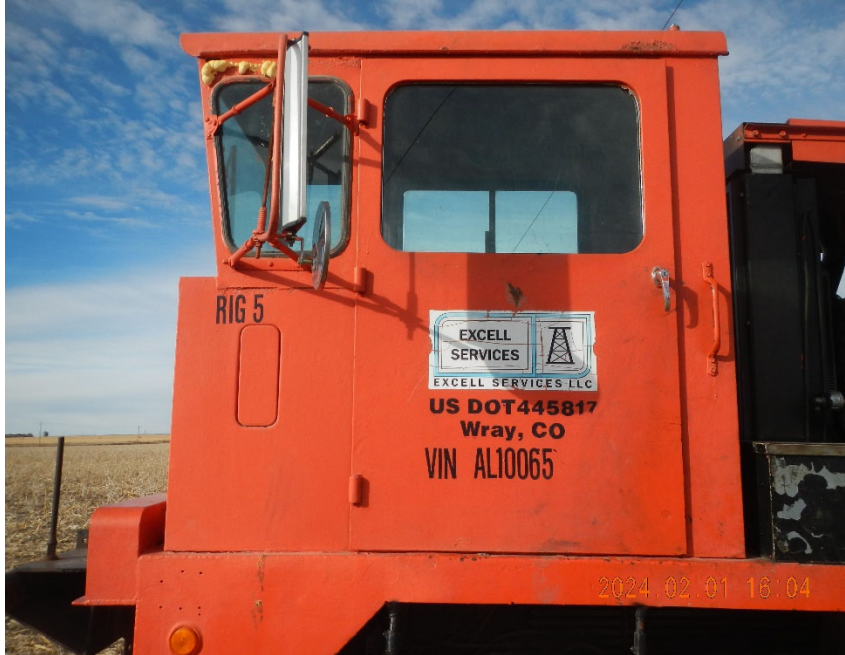
3. Excell Services Rig #5 on well.

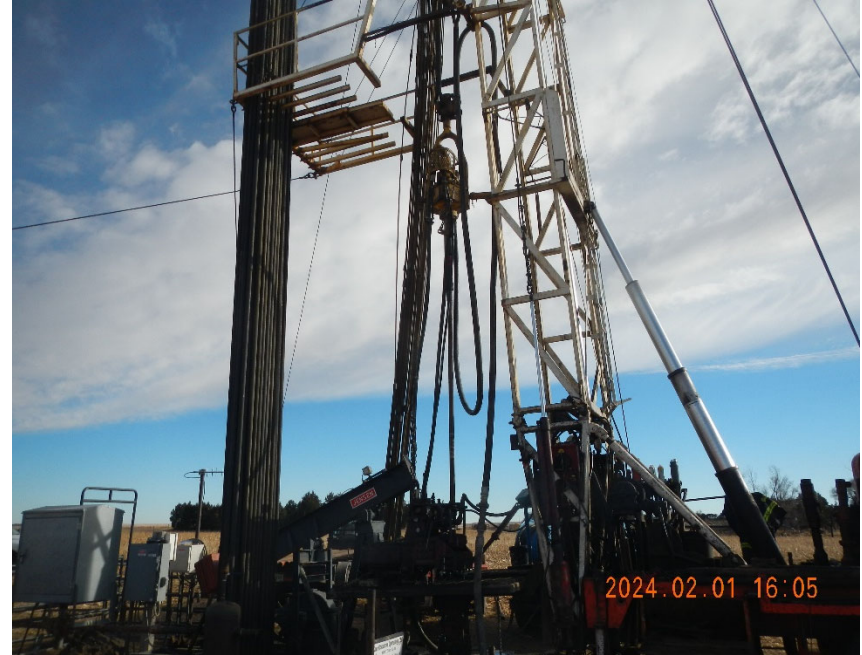
4. Power Swivel hung and running to drill the cement out of production casing.
