## Inspection Photos

Location Name: CAERUS PICEANCE LLC CLEM 15-14 (PA15) Pad

Location #: 324017

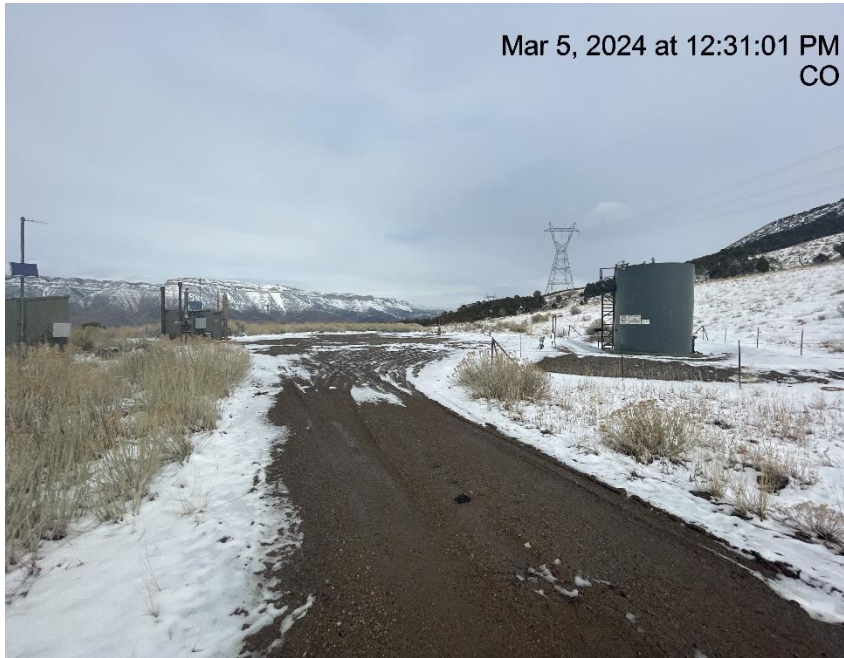
Photo # 8330 From entrance to location

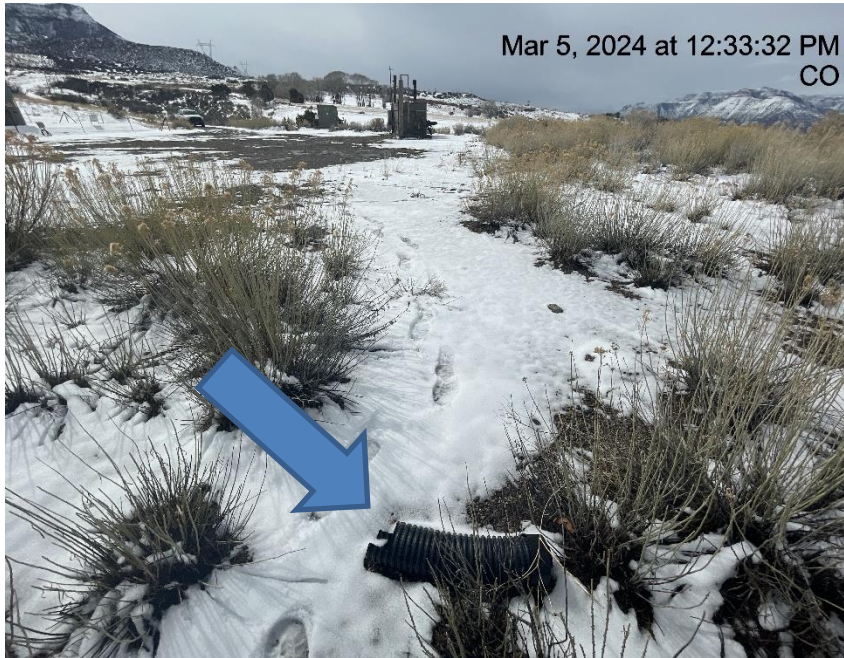
Photo # 8336 Debris
