Final Reclamation and Stormwater Inspection

Operator: NOBLE ENERGY INC - 100322

Location ID: 328321

Inspection Photos
Location Name: N36 - 16 Pad
Location ID: 328321

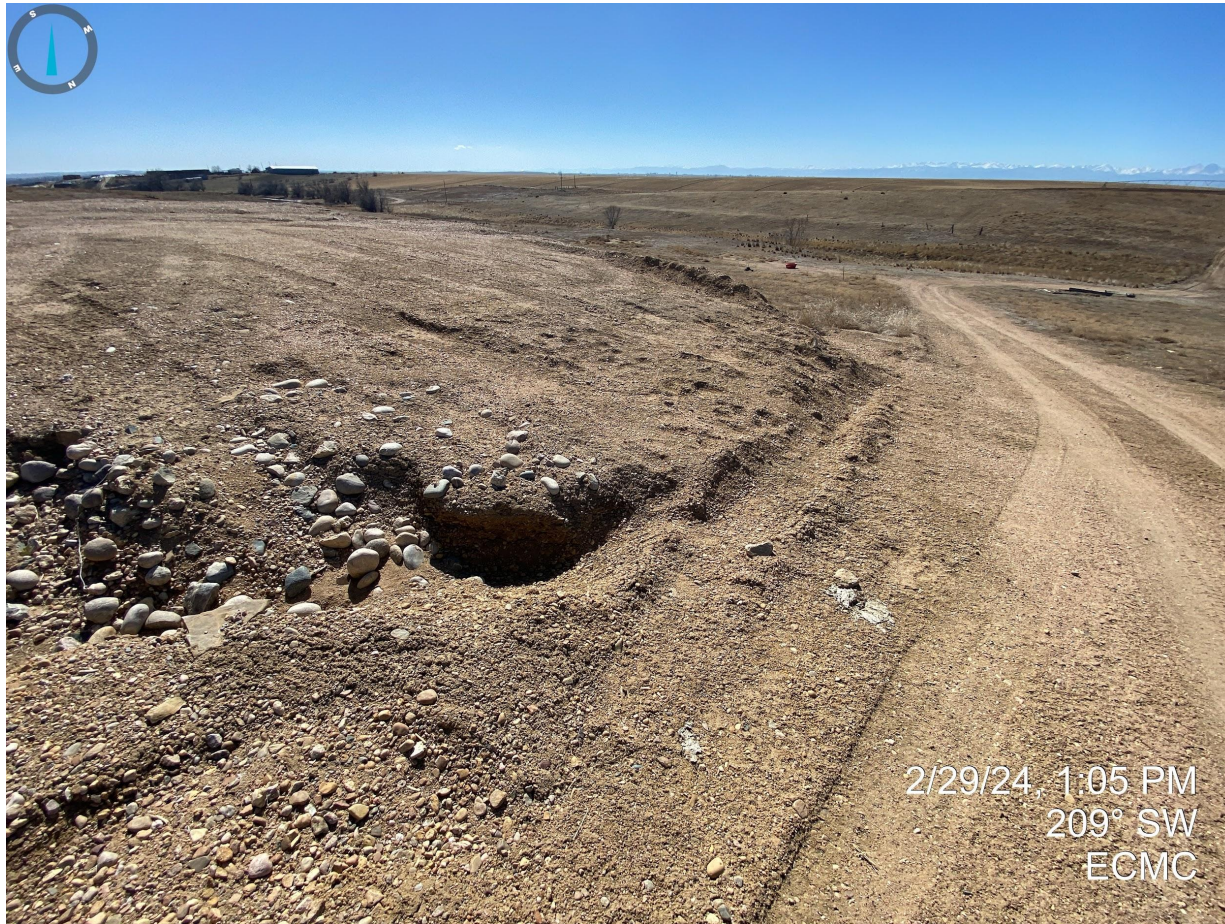
Photo 1. Gully erosion on the north side of the former tank battery location.

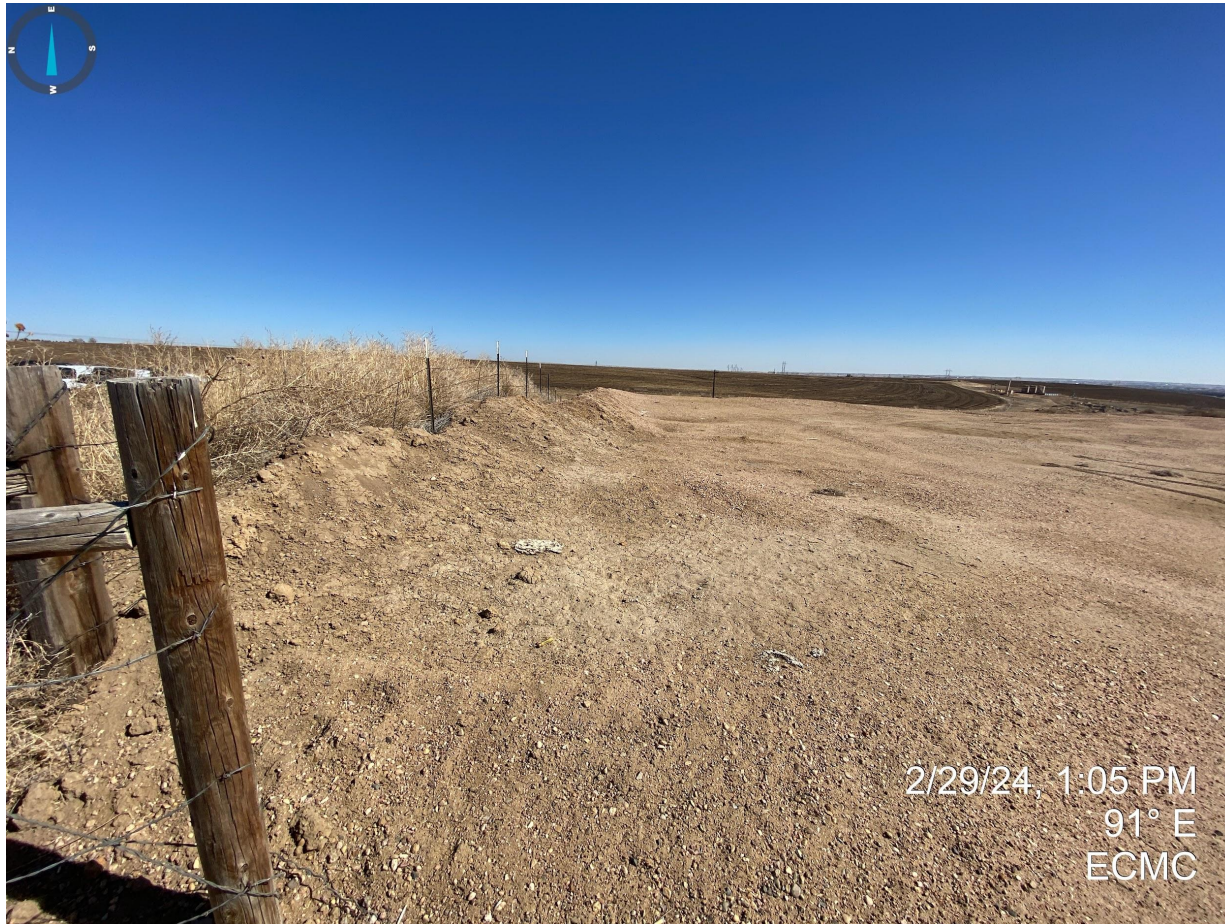
Photo 2. The former tank battery does not appear to have been reclaimed per Rule 1004.

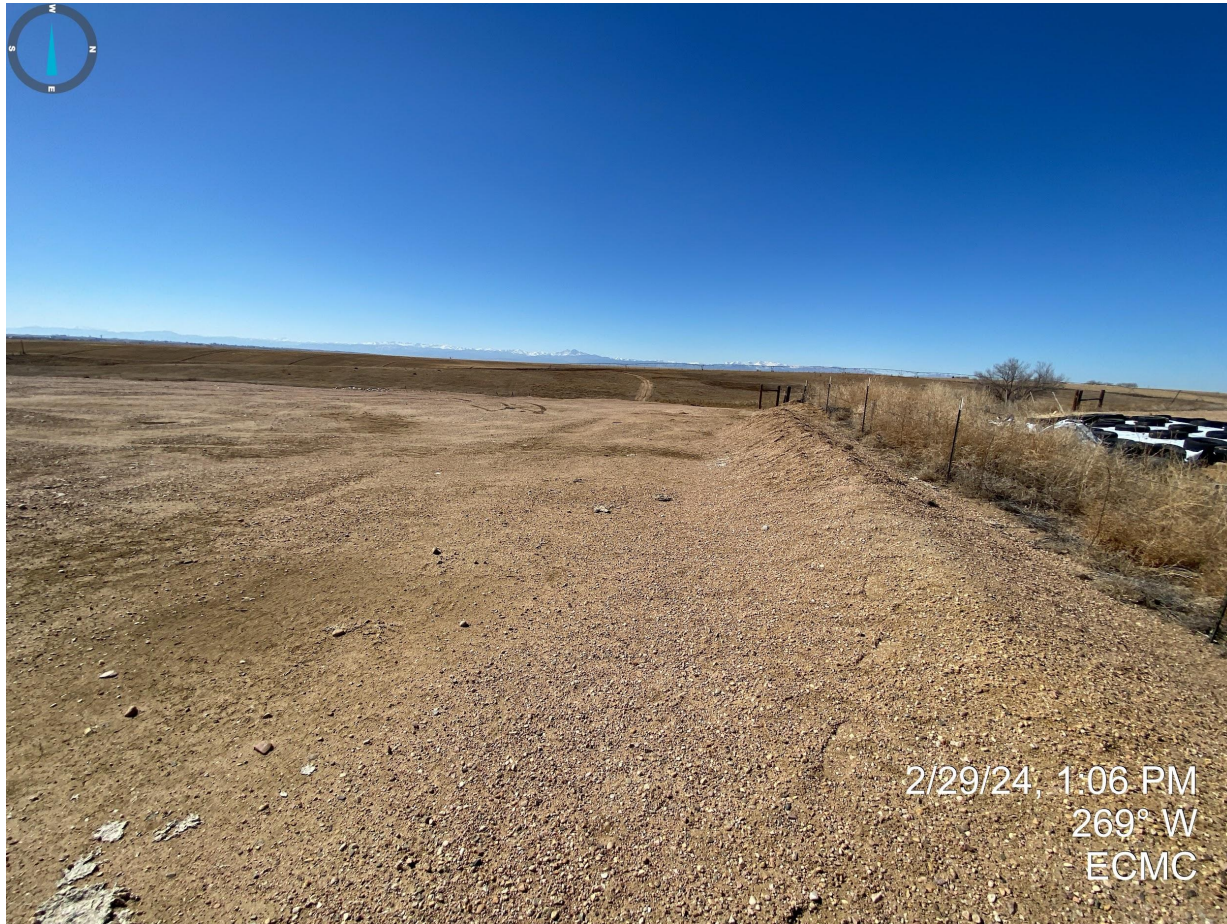
Photo 3. The former tank battery does not appear to have been reclaimed per Rule 1004.

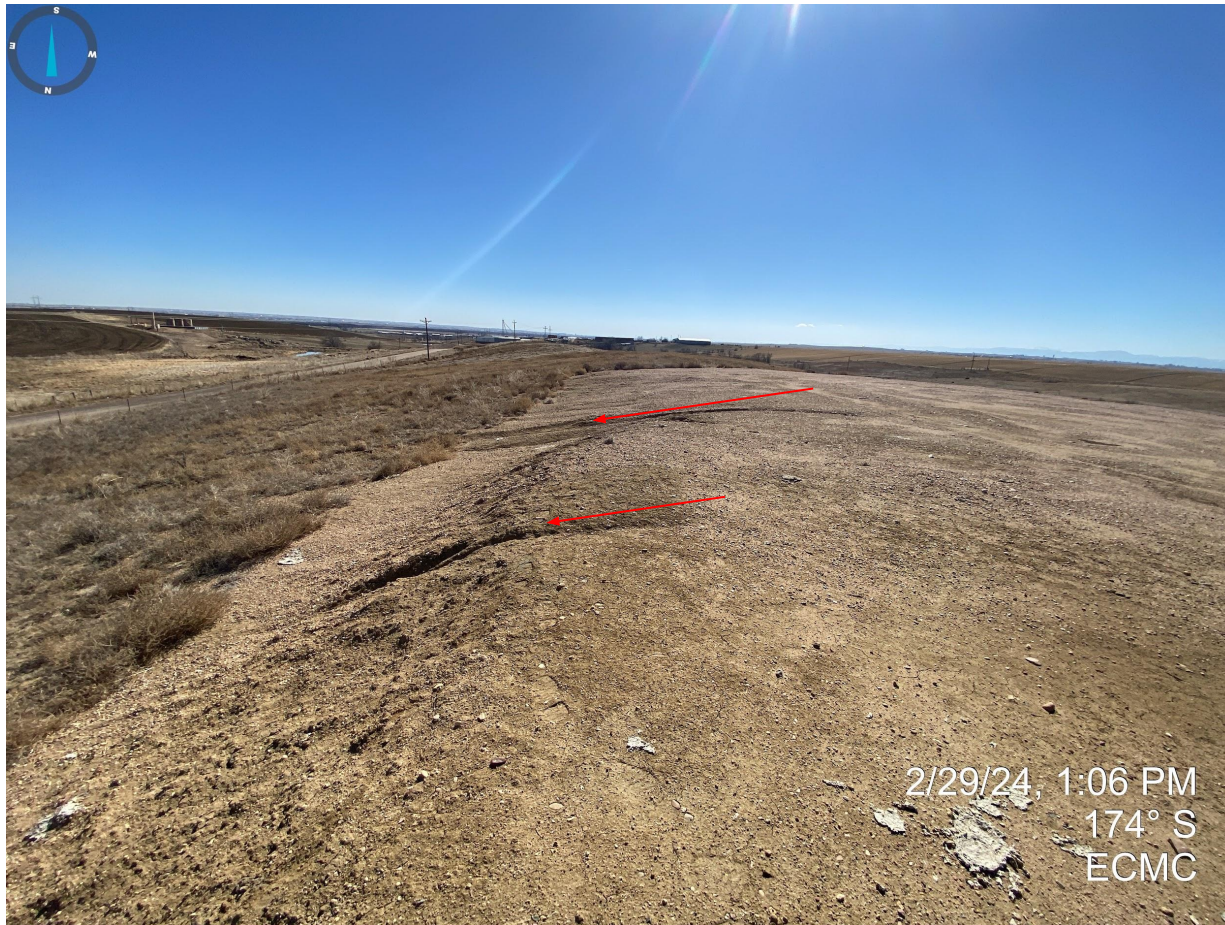
Photo 3. Eastern side of the former tank battery location. Erosion degradation pictured.

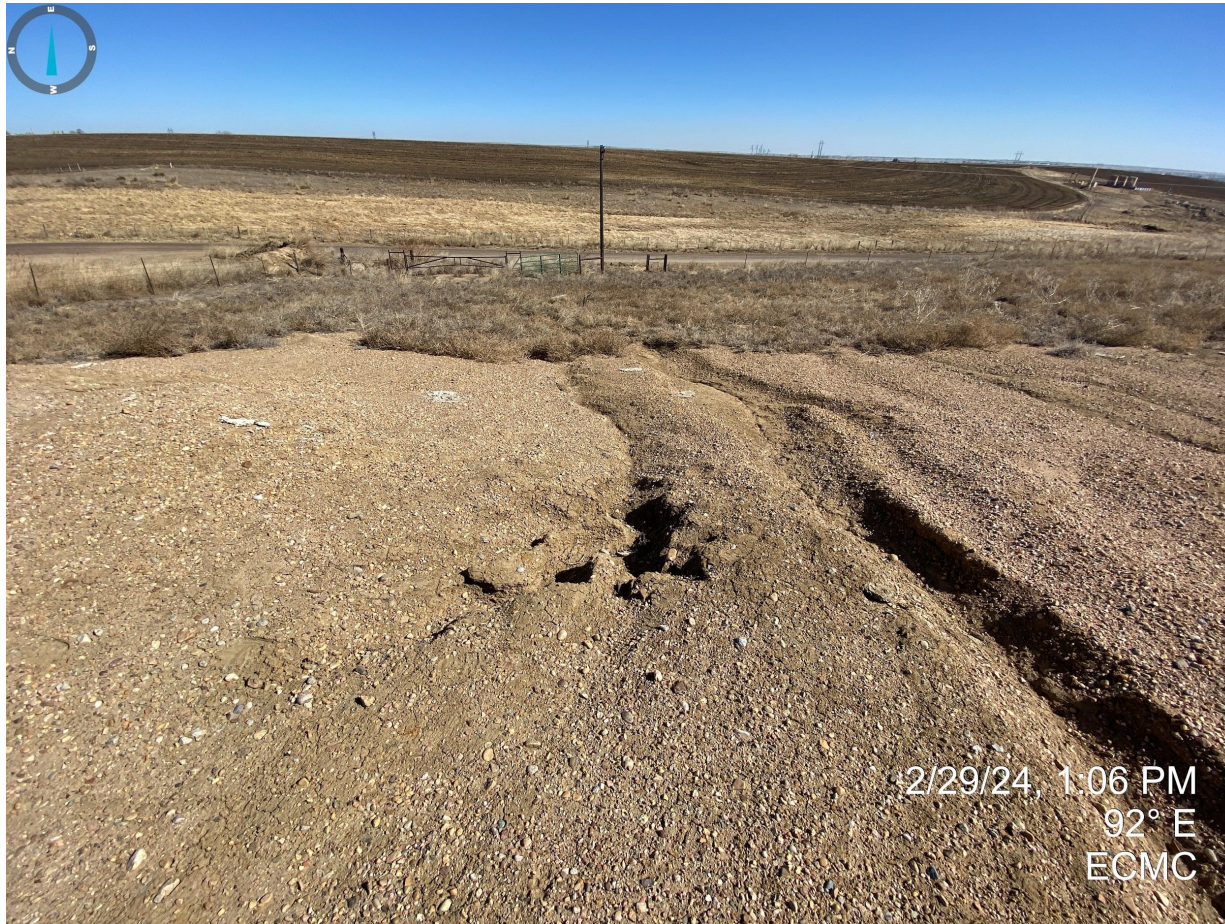
Photo 5. Close up of erosion degradation on the east side of the location.

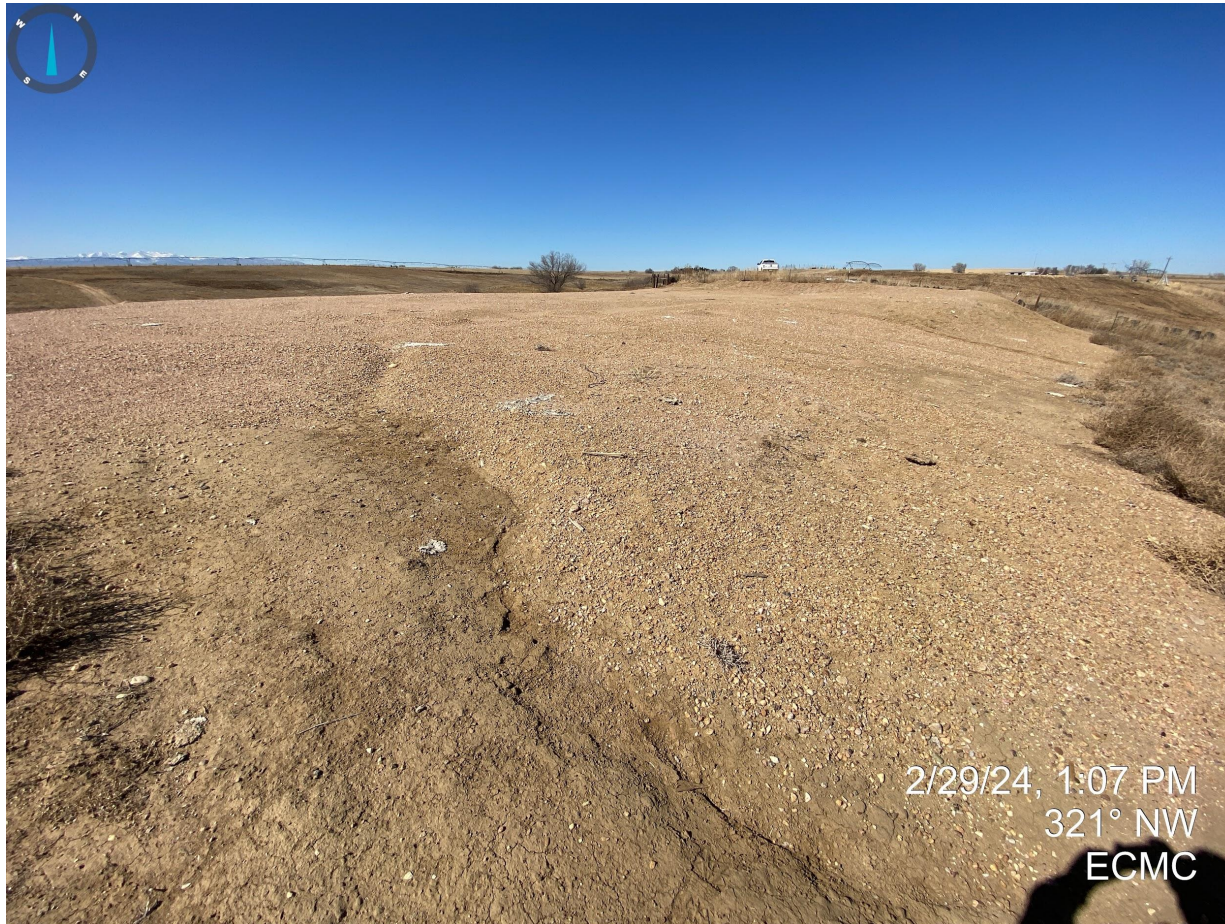
Photo 6. Erosion degradation occurring on the southeast corner of the location.

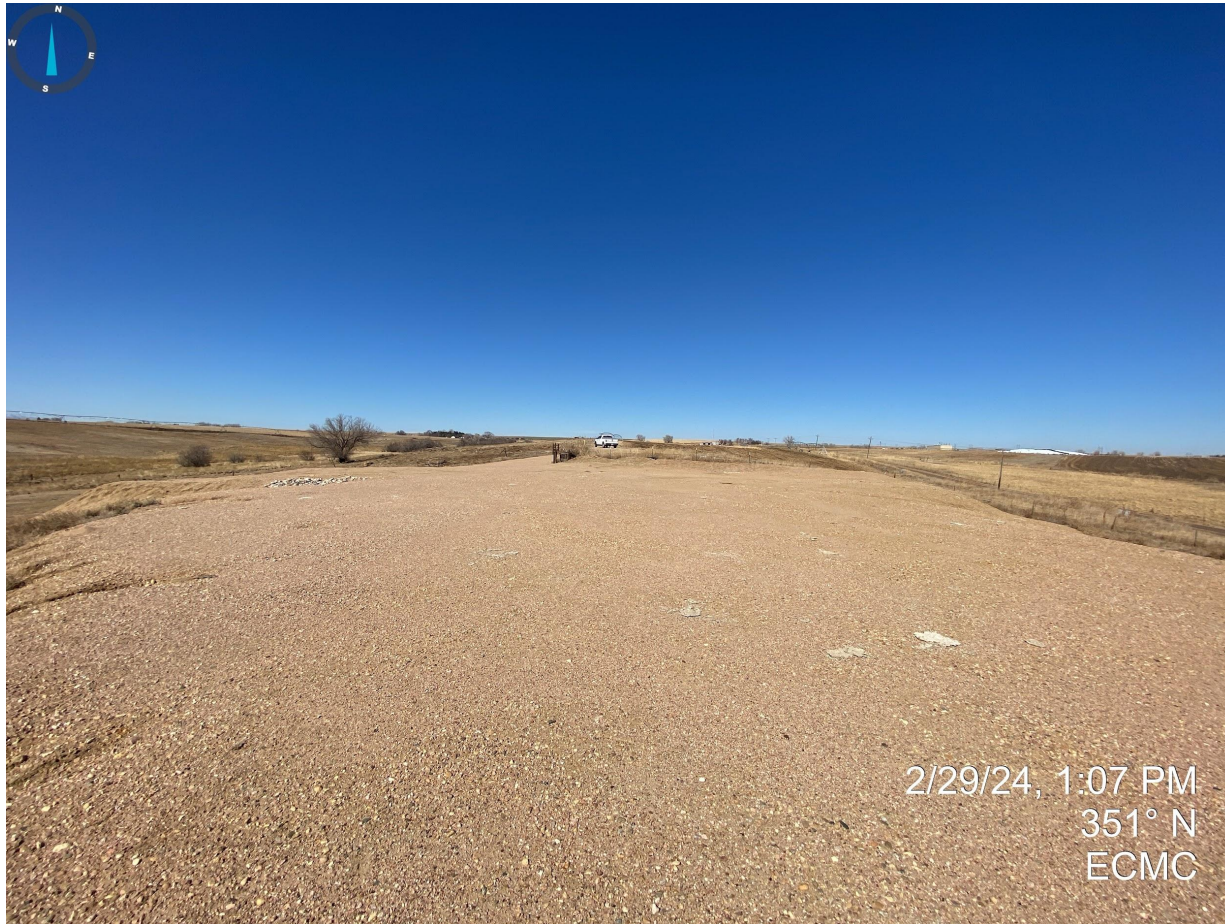
Photo 7. Taken from the southern end of the former tank battery location. The location does not appear to have been reclaimed per Rule 1004.

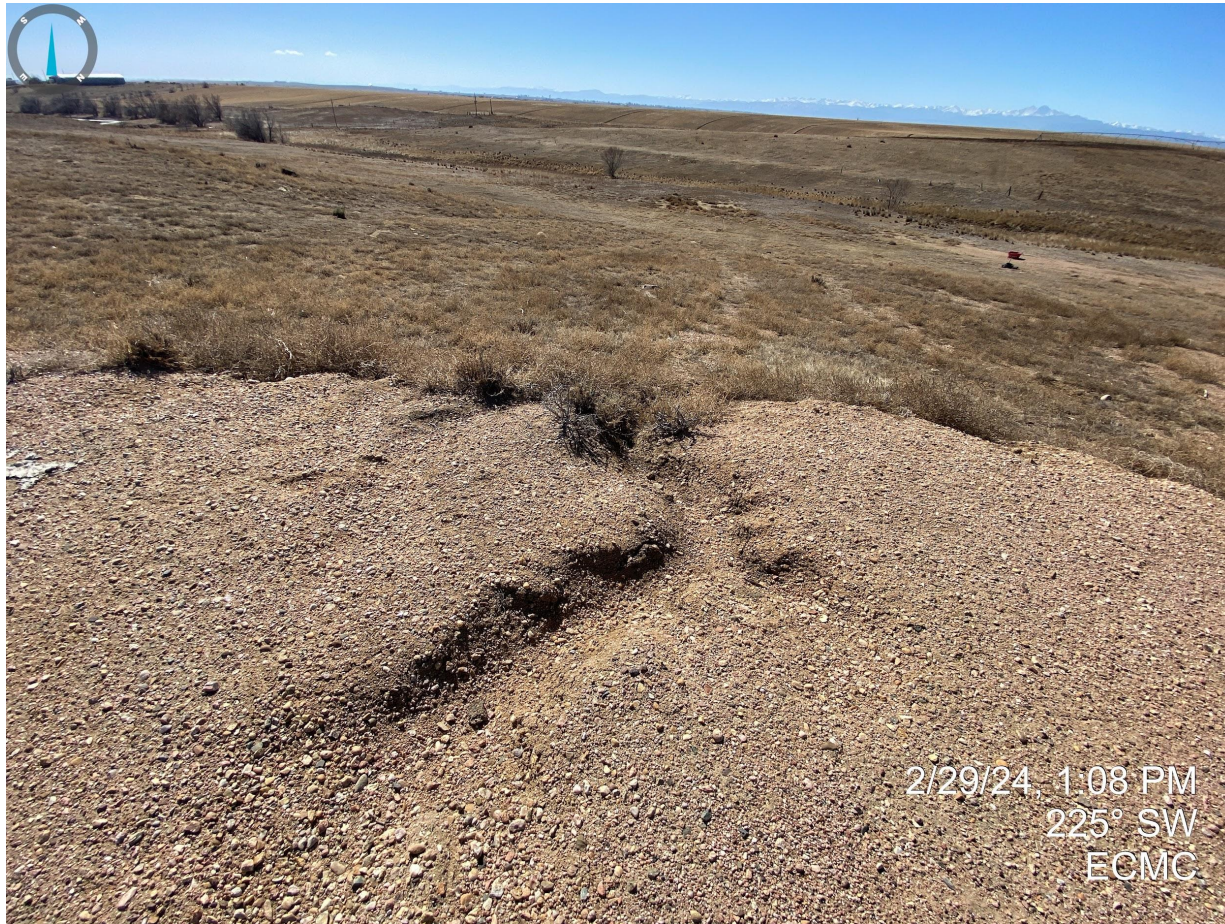
Photo 8. Erosion degradation occurring on the southwest corner of the location.

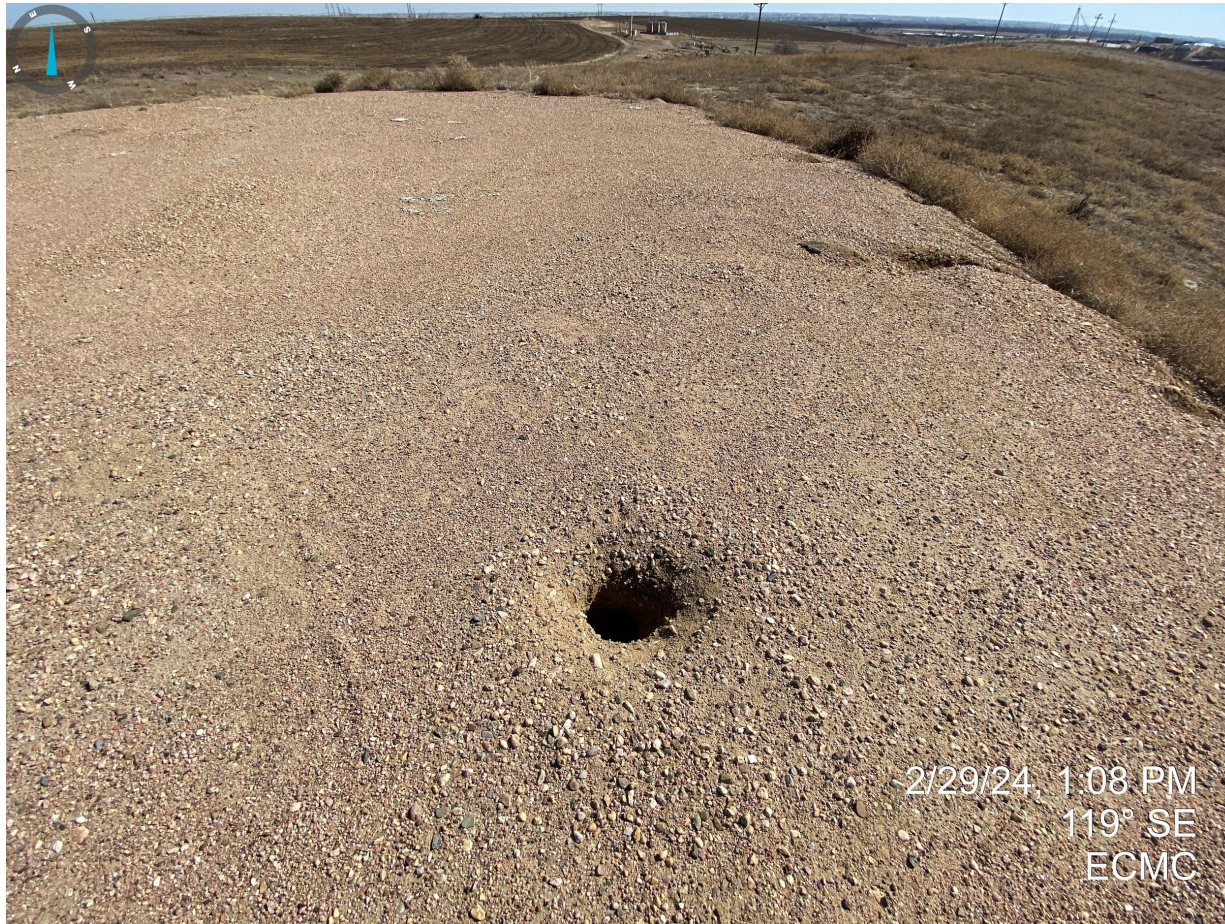
Photo 9. Mouse/rat holes not backfilled, located on the southwest portion of the location.

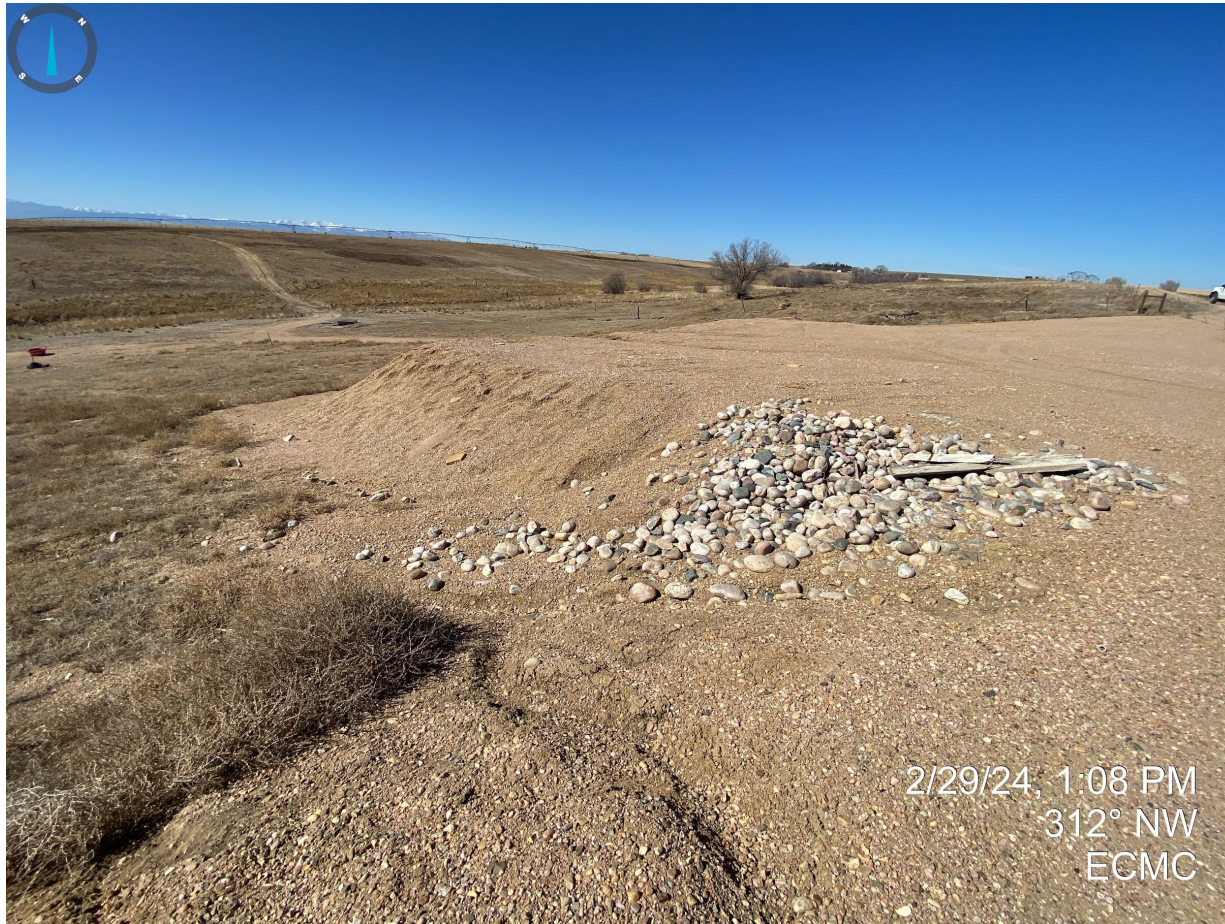
Photo 10. Erosion degradation occurring on the western portion of the location.

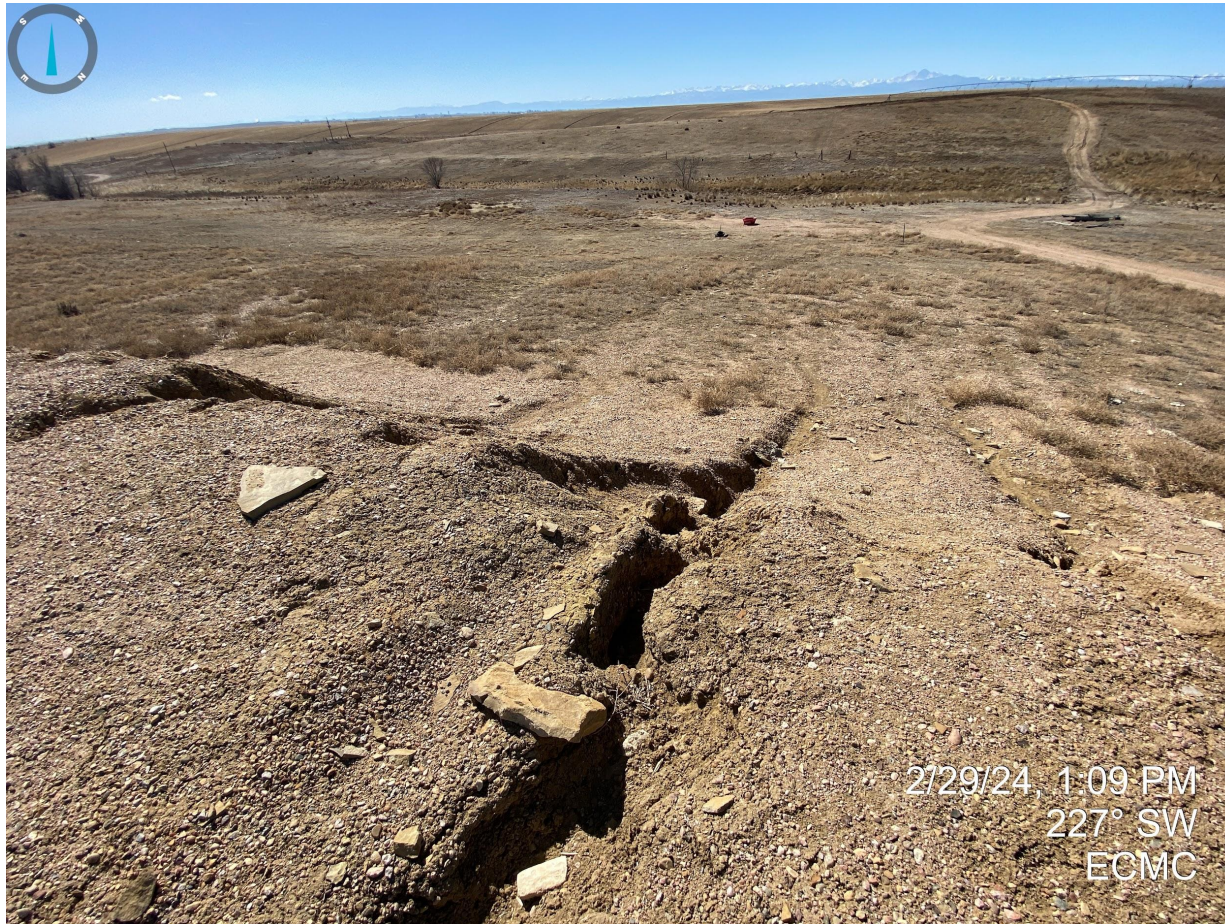
Photo 11. Erosion degradation occurring on the western portion of the location.

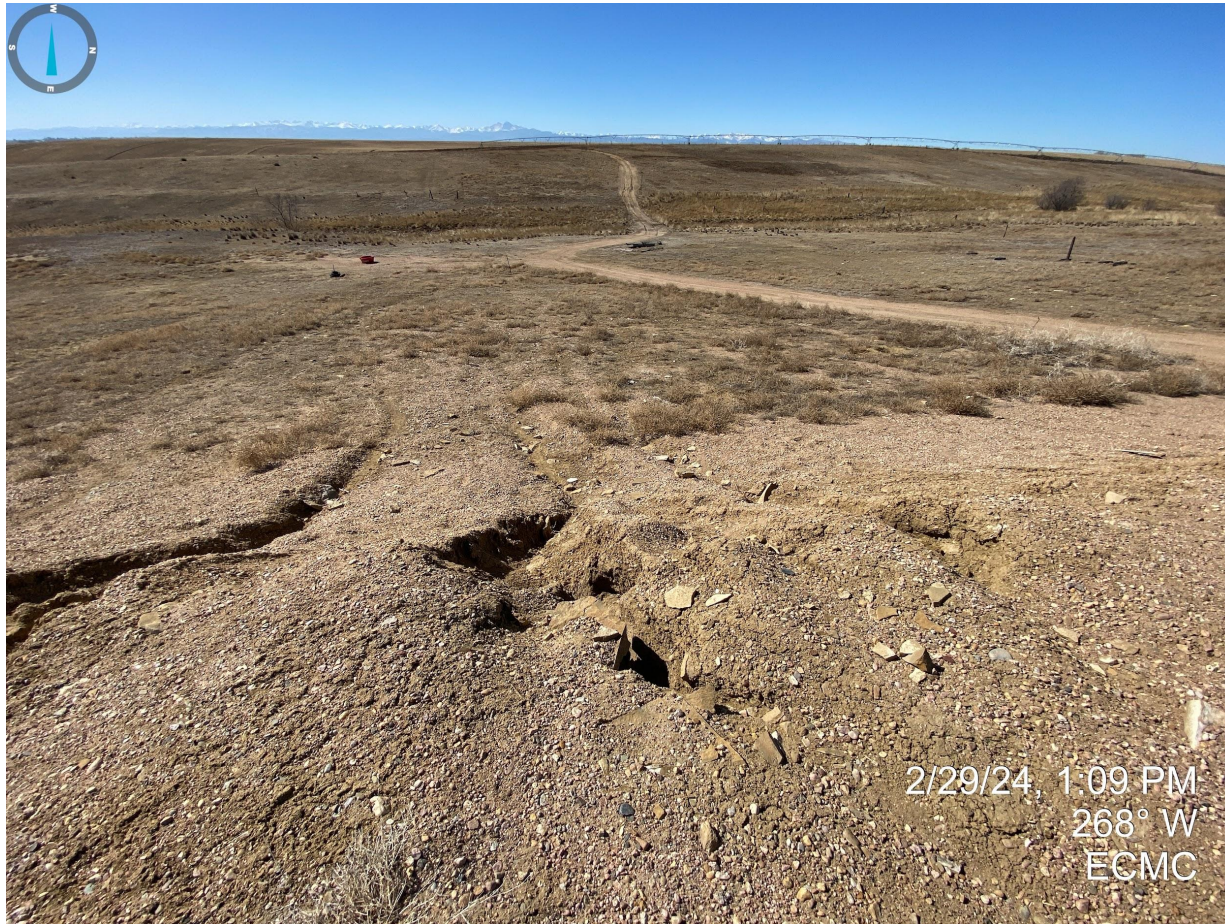
Photo 12. Continued from Photo 11. Erosion degradation occurring on the western portion of the location.

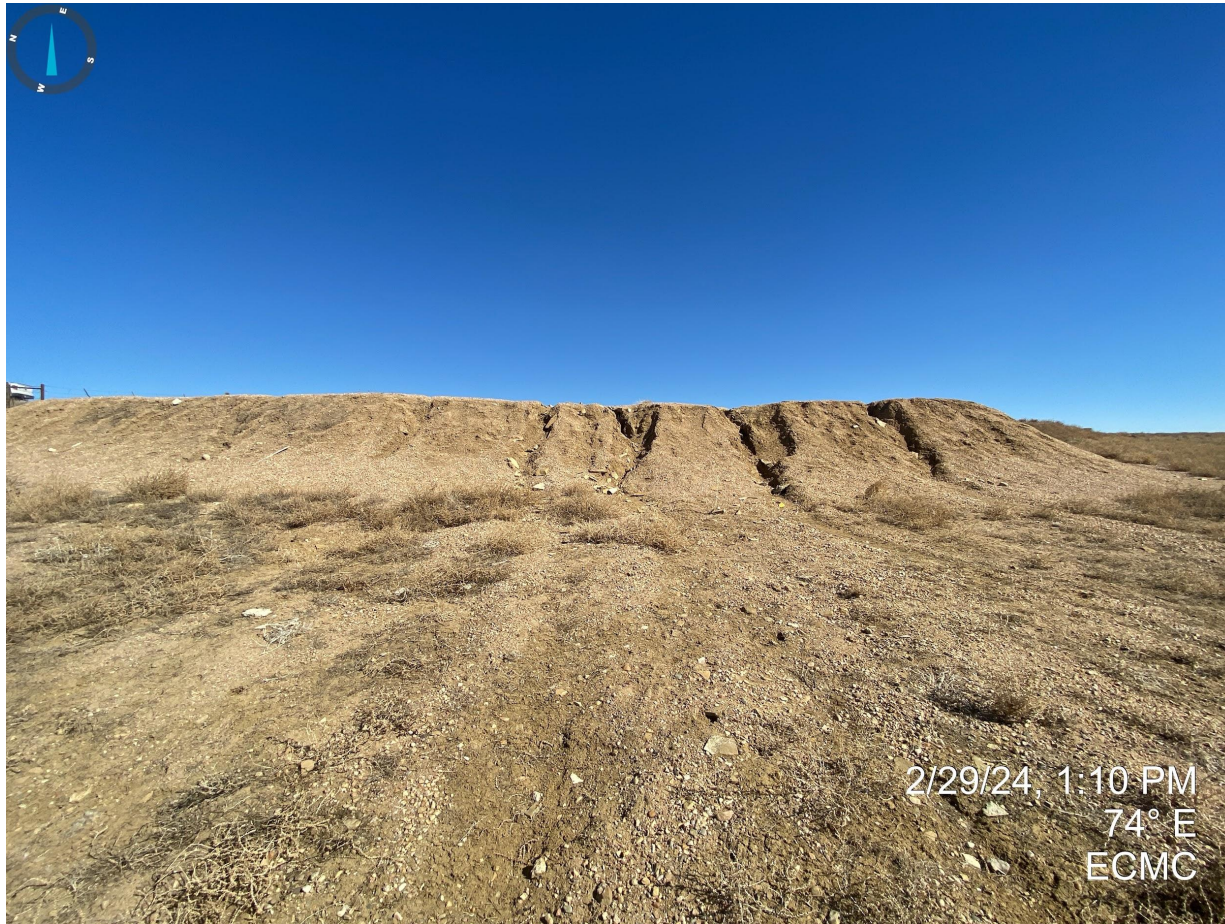
Photo 13. Erosion degradation occurring on the western portion of the location.

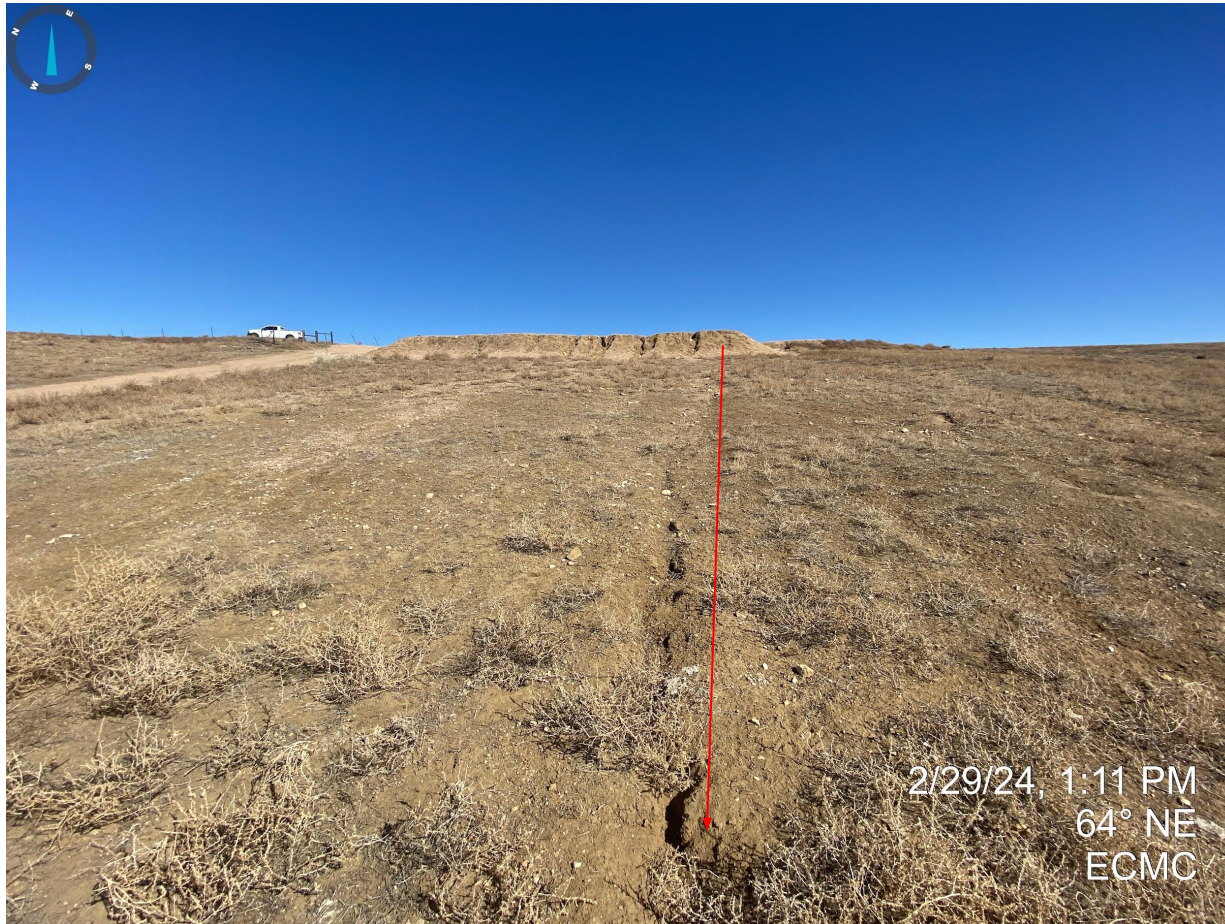
Photo 14. Taken feast of the former location. Erosion degradation occurring outside of the permitted location will need to be properly stabilized and repaired.

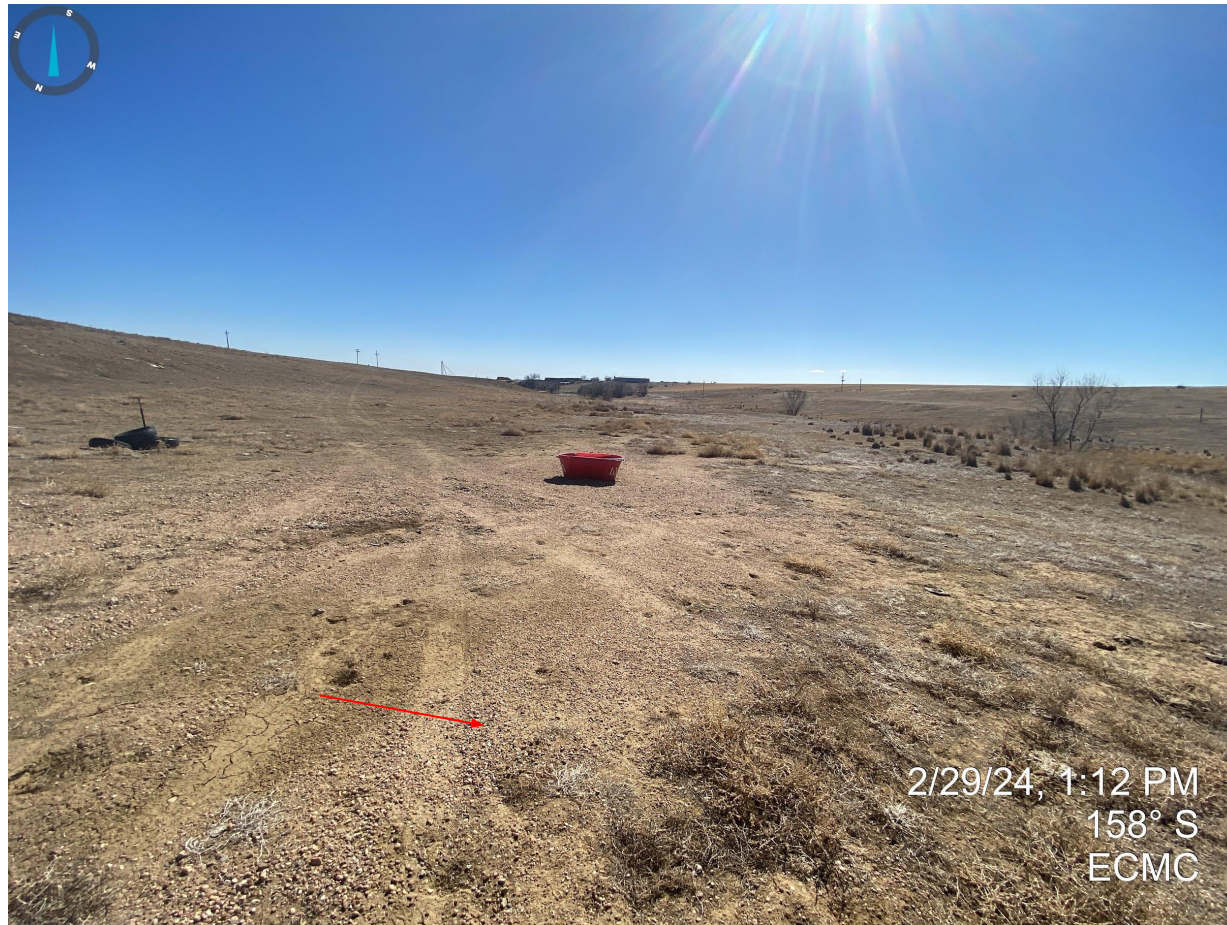
Photo 15. Road base material observed within the former access road footprint.

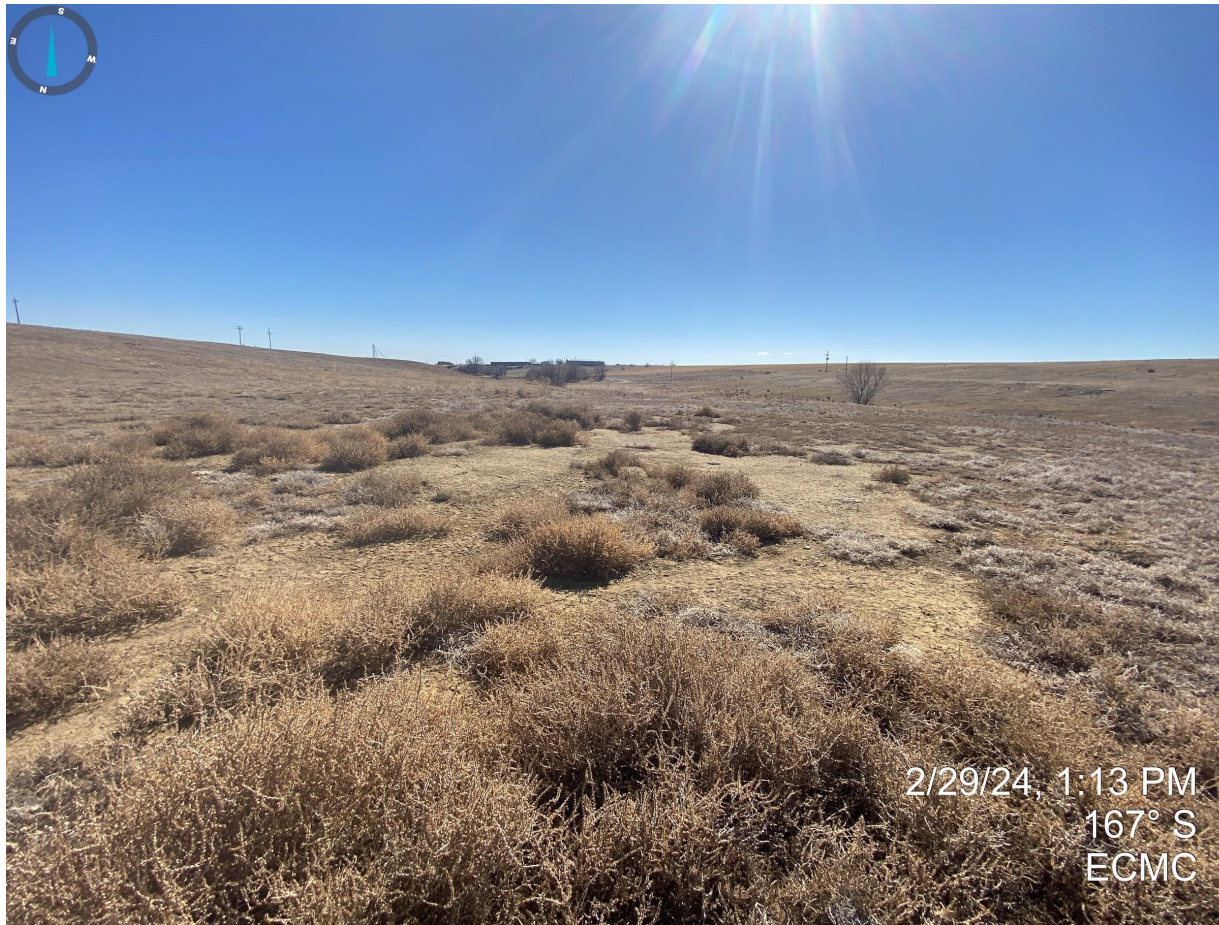
Photo 16. Taken from the northern portion of the former well location. It does not appear the well location has been reclaimed per Rule 1004 with evidence of bare soils and undesirable vegetation.

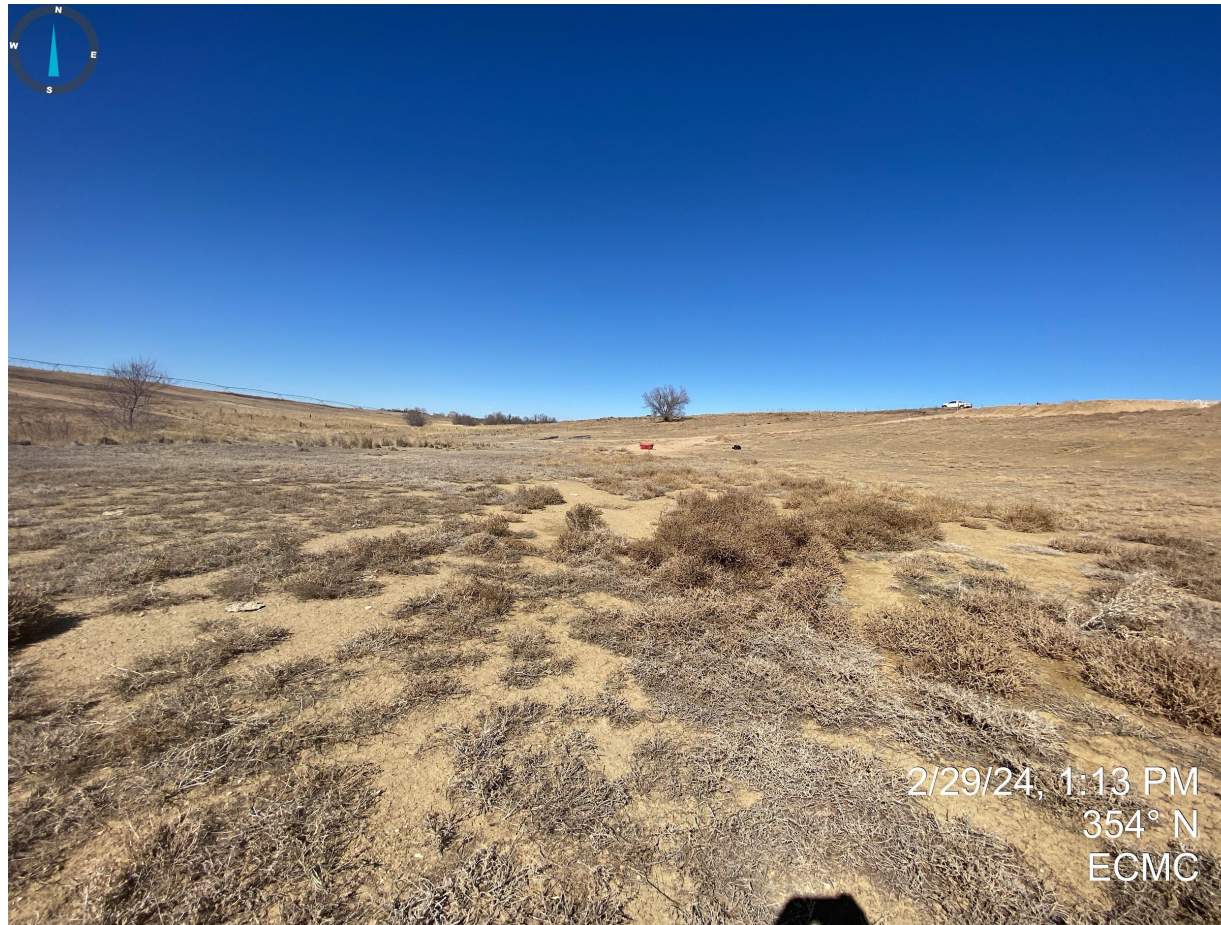
Photo 17. Taken from the southern portion of the former well location; see comments in Photo 16.
